Re: 216 Central Ave., Capitola, CA – Preliminary Design Review Letter
APN. 036-122-22

This letter summarizes the findings of our site visit and provides preliminary recommendations to the subject project's design drawings for conformance with the Secretary of the Interior's Standards for Rehabilitation.

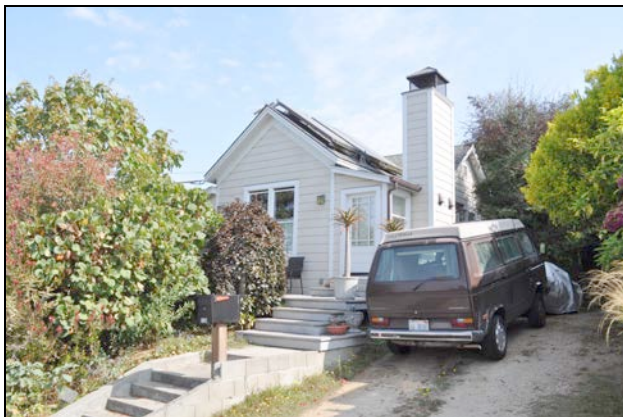
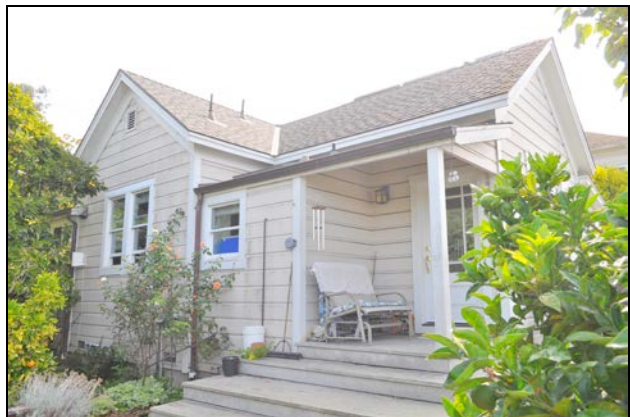
Figures 1 and 2. Left image shows the front (west) elevation, as viewed from the street. Right image shows the left side (north) elevation.

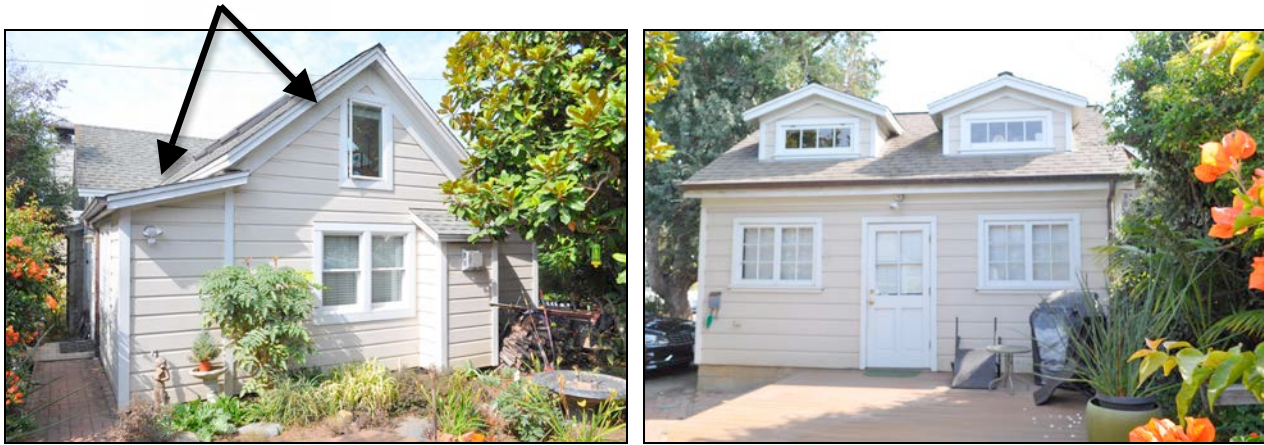
Following the property's relocation to the subject address at 216 Central Avenue, a large rear, gable roofed addition was constructed, removing the post-1915 rear addition (**Figure 3**). The garage was relocated and placed behind the house (**Figure 4**).

Figures 3 and 4. Left image shows the rear (east) elevation, with arrows indicating the large, circa-2000 addition installed behind the side gable roof. Right image shows the relocated garage.
