DATE: March 31, 2020; Revised April 3, 2020

RE: Proposed Rehabilitation and Repair Project, Capitola Wharf, Capitola, CA
Secretary of the Interior's Standards and Historic Integrity Review

FROM: Leslie A.G. Dill, Historic Architect

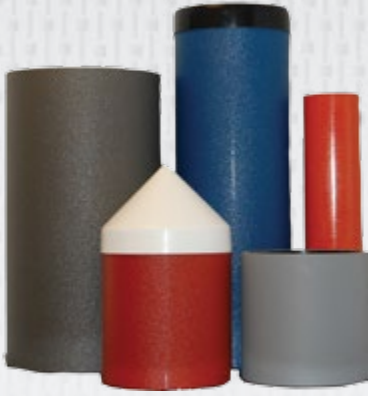
COLOR OPTIONS

The standard color of the FRP pile is black. Custom colors are available upon request. CPI recommends that a UV protection layer be incorporated onto the pile surface if the pile is exposed to UV light and the application is architectural or cosmetic.

The UV protection is available in the form of a paint or polyurethane coating or in the form of a high density polyethylene sleeve.

Polyurethane coatings have an advantage as they provide UV and abrasion protection while exhibiting a textured architectural appearance. Polyurethane and paint coatings are offered in various colors. Consult the factory and talk to a representative to determine the best UV protection option for your installation.

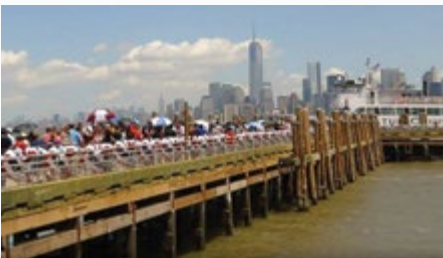
As an example, after Hurricane Sandy, the Federal Highway Administration (FHWA) replaced the visitor and service docks on Liberty Island, NY with new docks made of FRP and wood. The FHWA engineers specified polymer piles to be used for the bearing piles in order to increase the service life of the structure. The piles were driven to refusal and filled with concrete. The dock structure was erected and the wood plank decking attached.

Engineers and owners are discovering the benefits of using FRP piles in the splash zone. This exercise will significantly increase the service life of your structure.

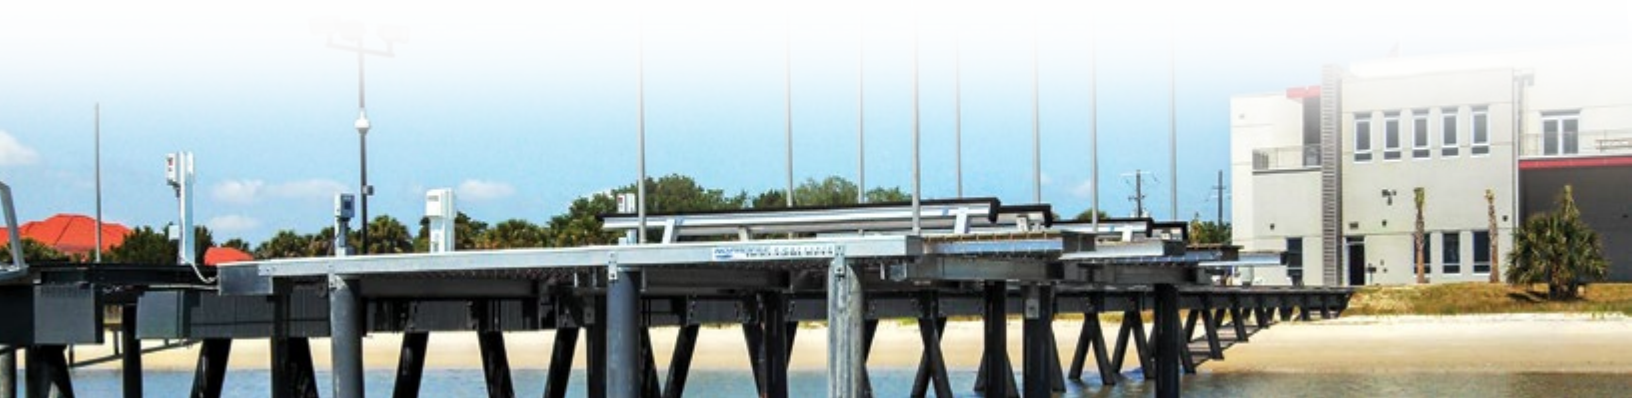
Another example of engineers and owners taking advantage of FRP materials involves the construction of an all composite fire boat dock in Jacksonville, Florida. The dock was designed for a category three hurricane direct hit, as the structure is critical for the fire department rescue team.

SUPERPILE® supports the boat lift. The substructure is made of FRP pultruded channels and beams that support the pultruded grating walkway that extends from the firehouse to the boat lifts.
