P A S T
CONSULTANTS LLC

November 11, 2021

Re: 1410 Prospect Ave., Capitola, CA – SOI Standards Design Review Letter
APN. 034-046-19

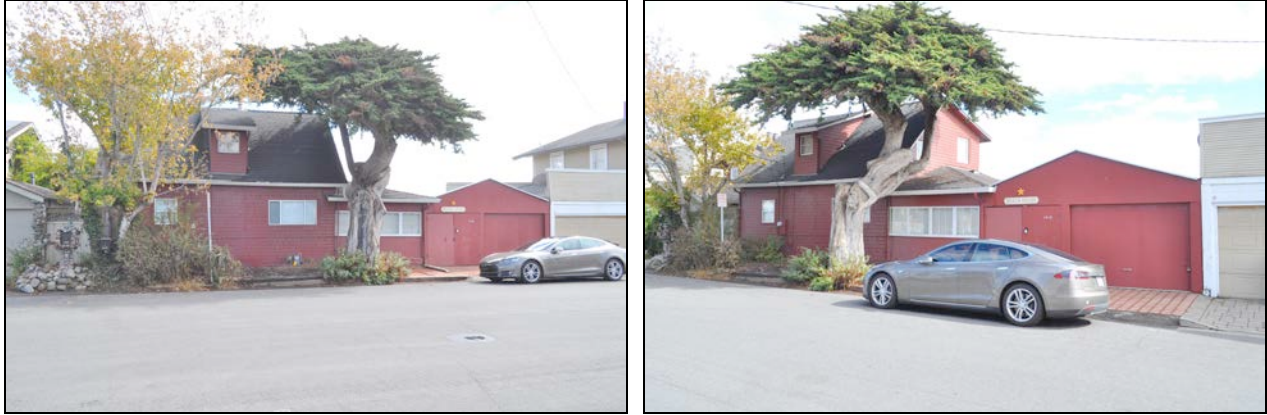
Figures 1 and 2. Left image shows the Prospect Avenue (west) elevation, as viewed from the street. Right image details the west elevation, showing the false-front, gable-roofed garage.

The site contains a highly modified two-story house (circa-1905) constructed in the Vernacular Style. The building has an altered, asymmetrical primary gable roofline with a west-elevation (Prospect Ave.) dormer addition, a detached, gable-roofed garage, an east elevation containing banked windows, and a mixed fenestration pattern consisting of single-pane fixed and wood-sash windows of varying eras. Wall cladding is primarily square-cut, wood-shingles, with plywood boards finishing the circa-1991 garage (**Figures 1 - 4**).

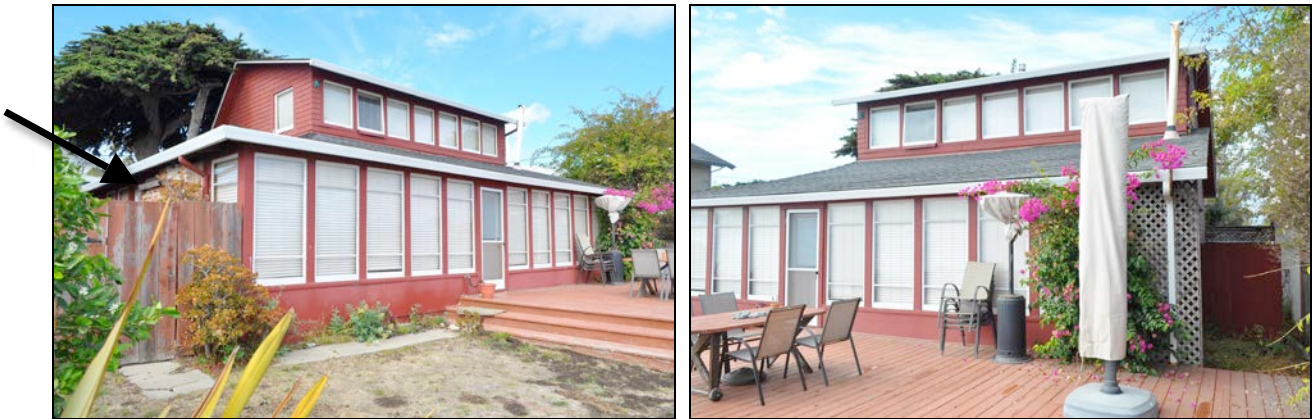
Figures 3 and 4. Left image shows the asymmetrical roofline of the Monterey Bay (east) elevation. The clipped brick chimney is on the south elevation (arrow). Right image details the banked windows of the east elevation.

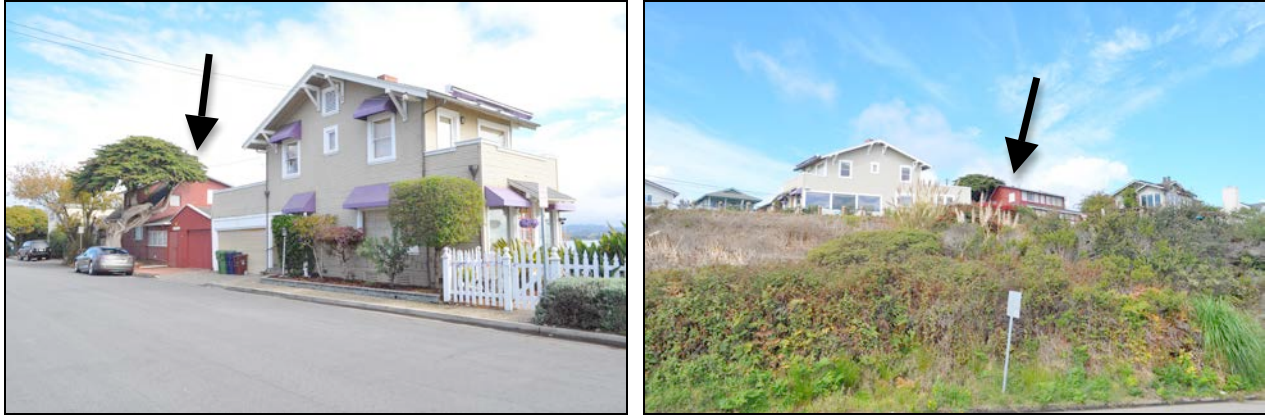
Figures 5 and 6. Left image shows the rhythm of gable roofs and false front roofs along Prospect Avenue, looking north, with the subject property indicated by an arrow. Right image views the variety of historic rooflines along the ridge looking northwest from Cliff Drive.

The established visual setting includes the varying pattern of building volumes, largely expressed in wood, that exist along Prospect Avenue. In addition, the variation of historic rooflines of the hillside location, as viewed from Monterey Bay, also represents a long established feature of the city (**Figures 5 and 6**).
