## **2021 Pavement Condition Study Final Report Casco, Maine**

PREPARED FOR:  
Town of Casco  
635 Meadow Road  
Casco, Maine 04015

SUBMITTED BY:  
Gorrill Palmer  
707 Sable Oaks Drive  
Suite 30  
So. Portland, ME  
04106 207.772.2515

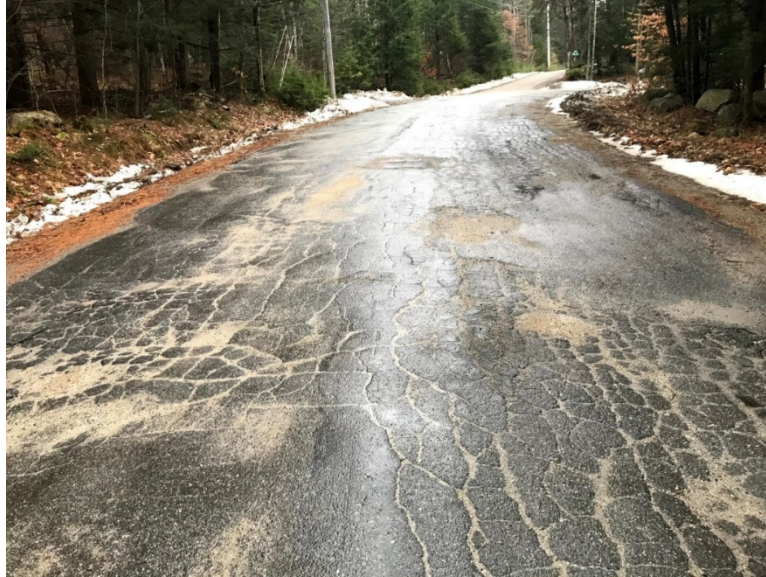
- Alligator Cracking: A series of interconnected cracks in the pavement resembling alligator skin or chicken wire. This type of cracking is typically caused by repeated traffic loadings and often indicates fatigue failure.

Alligator Cracking – New Road

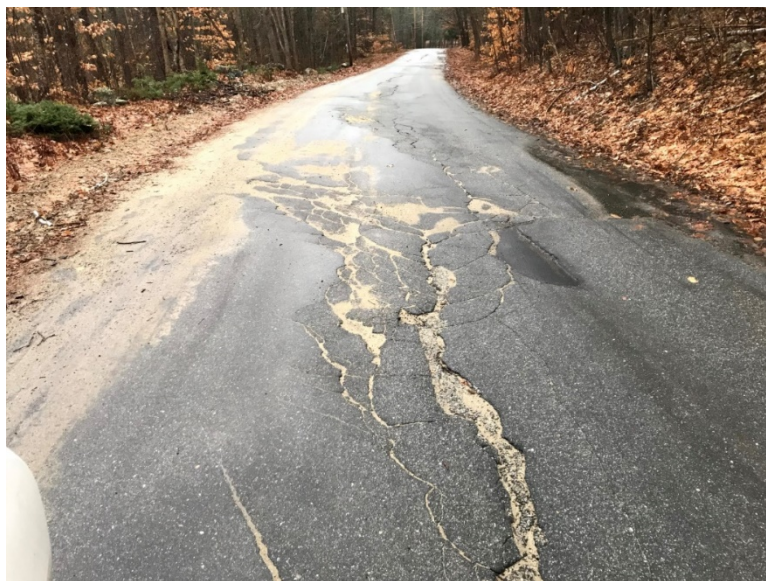
- Longitudinal/Transverse Cracking: Cracks running parallel and/or perpendicular to the roadway. These types of cracks are typically caused by inadequate support, reflection of underlying layers, or a precursor to alligator cracking.

Longitudinal Cracking – Burgess Road

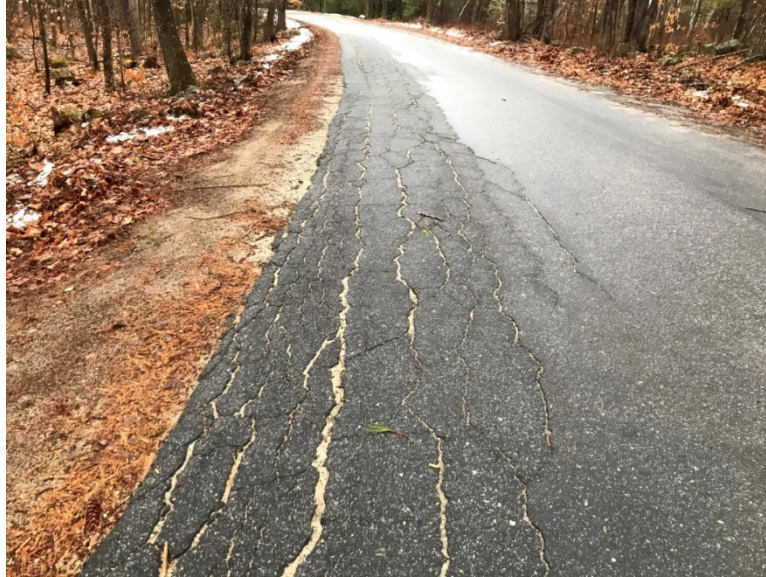
- Edge Cracking: Cracks begin parallel to and within 24 inches of the pavement edge. Cracking is either a fairly continuous straight crack or crescent-shaped cracks in wave-formation. Edge cracking can be caused by the lack of adequate road shoulders or damaged shoulders due to erosion or other causes.

Edge Cracking – Jim Small Road

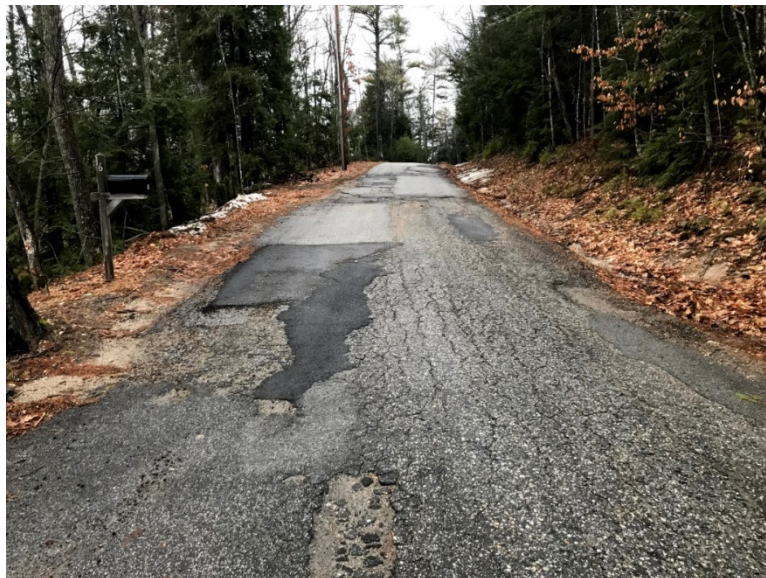
- Patching/Potholes: Patching is where original pavement has been replaced, but patch is failing. Potholes are where pavement has broken, leaving a bowl-shaped depression. A pothole is either not patched, or the patch is failing.

Patching/Potholes – Stone Road

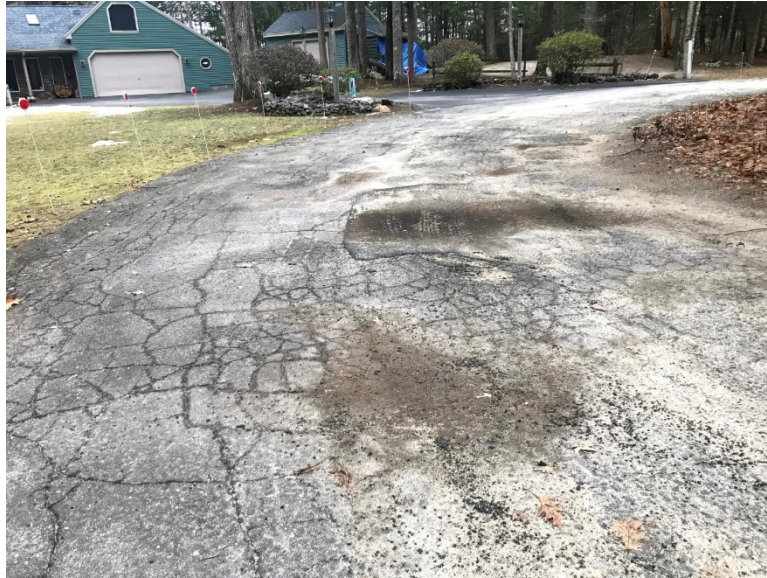
- Roughness: Uneven roadway surface that affects the comfort of the ride.

Roughness – Ward Circle

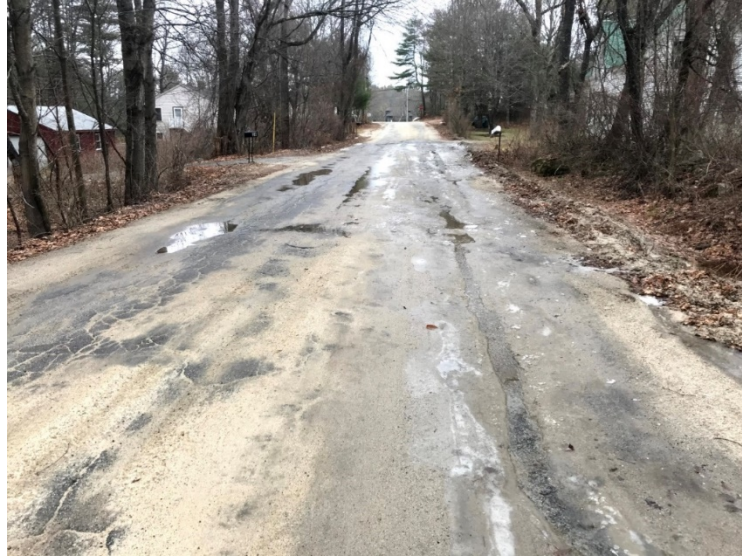
- Roadside Drainage: Proper drainage allows water to flow off the pavement freely and allows water in the pavement subbase to drain and be conveyed away from the road. Lack of drainage often results in damage to the pavement structure, either through frost heaving, resulting in pavement cracking, or weakened subbase resulting in structural damage to the pavement system.

Roadside Drainage – South Casco Village Road

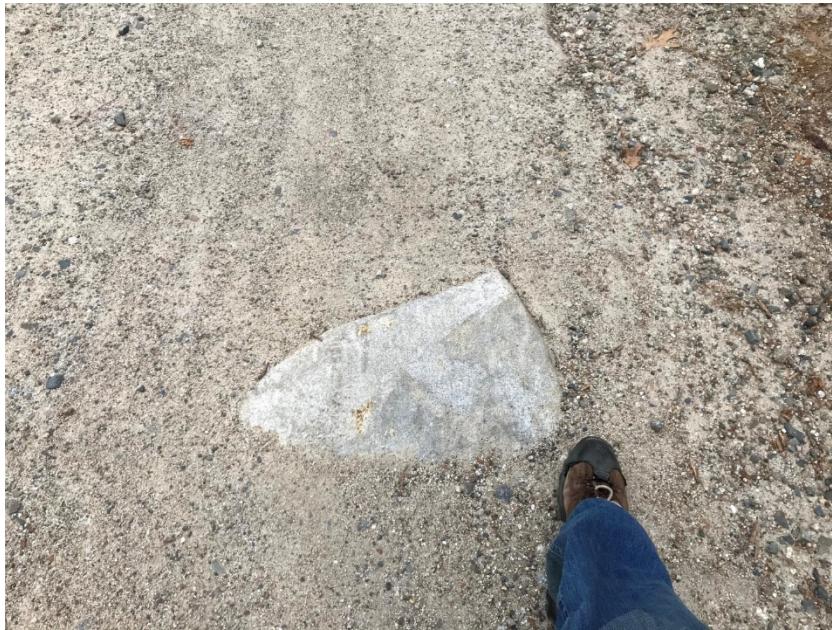
- Rock/Clay: Rocks larger than 6" and/or areas of clay in the road surface. Road lacks any apparent and suitable base material, and/or natural materials provide no support for anticipated traffic loading.

Rock/Clay – Lord Road

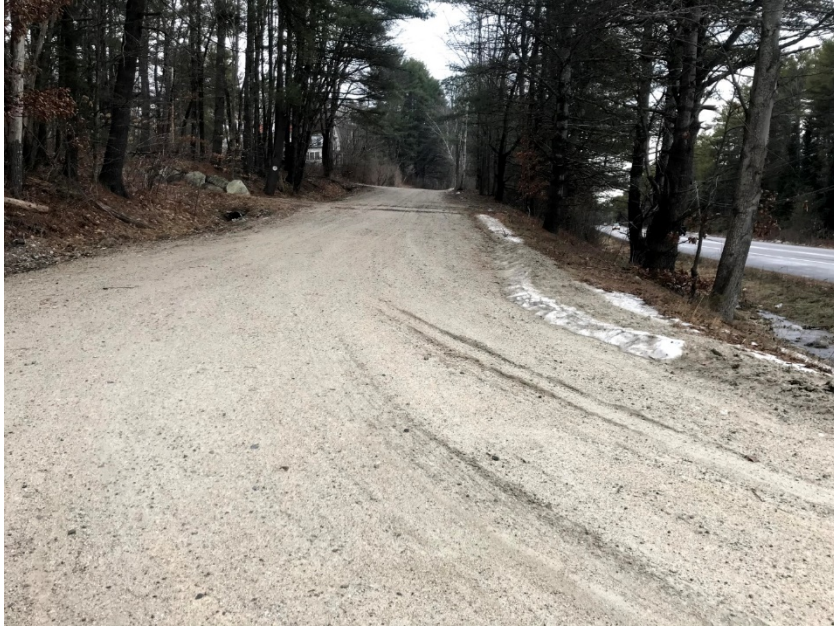
- Rutting: Long, narrow depressions caused by a vehicles' tires.

Rutting – Bramble Hill Road

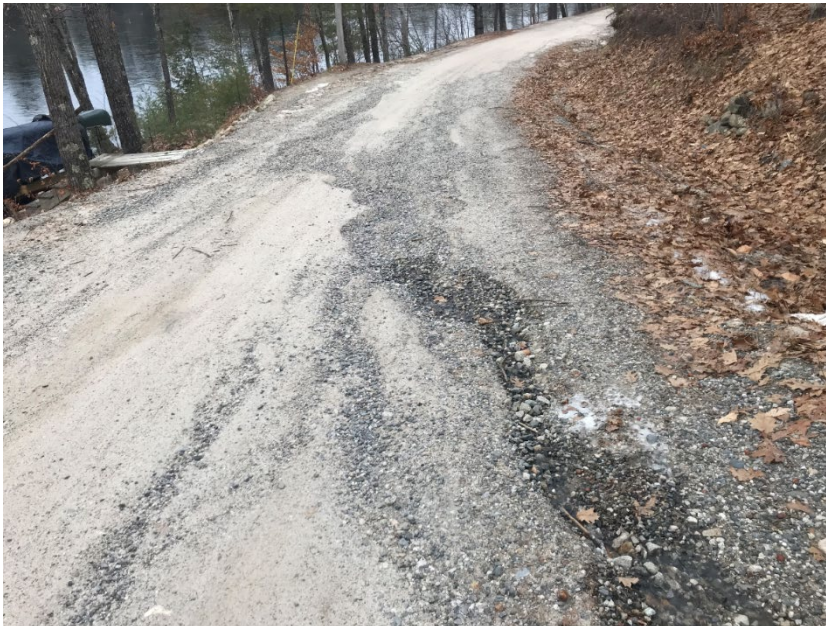
- Loose Aggregate: Loose material on the road surface.

Loose Aggregate – Lord Road

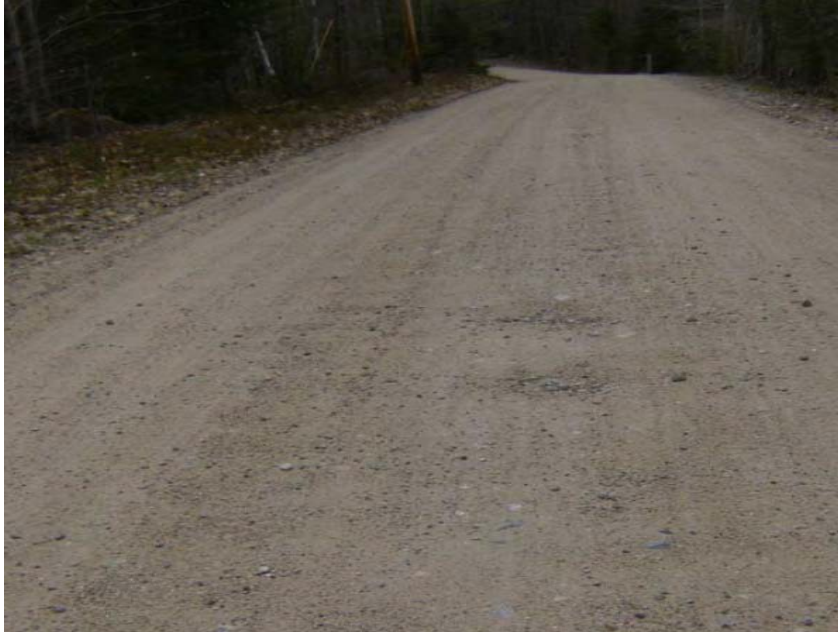
- Corrugations: A series of bumps perpendicular to the road surface, resembling a washboard.

Corrugations – Maine Local Roads Center (2011)

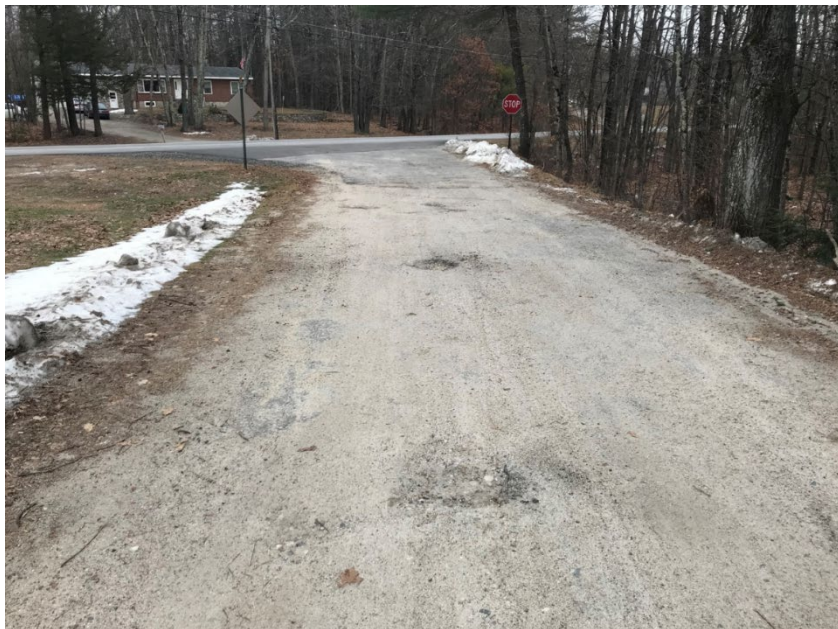
- Potholes: Areas where the road surface has eroded leaving a bowl-shaped depression

Potholes – Varney Road

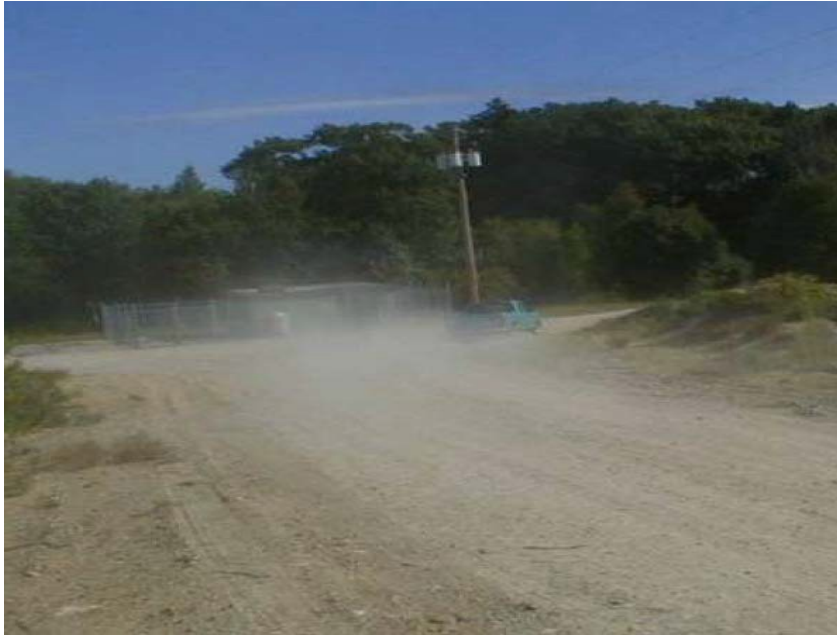
- Dust: Fine particles that are raised by wind or vehicular traffic, reducing visibility.

Dust – Maine Local Roads Center (2011)

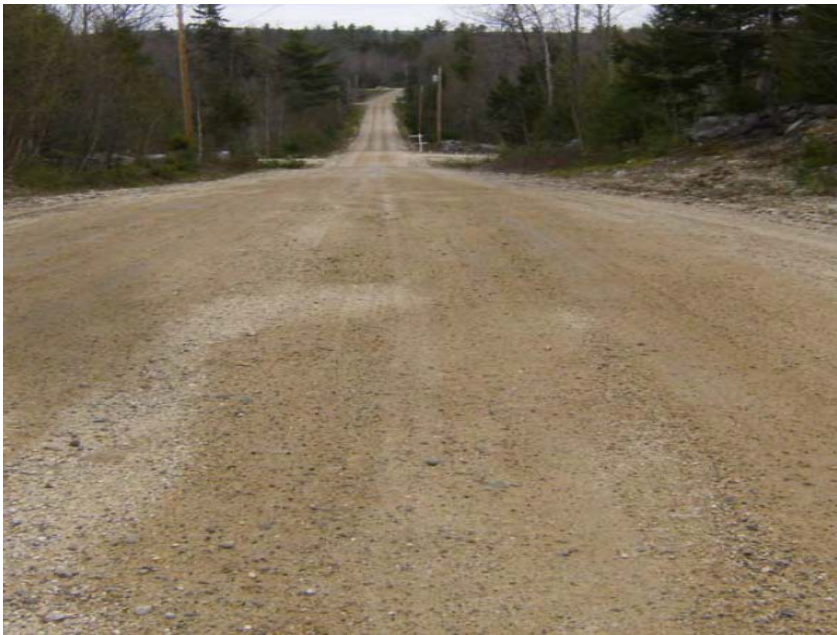
- Cross Section: Loss of crown, inhibiting natural drainage of water from the center to the sides of the road.

Cross Section – Maine Local Roads Center (2011)

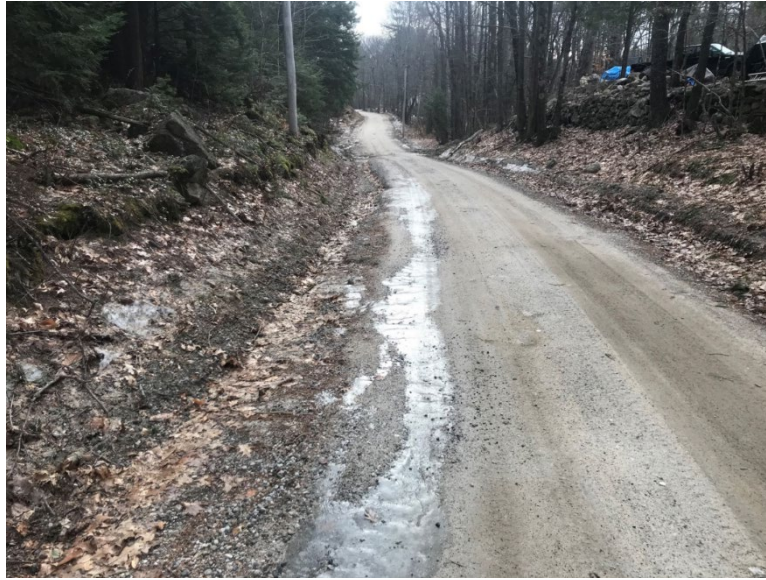
- Roadside Drainage: Same as paved roads.

Roadside Drainage – Jim Small Road

Jim Small Road is the only gravel road that falls under the Reconstruct maintenance category. Rutting, loose aggregate, low cross section, and poor drainage were all noted on the gravel portion of Jim Small Road. Treatment for gravel roads in the Reconstruct category involves the addition of up to 15" of gravel to the base and surface of a roadway.
