South West Pump & Drilling, Inc.
53-381 Highway 111
Coachella, CA 92236
Phone (760) 398-3977
Fax (760) 398-2287

RE: Well # 12 Facility B3 Pump - 100 HP Pressure Pump - Inspection Report

Well # 12 Facility B3 Pump - 100 HP Pressure Pump

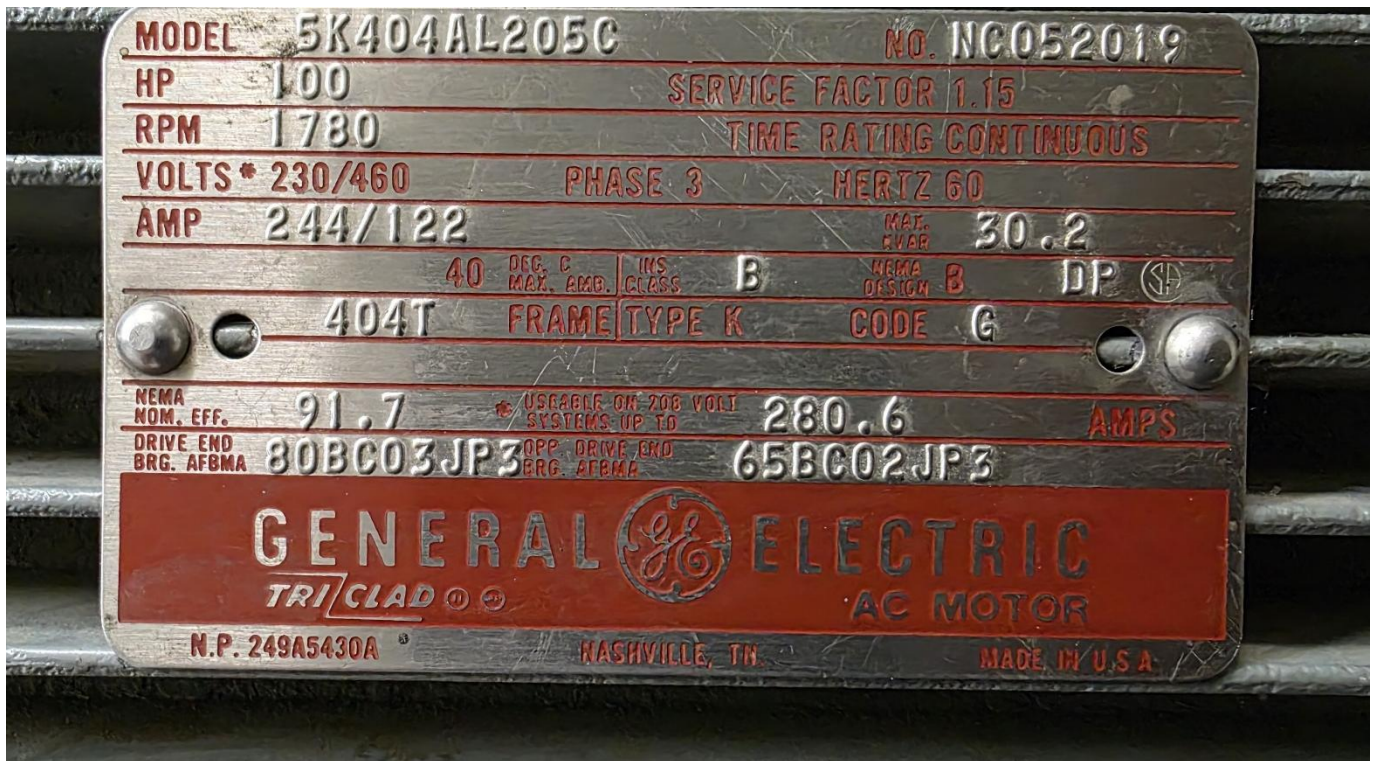
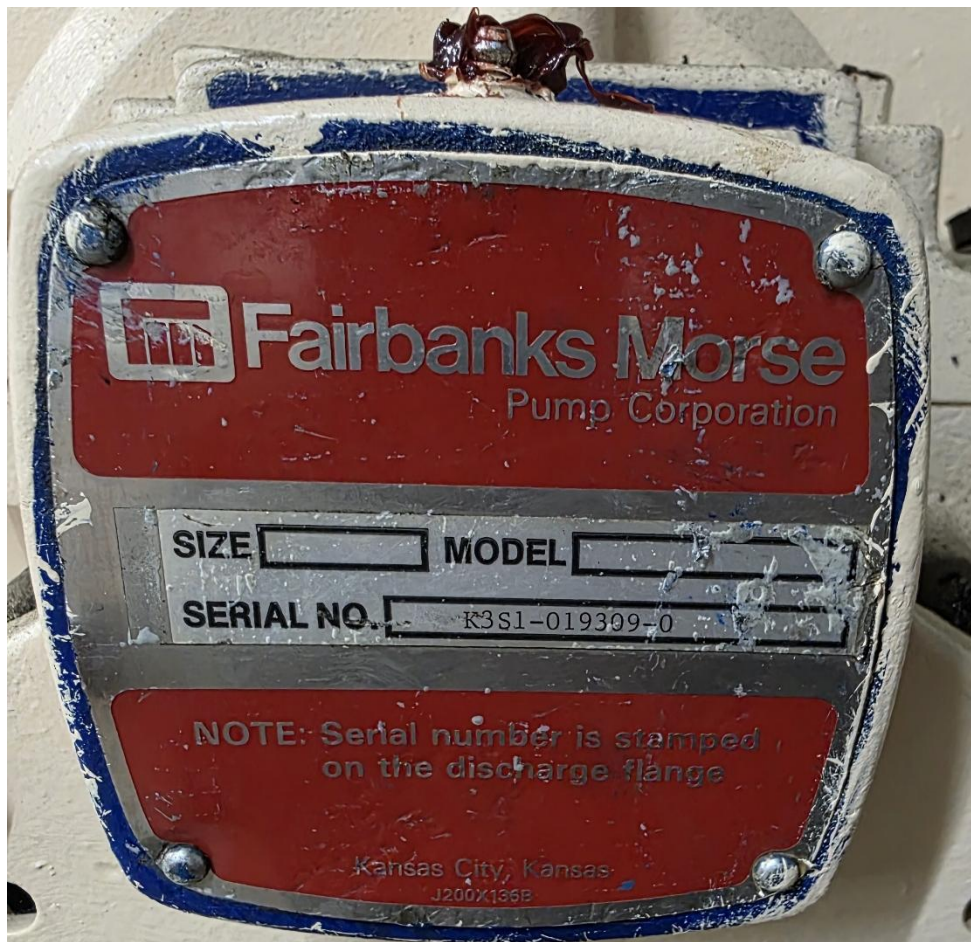
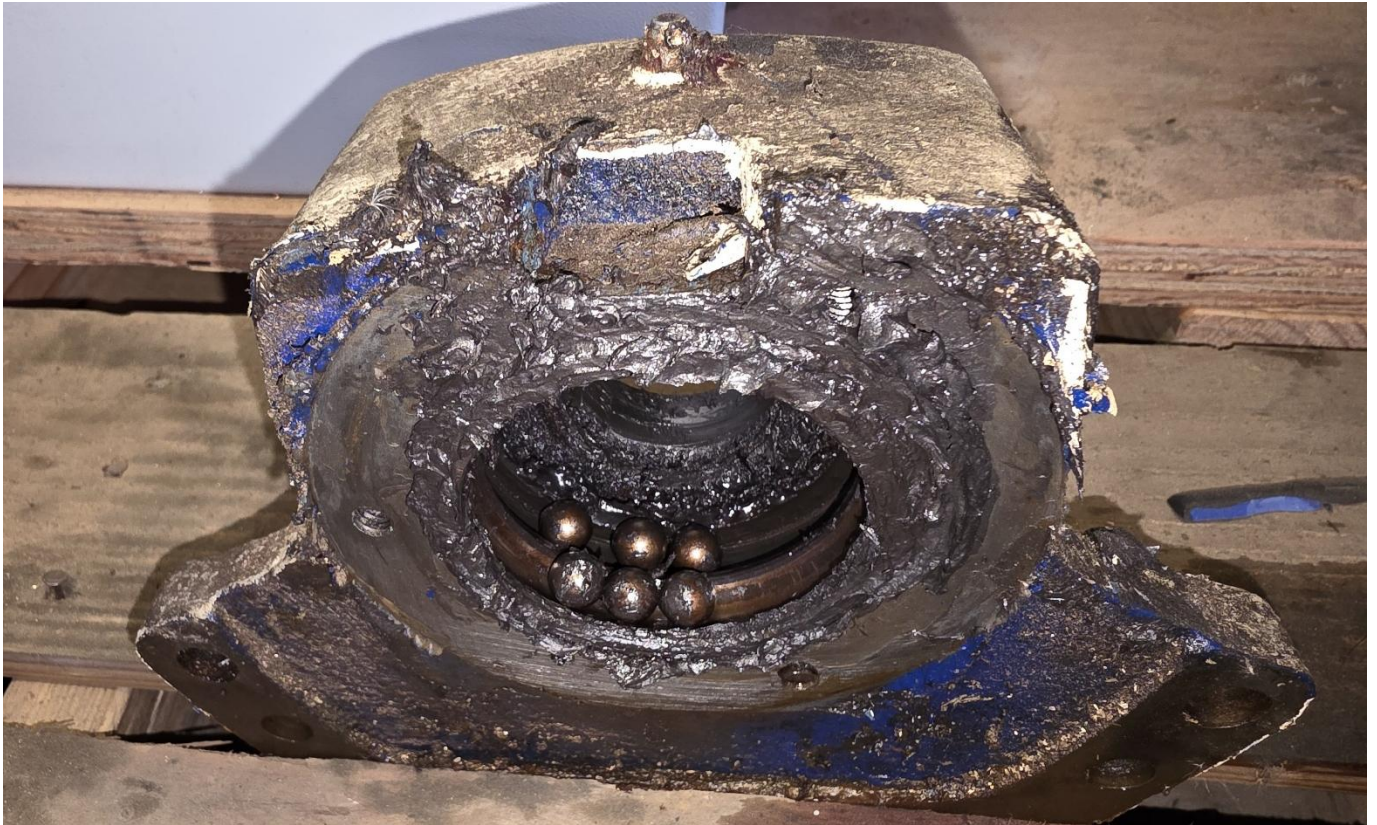
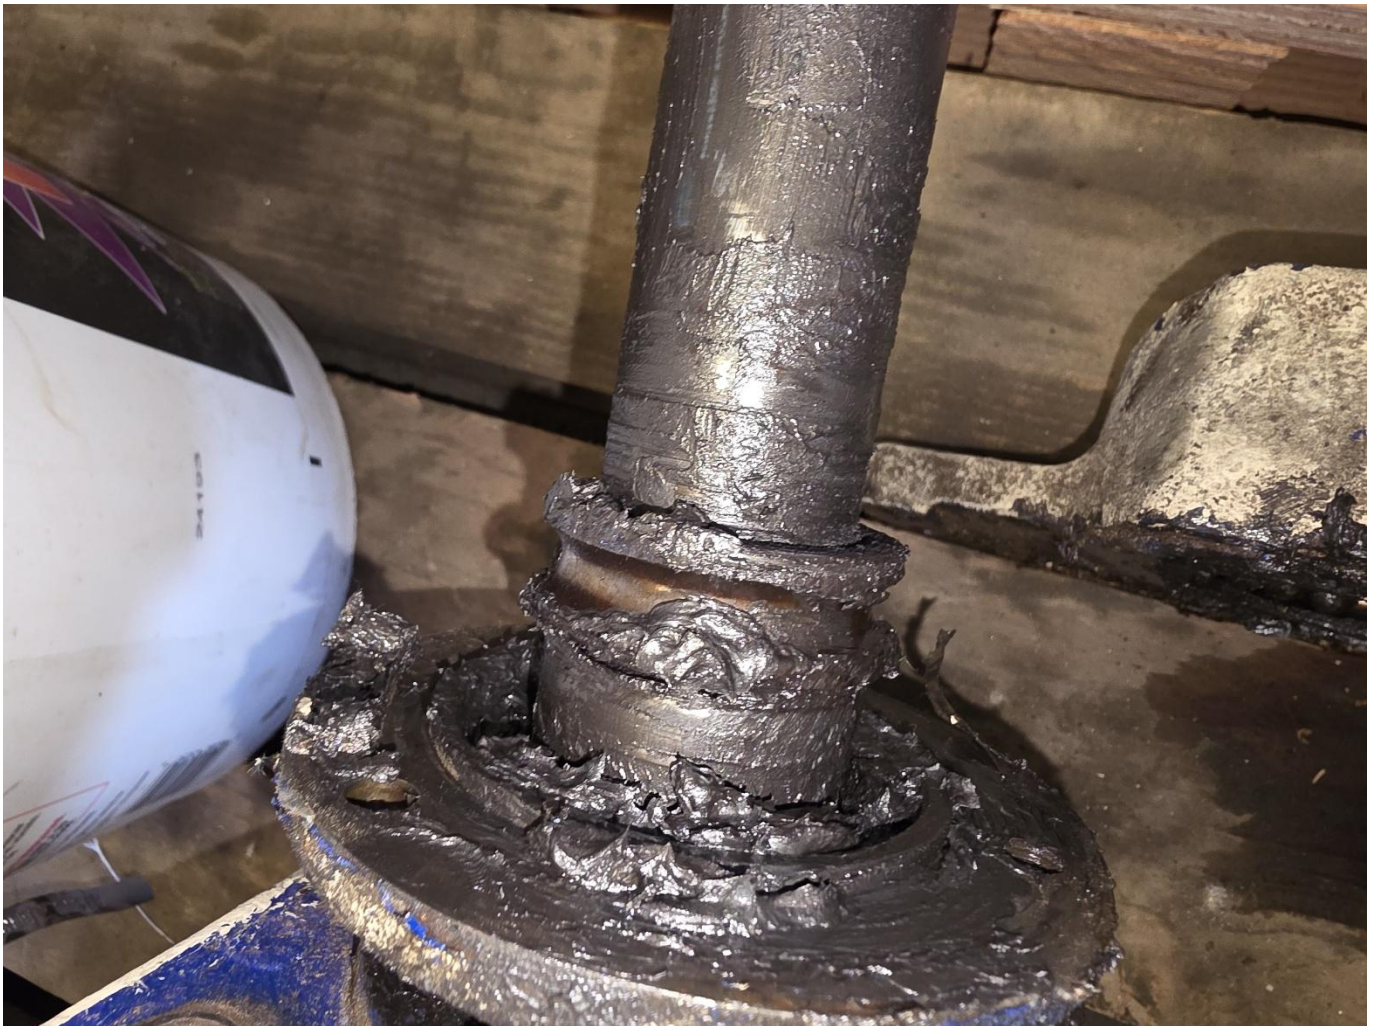
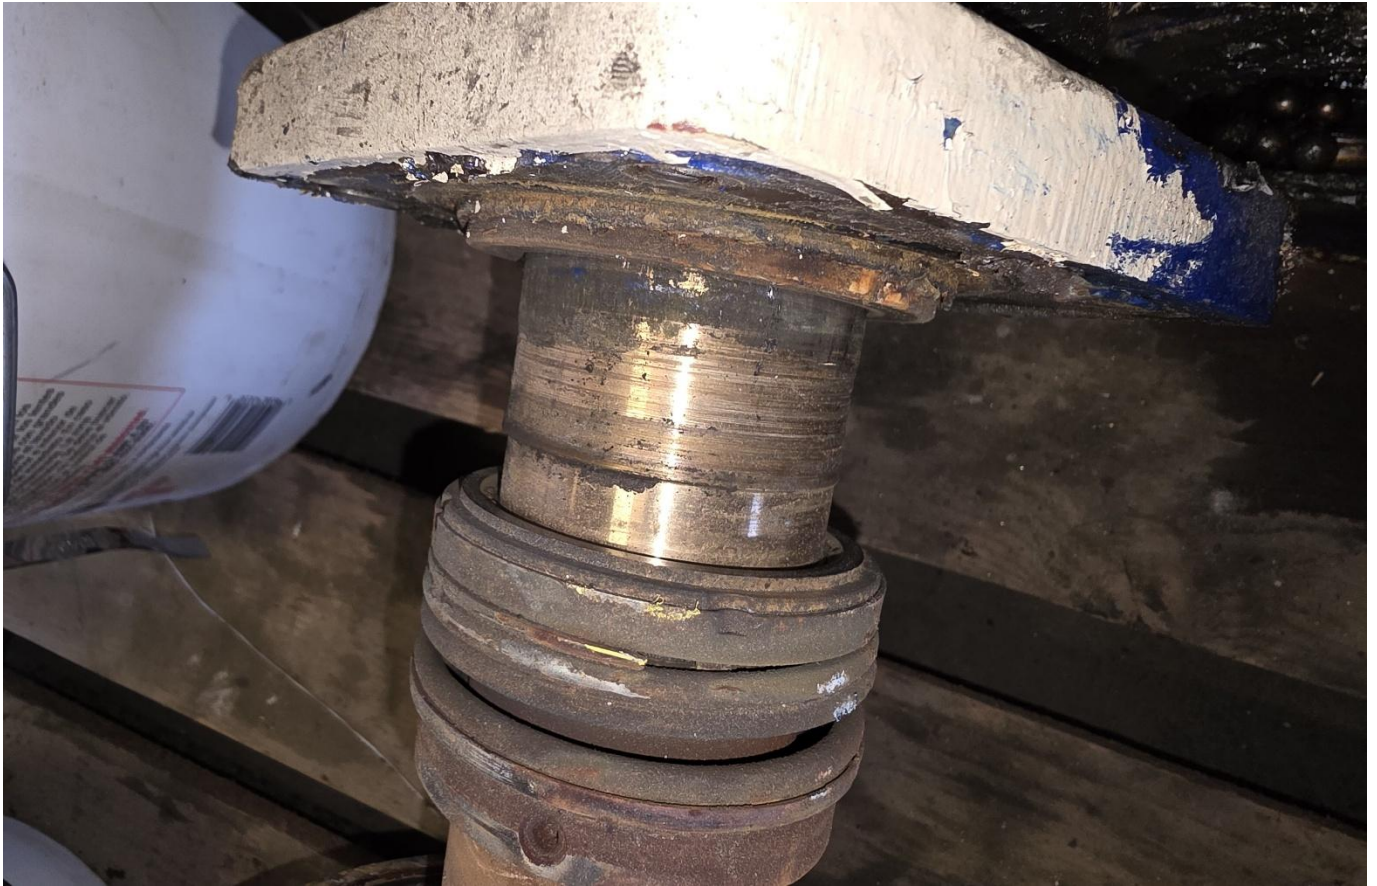
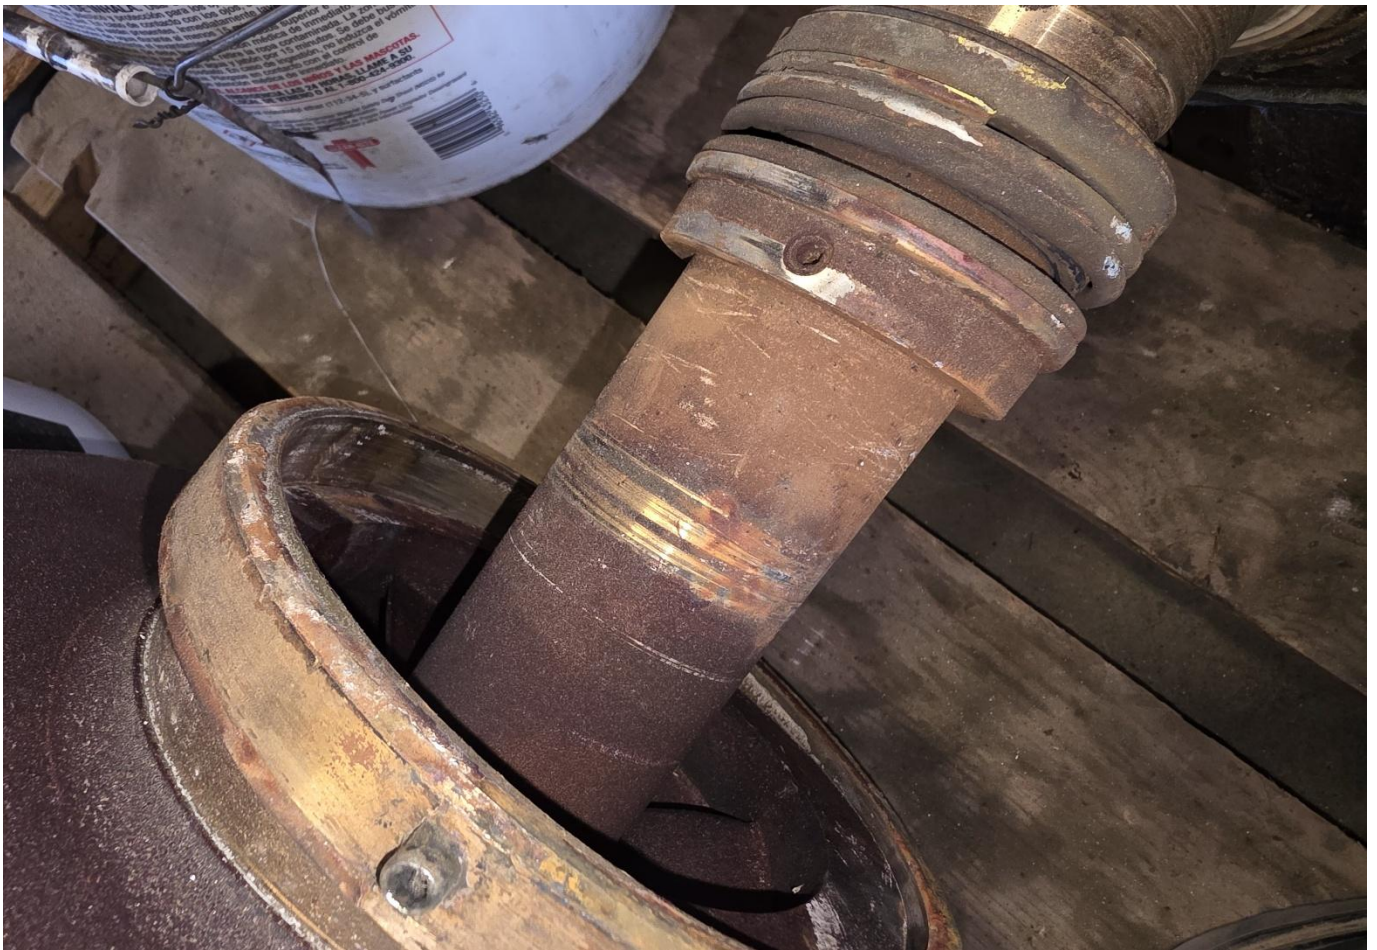
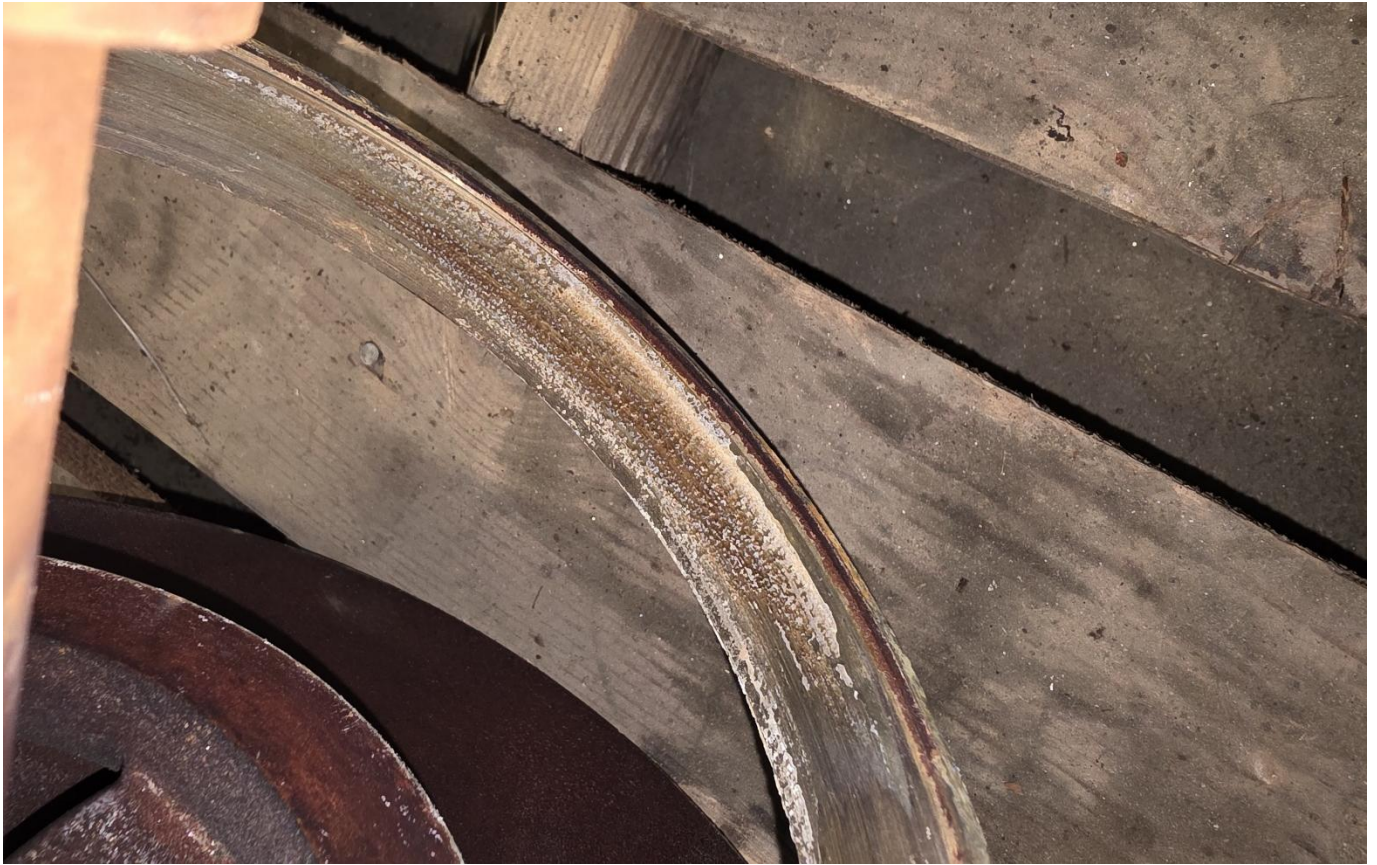
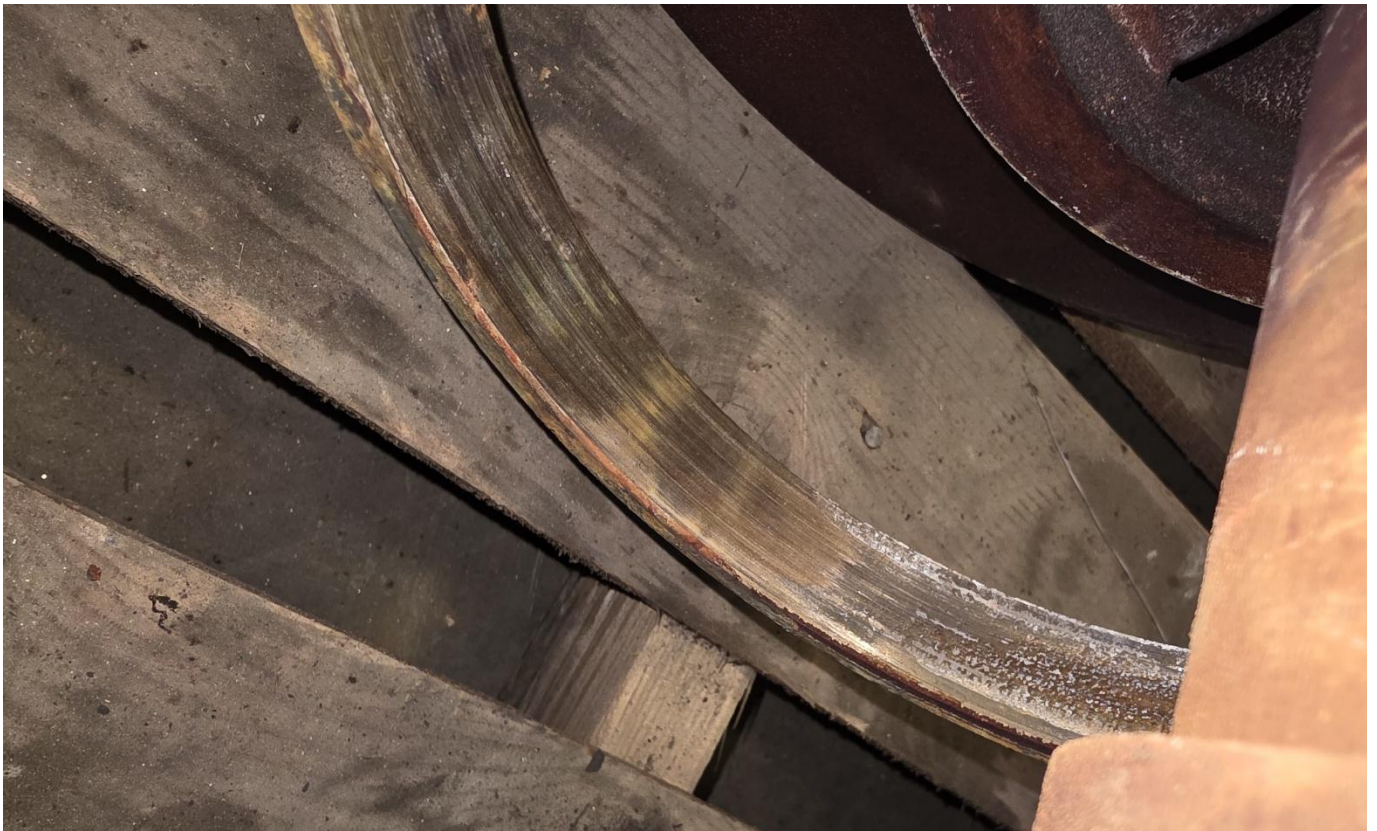
During the initial job walk, it was observed that metal shavings were present on the side of the bearing, and shaft deflection was noted.

On the scheduled removal day, it was confirmed that the inner bearing had failed. Upon disassembly, it was determined that the bearing had disintegrated. The failure pattern was consistent with a lack of lubrication, though the bearing appeared to have been recently greased. Other potential contributing factors to the failure include misalignment with the motor.

- Inner bearing: Severely damaged
- Brass shaft sleeve: Exhibiting damage from contact with the case
- Wear ring: Showing uneven wear due to bearing failure
- Mechanical seal sleeves: Displaying an inconsistent wear pattern

Upon inspection of the pump, SWP&D has determined that the pump can be reconditioned.
