Project Memorandum

Project: 8 Jefferson St Retaining Wall Reconstruction

Project #: 2021-379

RE: Emergency Construction Recommendation

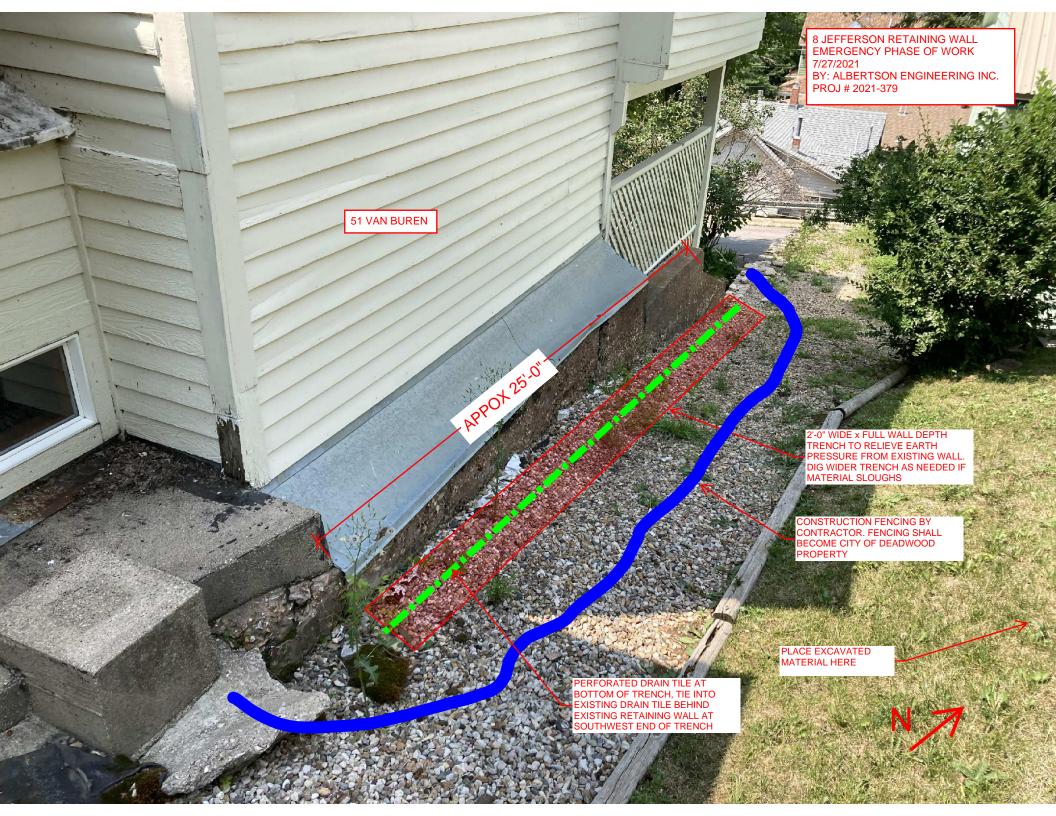
As requested, Jared Schippers, PE, of Albertson Engineering Inc. met on site July 26, 2021 with you and Larry Shama, homeowner of 51 Van Buren. The retaining wall, which we understand to be near or on the property line between 51 Van Buren and 8 Jefferson St, was observed to be overturning and is now transferring lateral earth pressure onto the residence located on 51 Van Buren.

The retaining wall in question is directly outboard and adjacent the residence foundation wall near the northeast corner of 51 Van Buren. A portion of the retaining wall is now in direct contact with a wood post as well as a small deck which is also attached to the residence. Drywall cracking was observed on the interior entry way in this same vicinity.

Due to the retaining wall failure, lateral earth pressures are now being resisted by portions of the house likely not originally intended to resist lateral earth forces.

A contractor shall excavate by hand or with a mini-excavator a minimum 2'-0" wide strip of soil for the full wall height in the area indicated in the photo. Access to the site shall be from Adams Street. Contractor to also provide permanent construction fencing around excavated area. Construction fencing shall become City of Deadwood property. Reconstruction of yard shall be excluded from emergency work and will be included in the publicly bid reconstruction documents. *See attached annotated photo*.
