62 1/2 Dunlap Ave, Deadwood, SD 57732

Report: 66358781

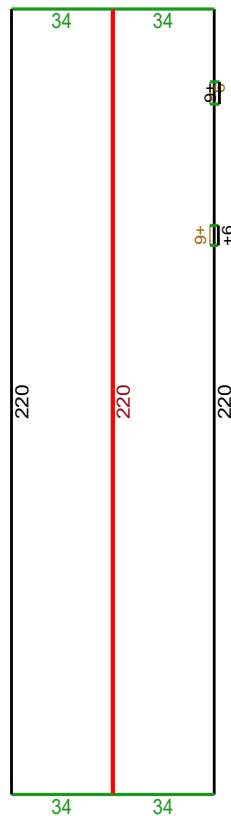
## LENGTH DIAGRAM

Total Line Lengths:

**Ridges = 220 ft**
**Hips = 0 ft**

Valleys = 0 ft

Rakes = 150 ft

Eaves = 452 ft

Flashing = 12 ft

Step flashing = 0 ft

**Parapets = 0 ft**

Note: This diagram contains segment lengths (rounded to the nearest whole number) over 5.0 Feet. In some cases, segment labels have been removed for readability. Plus signs preface some numbers to avoid confusion when rotated (e.g. +6 and +9).

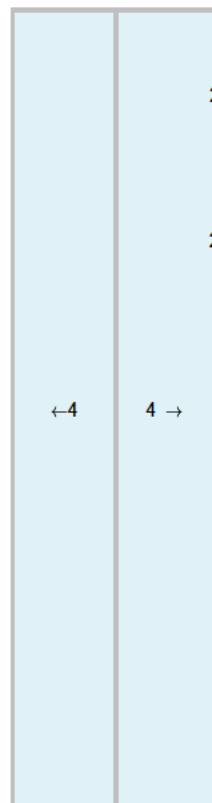
## PITCH DIAGRAM

Pitch values are shown in inches per foot, and arrows indicate slope direction. The predominant pitch on this roof is 4/12

Note: This diagram contains labeled pitches for facet areas larger than 20.0 square feet. In some cases, pitch labels have been removed for readability. Blue shading indicates a pitch of 3/12 and greater. Gray shading indicates flat, 1/12 or 2/12 pitches.

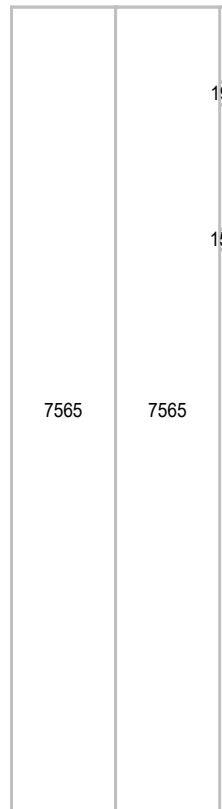
## AREA DIAGRAM

Total Area = 15,166 sq ft, with 4 facets.

Note: This diagram shows the square feet of each roof facet (rounded to the nearest Foot). The total area in square feet, at the top of this page, is based on the non-rounded values of each roof facet (rounded to the nearest square foot after being totaled).

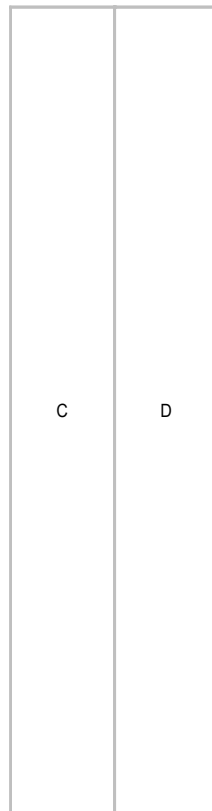
## NOTES DIAGRAM

Roof facets are labeled from smallest to largest (A to Z) for easy reference.

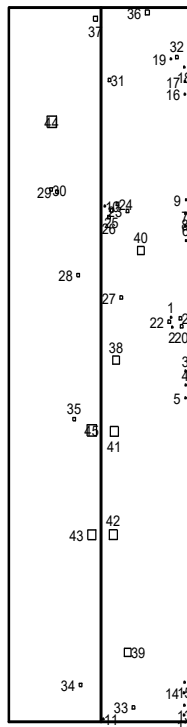
## PENETRATIONS NOTES DIAGRAM

Penetrations are labeled from smallest to largest for easy reference.

Total Penetrations = 45

Total Penetrations Area = 95 sq ft

Total Penetrations Perimeter = 208 ft

Total Roof Area Less Penetrations = 15,071 sq ft
