City of Dodgeville HWL Deposit Review

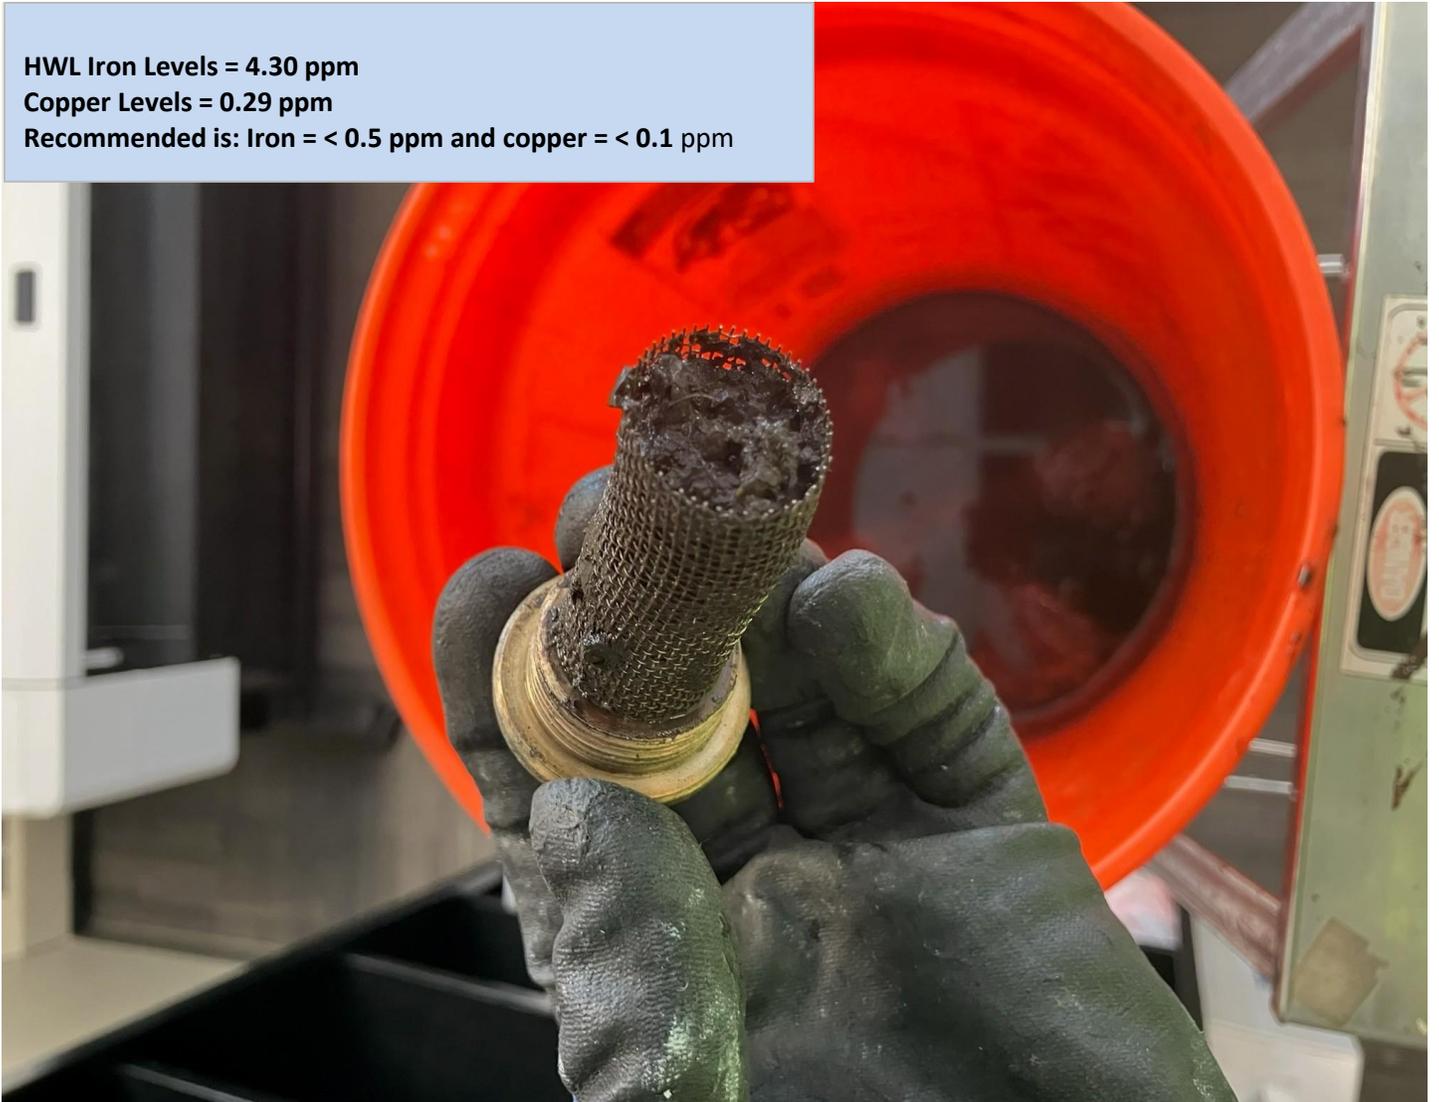
The displayed picture of fouled strainer in the HWL System shows the following:

Active corrosion in the HWL System

The corrosion is primarily iron, with copper components as well.

This type of scale deposit will:

Reduce Heat transfer operations = raise fuel costs

Impact the hot water flows for heating of building

Reduce life expectancy of recirculation pumps and pump seals

**HWL Iron Levels = 4.30 ppm
Copper Levels = 0.29 ppm
Recommended is: Iron = < 0.5 ppm and copper = < 0.1 ppm**

Solutions: Add ACS Closed Loop Treatments and Services. Utilize Griswold Filter System.
