# HISTORIC PRESERVATION MANUAL CERTIFICATE OF APPROPRIATENESS REVIEW

Date:	May 5, 2025
Project:	215 Old Fitzhugh Road, Tract 1, Dripping Springs, TX 78620
Applicant:	Carole Crumley
Historic Distric	t: Old Fitzhugh Road Historic District
Base Zoning:	CS
Proposed Use:	Commercial (Office Space)
Submittals:	Current Photograph Concept Plan Exterior Elevations Color & Materials Samples Sign Permit Application (permission letter)
with the City of I REGULATIONS	view has been conducted for the City of Dripping Springs to determine compliance and consistency Dripping Springs CODE OF ORDINANCES, Title 2 BUILDING AND DEVELOPMENT S, Chapter 24, BUILDING REGULATIONS, Article 24.07: HISTORIC PRESERVATION, Section TERIA FOR ISSUANCE OF CERTIFICATE OF APPROPRIATENESS."
Project Type &	& Description:
	use; Historic Renovation "The creation of a new office spaces within the Old gh Road Historic District will help add to the eclectic nature of the historic district.
rehabi while b	intends to rehabilitate an existing building to house a individual office spaces. The litation retains the historic character of the historic building and landscape features oringing the building into compliance with TAS acc

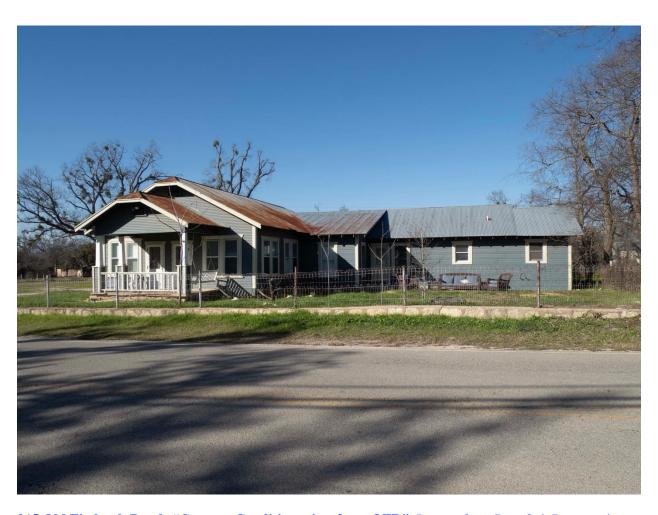
**215 Old Fitzhugh Road: "Current Condition, view from OFR"**. Images from Post Oak Preservation, Old Fitzhugh Road Historic Resources Survey, 2024.

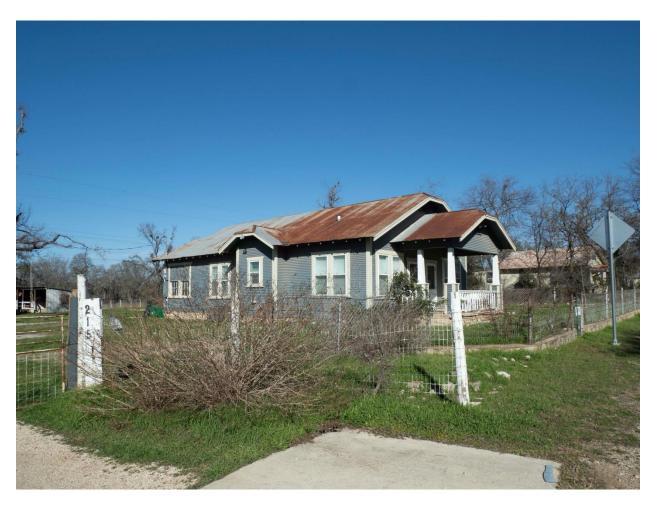
**Parking Arrangement:** While the new parking spaces are not at the rear of the property, they are located in an area that allows for ADA access to all building entrances on the front and rear elevations. The parking arrangement also preserves the historic landscape features along the front (east side) of the property

**251 Old Fitzhugh Road:** "Current Condition, view from OFR (location of proposed new parking)". Images from Post Oak Preservation, Old Fitzhugh Road Historic Resources Survey, 2024.

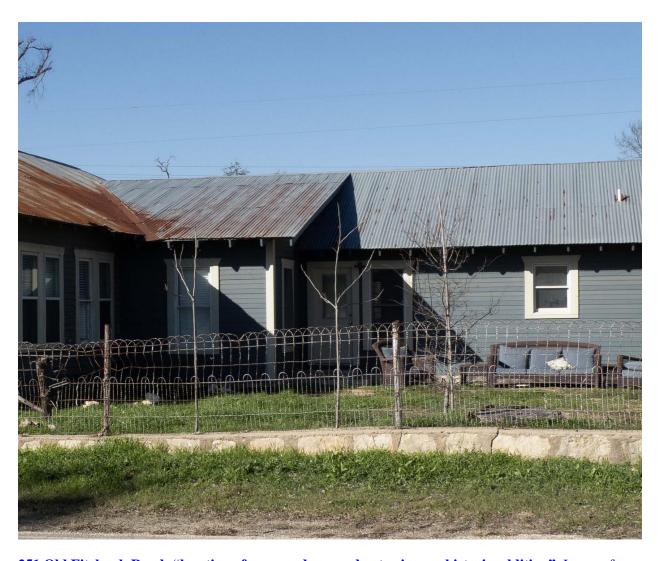
The creation of a covered entry at the northeast entrance minimally impacts the historic character of the building. The entry is located in the non-historic addition, and it is set back from the historic porch and

entrance. The existing roofline of the building will be extending, creating a minimal change in the building's appearance. The new rear deck is not visible from the public right of way.

**251 Old Fitzhugh Road: "location of proposed covered entry in non-historic addition"**. Images from Post Oak Preservation, Old Fitzhugh Road Historic Resources Survey, 2024.
