NORTH COLLEGE MAX BRT

EXISTING CONDITIONS REPORT

SEPTEMBER 2022

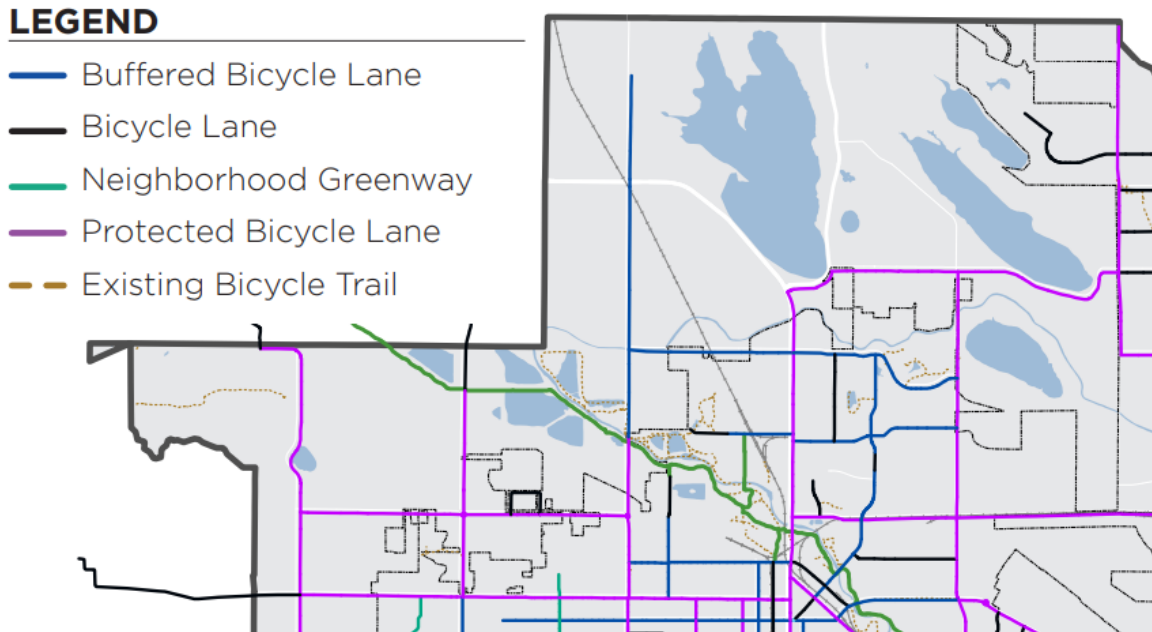
Figure 1: Future Bicycle Network (2019 Transportation Master Plan)

The 2019 Transportation Master Plan presented the 2014 Bicycle Master Plan. Near the North College corridor, buffered bike lanes are proposed on Willox Lane and Willow Street. The plan also extends the proposed protected bike lane on College Avenue south through the core of Fort Collins. The city set a goal of building one protected bike lane per year for the five years following the plan. **Figure 1** displays the Future Bicycle Network around the North College corridor created in the Transportation Master Plan

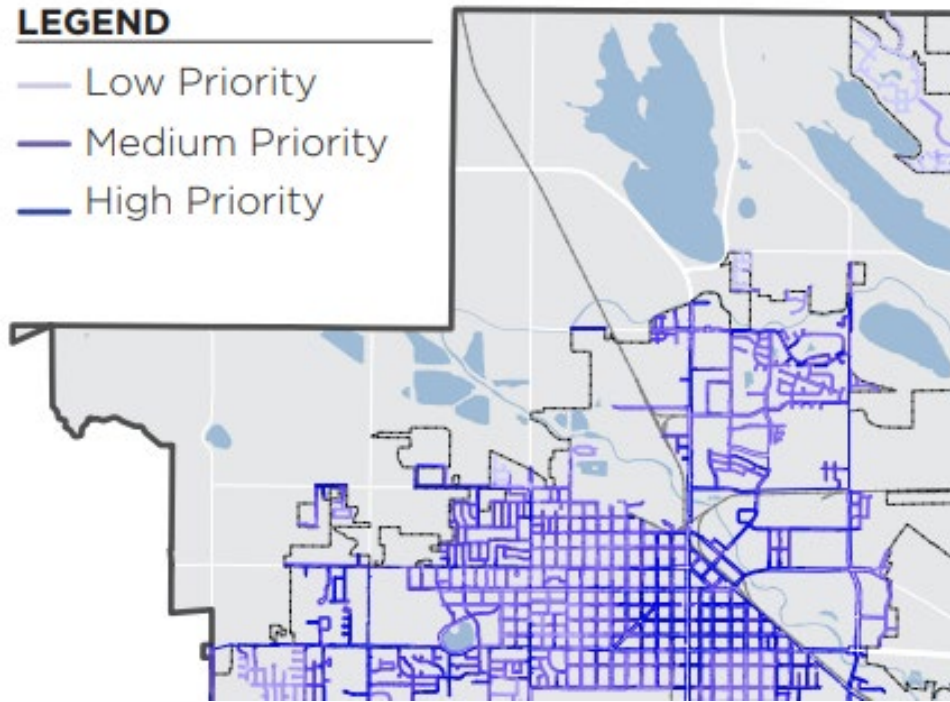
Figure 2: Sidewalk Prioritization (2019 Transportation Master Plan)

The Transportation Master Plan also determined the majority of sidewalks along the North College corridor to be high priority for sidewalk maintenance and filling gaps in the pedestrian network. **Figure 2** displays the priority level of sidewalks near the North College corridor.

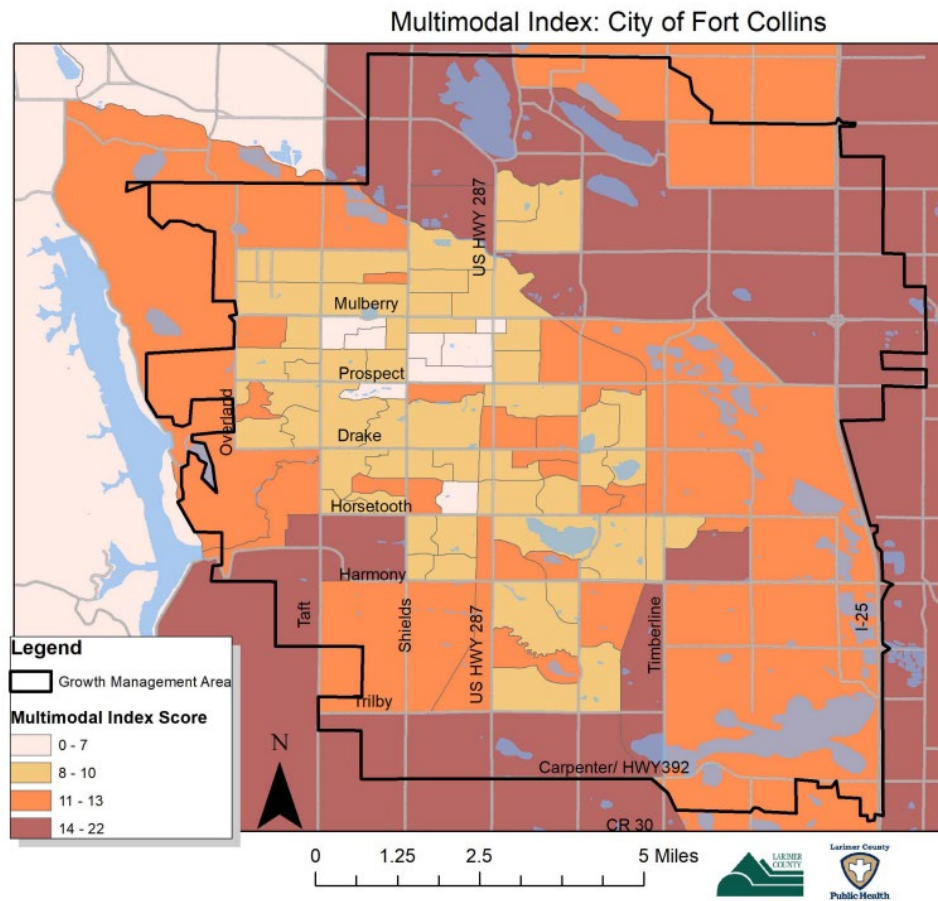
Figure 3: Multimodal Index

In 2019 a Multimodal Index was developed to identify areas of the city with the fewest transportation options. While the southern half of the North College corridor was identified as having a good amount of transportation options available, the northern half of the corridor was determined to have the fewest options. **Figure 3** displays a map of the multimodal index across the City of Fort Collins as well as an explanation of the index.

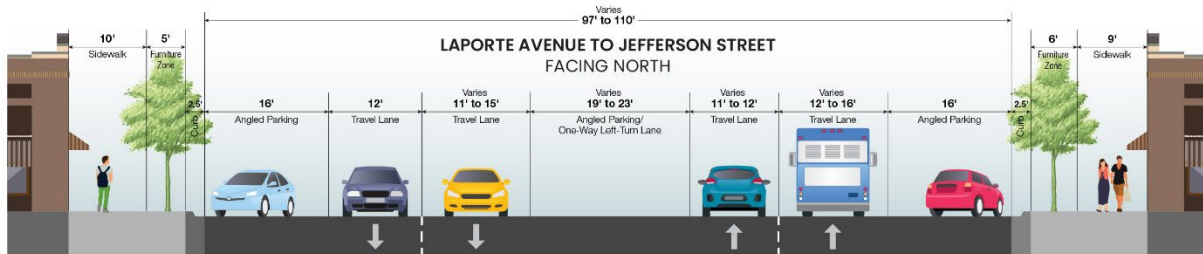
Figure 4: Cross Section - Laporte Avenue to Jefferson Street

Figure 4 - Figure 10 display the typical cross sections for each block along the corridor starting from Laporte Avenue and heading north to Terry Lake Road.

Notes: tree lawns or amenity zones with tree grates are shown in the cross-sections but are inconsistently present on the corridor. Sidewalks also function as shared-use paths where width allows.

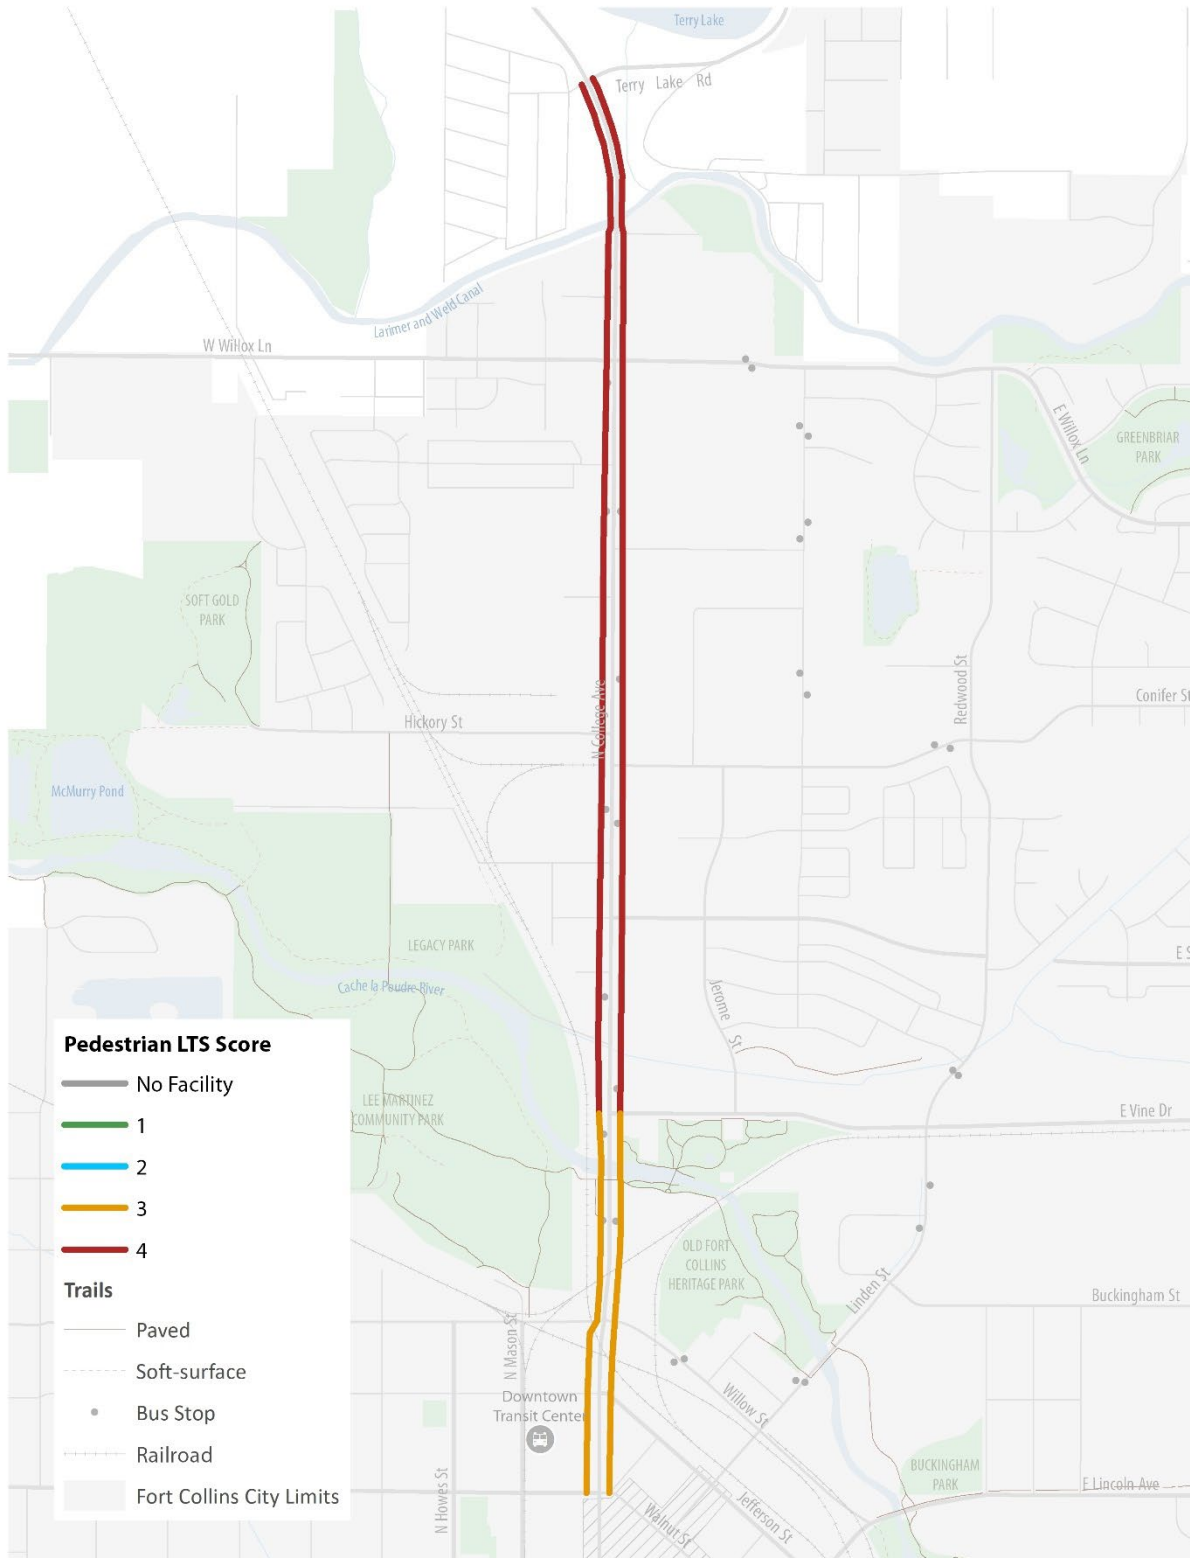
Figure 12: Level of Traffic Stress of Pedestrian Facilities

A pedestrian Level of Traffic Stress analysis was conducted along North College to understand the comfort level of the pedestrian facilities located on the corridor. The Level of Traffic Stress (LTS) methodology was developed to help guide jurisdictions to account for key comfort considerations when planning, designing, and evaluating their bicycle and pedestrian networks. This tool is developed based on research and best practices for measures of comfort including Mekuria, Furth, and Nixon's development of the original Level of Traffic Stress (2012) and NACTO Urban Streets Guide and safety research. Based on this research, this analysis incorporates a few key inputs that can serve as a proxy for understanding pedestrian comfort and safety based on best practices and data that is available. The Level of Traffic Stress (LTS) score for pedestrians along streets uses a 1 to 4 scale. This scoring system is conveyed in terms of comfort levels. Scores of 1 and 2 are considered low-stress and high comfort and scores of 3 to 4 are considered high-stress and low comfort:

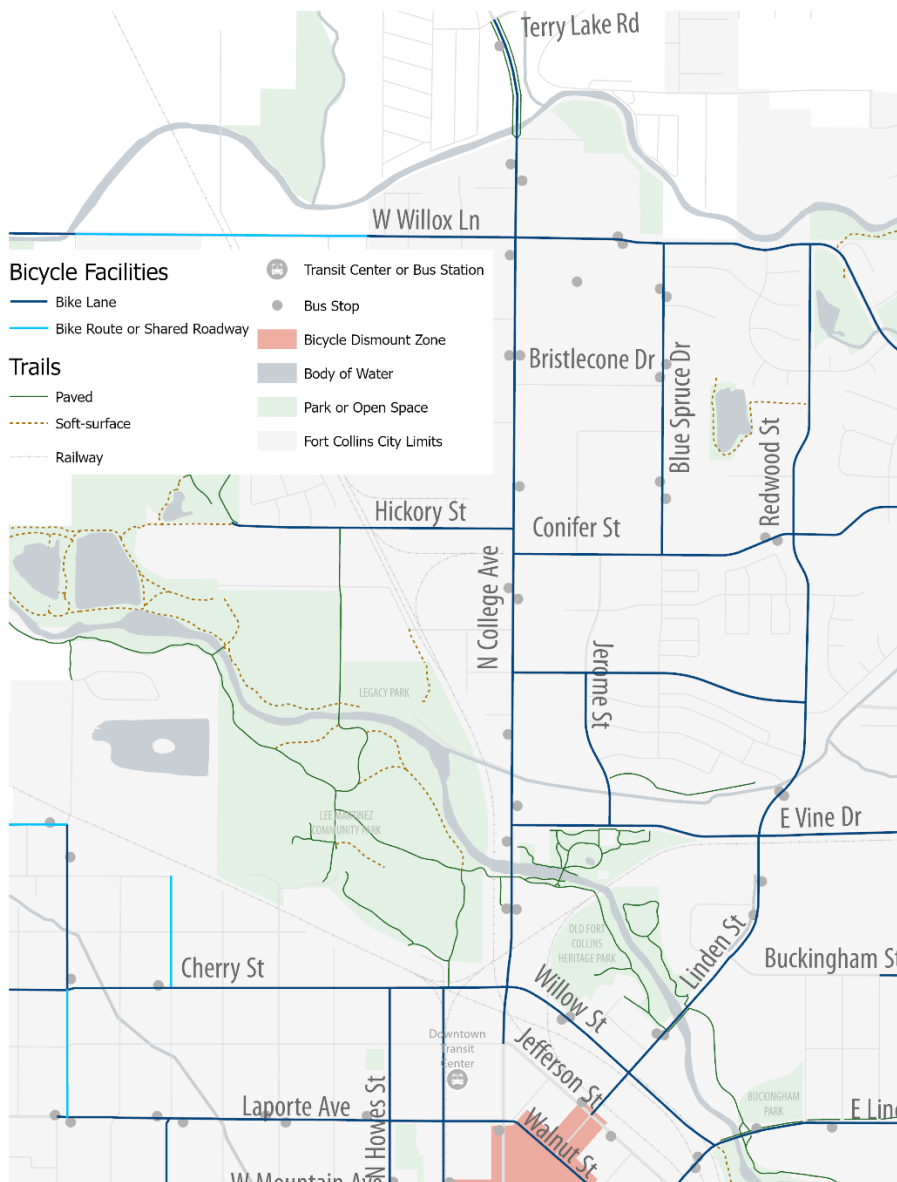
Figure 13: Existing On-street Bicycle Facilities

There either bike lanes or wide shoulders on most of North College Avenue from Highway 1 to Maple Street. There are also side paths on both sides of North College Avenue with varying widths. According to the Federal Highway Administration multi-use paths (pathways shared by pedestrians and people biking) are recommended to be a minimum of 10-feet wide. Many of the sidepaths on North College Avenue are 10-feet wide or more, but some are not this wide. For this assessment sidepaths less than 10-feet wide were not considered bicycle facilities. **Figure 13** displays the existing on-street bicycle facilities in the study area.

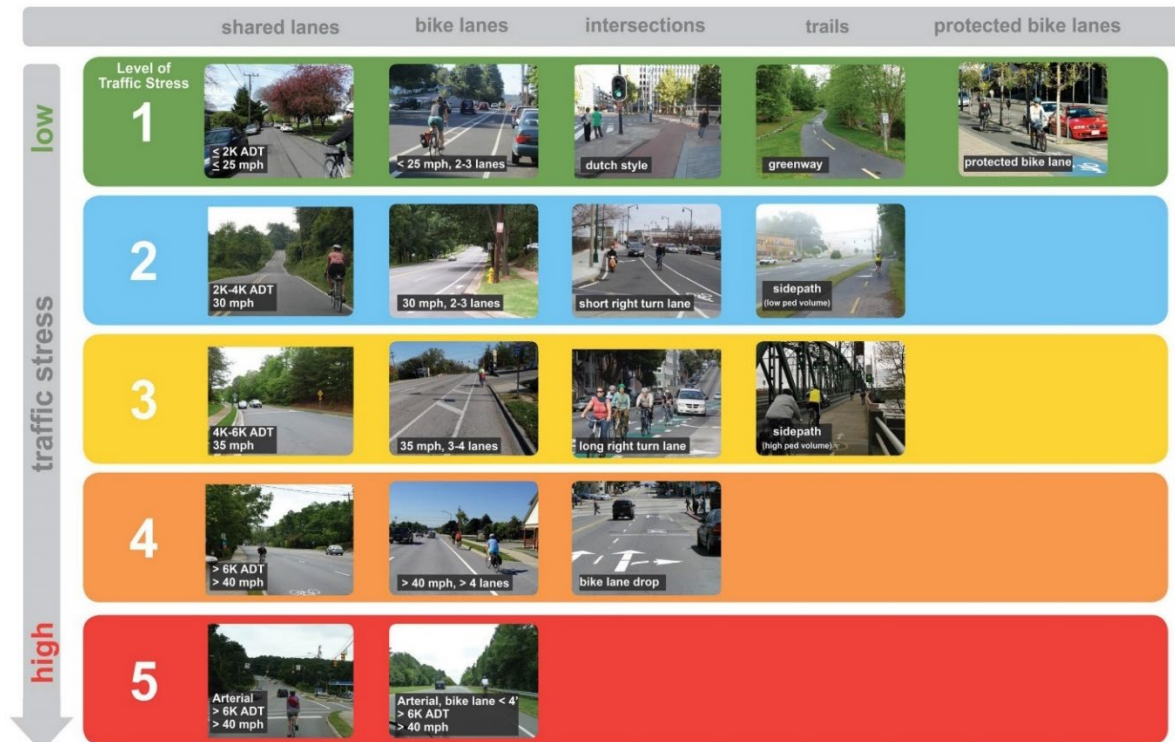
Figure 14: City of Fort Collins Level of Traffic Stress Criteria

A bicycle Level of Traffic Stress (LTS) analysis was conducted for both the on-street and off-street bicycle facilities along North College Avenue. This analysis used the criteria developed in the Fort Collins Bicycle Plan (2014) for determining the LTS score of different bicycle facilities. **Figure 14** displays the City of Fort Collins’ Bicycle Level of Traffic Stress criteria.

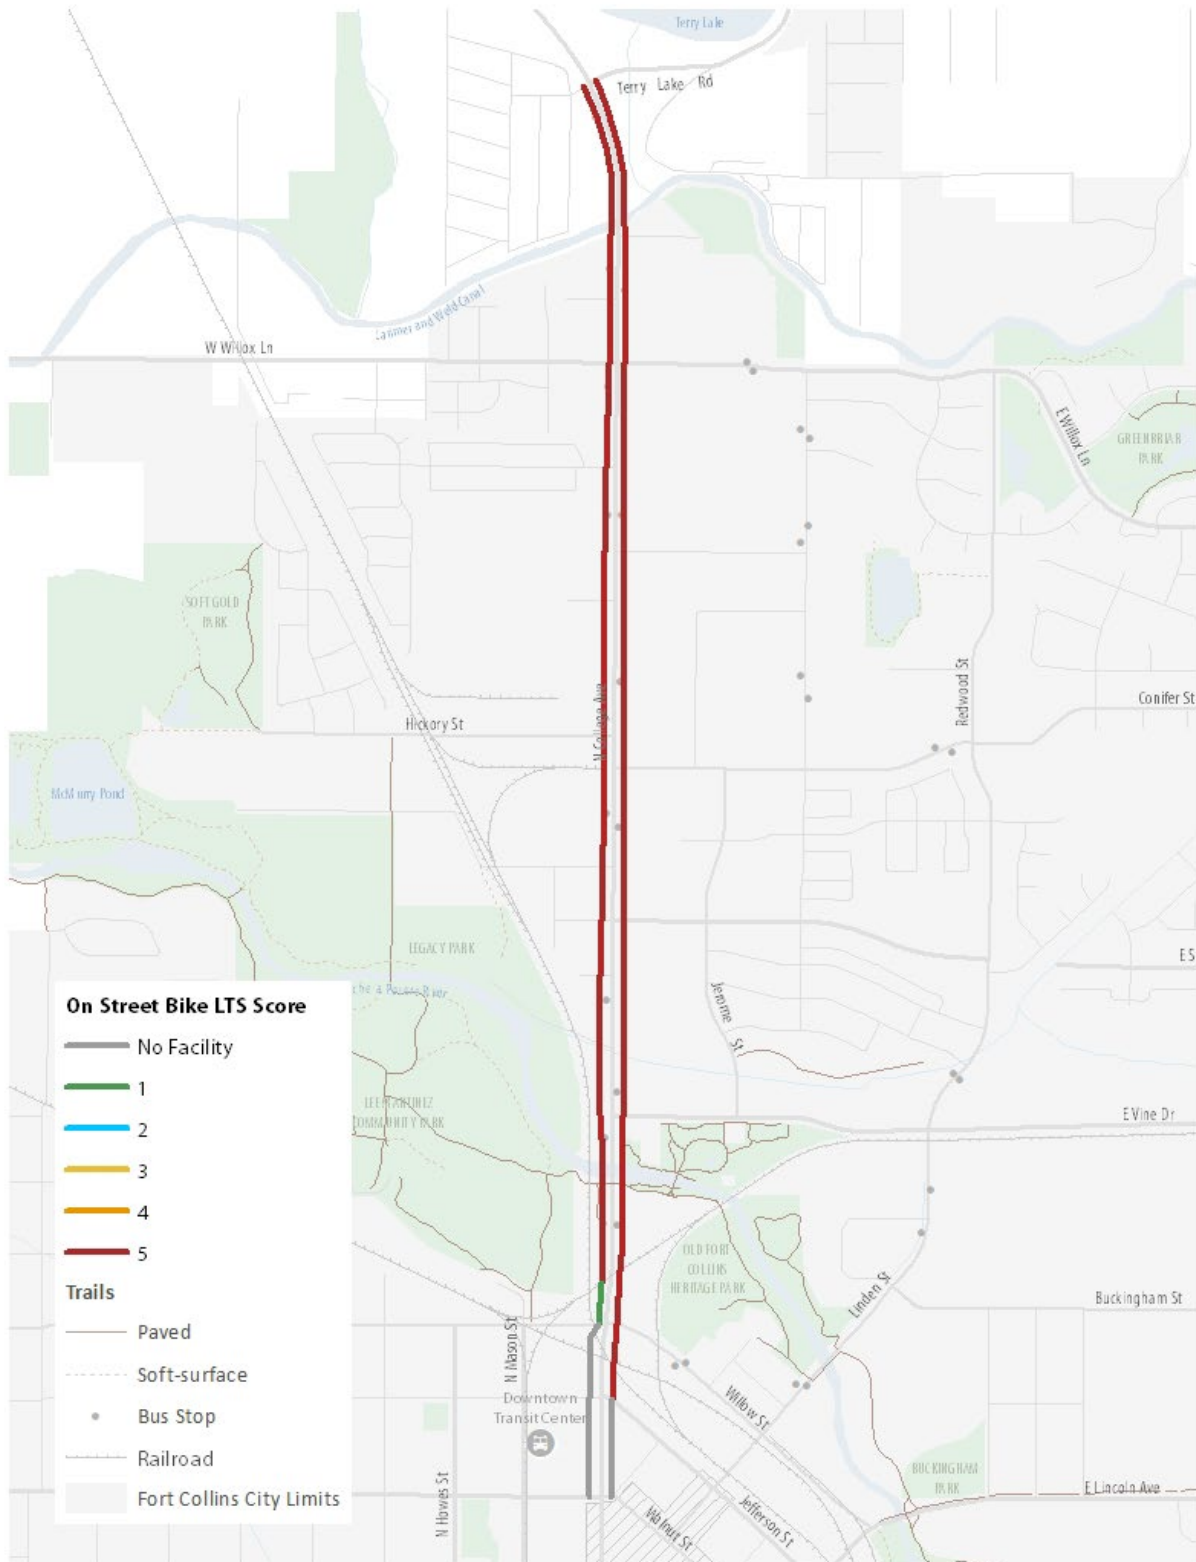
Figure 15: Level of Traffic Stress of On-Street Bicycle Facilities

Figure 15 displays the results of the LTS analysis for on-street bicycle facilities along North College Avenue (bike lanes and shoulders). All of the on-street bike lanes on the corridor were found to be high stress (LTS 5). The one LTS 1 section on the on-street facilities is a place where the on-street bike lane becomes a grade separated bike lane for a short distance.

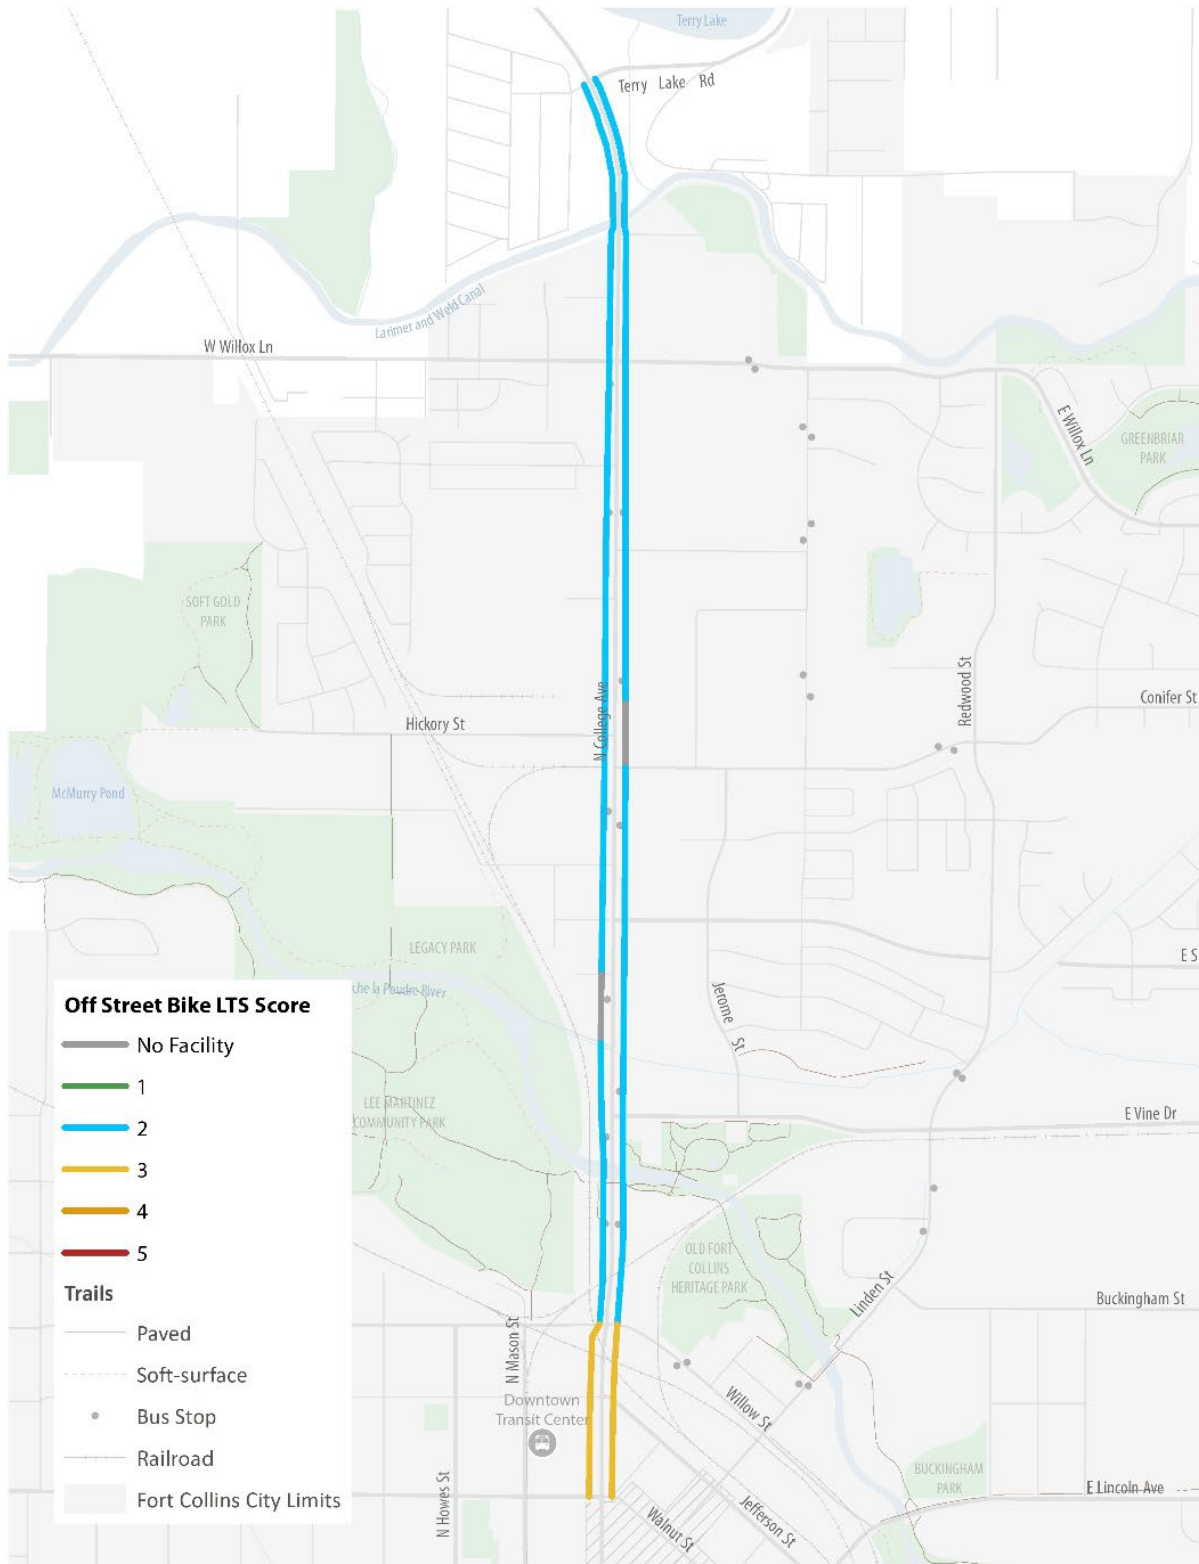
Figure 16: Level of Traffic Stress of Off-Street Bicycle Facilities

Figure 16 displays the results of the LTS analysis for off-street bicycle facilities (sidepaths). For this analysis only sidepaths with a width of 10 feet or wider were considered bicycle facilities. If there was a sidepath that was less than 10-feet wide this is displayed as “no facility” on the map. The off-street sidepaths on the corridor provide a lower stress option from the on-street bike lanes and were determined to be LTS 2 in some sections due to the low pedestrian volumes at those locations. The City of Fort Collins’ Bicycle Level of Stress Criteria does not include factors such as frequency of curb cuts for sidepaths or frequencies of crossing opportunities. The North College corridor has frequent driveways along sections and long stretches where there are no controlled crossings of North College Avenue. These factors may make the actual level of stress for people bicycling on the sidepaths higher than the map indicates.

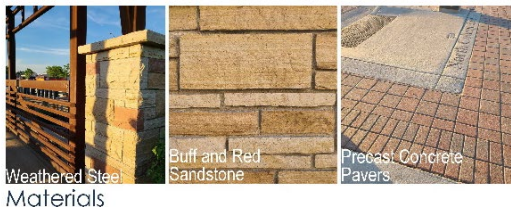
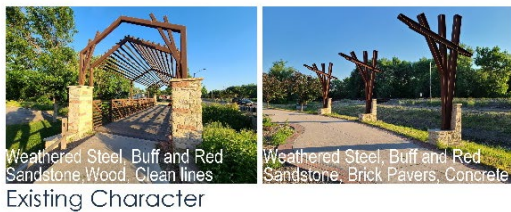
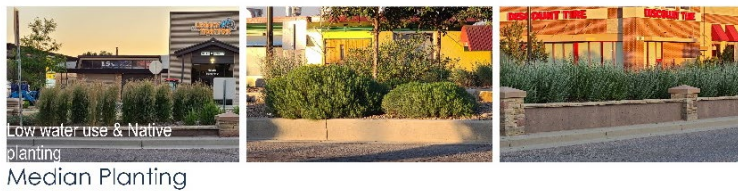
Figure 17: Existing Character Elements

The overall character of North College highlights both traditional, historic, and rustic elements. The strong presence of Weathered Steel (Corten) and Buff/Red Sandstone elements bring a cohesive aesthetic identity to the corridor. Low-water and native planting schemes tie the area to the surrounding environment and help maintain a sense of nature in the city. **Figure 17** displays examples of the types of design elements found on the North College corridor.

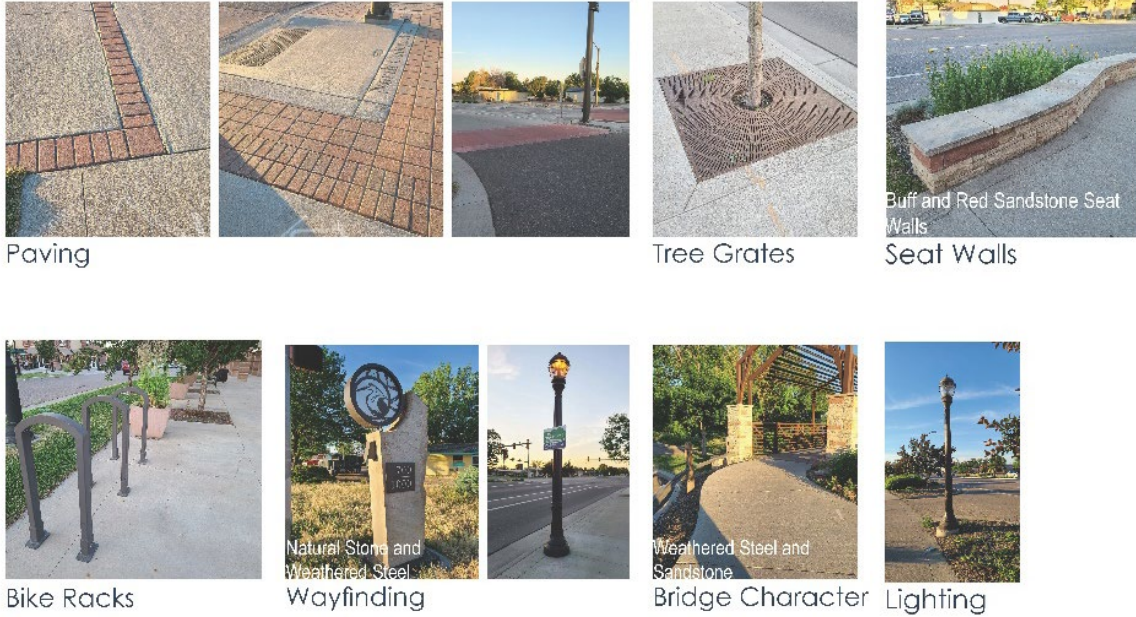
Figure 18: Emerging Character Elements

Site elements that have been updated include the stone wayfinding signage, special pavement, lighting elements, sandstone seat walls, and a consistent planting palette. These elements (shown in **Figure 18**) set the precedent for the area’s character moving forward.

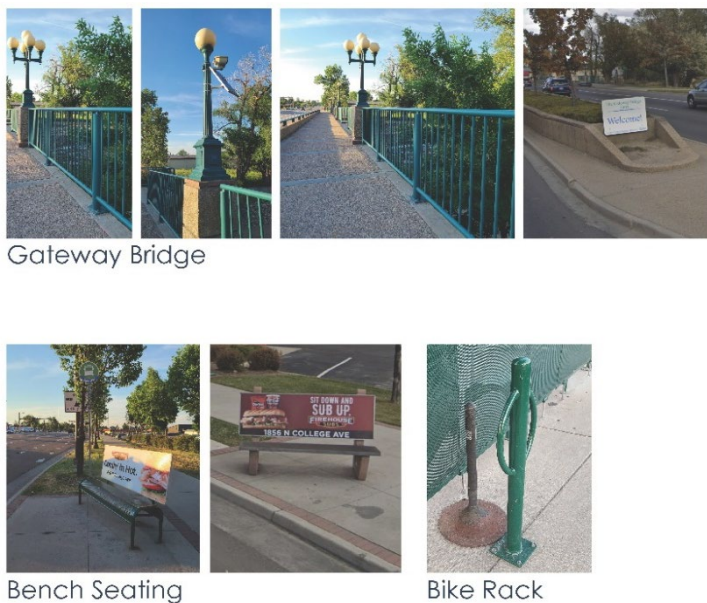
Figure 19: Older Character Elements

Older design elements remain throughout the corridor in areas that have not yet been updated. These inconsistent conditions (shown in **Figure 19**) make the corridor feel disjointed and divided. These elements should be updated to compliment the corridor’s improved streetscape renovations and character.

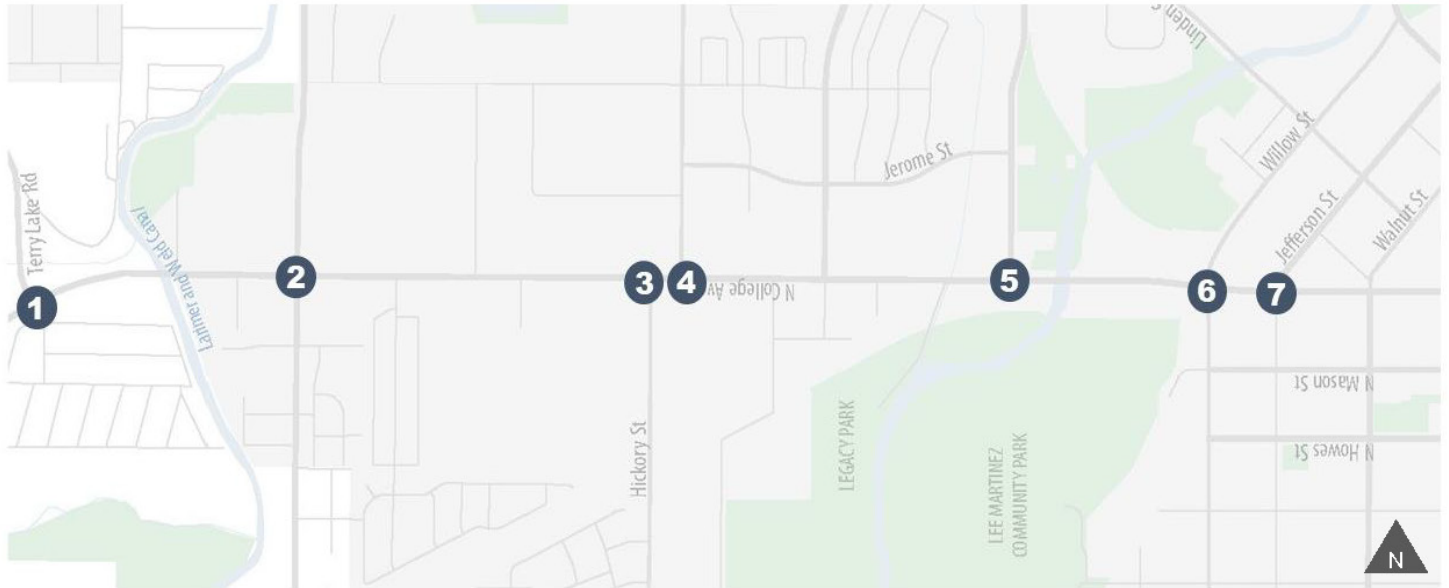
Figure 23: 2020 Peak Hour Vehicle Volumes and Lane Configurations

1. College/Poudre Mobile Park/Hwy 1	2. College/Wilcox	3. College/Hickory	4. College/Conifer
<p>College Ave</p> <p>Northbound: 3 (1) (111), 395 (425) (383), 87 (66) (122)</p> <p>Southbound: 81 (85) (88), 8 (9) (15), 541 (341) (318)</p> <p>Hwy 1</p> <p>Westbound: 3 (1) (5), 8 (3) (8), 89 (37) (61)</p> <p>Eastbound: 20 (43) (109), 266 (468) (439), 182 (367) (612)</p>	<p>College Ave</p> <p>Northbound: 139 (68) (77), 653 (327) (499), 79 (78) (85)</p> <p>Southbound: 29 (92) (166), 143 (142) (176), 102 (171) (139)</p> <p>Wilcox</p> <p>Westbound: 103 (115) (164), 165 (144) (149), 100 (92) (62)</p> <p>Eastbound: 50 (134) (130), 270 (441) (720), 61 (153) (169)</p>	<p>College Ave</p> <p>Northbound: 53 (42) (53), 801 (695) (660)</p> <p>Southbound: 34 (54) (60), 95 (70) (104)</p> <p>Hickory</p> <p>Westbound: 86 (74) (103), 421 (744) (1,007)</p> <p>Eastbound: 467 (747) (1,063), 118 (140) (118)</p>	<p>College Ave</p> <p>Northbound: 867 (714) (711), 21 (43) (40)</p> <p>Southbound: 39 (73) (70), 162 (184) (239)</p> <p>Conifer</p> <p>Westbound: 467 (747) (1,063), 118 (140) (118)</p> <p>Eastbound: 467 (747) (1,063), 118 (140) (118)</p>

5. College/Vine	6. College/Cherry/Willow	7. College/Maple/Jefferson (State 14)	
<p>College Ave</p> <p>Northbound: 958 (890) (898), 1,29 (110) (149)</p> <p>Southbound: 100 (118) (145), 161 (96) (141)</p> <p>Vine</p> <p>Westbound: 554 (868) (1,183), 73 (96) (150)</p> <p>Eastbound: 554 (868) (1,183), 73 (96) (150)</p>	<p>College Ave</p> <p>Northbound: 275 (206) (263), 7,21 (675) (855), 60 (61) (67)</p> <p>Southbound: 45 (54) (76), 85 (81) (194), 39 (62) (55)</p> <p>Cherry</p> <p>Westbound: 170 (214) (304), 142 (103) (125), 130 (77) (83)</p> <p>Eastbound: 52 (69) (88), 498 (752) (933), 38 (68) (80)</p>	<p>College Ave</p> <p>Northbound: 18 (17) (27), 612 (662) (662), 342 (272) (265)</p> <p>Southbound: 240 (272) (323), 163 (95) (152), 120 (114) (106)</p> <p>Maple</p> <p>Westbound: 6 (17) (27), 76 (74) (150), 16 (24) (36)</p> <p>Eastbound: 22 (28) (32), 316 (636) (706), 121 (175) (262)</p> <p>Jefferson (State 14)</p> <p>Westbound: 22 (28) (32), 316 (636) (706), 121 (175) (262)</p> <p>Eastbound: 22 (28) (32), 316 (636) (706), 121 (175) (262)</p>

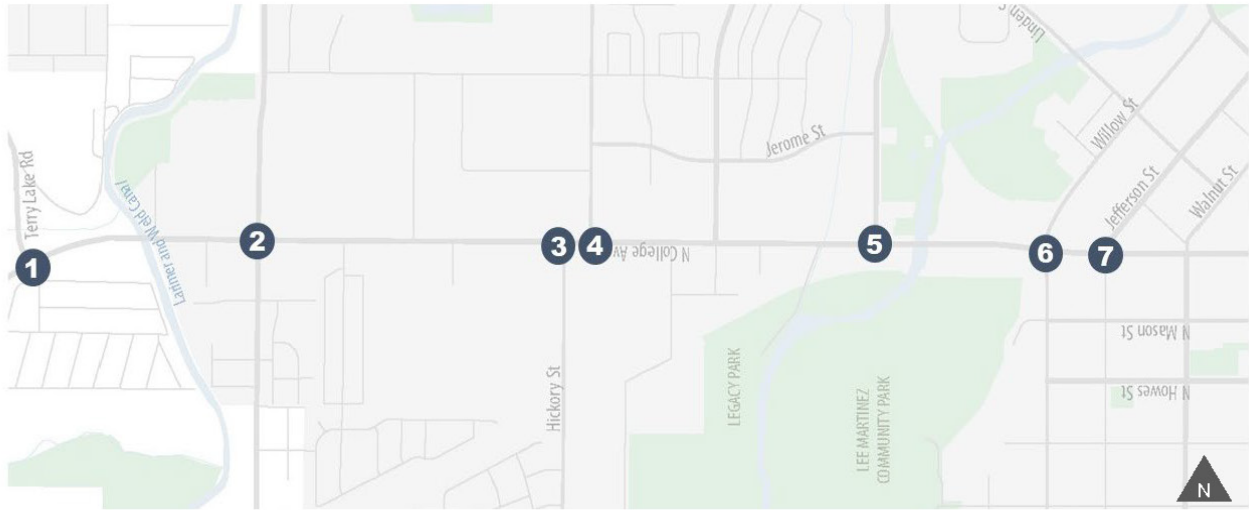
Figure 24: 2045 Peak Hour Vehicle Volumes and Lane Configurations

The NFRMPO Traffic Model estimates that in 2045 traffic volumes on North College Avenue will increase by about 22% from existing levels. To model this growth the existing traffic counts for the corridor were grown by 22% and an intersection level of service (LOS) analysis was conducted. Volumes for all movements were increased by 22% and rounded to the nearest 10 to test a conservative estimate for future conditions. It is possible that the future volumes on North College would increase at a faster rate than the volumes on the side streets. **Figure 24** displays the estimated volumes for 2045 on existing lane configurations.

1. College/Poudre Mobile Park/Hwy 1	2. College/Willow	3. College/Hickory	4. College/Conifer
<p>College</p> <p>Poudre Mobile Park</p> <p>Hwy 1</p> <p>0 (0) (10) 480 (520) (470) 110 (80) (150)</p> <p>100 (100) (110) 10 (10) (20) 660 (420) (390)</p> <p>0 (0) (10) 10 (0) (10) 110 (50) (70)</p> <p>20 (50) (130) 330 (570) (540) 220 (450) (750)</p>	<p>College</p> <p>Willow</p> <p>170 (70) (80) 800 (400) (610) 100 (100) (100)</p> <p>40 (110) (200) 170 (170) (220) 120 (210) (170)</p> <p>130 (140) (200) 200 (180) (180) 120 (110) (80)</p> <p>60 (150) (160) 330 (540) (860) 70 (180) (210)</p>	<p>College</p> <p>Hickory</p> <p>70 (50) (70) 880 (860) (780)</p> <p>40 (70) (70) 120 (90) (130)</p> <p>110 (60) (130) 510 (910) (1,230)</p>	<p>College</p> <p>Conifer</p> <p>1,060 (870) (870) 30 (50) (60)</p> <p>50 (90) (90) 200 (220) (290)</p> <p>670 (910) (1,300) 140 (170) (140)</p>

5. College/Vine	6. College/Cherry/Willow	7. College/Maple/Jefferson (State 14)	
<p>College</p> <p>Vine</p> <p>1,170 (1,070) (1,100) 160 (130) (180)</p> <p>120 (140) (180) 200 (120) (170)</p> <p>660 (1,060) (1,440) 90 (120) (160)</p>	<p>College</p> <p>Cherry</p> <p>Willow</p> <p>340 (260) (320) 880 (620) (1,040) 70 (70) (80)</p> <p>60 (70) (90) 100 (100) (240) 50 (80) (70)</p> <p>210 (260) (370) 170 (130) (150) 160 (90) (100)</p> <p>60 (80) (110) 610 (620) (1,140) 50 (50) (60)</p>	<p>College</p> <p>Maple</p> <p>Jefferson (State 14)</p> <p>20 (20) (30) 750 (690) (800) 420 (330) (320)</p> <p>290 (330) (390) 200 (120) (190) 150 (140) (130)</p> <p>10 (20) (30) 90 (90) (180) 20 (30) (40)</p> <p>30 (30) (40) 390 (650) (860) 150 (210) (320)</p>

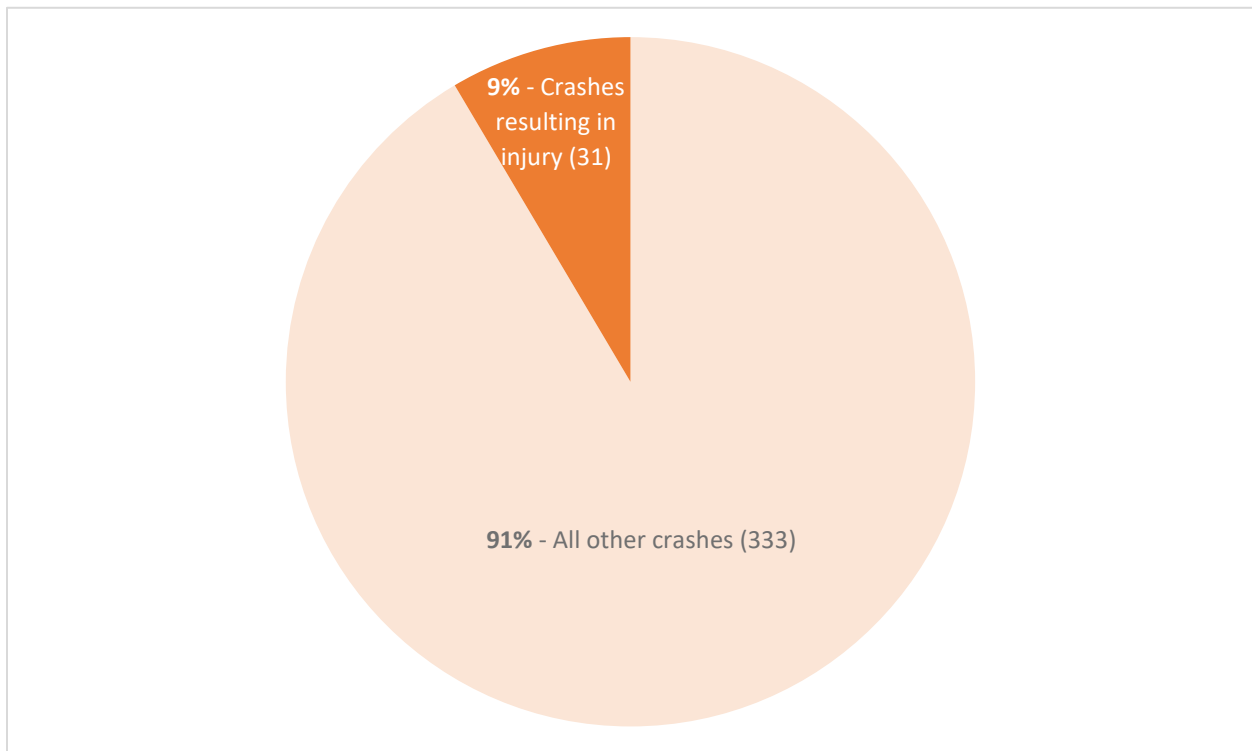
Figure 25: Share of Corridor Crashes Resulting in Injuries (2017-2020)

Figure 25 illustrates the share of total crashes that resulted in injuries on the corridor from 2017 to 2020. **Figure 26** displays a chart of crashes by time of day which shows there was not a time of day where significantly more injury crashes occurred when compared to overall crashes.

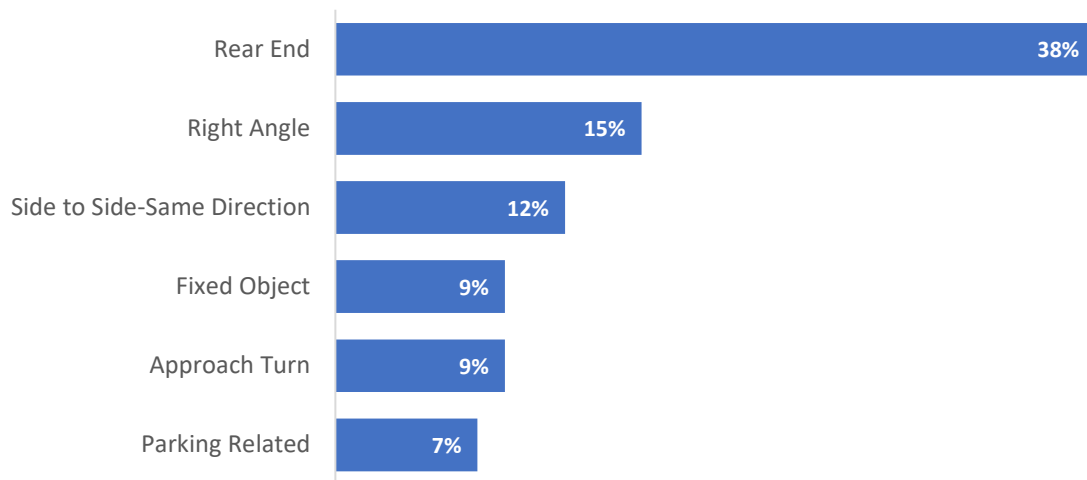
Figure 27: Top Harmful Events Corridor Wide

Figure 27 is a chart of the top harmful events for all crashes along the corridor. Rear end crashes were the greatest share of crashes followed by right angle crashes. Figure 28 lists the top harmful events for crashes resulting in injuries on the corridor. It stands out that bicycle and pedestrian crashes are overrepresented in crashes resulting in injuries when compared to overall crashes. Parking related crashes and side swipe crashes, significant shares of overall crashes, were not in the top harmful events for injury crashes.

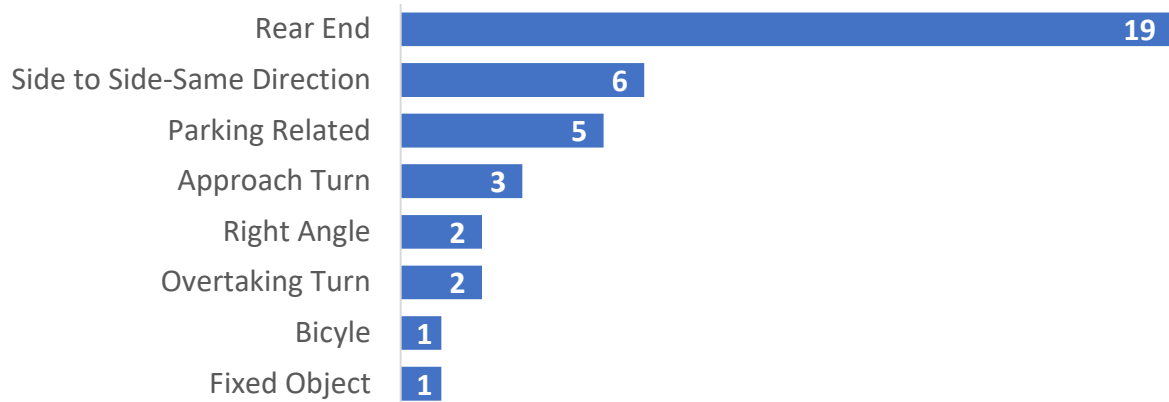
Figure 31: Top Harmful Events at Laporte Avenue/Walnut Street & North College Avenue

Figure 30 displays an aerial image of this intersection. **Table 6** displays the control type of each of the left turn movements in the intersection. **Figure 31** displays the top harmful events and **Figure 32** displays the top driver actions across the crashes at this intersection.

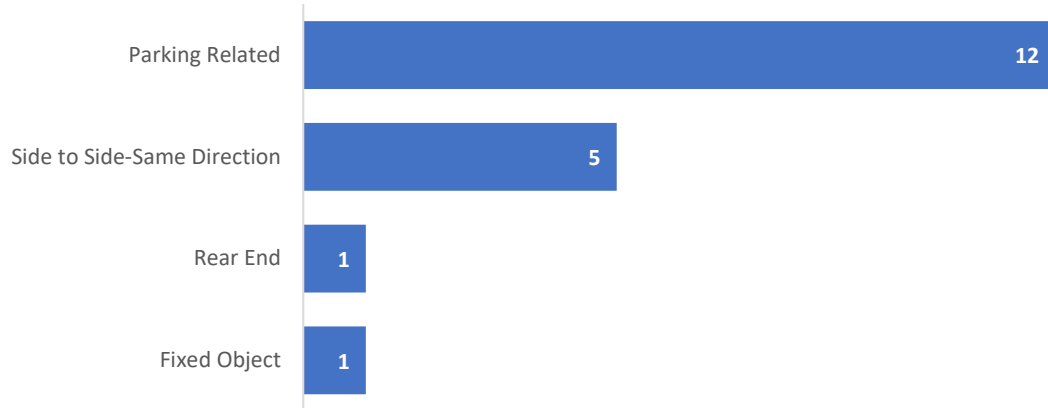
Figure 34: Top Harmful Events along the 200 Block of North College Avenue

The 200 Block of North College Avenue is located between Laporte Avenue and Maple Street. From 2017-2020 there were 19 crashes along this segment, none resulted in injury.

Figure 33 displays an aerial image of this block. **Figure 34** displays the top harmful events and **Figure 35** displays the top driver actions across the crashes along this block.

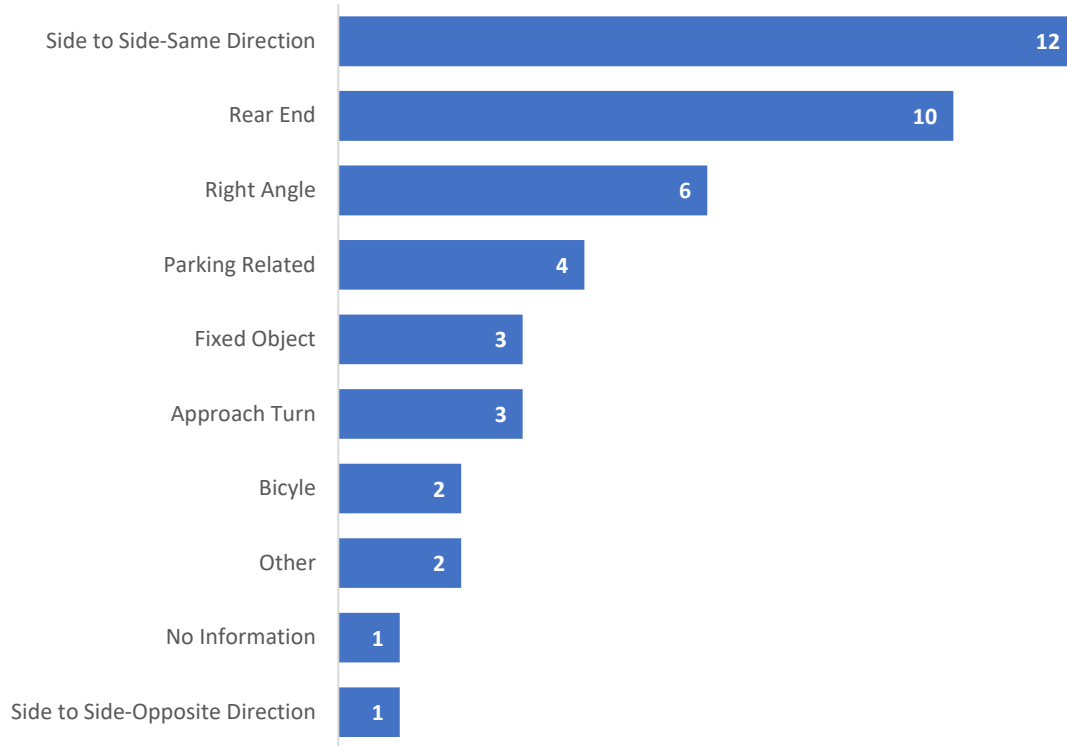
Figure 37: Top Harmful Events at Maple Street/Jefferson Street & North College Avenue

Maple Street/Jefferson Street & North College Avenue is a signalized intersection. From 2017-2020 there were 44 crashes at this intersection, two resulted in injury. Both of the crashes that resulted in injuries involved a vehicle hitting a person bicycling. One of the crashes was caused by a driver failing to yield right-of-way and hitting a person bicycling. This crash resulted in non-incapacitating injuries. The second injury crash occurred when a driver that was determined to be driving carelessly hit a person bicycling. The crash resulted in incapacitating injuries.

Figure 36 displays an aerial image of this intersection. Table 7 displays the control type of each of the left turn movements in the intersection. Figure 37 displays the top harmful events and Figure 38 displays the top driver actions across the crashes at this intersection.

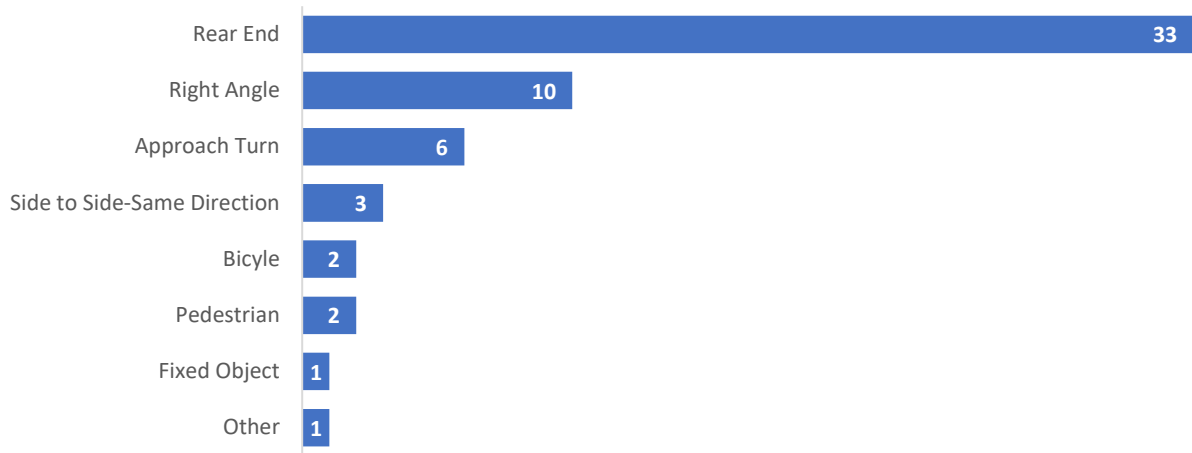
Figure 40: Top Harmful Events at Cherry Street/Willow Street & North College Avenue

Cherry Street/Willow Street & North College Avenue is a signalized intersection at the south end of the study area. From 2017-2020 there were 58 crashes at this intersection, seven resulted in injury. One of the pedestrian crashes and one of the bicycle crashes on this corridor resulted in injuries. The pedestrian involved crash resulted in an incapacitating injury. Of the five remaining injury crashes, two were approach turn crashes, two were right angle crashes, and one was a rear-end crash. All five crashes resulted in non-incapacitating injuries

Figure 39 displays an aerial image of this intersection. **Table 8** displays the control type of each of the left turn movements in the intersection. **Figure 40** displays the top harmful events and **Figure 41** displays the top driver actions across the crashes at this intersection.

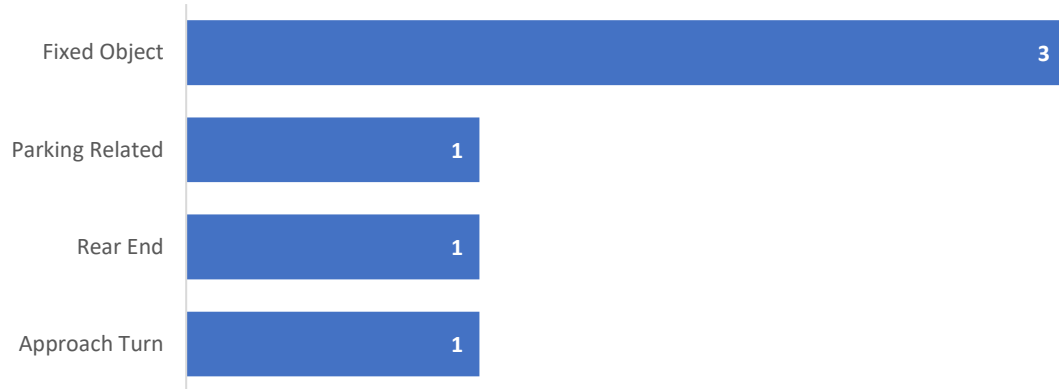
Figure 43: Top Harmful Events along the 400 Block of North College Avenue

The 400 Block of North College Avenue is located between Cherry Street and Vine Drive. From 2017-2020 there were 6 crashes along this segment, none resulted in injury.

Figure 42 displays an aerial image of this block. **Figure 43** displays the top harmful events and **Figure 44** displays the top driver actions across the crashes along this block.

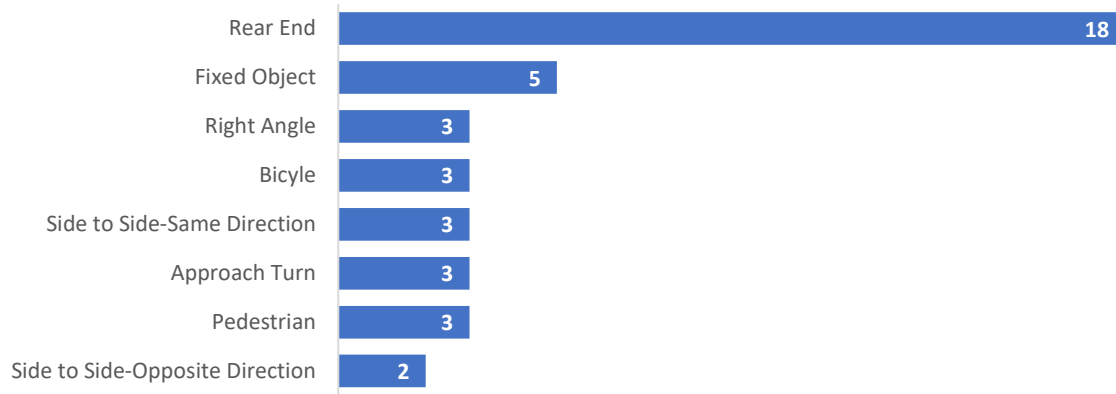
Figure 46: Top Harmful Events at Vine Drive & North College Avenue

Vine Drive & North College Avenue is a signalized intersection at the south end of the study area. From 2017-2020 there were 40 crashes at this intersection, five resulted in injury. One of the crashes involving a person bicycling resulted in an incapacitating injury. Of the other four injury crashes, two were approach turn crashes, one was a rear end crash, and one was a fixed object crash where a vehicle hit a guardrail. One of the approach turn crashes resulted in an incapacitating injury.

Figure 45 displays an aerial image of this intersection. Table 9 displays the control type of each of the left turn movements in the intersection. Figure 46 displays the top harmful events and Figure 47 displays the top driver actions across the crashes at this intersection.
