NORTH COLLEGE MAX BRT

EXISTING CONDITIONS REPORT

SEPTEMBER 2022

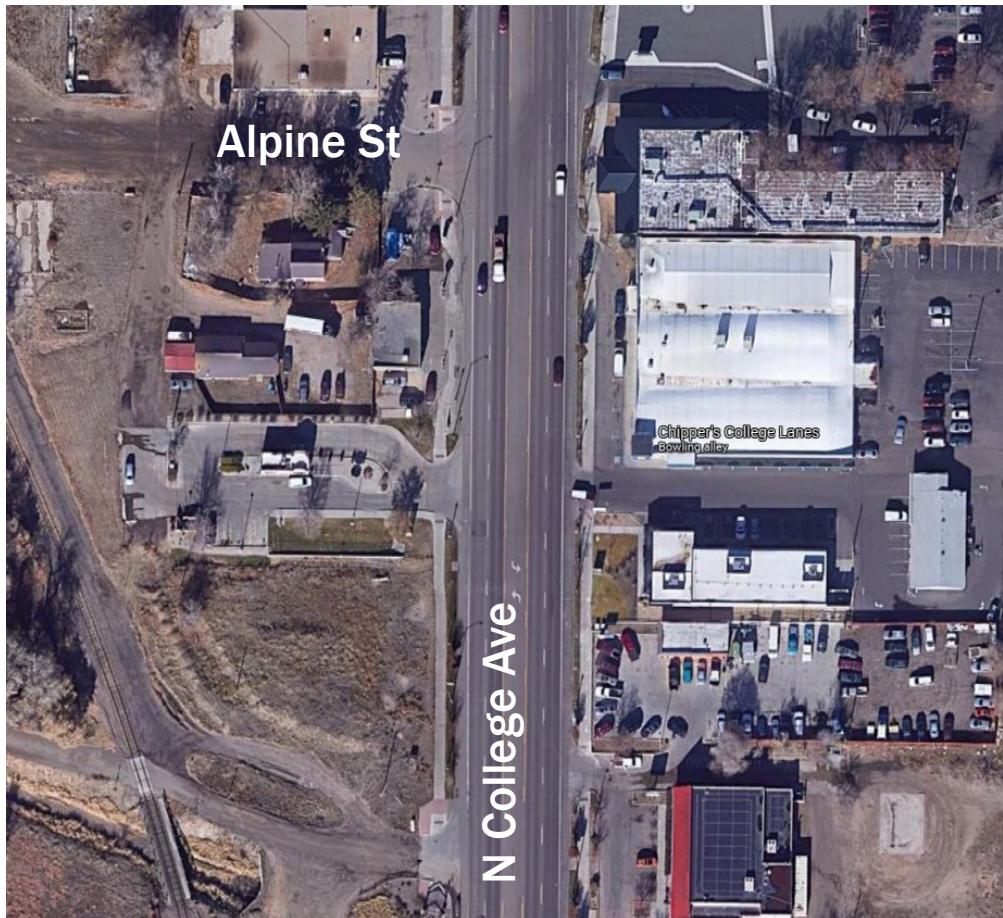
Figure 48: Aerial of the 800 Block of North College Avenue

The 800 Block of North College Avenue is located between Vine Drive and Alpine Street. From 2017-2020 there were 17 crashes along this segment, three resulted in injury. One of crashes involving a person bicycling resulted in a non-incapacitating injury. Of the other two injury crashes one was a right-angle crash and the other was an overtaking turn crash. Both resulted in non-incapacitating injuries.

Figure 48 displays an aerial image of this block. **Figure 49** displays the top harmful events and **Figure 50** displays the top driver actions across the crashes along this block.

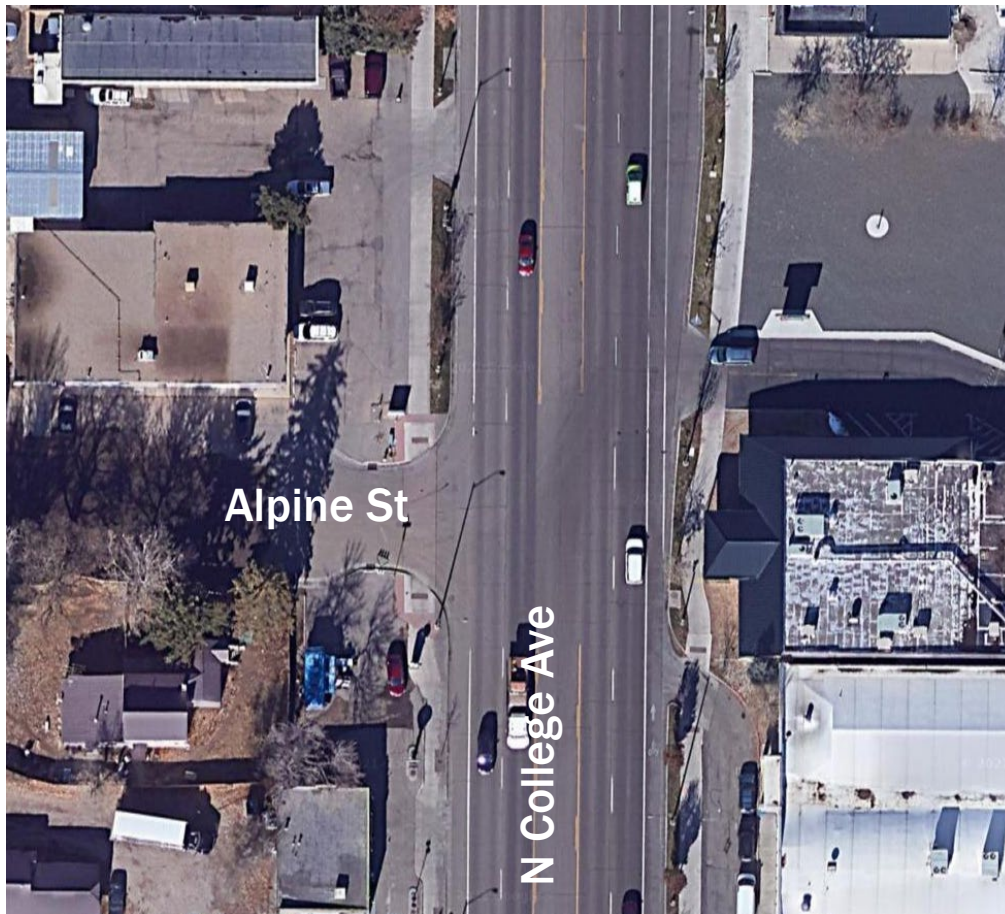
Figure 51: Aerial of Alpine Street & North College Avenue

Alpine Street & North College Avenue is an intersection with a stop sign on Alpine Street. From 2017-2020 there were 4 crashes at this intersection, none resulted in injury.

Figure 51 displays an aerial image of this intersection. **Figure 52** displays the top harmful events and **Figure 53** displays the top driver actions across the crashes at this intersection.

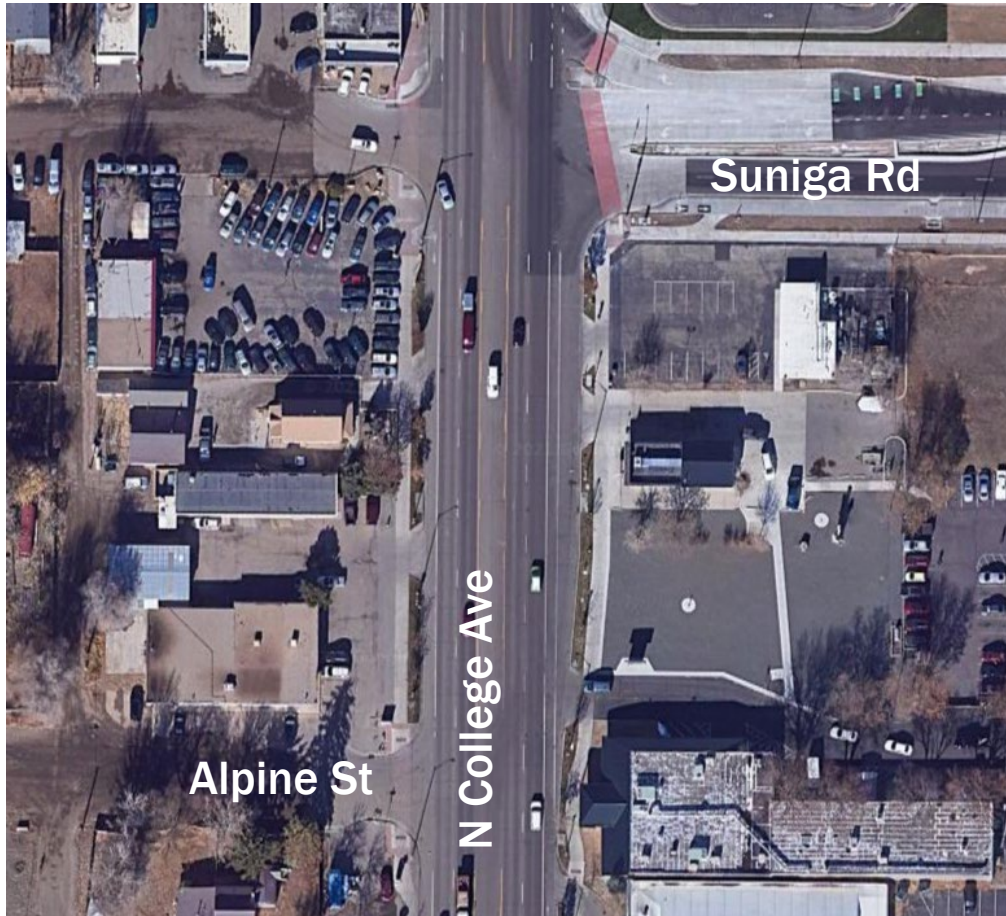
Figure 54: Aerial of the 900 Block of North College Avenue

The 900 Block of North College Avenue is located between Alpine Street and Suniga Road. From 2017-2020 there were 9 crashes along this segment, one of these resulted in injury. The injury crash at this location was caused by a vehicle executing a lane violation and hitting a person bicycling. This crash resulted in a non-capacitating injury.

Figure 54 displays an aerial image of this block. **Figure 55** displays the top harmful events and **Figure 56** displays the top driver actions across the crashes along this block.

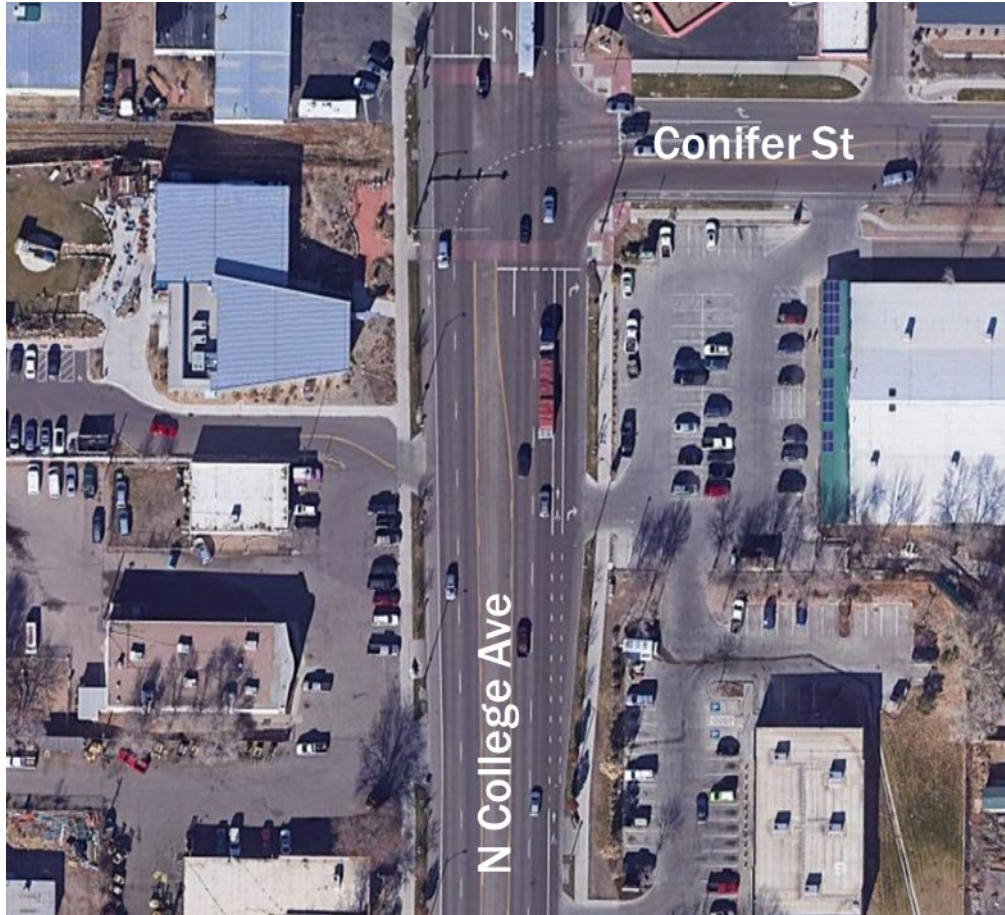
Figure 57: Aerial of the 1200 Block of North College Avenue

The 1200 Block of North College Avenue is located between Suniga Road and Conifer Street. From 2017-2020 there were 5 crashes along this segment, one of these resulted in injury. The injury crash at this location was a parking related crash and involved a large rock or boulder. This crash resulted in a non-incapacitating injury.

Figure 57 displays an aerial image of this block. **Figure 58** displays the top harmful events and **Figure 59** displays the top driver actions across the crashes along this block.

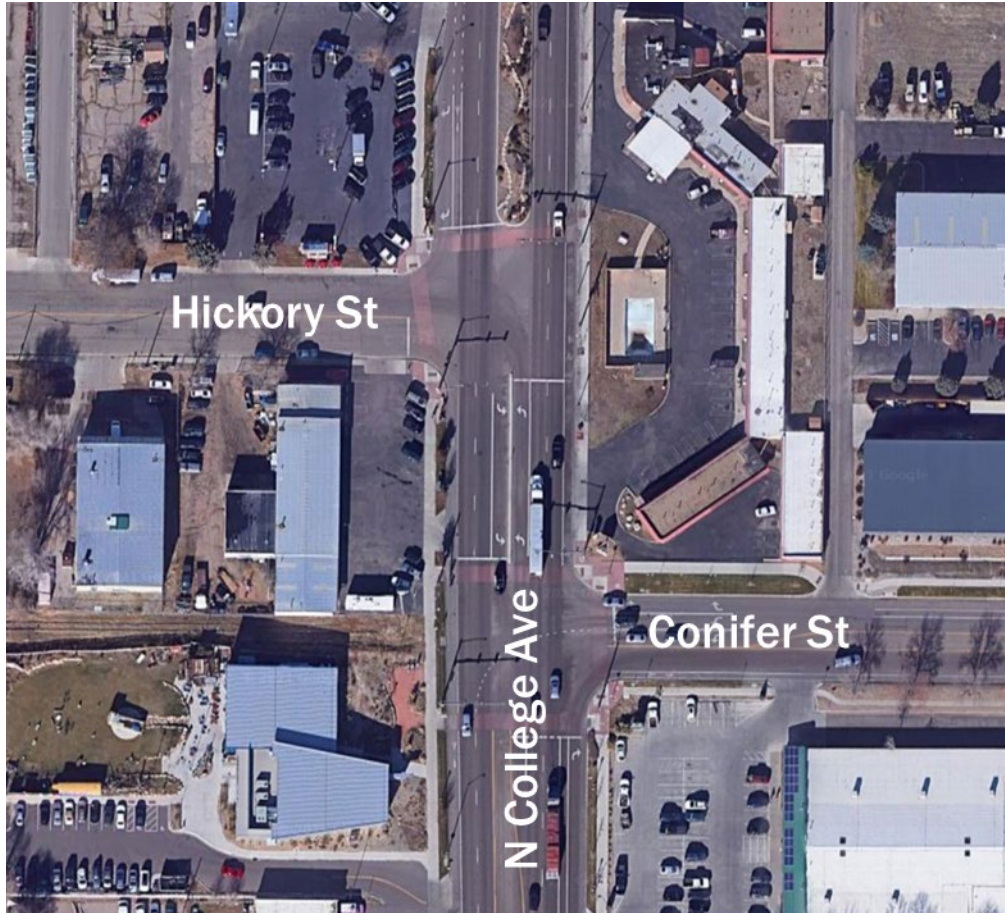
Figure 60: Aerial of Conifer Street/Hickory Street & North College Avenue

Conifer Street/Hickory Street & North College Avenue are two signalized “T” intersections. From 2017-2020 there were 23 crashes at this intersection, one resulted in injury. The injury crash at this location was a head-on collision that resulted in a non-incapacitating injury.

Figure 60 displays an aerial image of this intersection. Table 10 displays the control type of each of the left turn movements in the intersection. Figure 61 displays the top harmful events and Figure 62 displays the top driver actions across the crashes at this intersection.

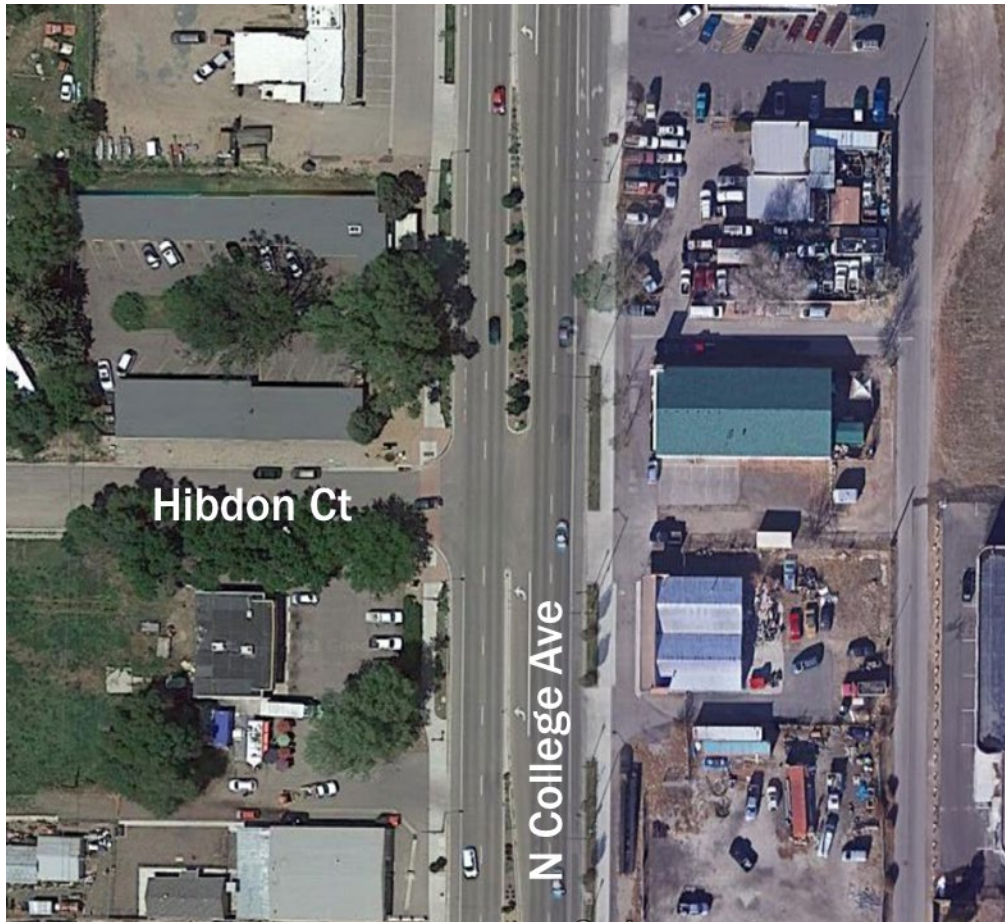
Figure 63: Aerial of Hibdon Court & North College Avenue

Hibdon Court & North College Avenue is a stop-controlled intersection with a stop sign on Hibdon Court. From 2017-2020 there were 5 crashes at this intersection, one resulted in injury. The injury crash at this location was right angle crash that resulted in a non-incapacitating injury.

Figure 63 displays an aerial image of this intersection. **Figure 64** displays the top harmful events and **Figure 65** displays the top driver actions across the crashes at this intersection.

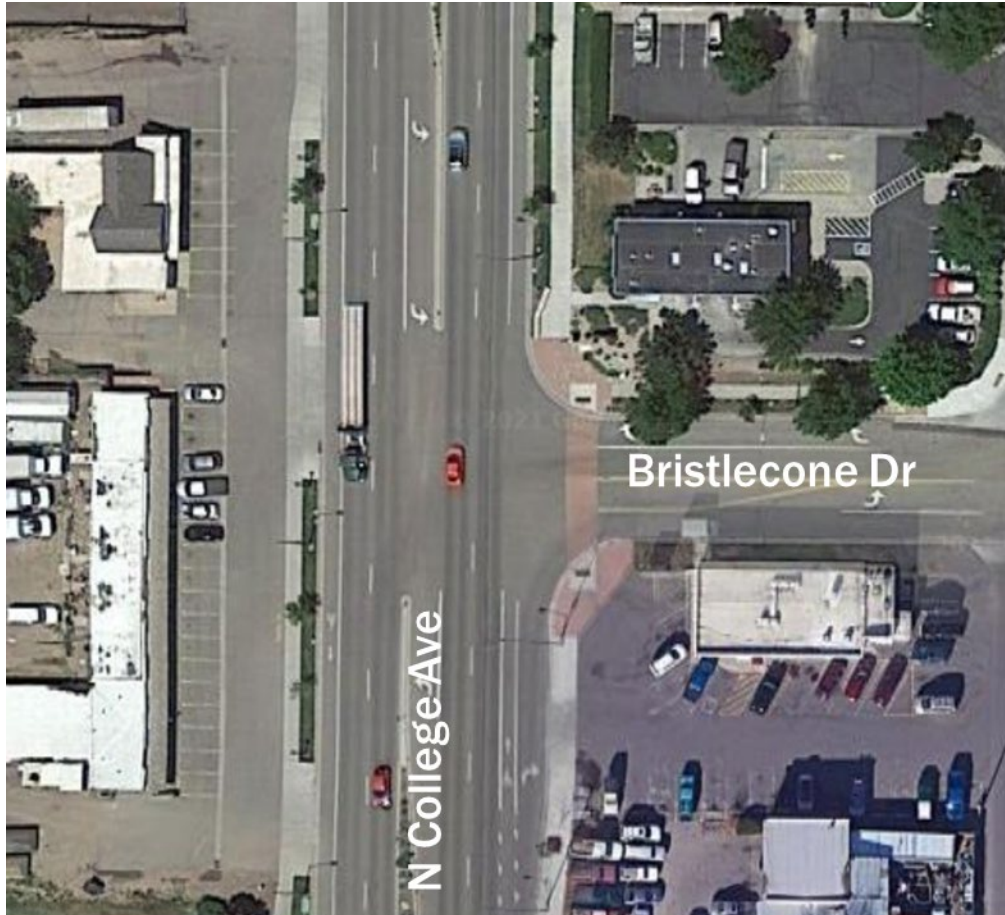
Figure 66: Aerial of Bristlecone Drive & North College Avenue

Bristlecone Drive & North College Avenue is a stop-controlled intersection with a stop sign on Bristlecone Drive. From 2017-2020 there were 9 crashes at this intersection, two resulted in injury. The crash involving a person bicycling resulted in an incapacitating injury. The second injury crash was an approach turn crash that resulted in a non-incapacitating injury.

Figure 66 displays an aerial image of this intersection. **Figure 67** displays the top harmful events and **Figure 68** displays the top driver actions across the crashes at this intersection.

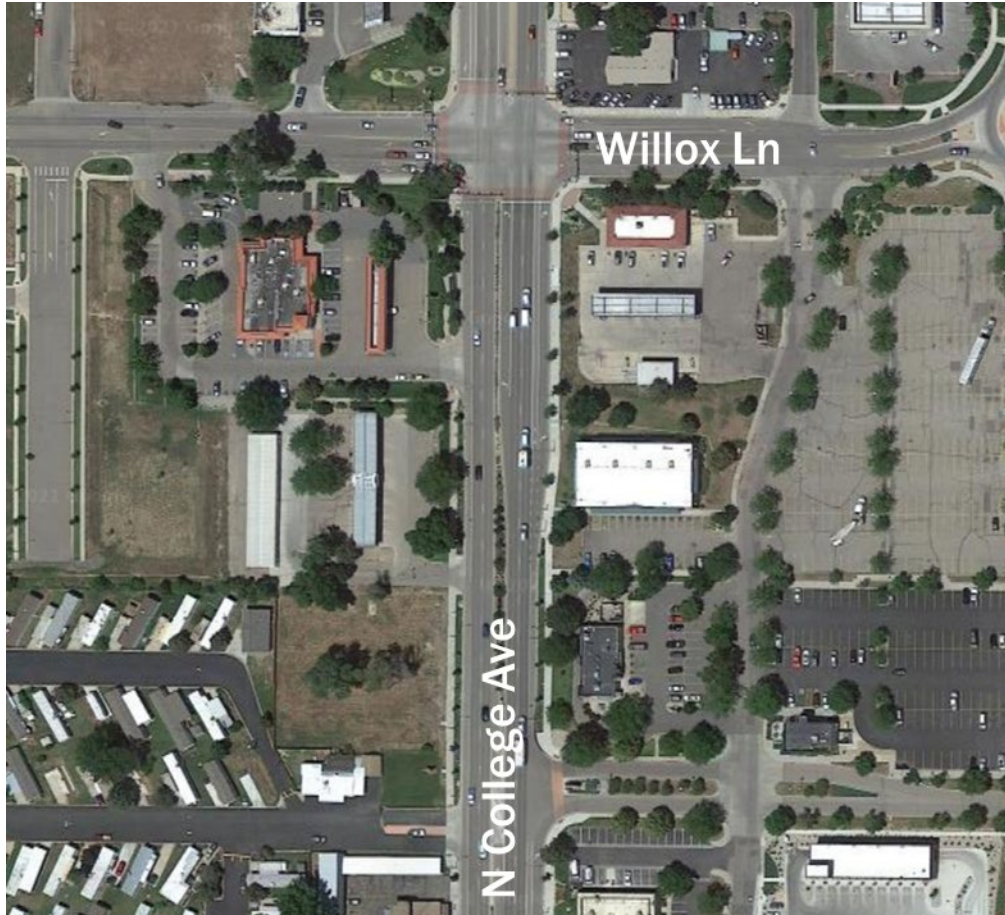
Figure 69: Aerial of the 1600 Block of North College Avenue

The 1600 Block of North College Avenue is located between Bristlecone Drive and Willox Lane. From 2017-2020 there were 4 crashes along this segment, none of these resulted in injury.

Figure 69 displays an aerial image of this block. **Figure 70** displays the top harmful events and **Figure 71** displays the top driver actions across the crashes along this block.

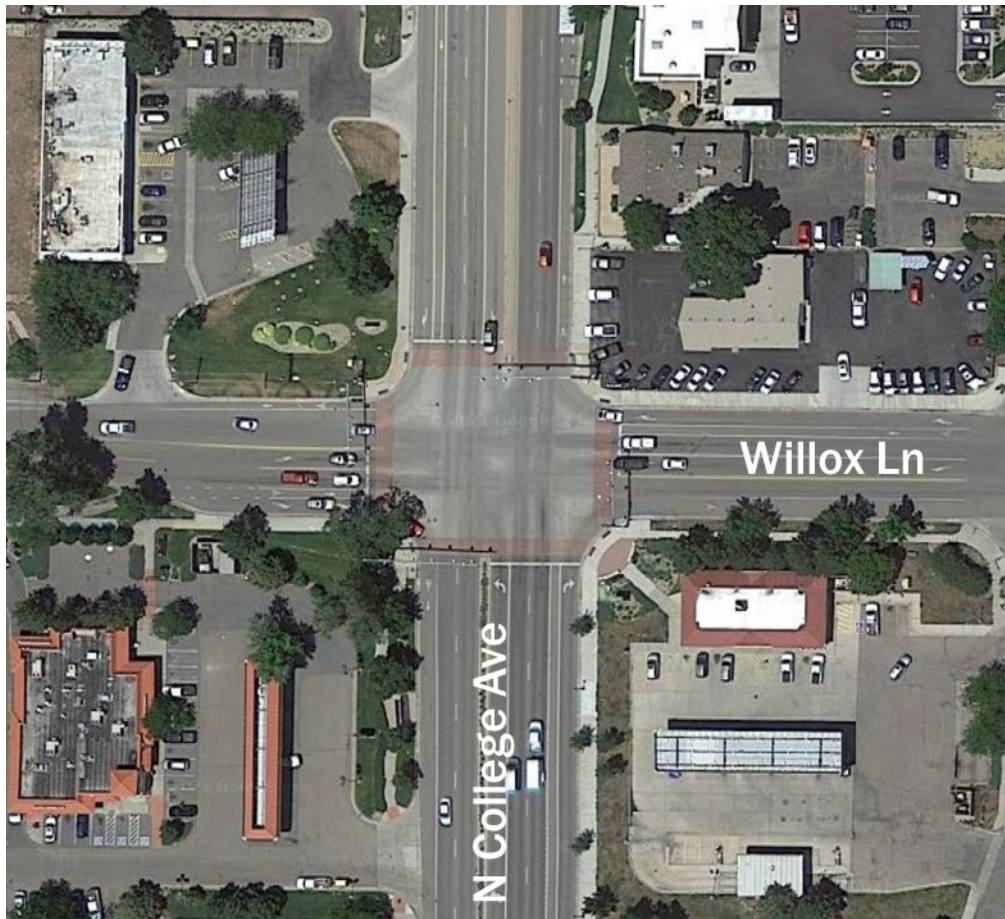
Figure 72: Aerial of Wilcox Lane & North College Avenue

Wilcox Lane & North College Avenue is a signalized intersection at the north end of the study area. From 2017-2020 there were 64 crashes at this intersection, six resulted in injury. One of the pedestrian crashes and one of the bicycle crashes at this intersection resulted in non-incapacitating injuries. Of the four remaining injury crashes, two were approach turn crashes, one was a rear-end crash, and one was a fixed object crash where a vehicle hit a barricade. All four crashes resulted in non-incapacitating injuries.

Figure 72 displays an aerial image of this intersection. **Table 11** displays the control type of each of the left turn movements in the intersection. **Figure 73** displays the top harmful events and **Figure 74** displays the top driver actions across the crashes at this intersection.

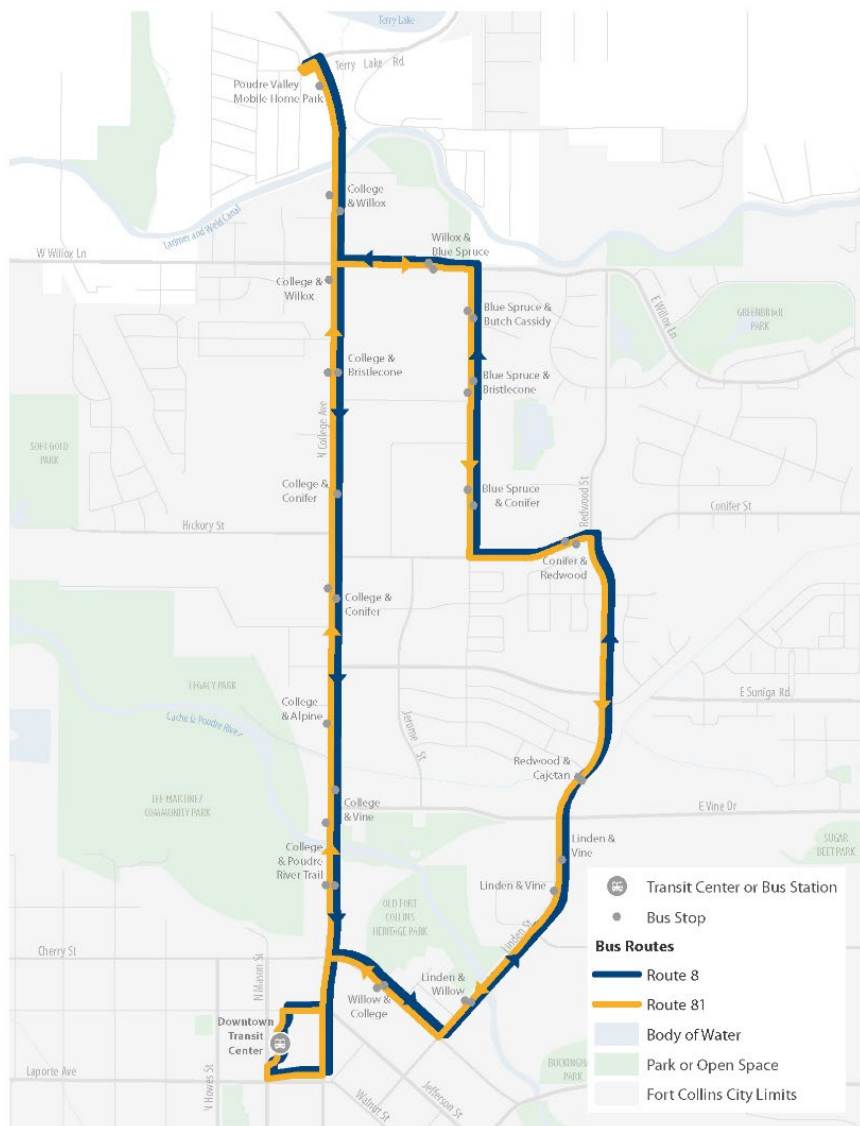
Figure 75: Map of Routes 8 and 81

Routes 8 and 81 are parallel routes that run loops in opposite directions. Route 8 runs in a counterclockwise loop while Route 81 runs in a clockwise loop. These two routes provide transit service for the North College corridor and the areas east of North College Avenue including to many community services located east of North College Avenue. **Figure 75** displays a map of Routes 8 and 81 as well as the locations of the bus stops along these routes.

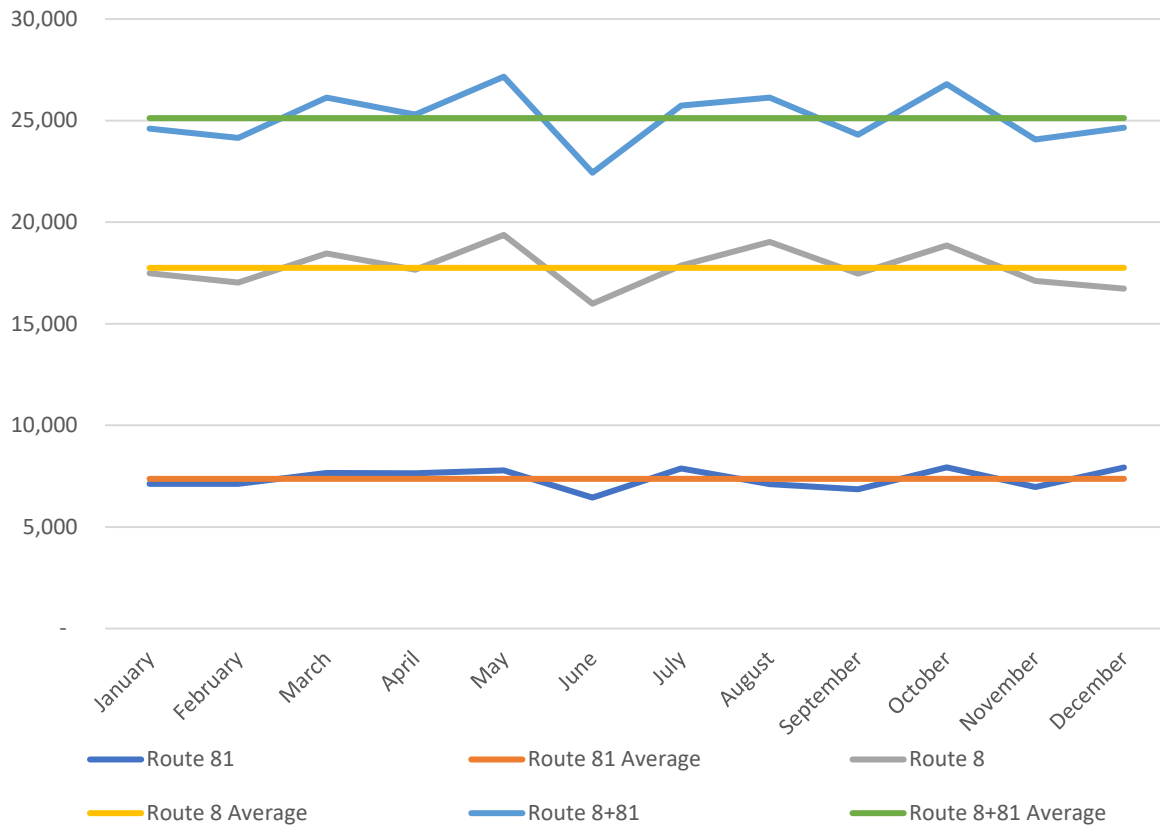
Figure 76: Average Monthly Ridership

Ridership, or one-way boardings, by month for 2019 is shown in **Figure 76** and indicates that average ridership is 7,370 for Route 8, 17,755 for Route 81, and 25,125 for Routes 8 and 81 combined.

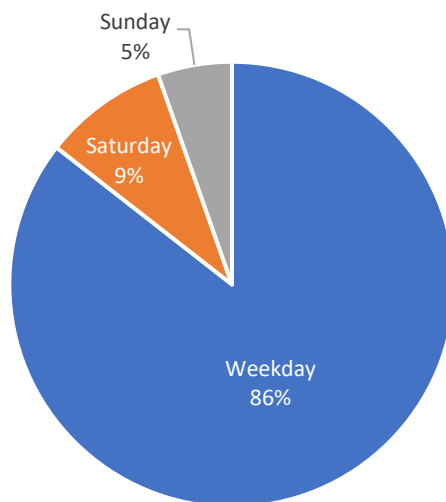
Figure 77: Share of Ridership by Day of the Week

Ridership by day of week is shown in **Figure 77** and indicates that while the majority of ridership occurs on weekdays, weekend ridership at 14% in total is sizeable.

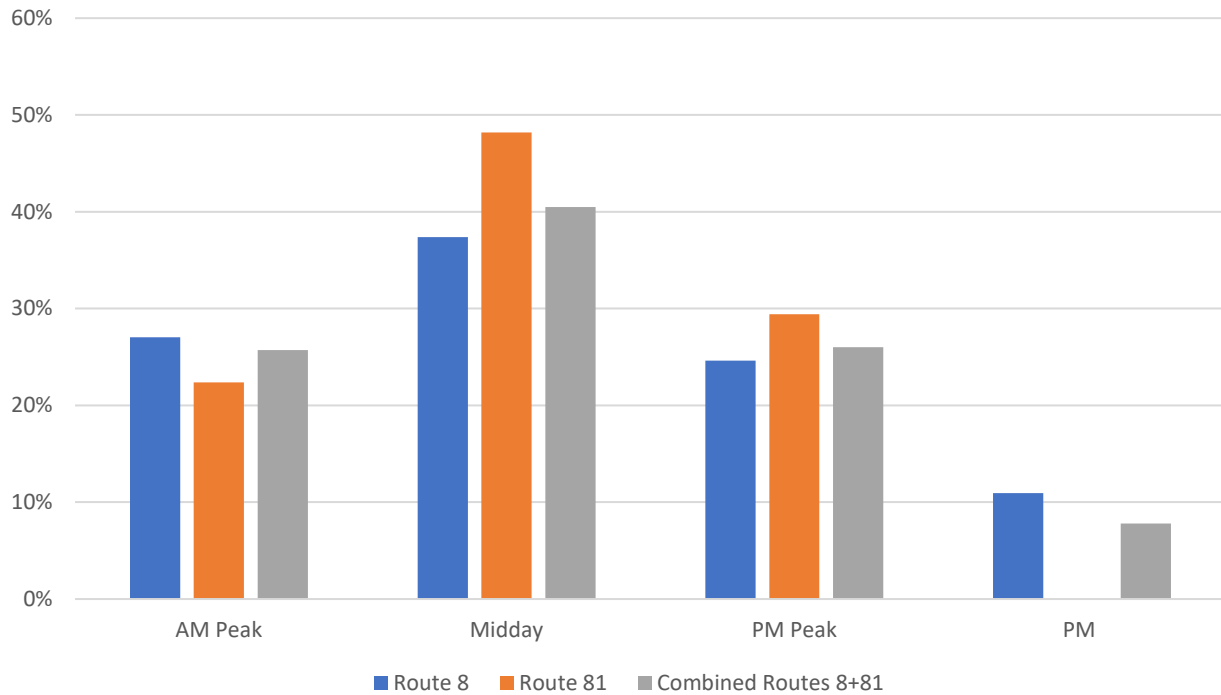
Figure 78: Share of Ridership by Route and Time of Day

As shown in **Figure 78**, the majority of ridership on Routes 8 and 81 occurs during the midday, with less ridership in the AM and PM peak periods. This indicates that Routes 8 and 81 do not have significant commuter or student ridership, as is more common for other Transfort routes, and that most riders are likely using these routes to access services during the midday.

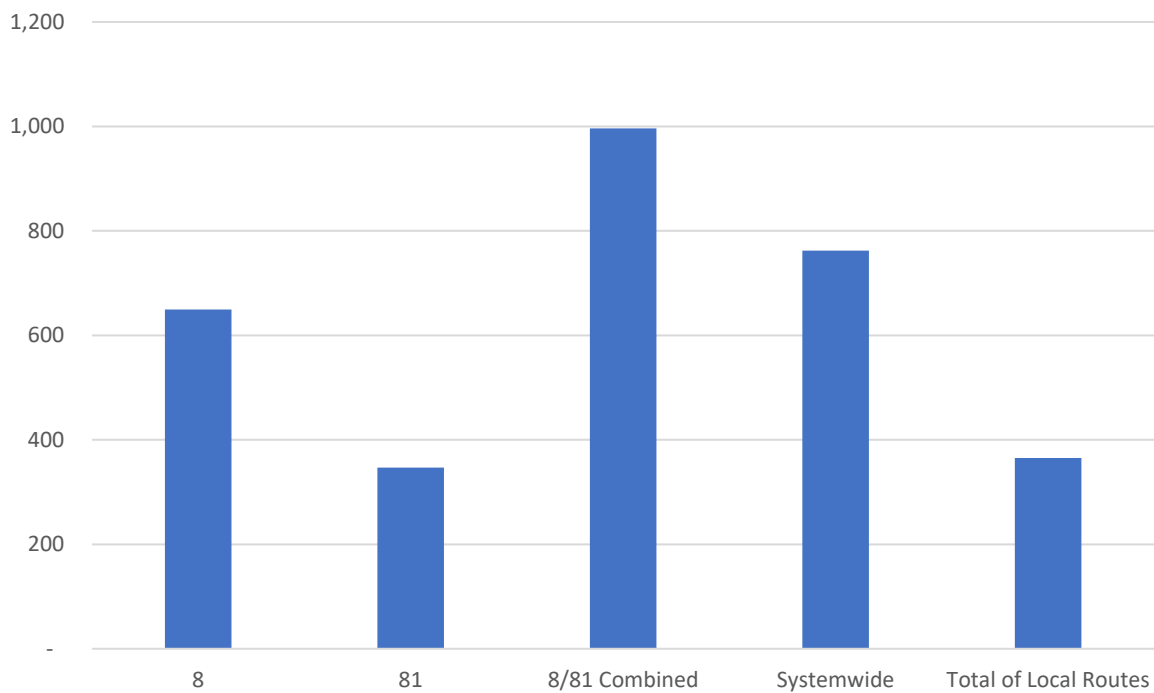
Figure 79: Average Weekday Boardings by Route (2019)

Table 13, Figure 79, and Figure 80 show performance characteristics for Routes 8 and 81 in comparison to the entire Transfort system, as well as just the local routes. For Routes 8 and 81 together, productivity (per hour and per mile) and weekday boardings are higher than the local routes and systemwide averages.

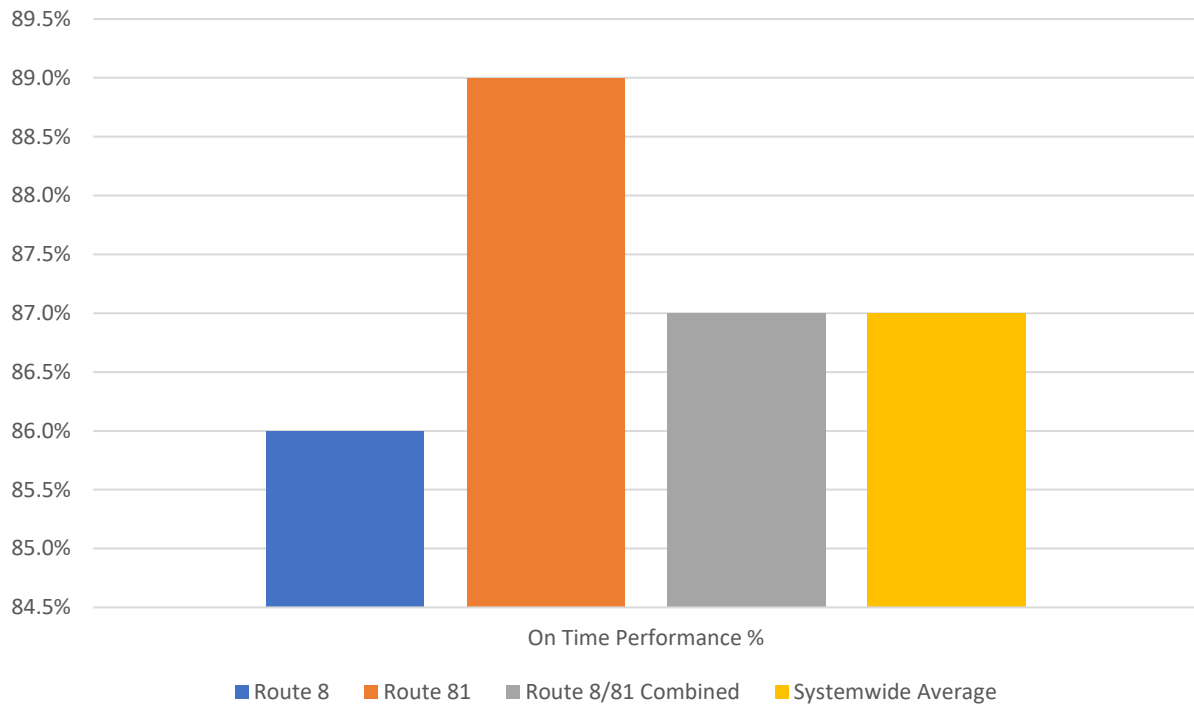
Figure 81: Chart of On-time Performance

Figure 81 shows the on-time performance of Routes 8 and 81, which is the same as the system-wide average for the combined route performance.

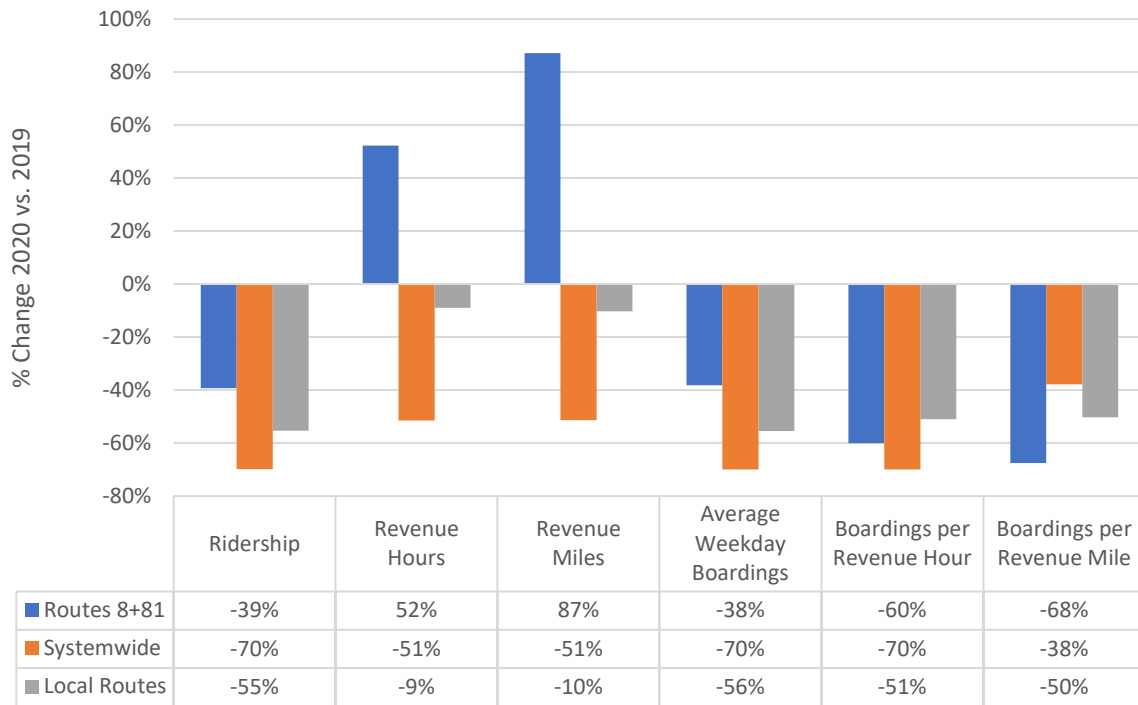
Figure 82: Comparison of operational metrics (2019 vs. 2020)

The COVID-19 pandemic reduced transit ridership across the country and Transfort was no exception. **Figure 82** shows the precipitous drop in ridership that happened in 2020 in comparison to 2019. In total, systemwide ridership for 2020 was 70% lower in comparison to 2019; however, it is notable that ridership on Routes 8 and 81 was only 39% lower, which could point to high transit dependence of Routes 8 and 81 riders who still needed to use the bus to access services in the North College Avenue area. It is also notable that Transfort had to add 52% more vehicle revenue hours and 87% more vehicle miles systemwide in 2020 in comparison to 2019 – according to Transfort staff, this was due to public health bus capacity restrictions combined with ridership that remained high. Transfort put extra buses in place throughout the day to accommodate the continued ridership demand while staying within the capacity restrictions.

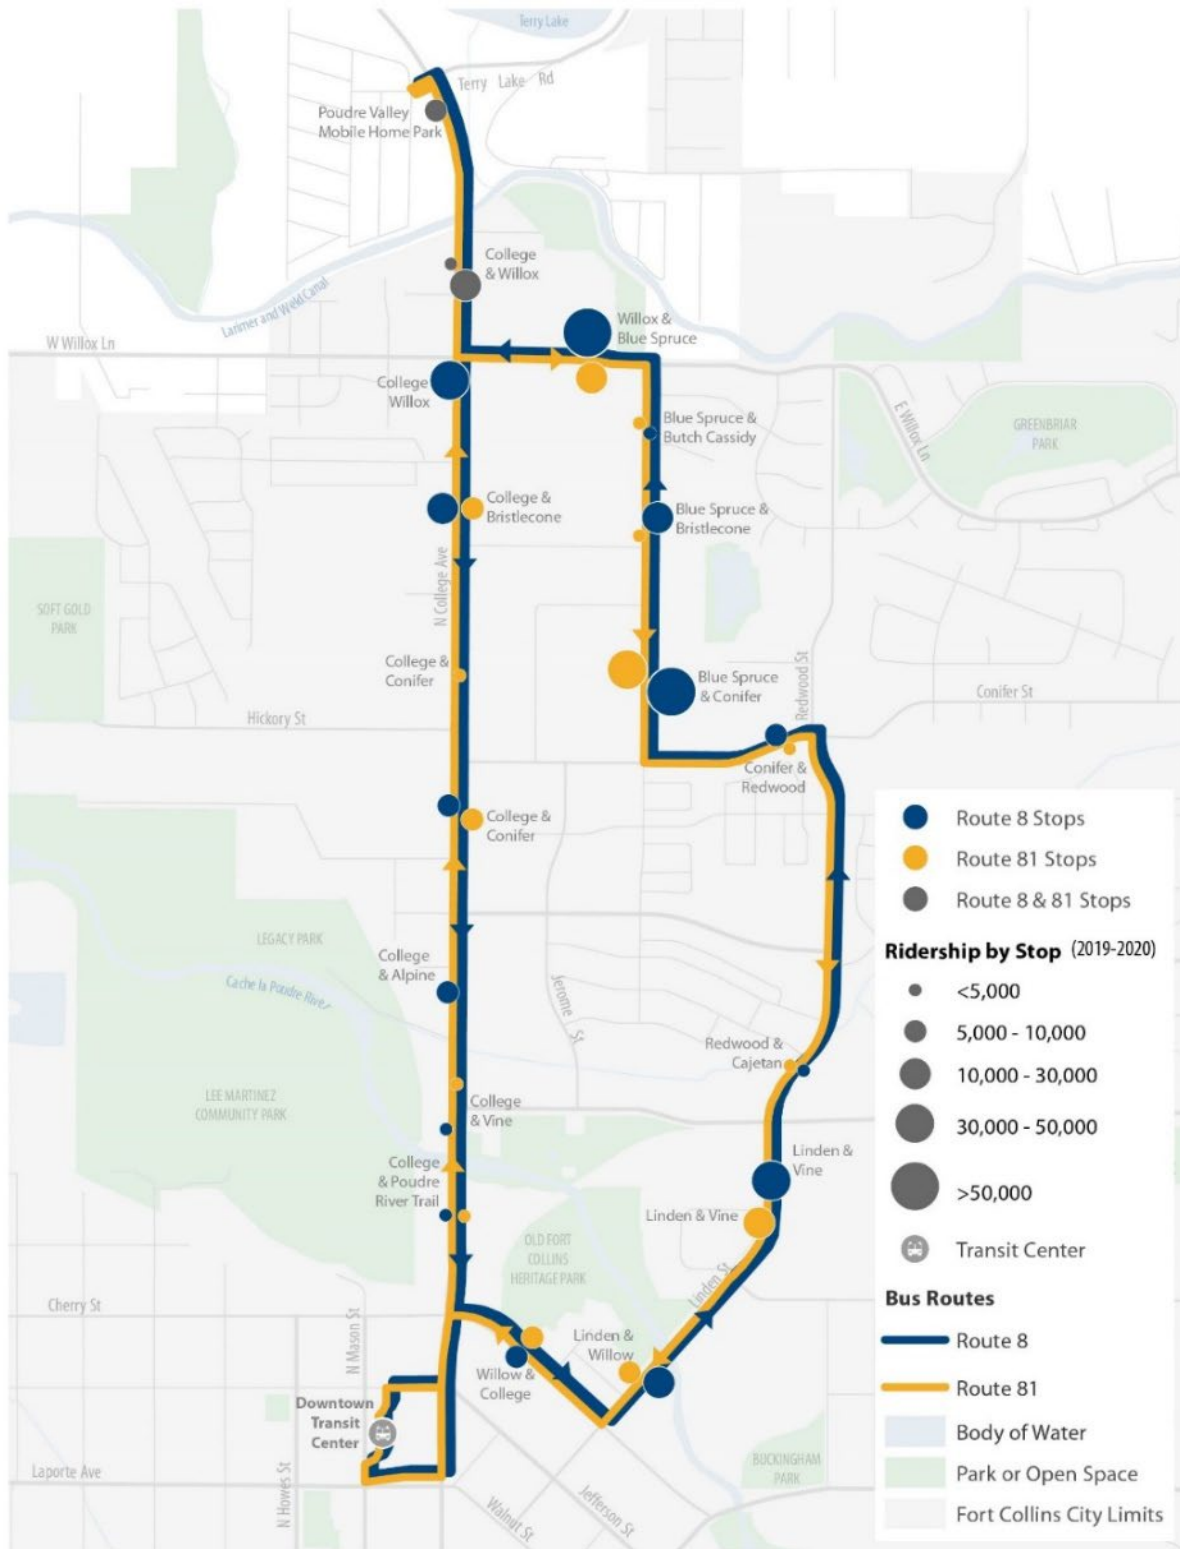
Figure 83: Map of Ridership by Stop

Figure 83 displays a map of ridership on Routes 8 and 81 by stop. The stops with the greatest ridership for these routes are located east of North College Avenue and are located near existing community services.

Note: Ridership by stop data is the total ridership over a 24-month period from 2019 through 2020. The numbers displayed are the sum of boardings and alightings over this period.

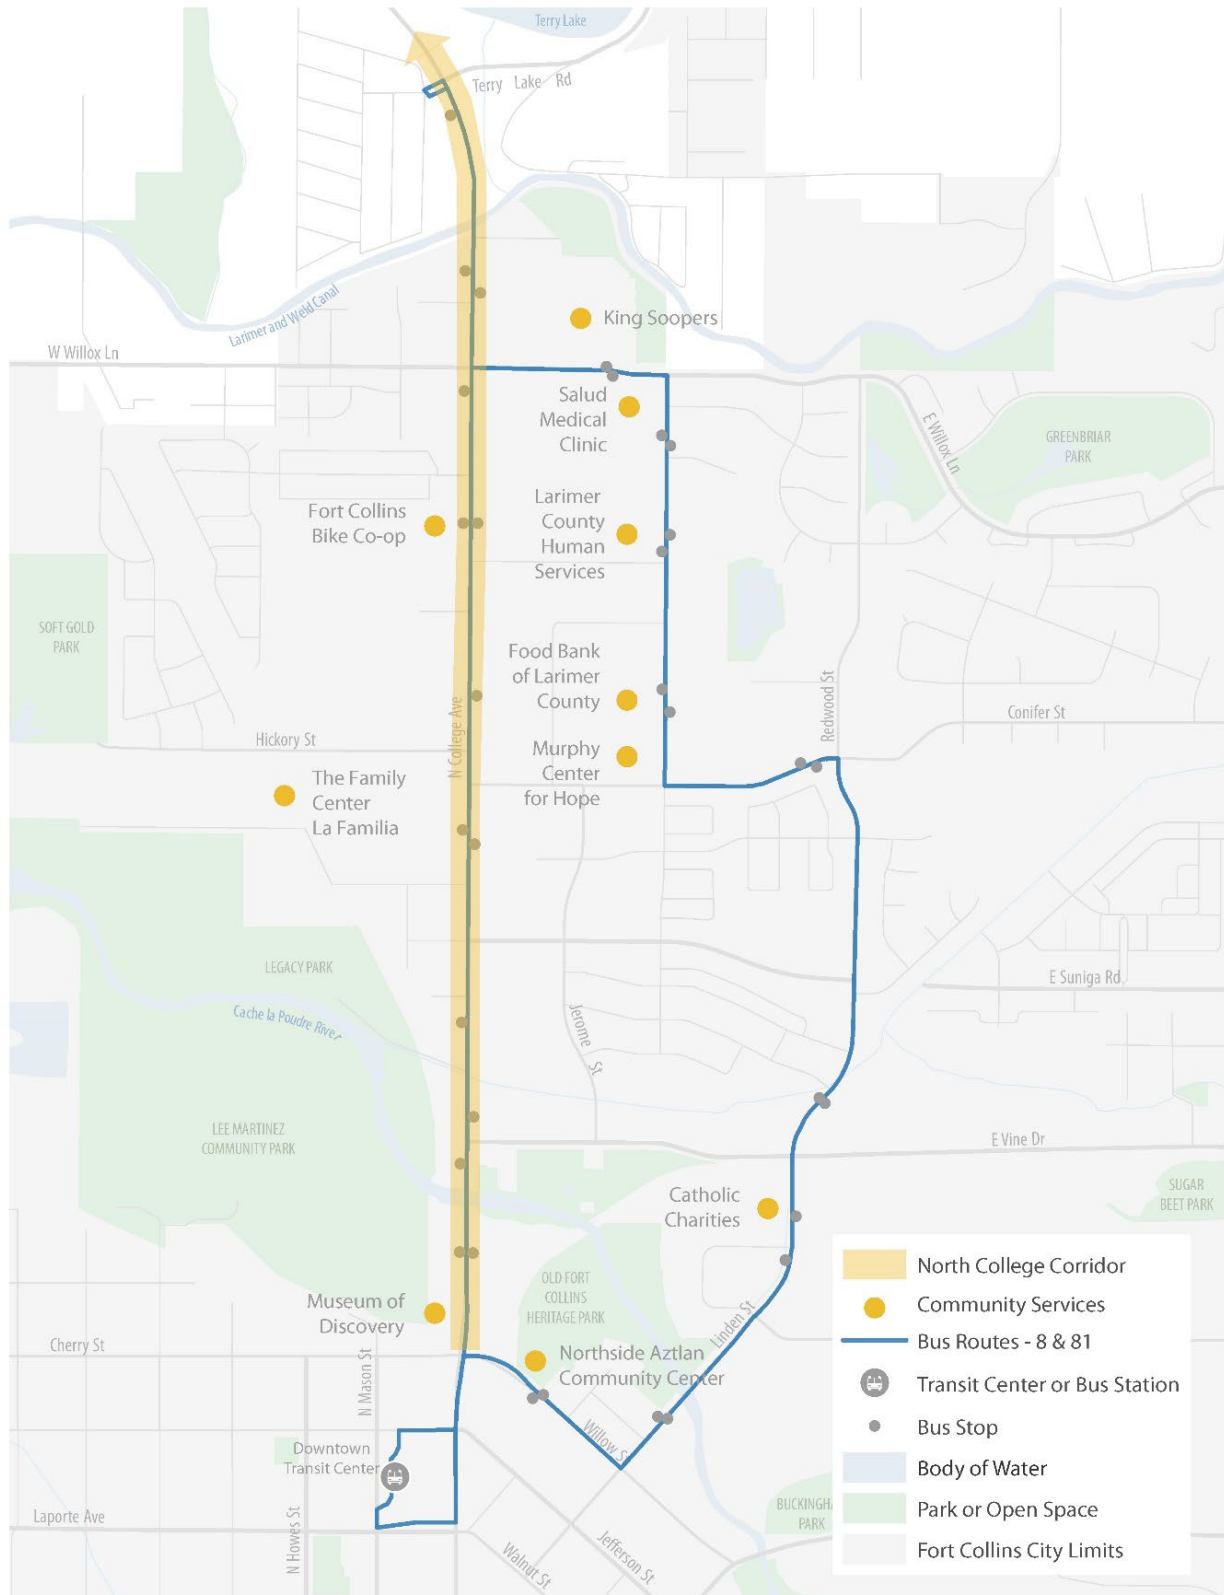
Figure 84: Map of Community Services Located Near Routes 8 and 81

Figure 84 displays a map of Routes 8 and 81 and the locations of nearby community services for reference. **Figure 85** shows a chart of the ridership data by stop with boardings versus alightings separated.

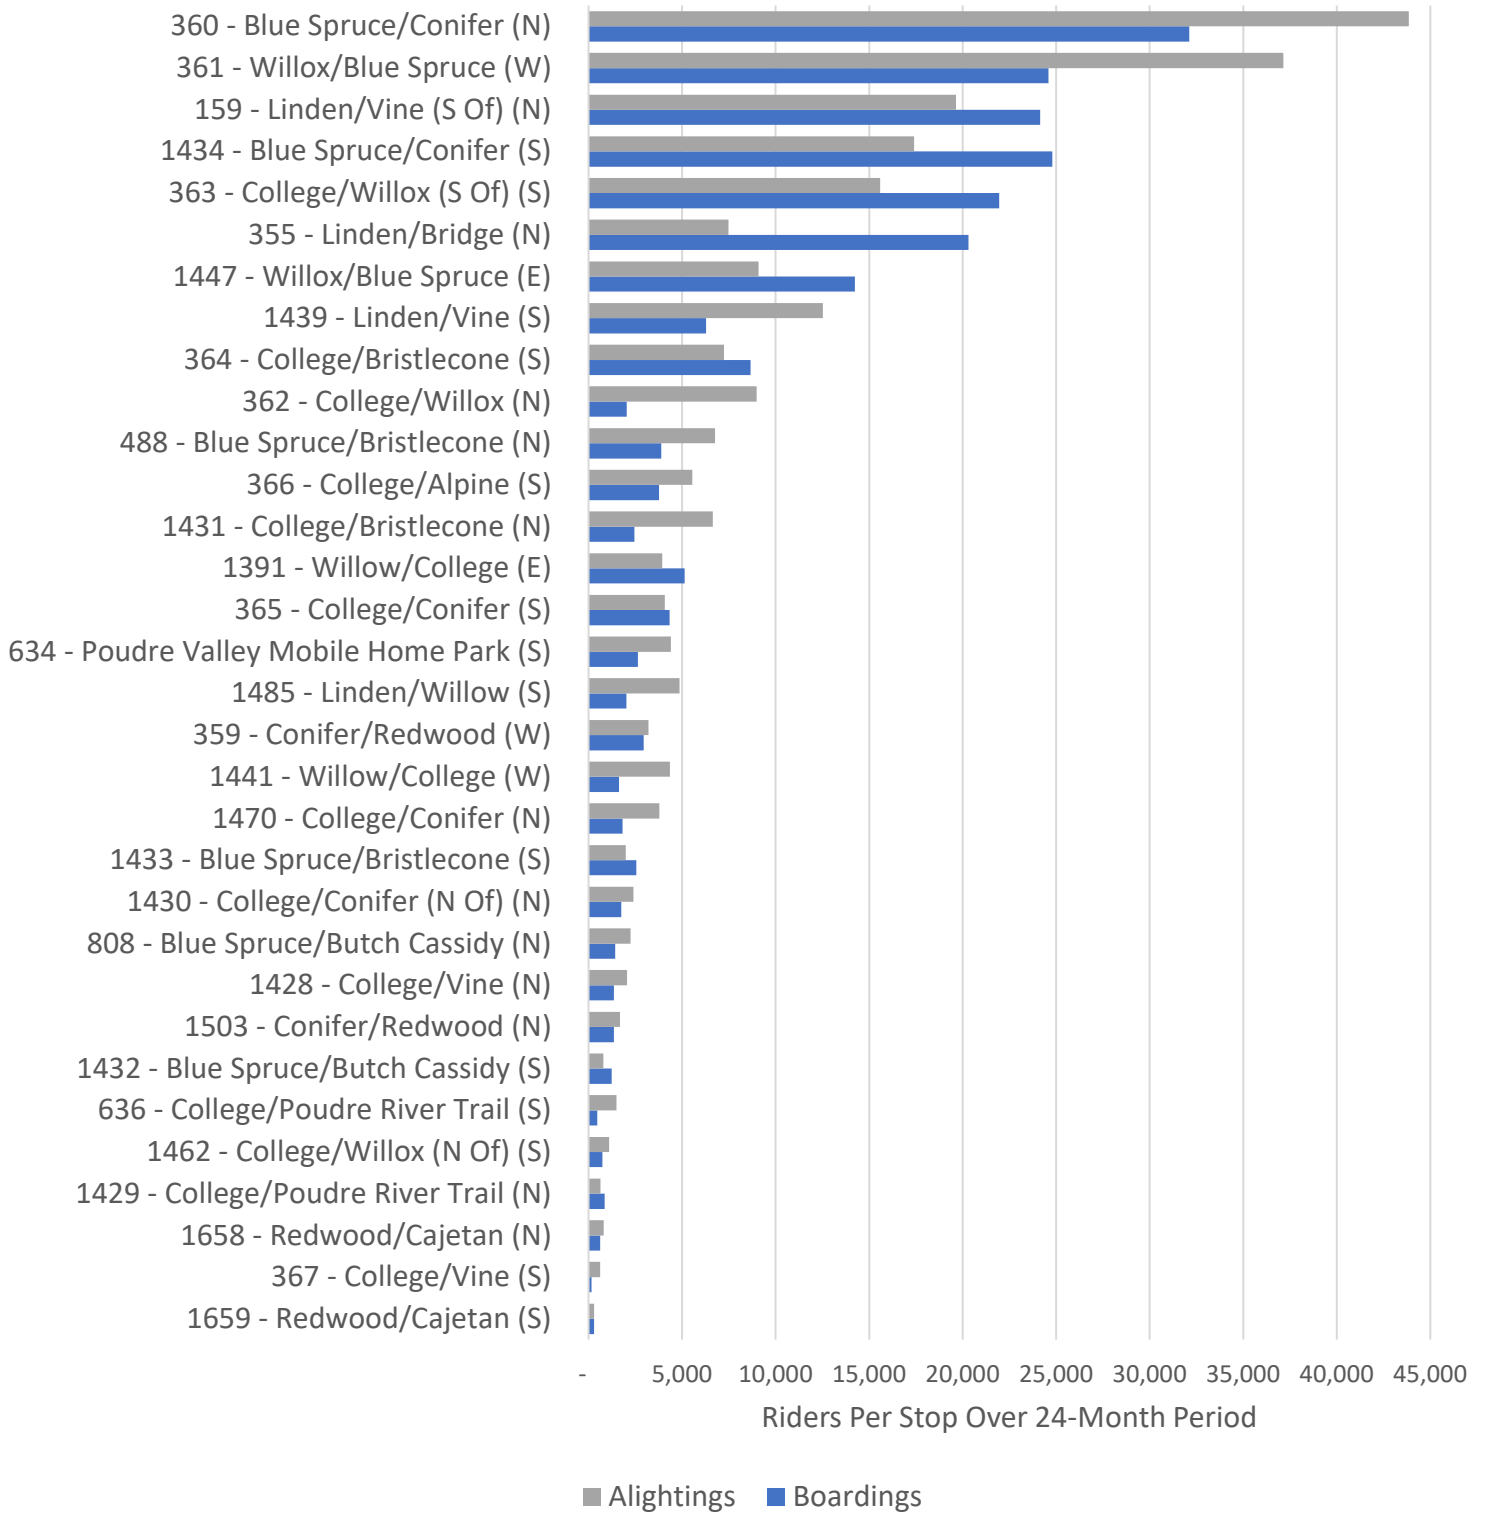
Figure 85: Ridership by Stop (2019-2020)

Note: Ridership by stop data is the total ridership over a 24-month period from 2019 through 2020.
