NORTH COLLEGE MAX BRT

EXISTING CONDITIONS REPORT

SEPTEMBER 2022

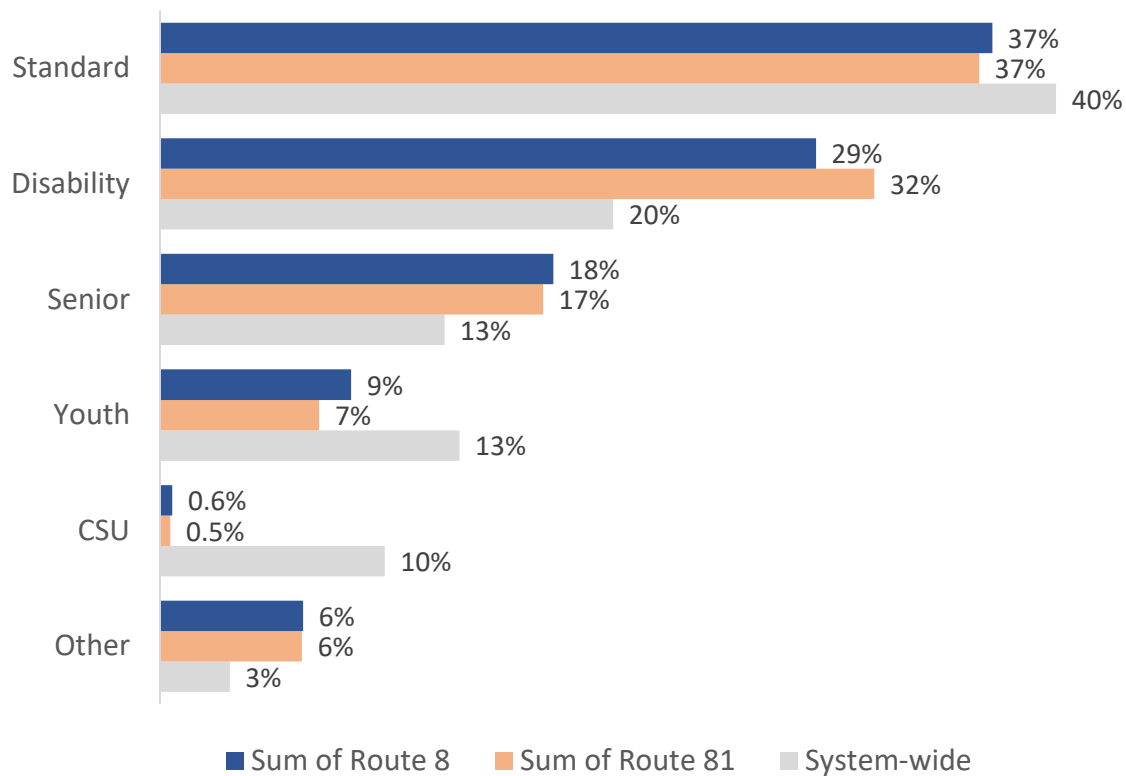
Figure 88: Comparison of Share of Fare Type

Figure 88 details the breakdown of fare types used on Routes 8 and 81 when compared to the averages for the entire Transfort system. A smaller share of riders pay standard (non-discounted fares), youth fares, and CSU affiliated fares on Routes 8 and 81 when compared to the system average. On Routes 8 and 81, a larger share of ridership pays discounted fares for seniors or people with a disability when compared to the system as a whole.

Data from 2019 annual farebox reporting.

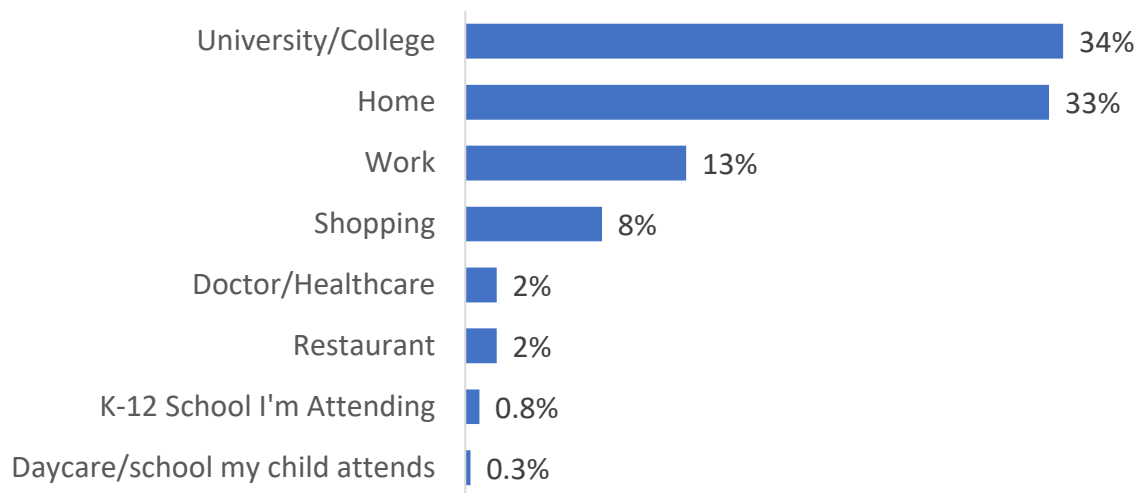
Figure 89: Survey Results for Trip Destination

The results of the 2017 system-wide survey showed the most common destination for people riding the bus was a university or college. Home was the second most common destination. **Figure 89** shows the survey results for respondents’ bus trip destinations. Considering less than 1% of Routes 8 and 81 riders pay CSU fares, compared to 10% system-wide, it is expected that the share of riders accessing a university or college on these routes is also significantly lower.

Data from Transfort 2017 Transit Passenger Survey

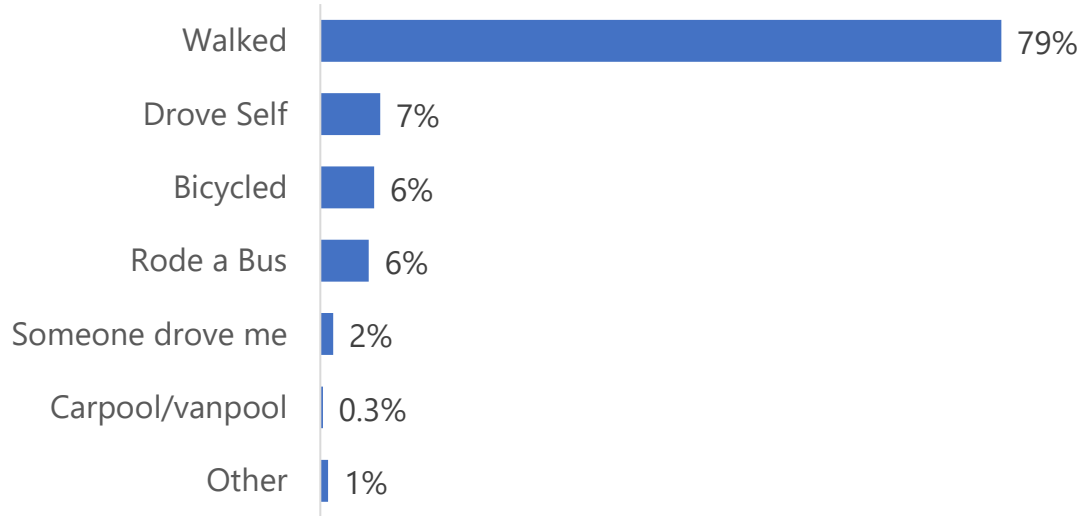
Figure 90: Methods of Reaching the Bus Stop

Across all of the surveys, the most common way that people accessed the bus, and got from the bus to their destination, was by walking. Walking was chosen by respondents more than ten times more than the other modes. **Figure 90** and

Data from Transfort 2017 Transit Passenger Survey

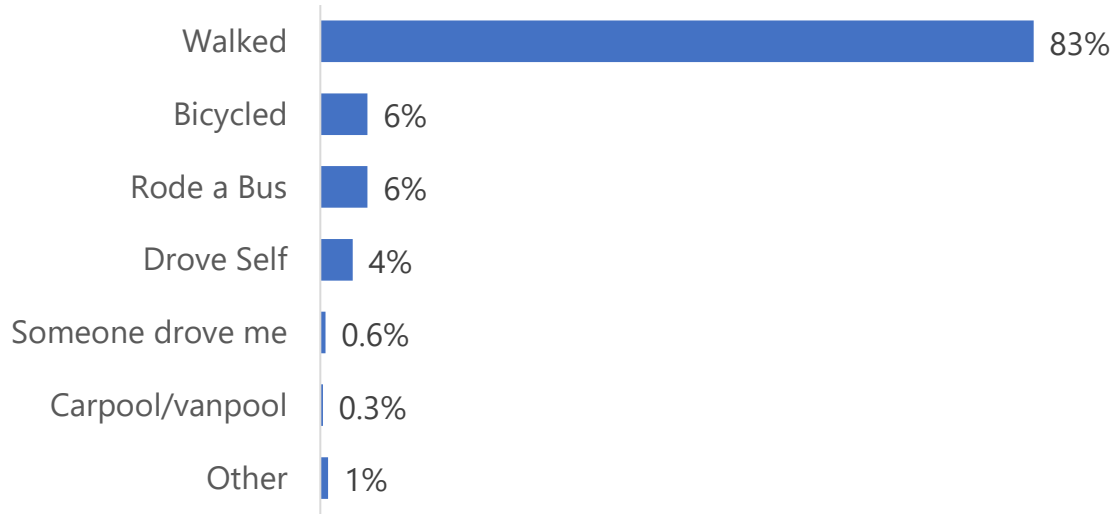
Figure 91: Methods of Reaching Final Destination

Figure 91 display the results of how riders accessed the bus and their final destinations.

Data from Transfort 2017 Transit Passenger Survey

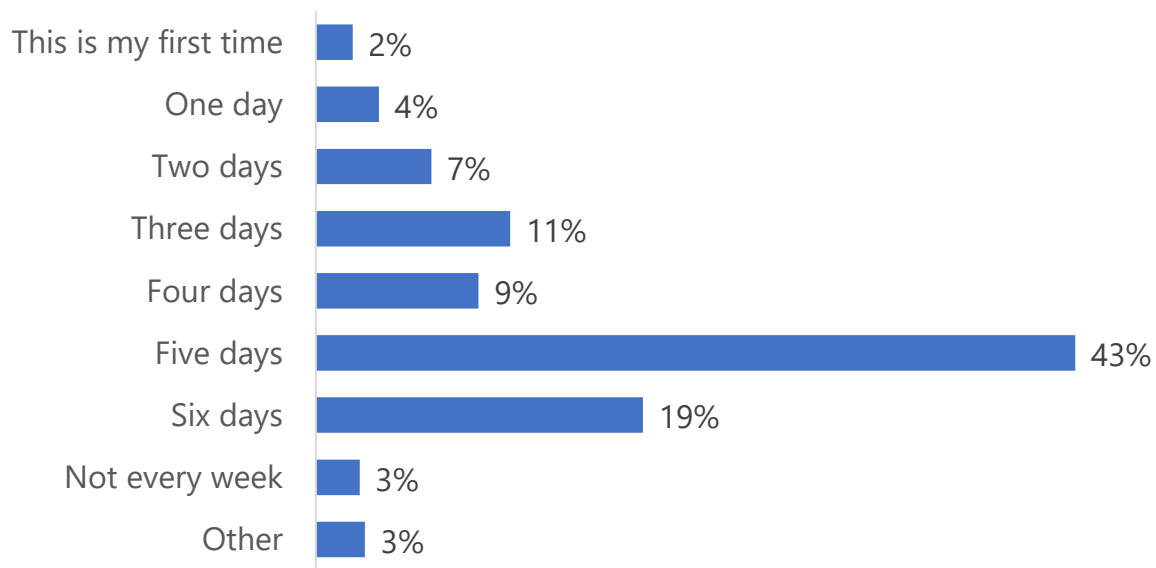
Figure 92: Number of Bus Rides Weekly

Based on survey responses, the majority of Transfort riders in 2017 (67%) rode the bus five days a week or more. Only 2% of survey respondents were riding the bus for the first time. **Figure 92** shows how many days per week survey respondents rode the bus. This trend was also reported in the 2018 and 2019 surveys.

Data from Transfort 2017 Transit Passenger Survey

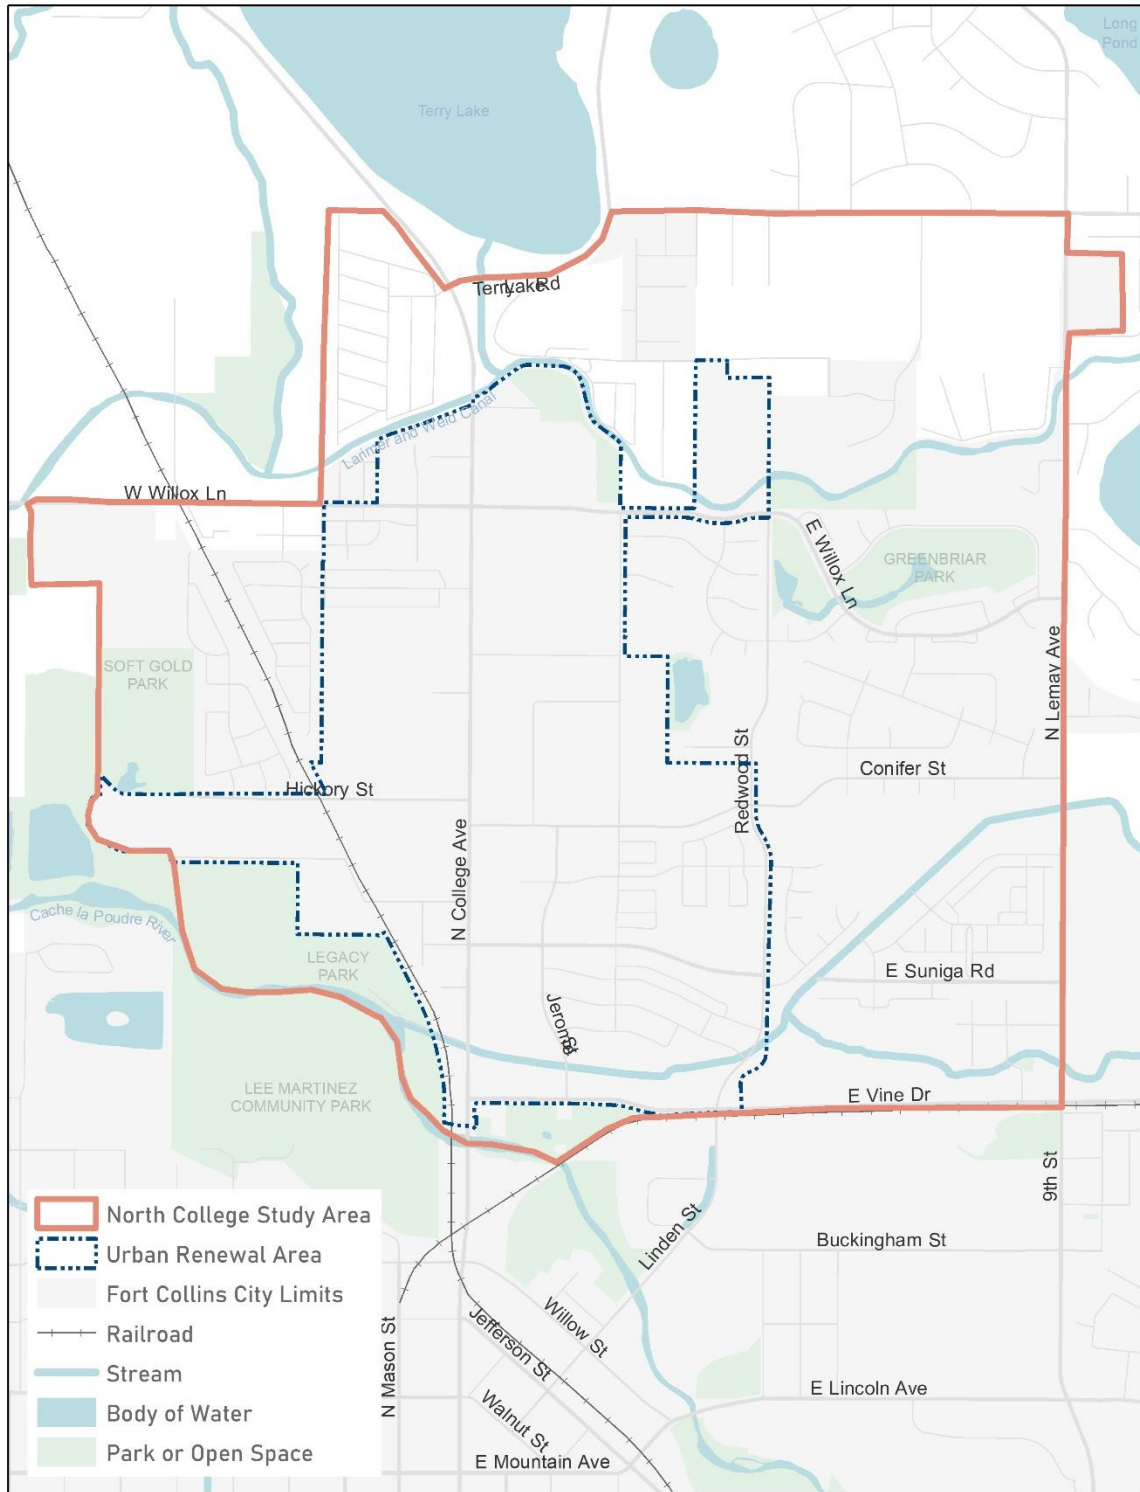
Figure 1. North College Study Area

The North College Study Area, shown below in **Figure 1**, extends from Terry Lake Road to the north, East Vine Drive to the south, North Lemay Avenue to the east, and Cache la Poudre River to the west. The Study Area includes the North College Urban Renewal Authority (URA) boundary as shown. The majority of the Study Area is within the City of Fort Collins with the exception of the northern portion, which is located in Unincorporated Larimer County.

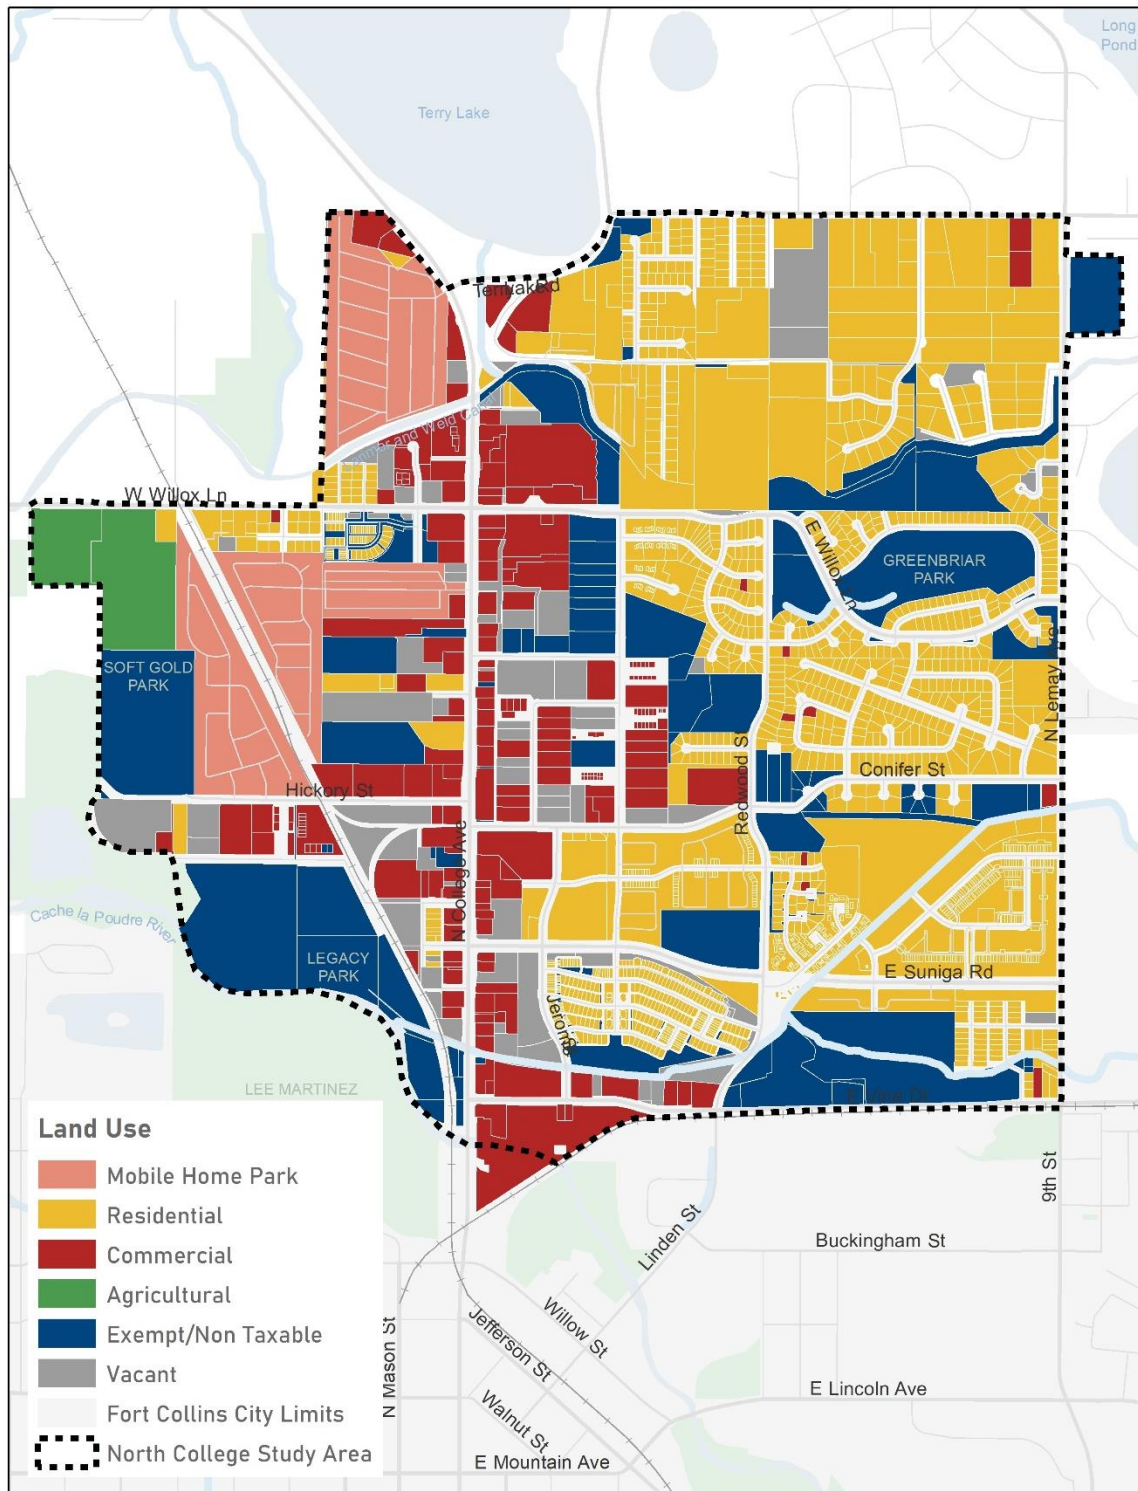
Figure 11. North College Study Area Land Use

Existing land use conditions are shown by category in **Figure 11**. Commercial uses primarily line North College Avenue with residential or vacant land behind the commercial frontage. There is a section east of North College Avenue between Conifer Street and Willox Lane that contains light industrial, and institutional/non-profit uses within office and flex-industrial buildings. The residential uses within the area for the most part are the result of new development, with the exception of a few larger residential properties and large existing mobile home parks. There are three mobile home parks within the Study Area including Hickory Village west of North College Avenue, North College LLC Senior Community west of North College Avenue, and Poudre Valley Mobile Home Park in the northwest section of the Study Area.

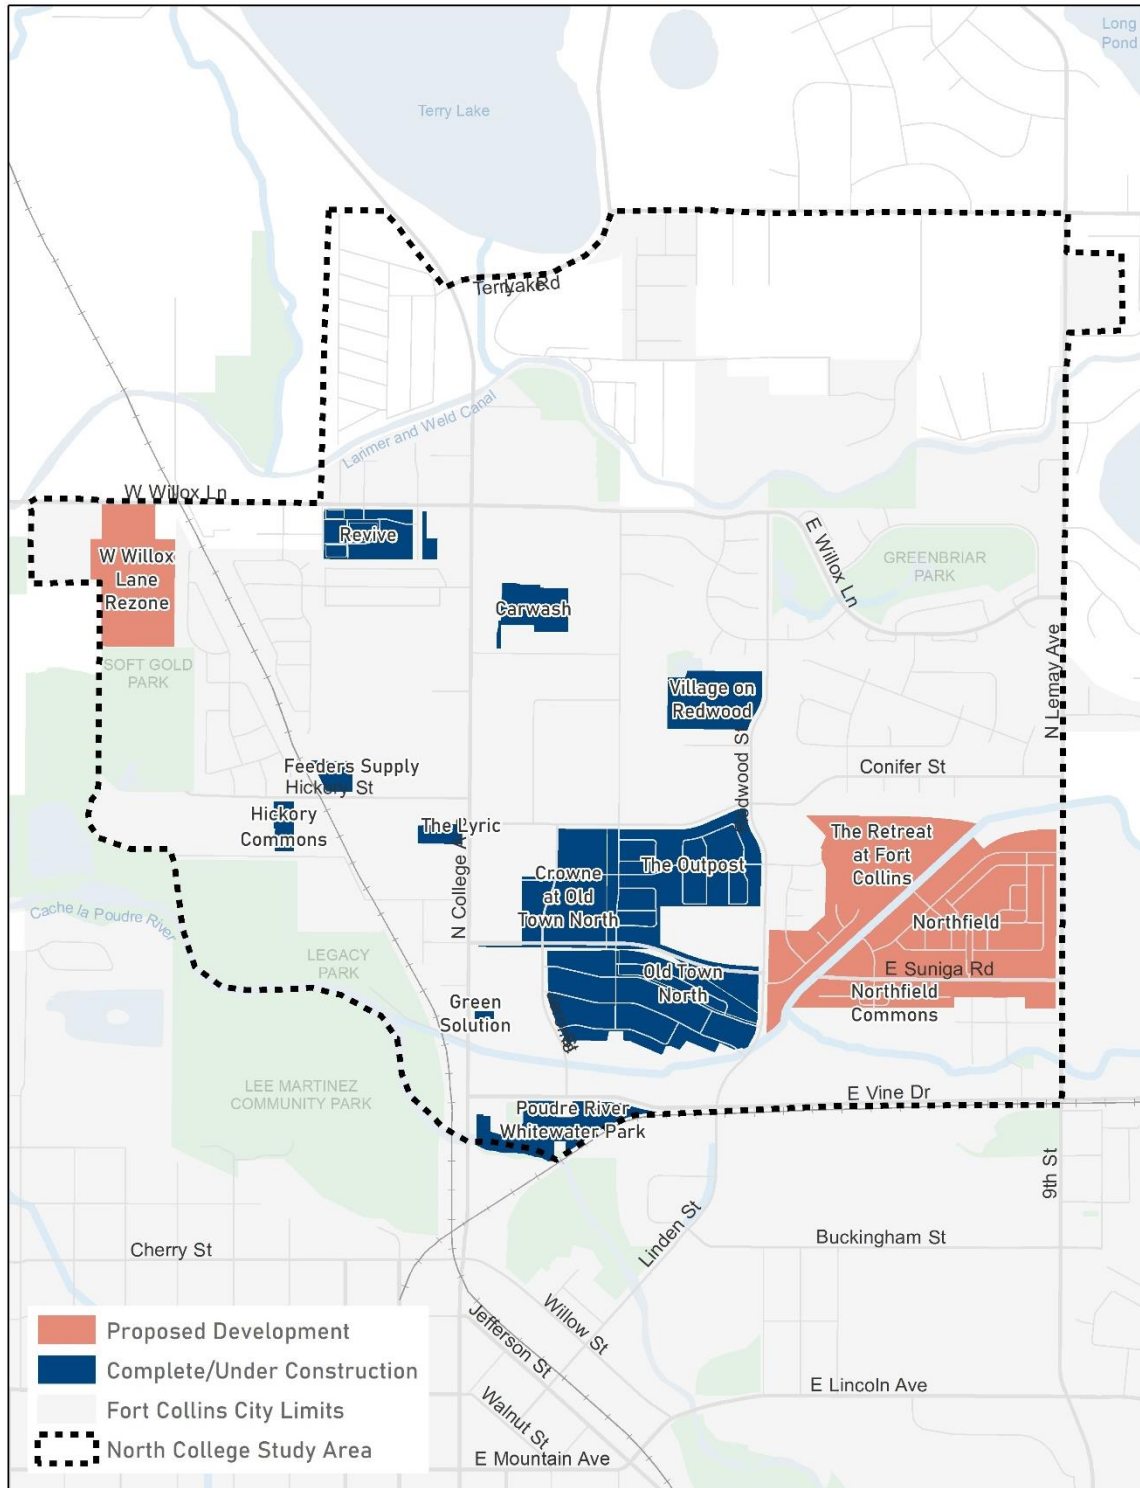
Figure 12. Recent and Proposed Development

The recently completed and proposed development projects within the Study Area are shown in **Figure 12**. There are two recently completed destination recreation/entertainment uses, the Lyric Movie Theatre and Poudre River Whitewater Park, that may drive visitation to the area and additional demand. Additionally, there are recently completed infill commercial projects including a dispensary, warehouse, and carwash. There are approximately 850 residential units recently completed or under construction and 662 units proposed. The recent and proposed development projects are briefly described below.

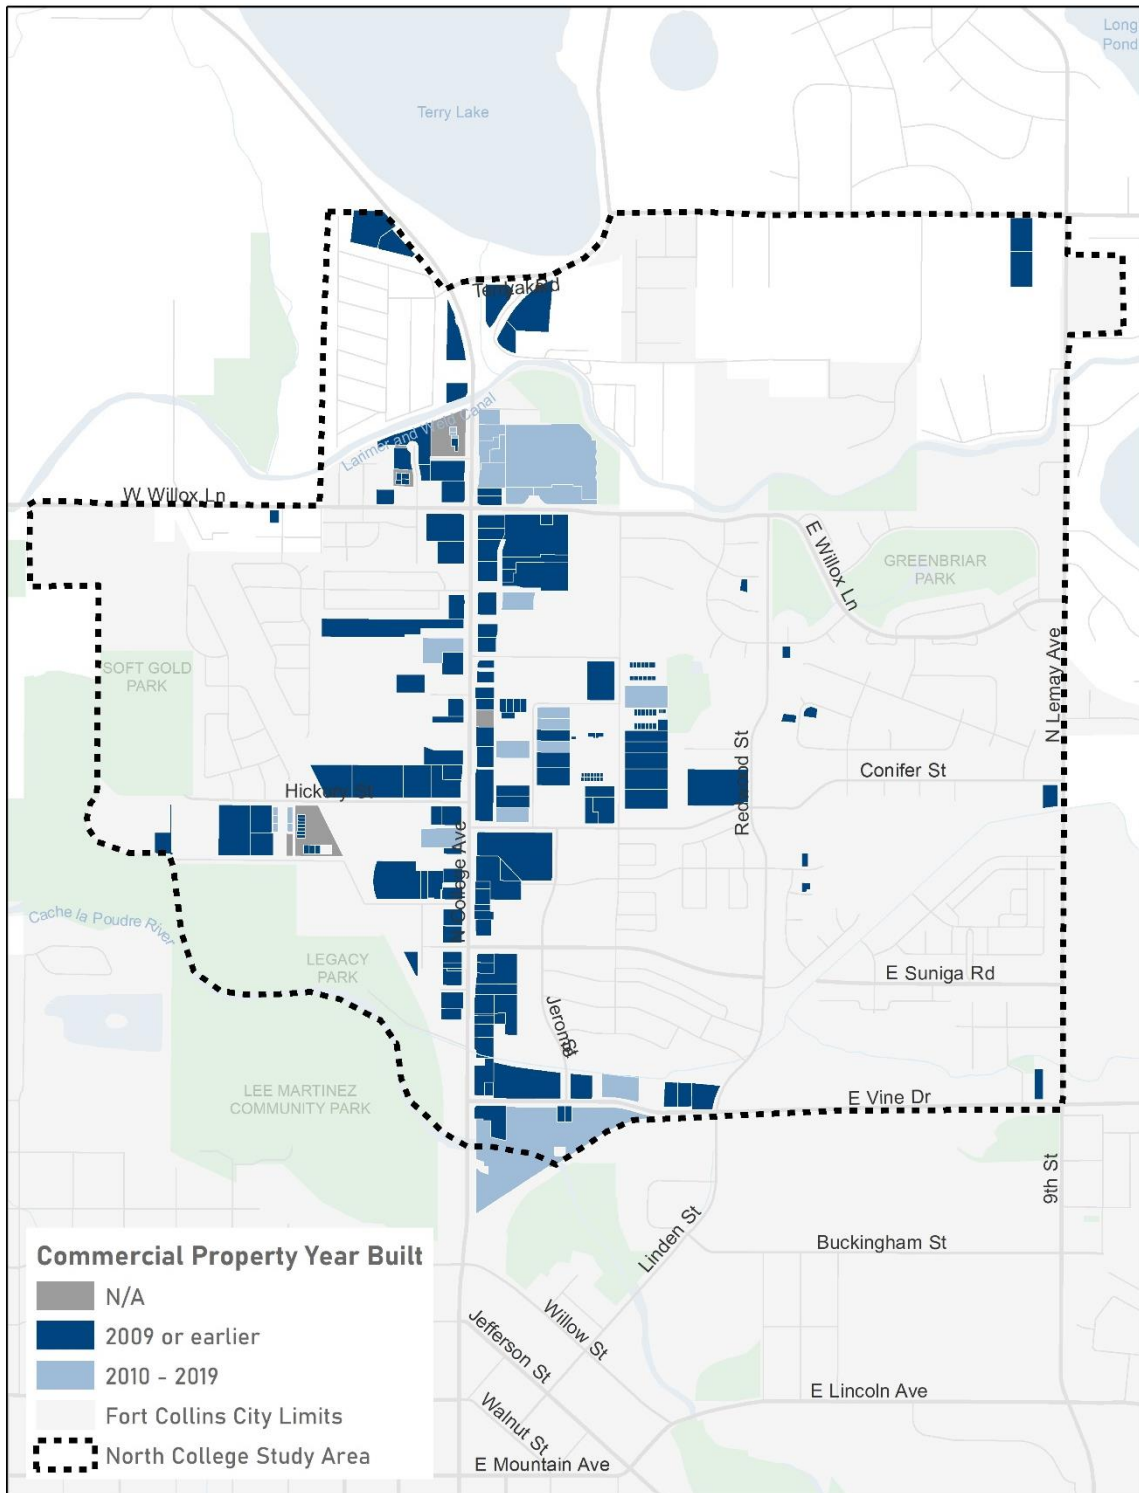
Figure 13. Commercial Property by Year Built

The commercial property within the Study Area is shown below in **Figure 13** by year built. The majority of the commercial property along North College Avenue is older and was built prior to 2010, and much of it was built in Larimer County prior to annexation. There are a few recent commercial developments including the King Soopers Marketplace, which was built in 2010 and remodeled in 2015. Other newer commercial developments include Chase Bank, fast food restaurants, medical offices, office buildings, storage warehouses, car wash, movie theatre, and mini-storage facility.

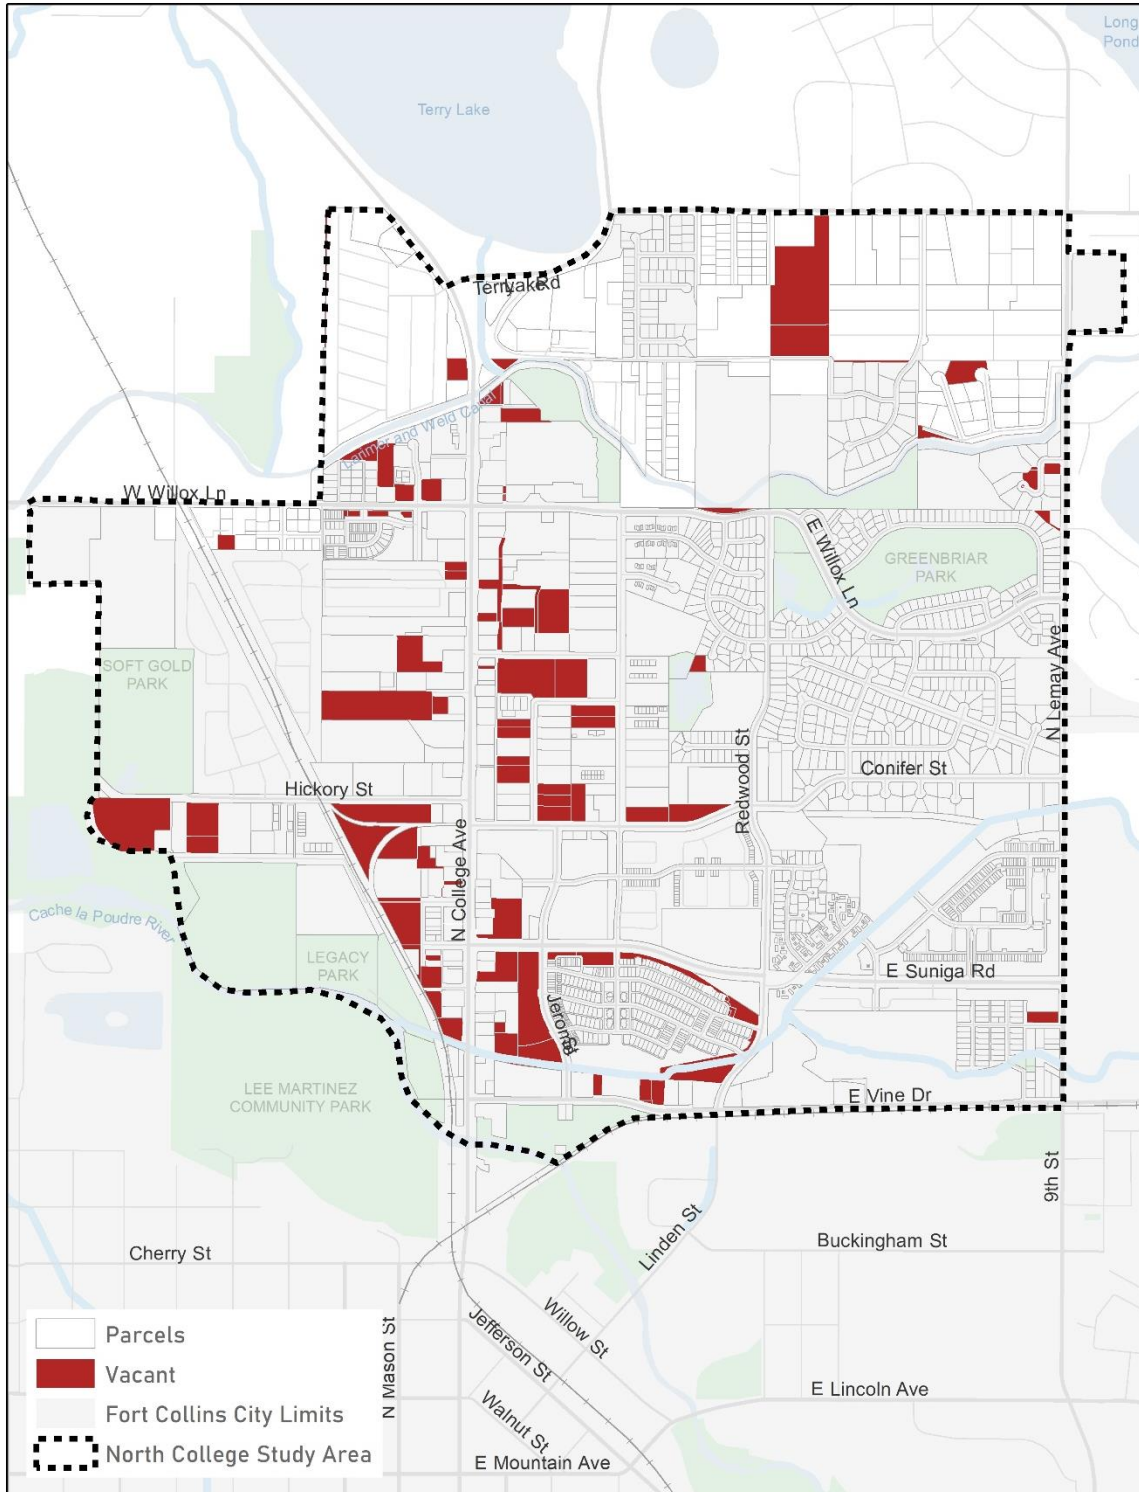
Figure 14. North College Study Area Vacant Parcels

Vacant sites were identified based on Larimer County Assessor parcel data and aerial photography review. The vacant sites (excluding single platted residential lots) identified in the Study Area are shown in **Figure 14**. There are 95 vacant parcels consisting of approximately 97 acres. Vacant parcels range in size from 0.2 acres to 9.05 acres. The vacant land is primarily located behind parcels fronting North College Avenue. Lacking major north-south parallel roads, these parcels did not have a street to orient to and in many cases were subdivided off parcels located on College Avenue. As a result, these parcels remained vacant but have inferior or limited access. These parcels’ viability for commercial uses is diminished due to their lack of North College Avenue frontage; therefore, their reuse is more likely to be for residential or industrial uses.

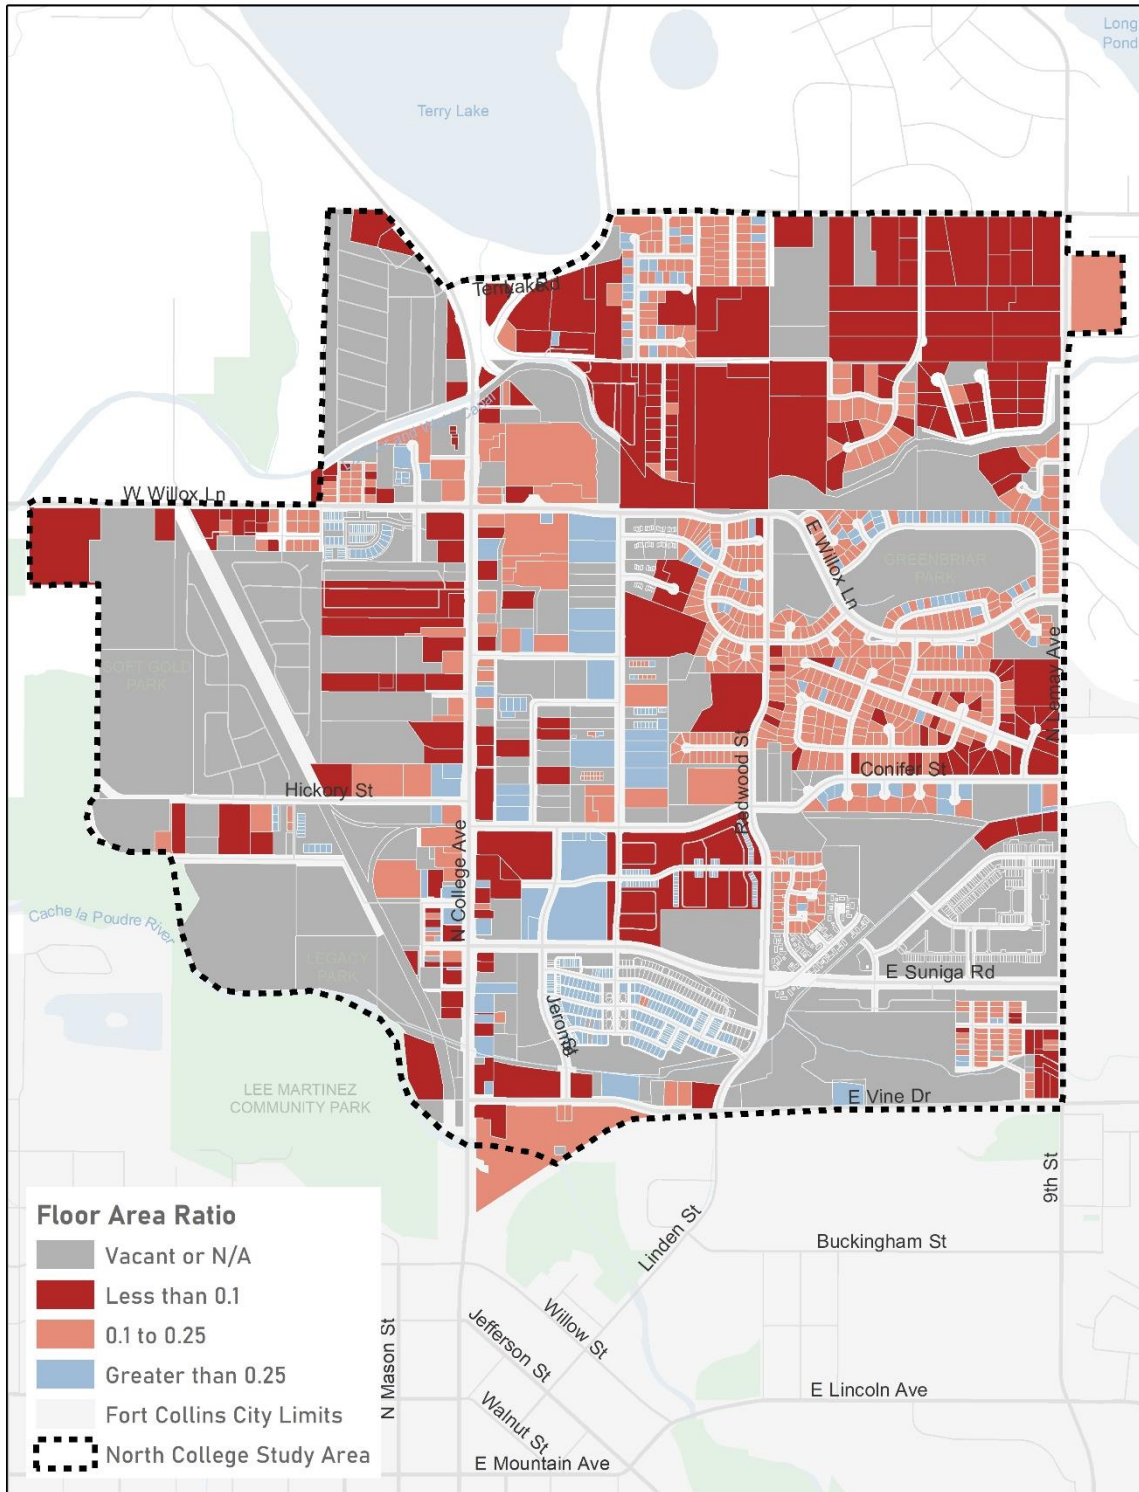
Figure 15. Floor Area Ratio (FAR)

The floor area ratio (FAR) of parcels in the North College Study Area was estimated to identify properties that can be characterized as underutilized. The floor area ratio (FAR) is calculated by dividing the total square feet of the buildings (improvements) on a parcel by the total square feet of the land area of parcel and shown in **Figure 15**. The definition of underutilized based on FAR varies by context and use but in this context, a FAR below 0.25 is considered potentially underutilized. There are a handful of parcels along North College Avenue that are underutilized based on FAR. These parcels are relatively small on average but could be connected in many cases with larger, vacant parcels behind to create larger development sites. Additionally, there are large lot, single family residential residences in the northeast corner of the Study Area with a FAR of 0.1 or less. Many of these homes are older and are not expected to redevelop.

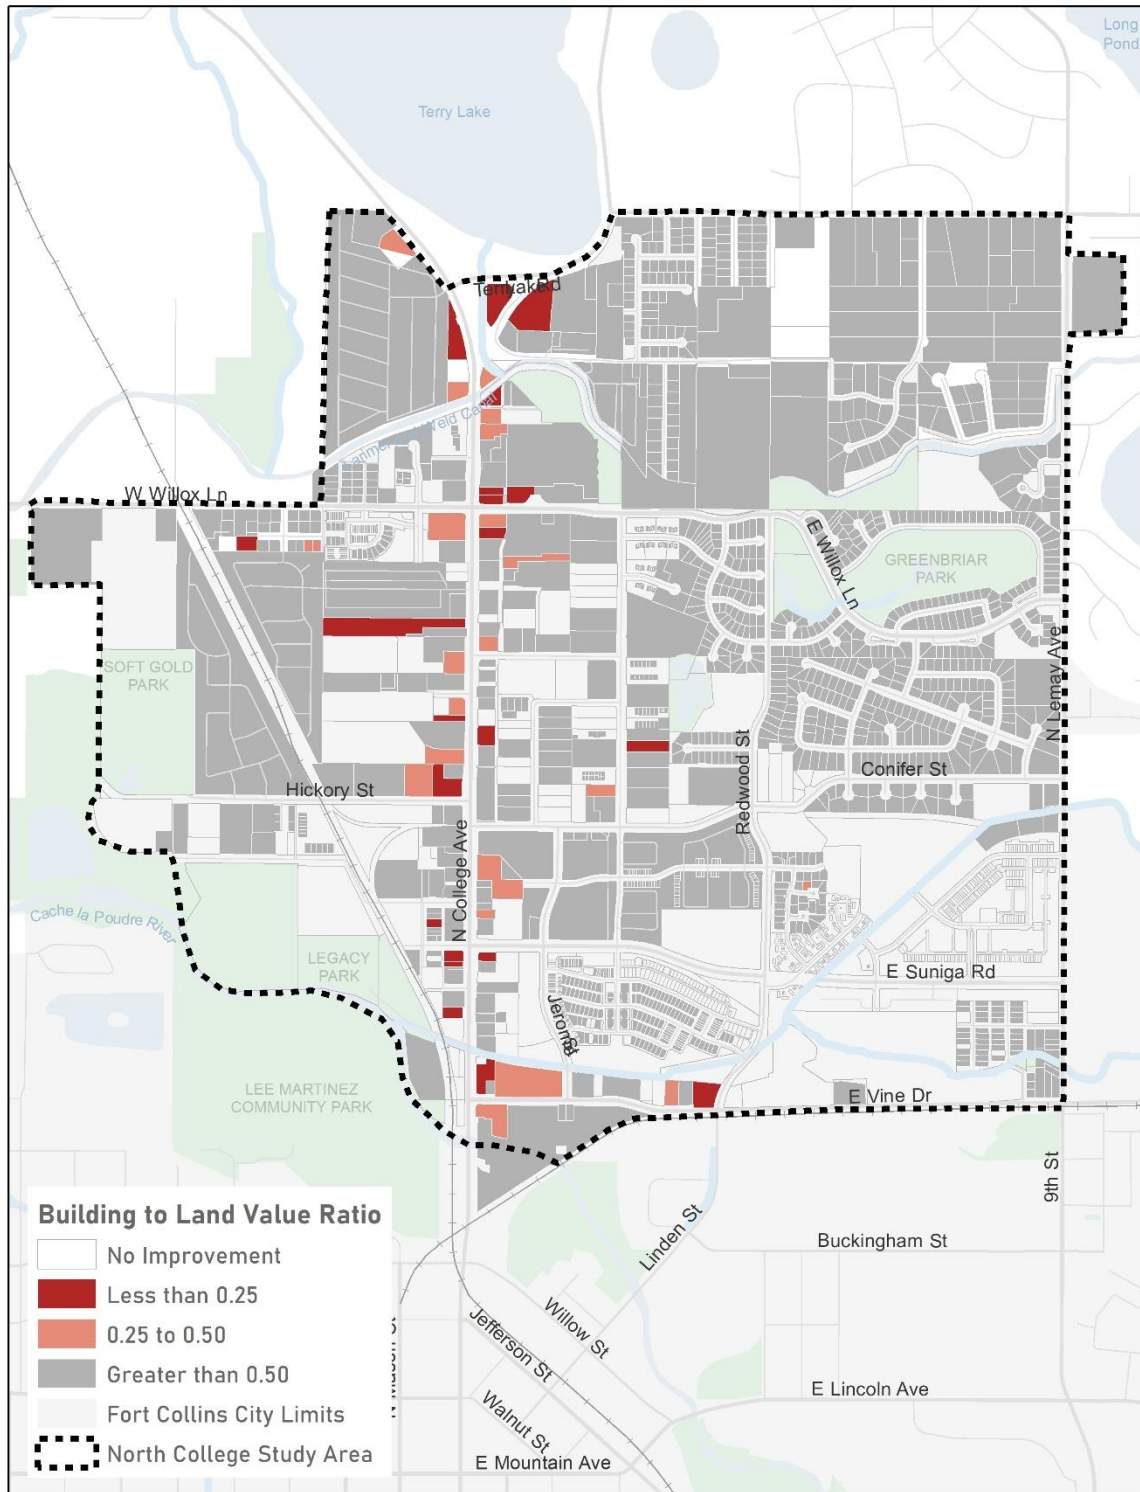
Figure 16. Building to Land Value Ratio

The building to land value ratio is another measure to identify underutilized parcels as shown in **Figure 16**. In this context, parcels that are valued at one half or less of the value of land they are located on is potentially underutilized. To qualify, parcels with a building to land value ratio of less than 0.5 are analyzed. The pattern of underutilized parcels based on economic value matches closely with the FAR analysis, with a scattered set of underutilized parcels mostly lined along North College Avenue. As mentioned above, these parcels are relatively small but are next to vacant parcels in many cases. A potential approach to attracting redevelopment would be to connect areas along North College Avenue that are underutilized with vacant parcels behind. The connection allows for a large enough site and development program to justify redevelopment of the marginal/underperforming uses along North College Avenue.

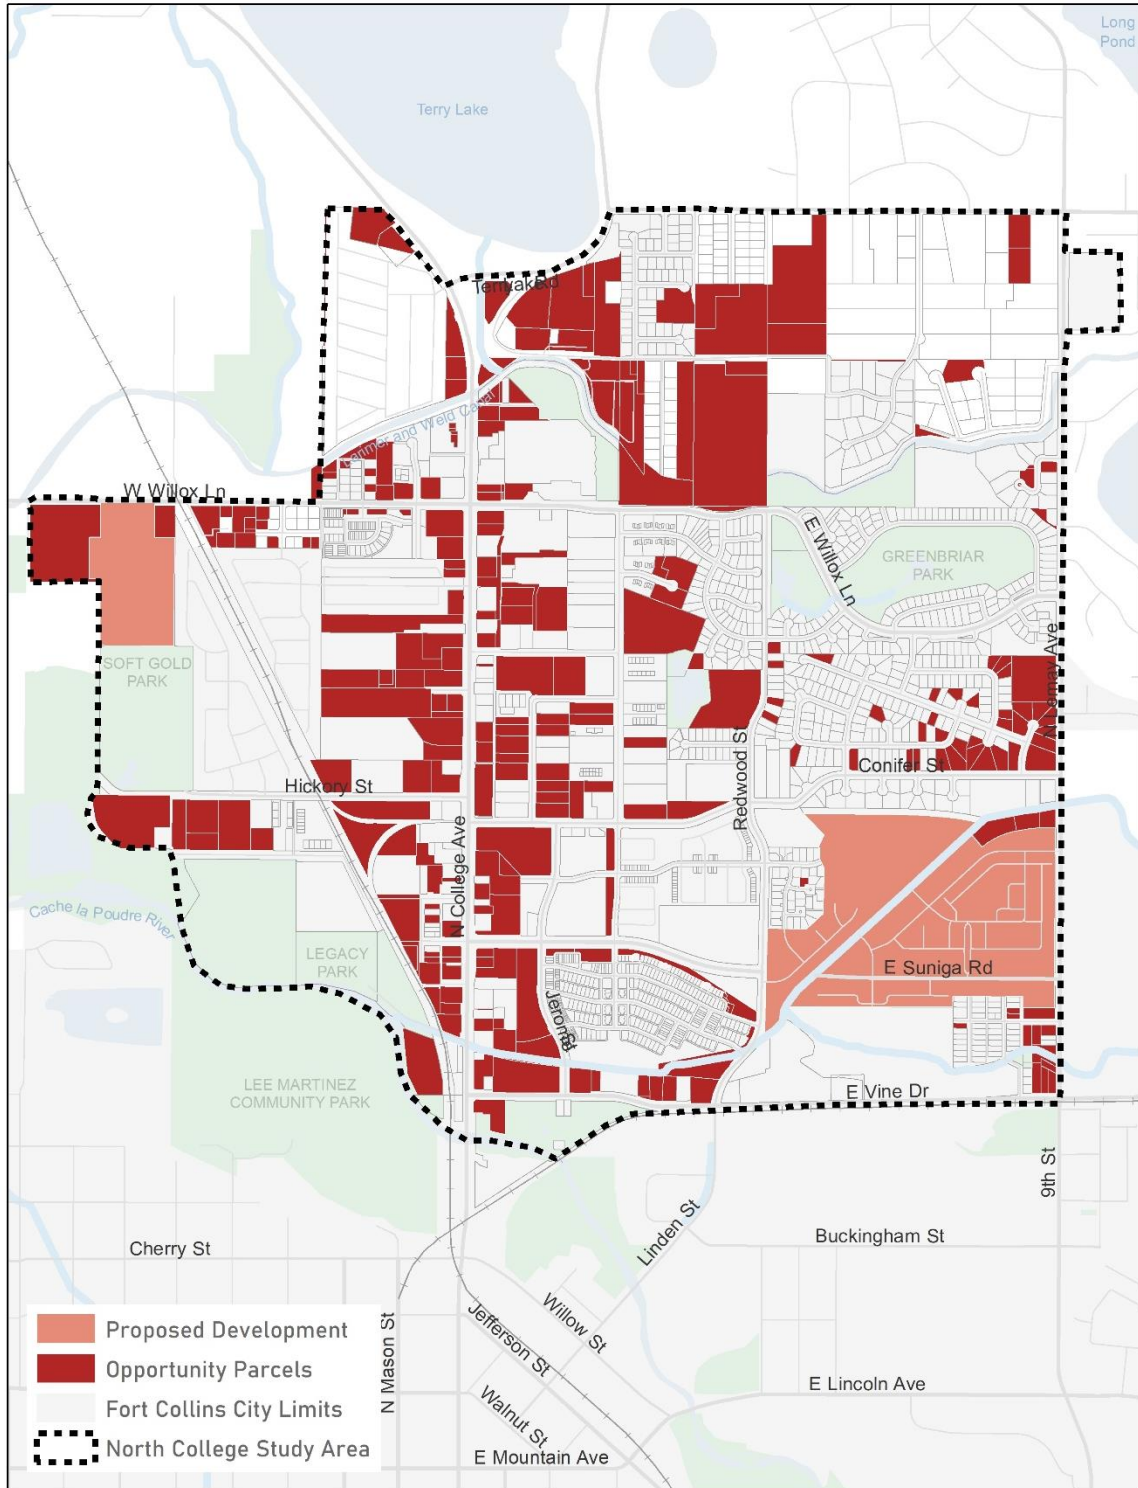
Figure 17. Opportunity Parcels

Opportunity parcels are shown below in **Figure 17**. These parcels are a combination of vacant parcels, parcels with a floor area ratio of 0.1 or less, and parcels with a building to land value ratio of 0.5 or less. These characteristics demonstrate the opportunity for properties to develop or redevelop based on current underutilization.

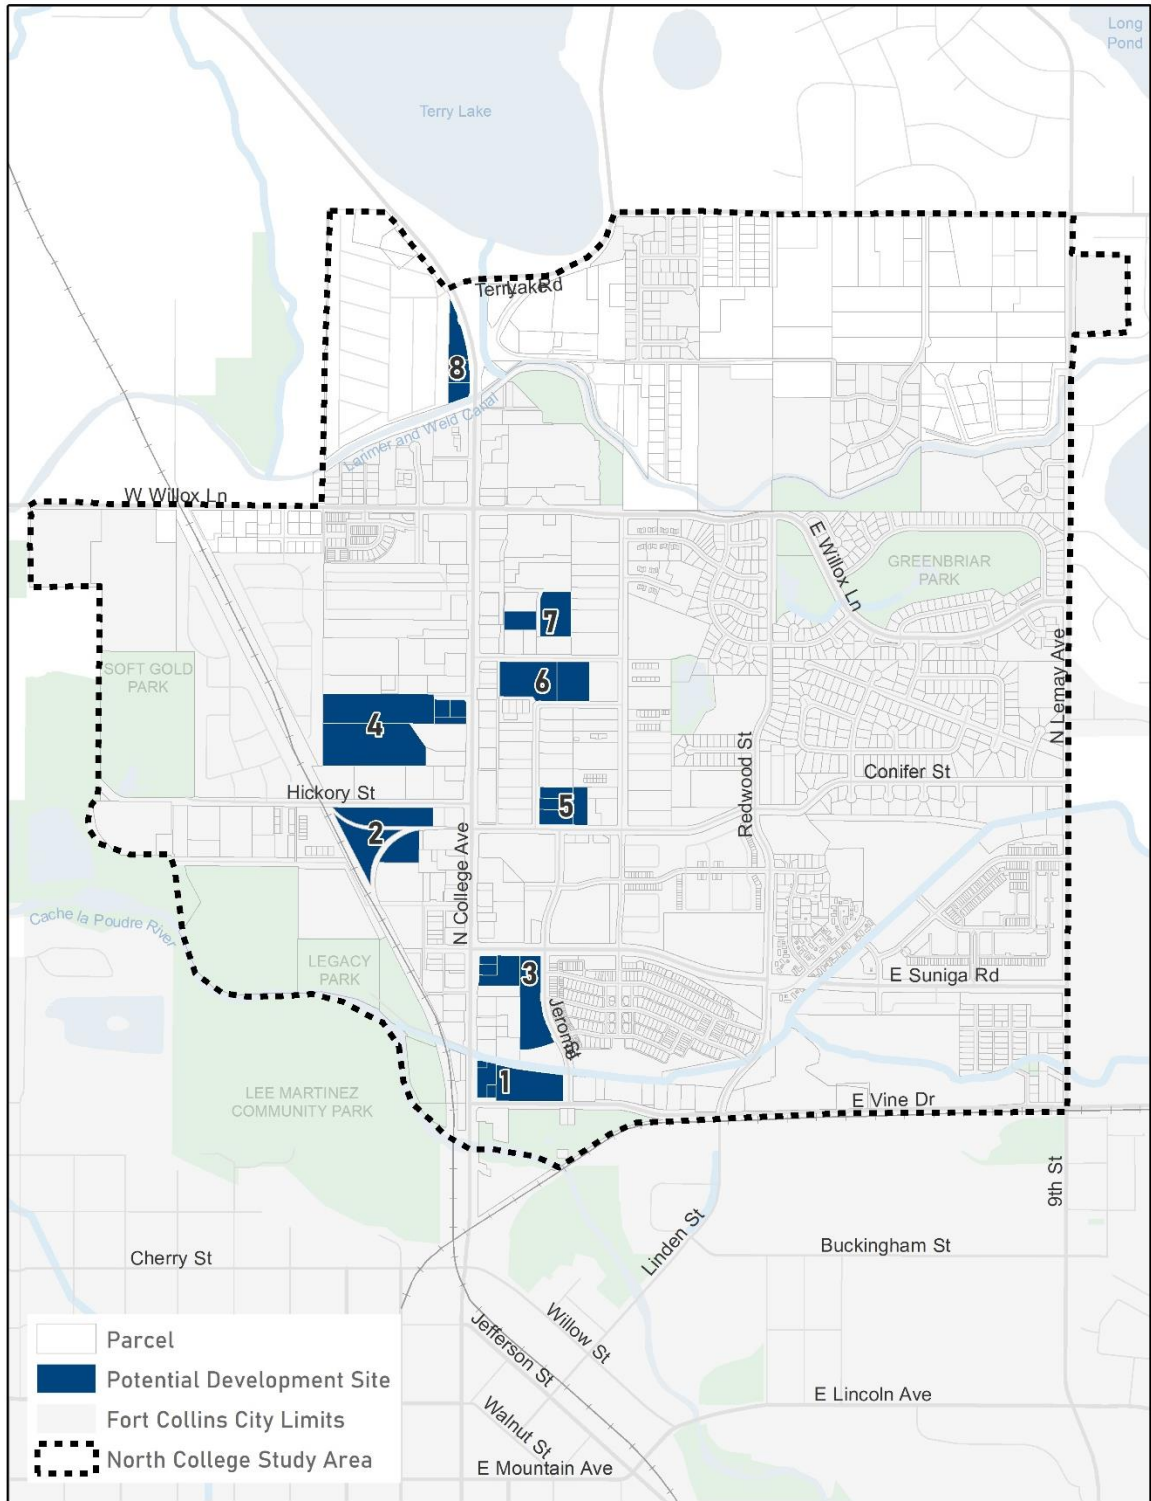
Figure 18. Potential Development Sites

Based on the opportunity areas defined by vacancy, low FAR, and low building to land value ratio, potential development sites are identified below in **Figure 18**. Many of these parcels are currently vacant commercial properties. In order for parcels to develop along North College Avenue, many need to be combined with surrounding parcels due to small acreage and limited access. Each potential development site is described in detail below.

Site 1 includes four parcels totaling 5.30 acres, shown in **Table 6**. Two parcels are owned by Powerhouse II LLC and are currently used as truck dealership. One parcel is owned by W and P LLC and is currently used as an auto repair shop. One small parcel is owned by the City of Fort Collins and is vacant. This area has the potential to redevelop as retail and office uses that front onto the corner of North College Avenue and Vine Drive, which is an important intersection and likely BRT stop.
