NORTH COLLEGE MAX BRT

EXISTING CONDITIONS REPORT

SEPTEMBER 2022

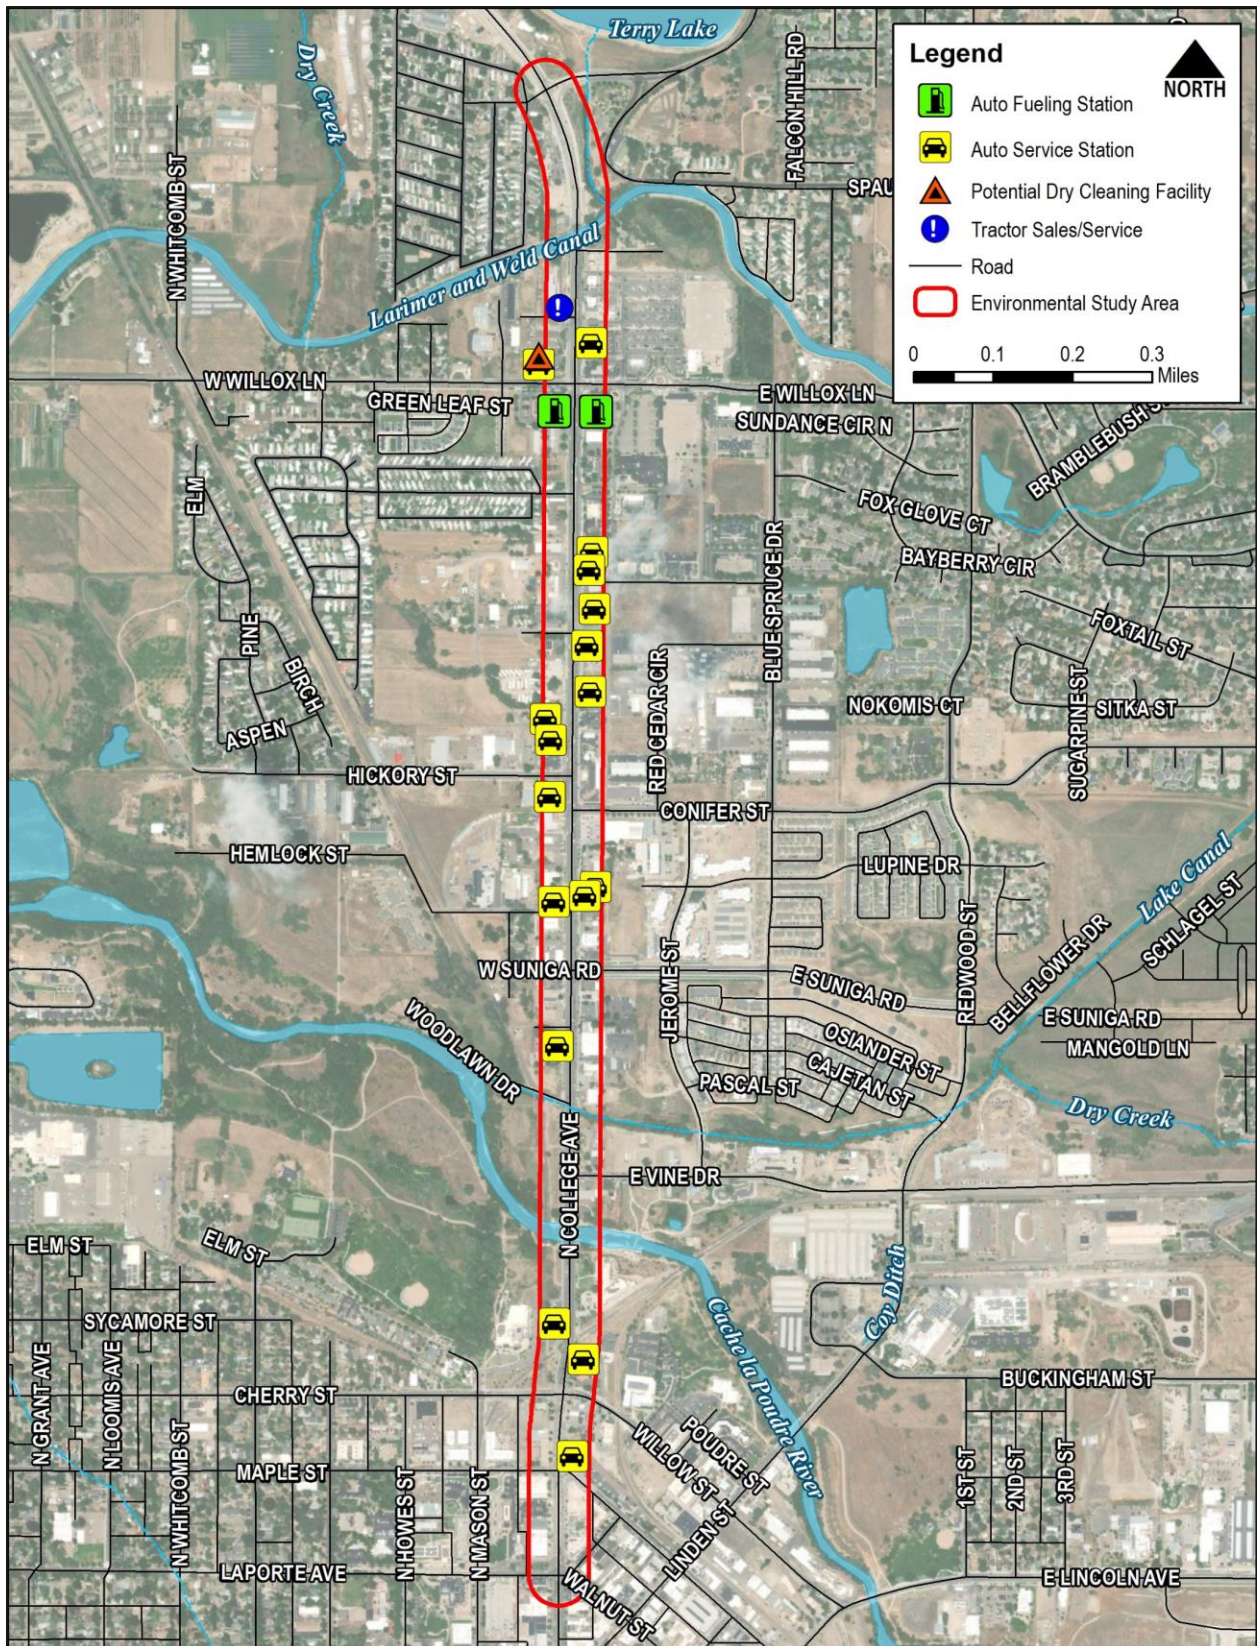
Figure 3. Hazardous Materials

- Legacy Tractor Sales and Service (1845 North College)
- Discount Tire (1830 North College)
- ExelAnce Laundry (1805 North College)
- Loaf N Jug (1801 North College)
- Valero (1660 North College)
- Conoco (1675 North College)
- Big O Tires (1506 North College)
- Grease Monkey (1500 North College)
- Terry's Midtown Auto Service (1420 North College)
- Collins Auto Renewal (1314 North College)
- Rulon's Service (1304 North College)
- Big Tire and Wheel (1295 North College)
- Auto Trends (1235 North College)
- Ken's Automotive Repair (1219 North College)
- Frieson's Auto Center (1110 North College)
- Fort Collins 444 (1101 North College)
- Colorado Motor Car Care (1108 North College)
- Quick Lube (825 North College)
- J & M Precision Automotive (425 North College)
- Valvoline Instant Oil Change (410 North College)
- A Classic Touch Motorcycle Shop (300 North College)

These facilities are depicted in **Figure 3**. In addition to the facilities listed above, there may other properties that were previously located within the study area that may have affected groundwater and subsurface soils but have since been occupied by another business. Finally, there could be facilities located near the study area that may be undergoing active groundwater remediation.

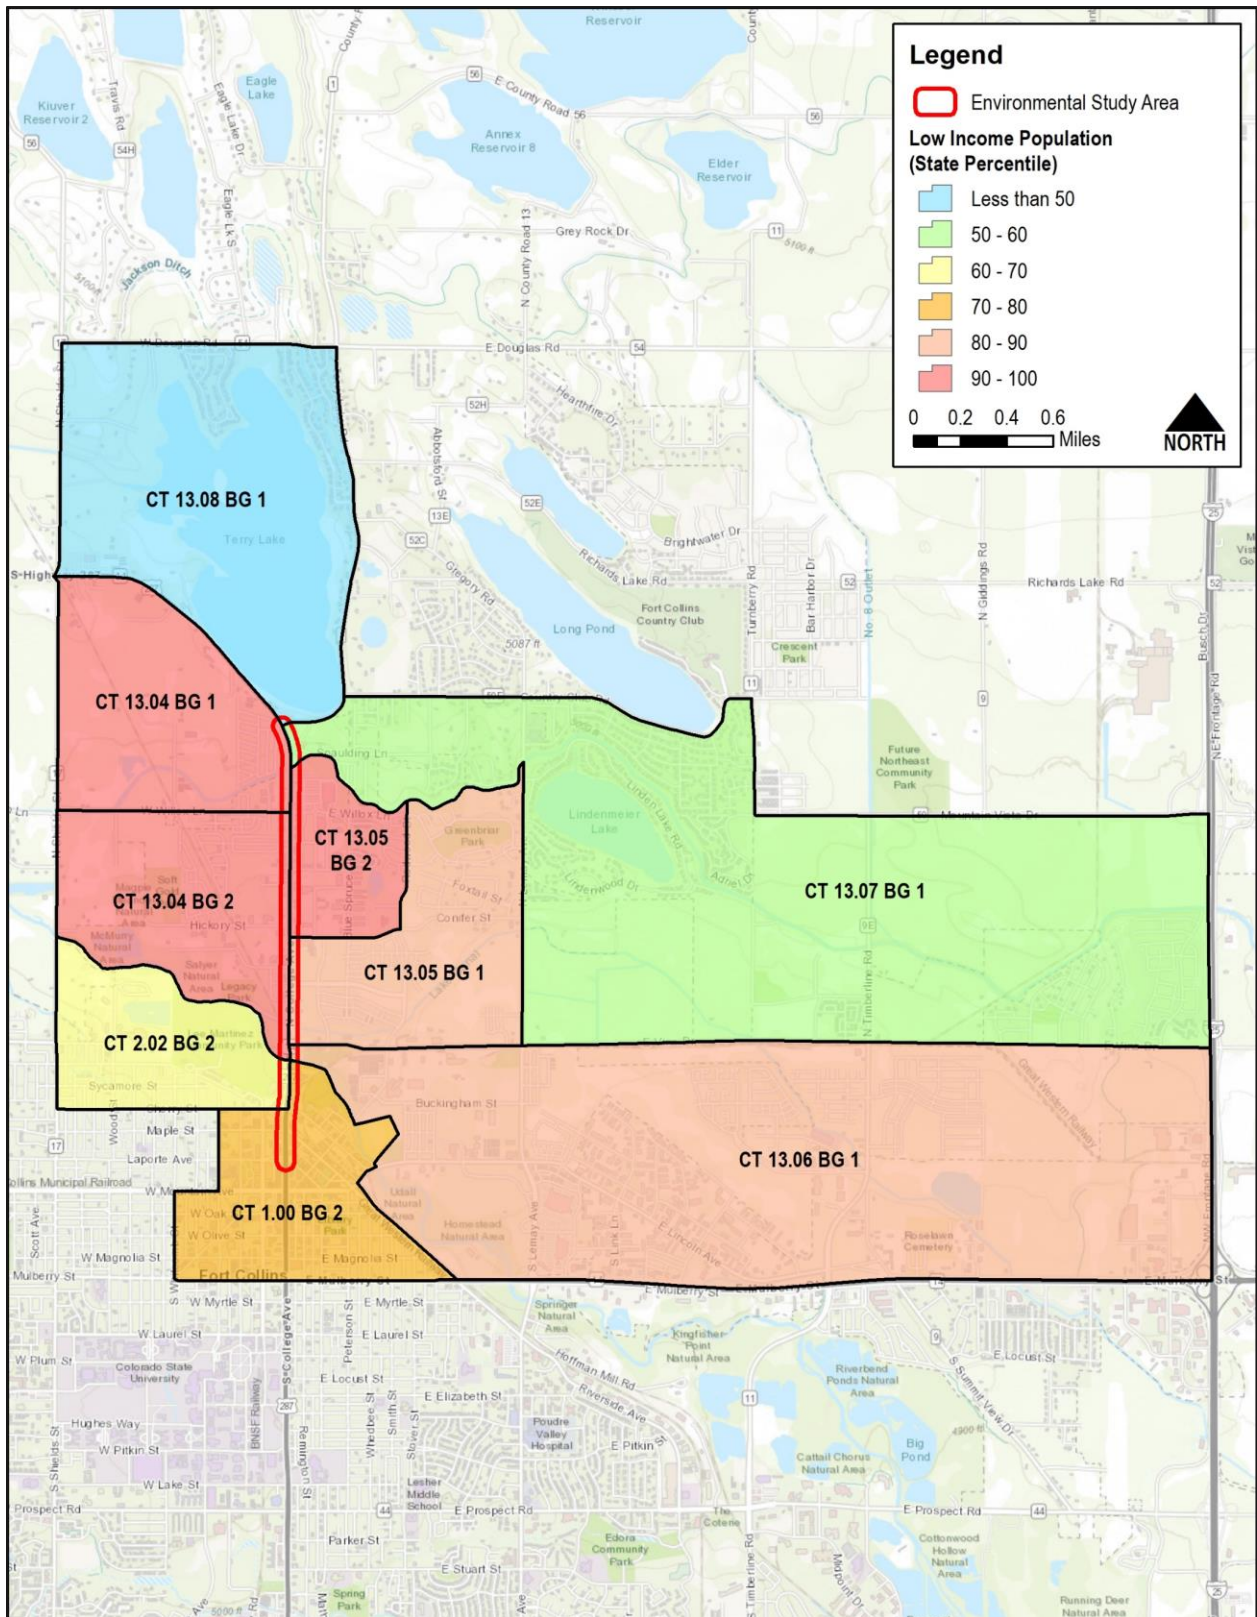
Figure 4. Low Income Populations

According to the EJSCREEN, only Census Tract 13.08 Block Group 1 has less than a 50-percentile low-income population (see **Table I**). The census block groups surrounding the environmental study area have a high population of low-income people. **Figure 4** shows the state percentile of low-income populations within the census block groups surrounding the environmental study area. A block group is an area defined by the U.S. Census Bureau that usually has in the range of 600-3,000 people living in it. Low-income populations are defined by USEPA as: “The percent of a block group’s population in households where the household income is less than or equal to twice the federal poverty level.”

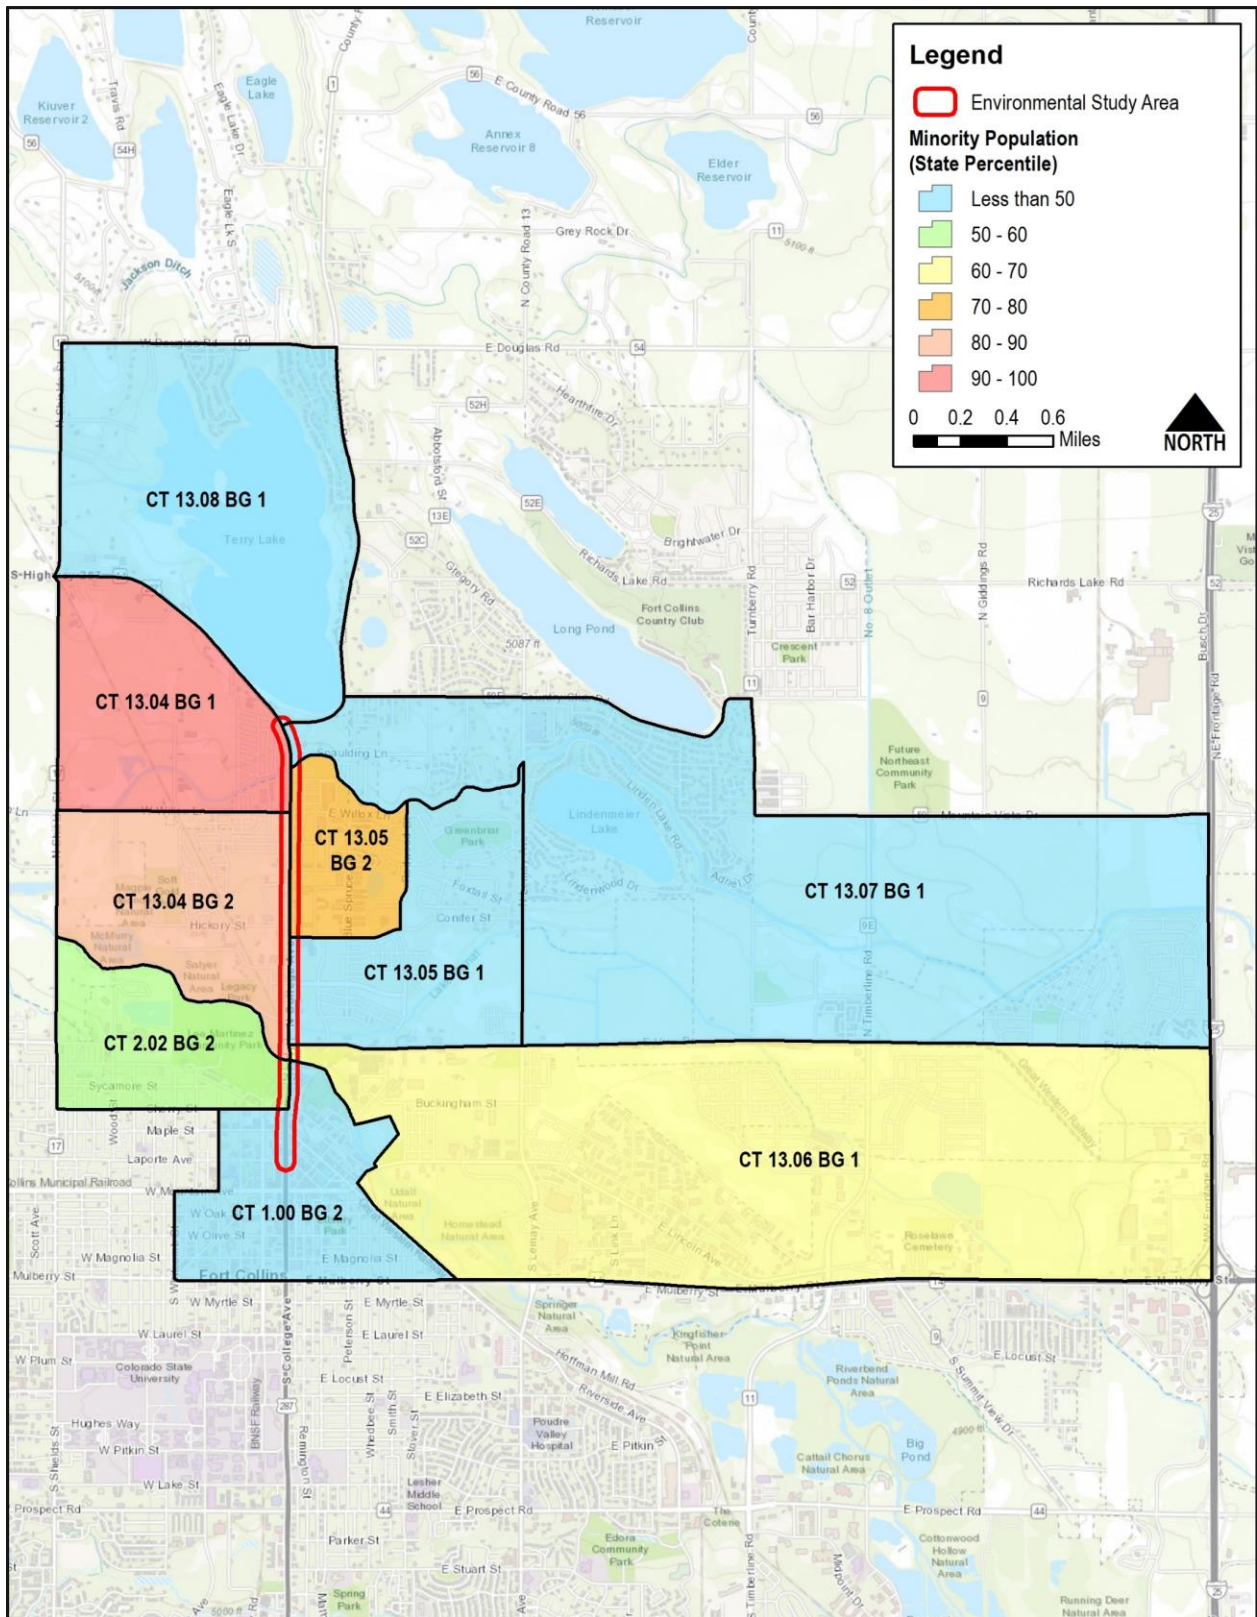
Figure 5. Minority Populations

The EJSCREEN indicated that much of the study area is within a higher percentage of minority populations. Census Tract 13.04 Block Group 1, Census Tract 13.04 Block Group 2, Census Tract 13.06 Block Group 2, Census Tract 13.08 Block Group 1, and Census Tract 2.02 Block Group 2 all had a state percentile greater than 50 percent (see **Table I**). **Figure 5** shows the state percentile of minority populations within the census block groups surrounding the environmental study area. Minority populations are defined by the U.S. Census Bureau as: “A population of people who are not single-race white and not Hispanic. Populations of individuals who are members of the following population groups: American Indian or Alaskan Native; Asian or Pacific Islander; Black, not of Hispanic origin; or Hispanic.”

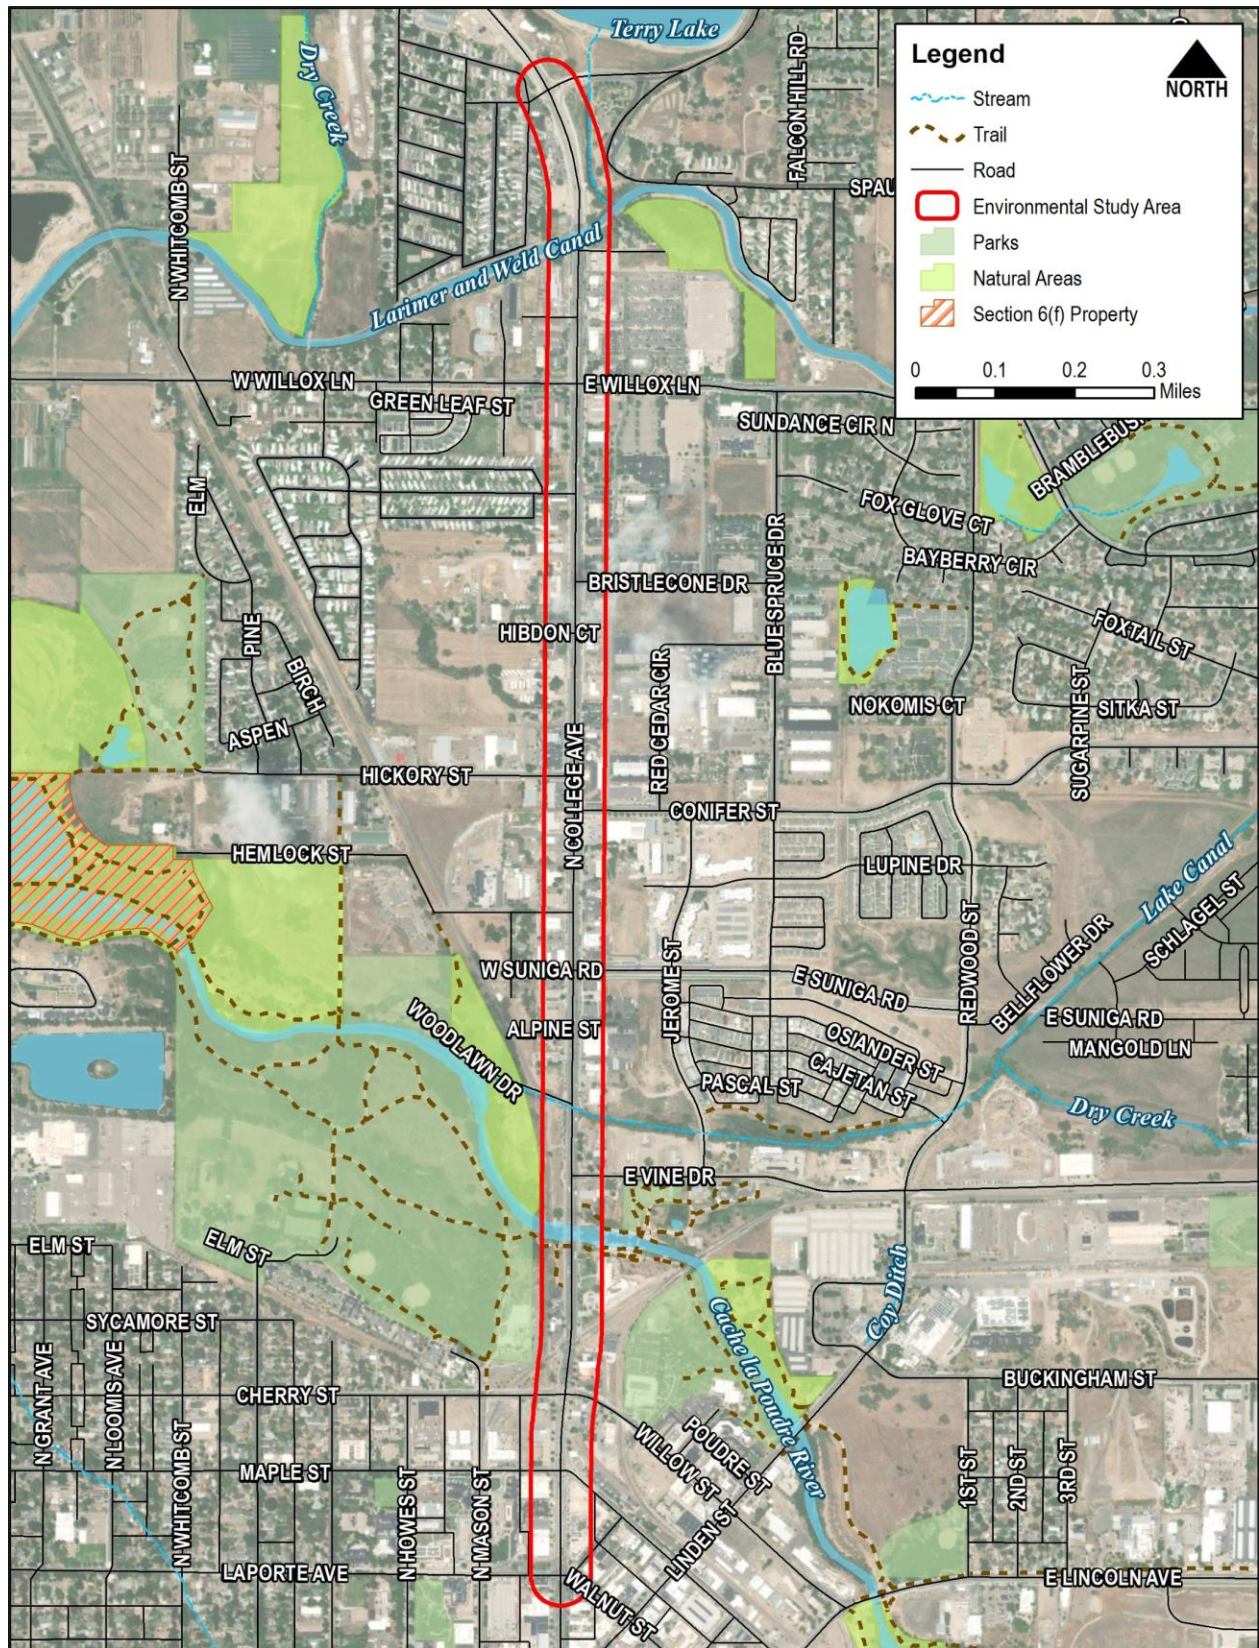
Figure 7. Parks and Recreation Areas

Figure 7 shows the location of parks, natural areas, and trails that are within and surrounding the environmental study area. The Poudre Trail crosses the study area along the Cache la Poudre River, approximately 500 feet south of East Vine Drive and North College. Bordering the study area on the west side between Cherry Street and Woodlawn Drive is Lee Martinez Community Park and Rivers Edge Natural Area. The Poudre River Whitewater Park overlaps the study area on the east side of North College south of East Vine Drive.

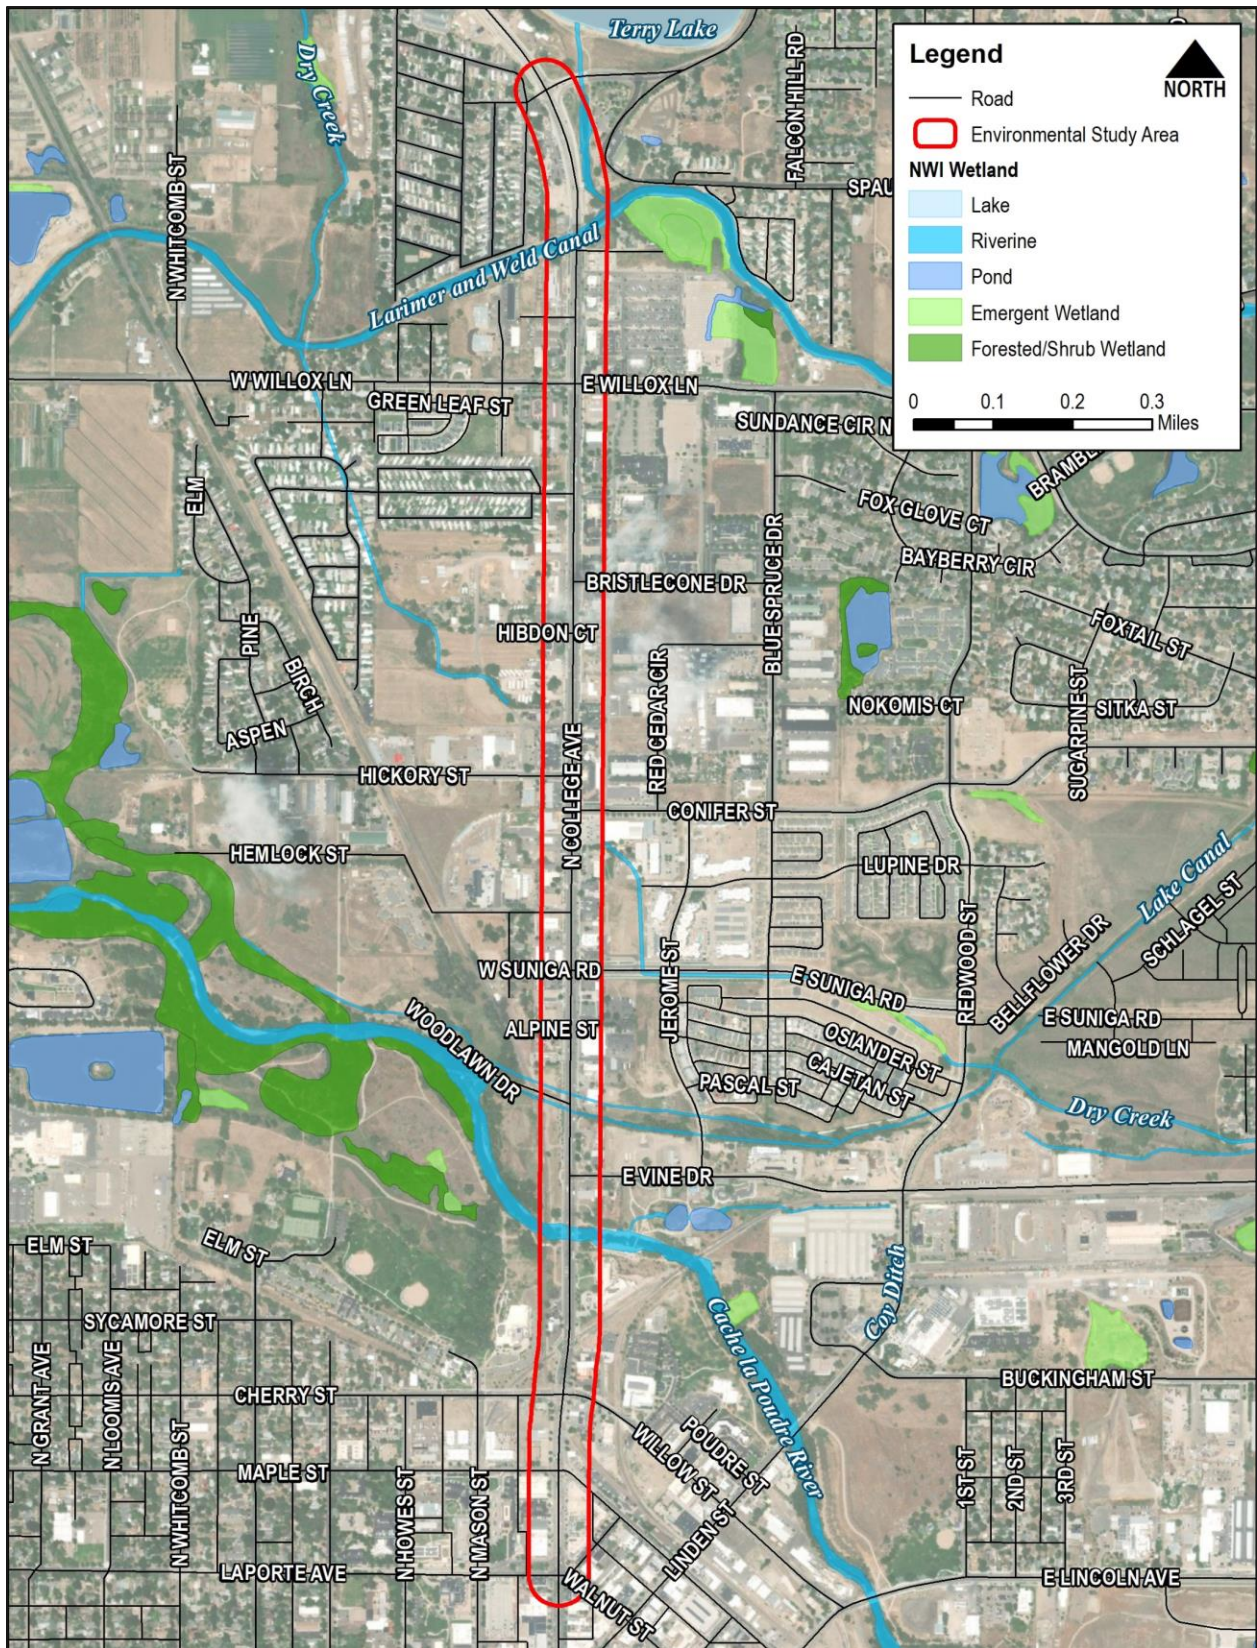
Figure 9. NWI Wetlands and Other Waters of the U.S.

The NWI wetlands adjacent to the Cache la Poudre River within the study area consist of R2UBG, which is defined as a Riverine System, Lower Perennial Subsystem, Unconsolidated Bottom Class, with an Intermittently Exposed Water Regime. These wetlands are characterized by having some water flows all year, except during years of extreme drought and have a substrate that mainly consists of sand and mud with the vegetation covering less than 30 percent (USFWS, 2021a).

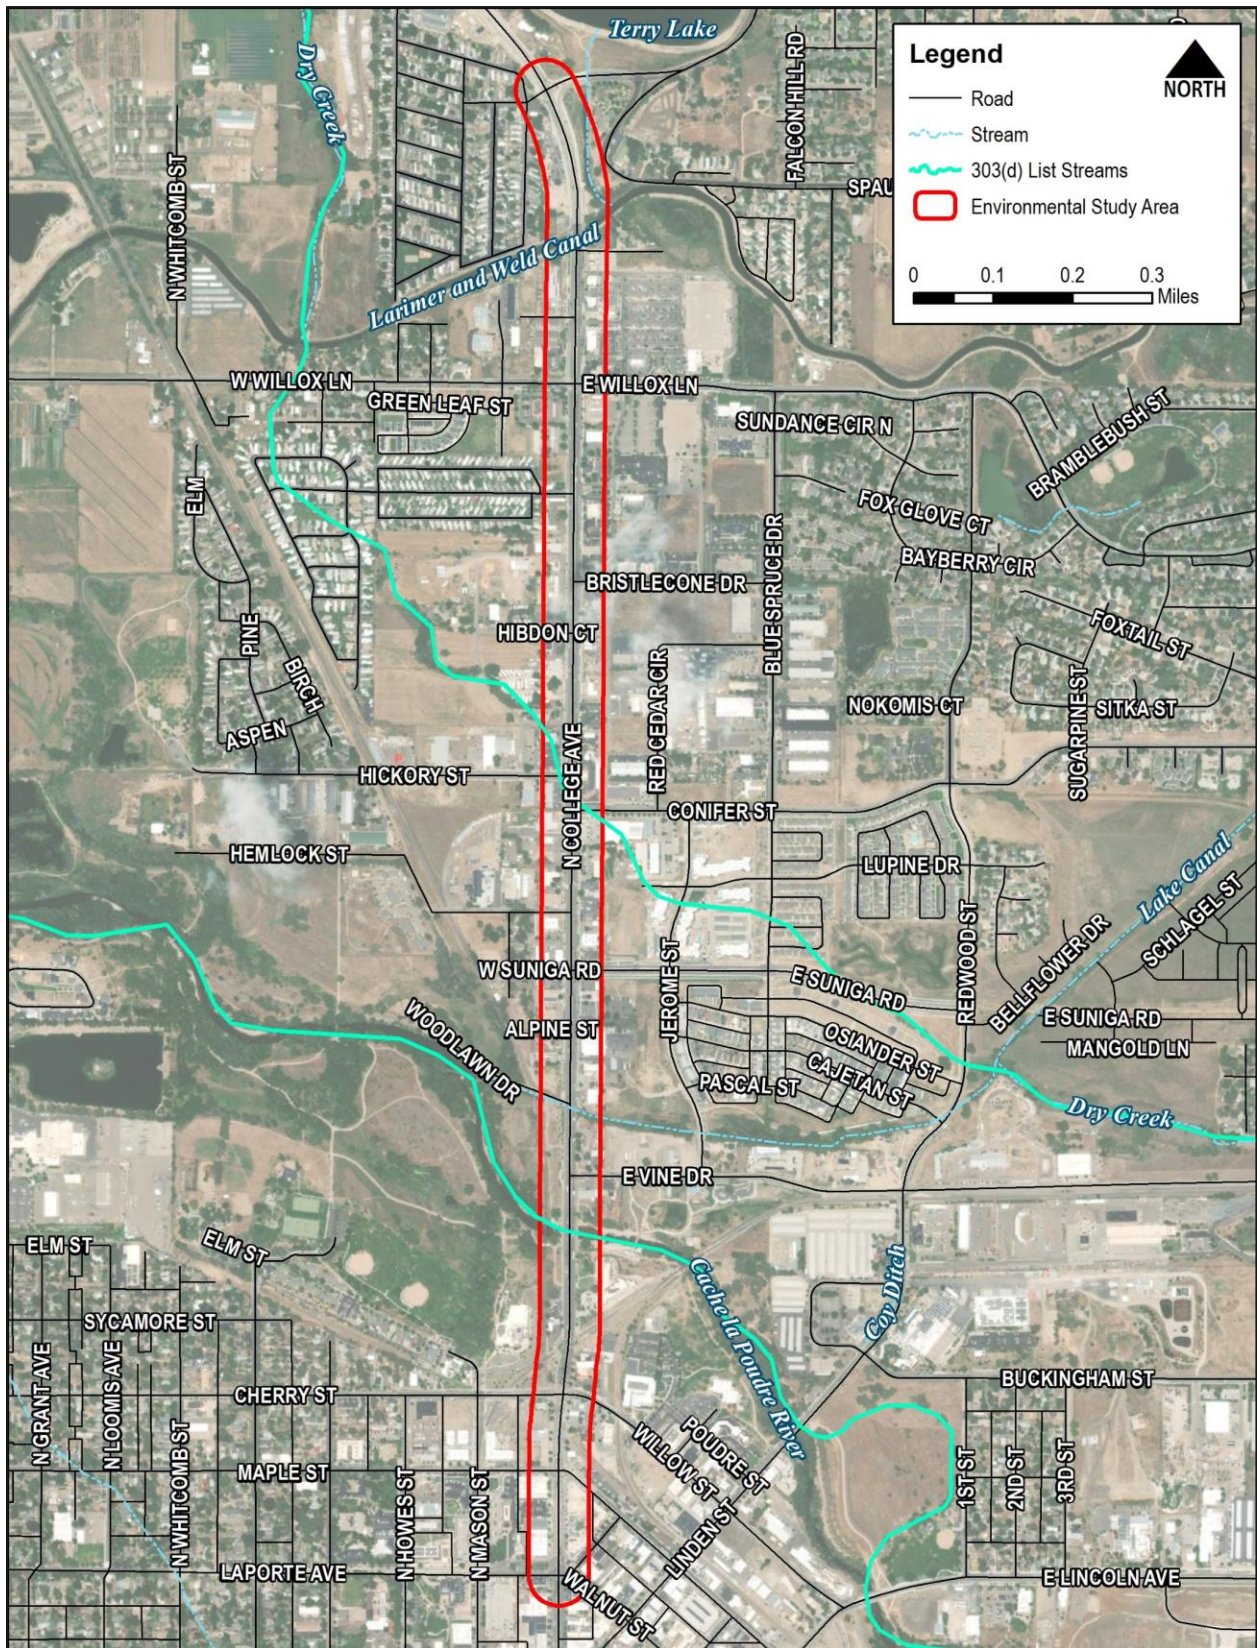
Figure 10. 303(d) List Streams

According to the Colorado Department of Public Health and Environment (CDPHE) the 2020 303(d) list of water quality limited segments requiring Total Maximum Daily Loads (TMDLs) includes the segment of Dry Creek (COSPCPI3a_B) and all its tributaries and the Cache la Poudre River segment (COSPCPI1_A) from Shields Street in Ft. Collins to a point immediately above the confluence with Boxelder Creek (CDPHE, 2020) (see **Figure 10**). For these segments, TMDLs are required for those parameters that are identified as impairments. Dry Creek is listed as having an impaired use due to Selenium (Dissolved), which affects Aquatic Life Use and has a medium priority level. The Cache la Poudre River segment is listed as having an impaired use due to E. coli, which affects Recreational Use and has a high priority.

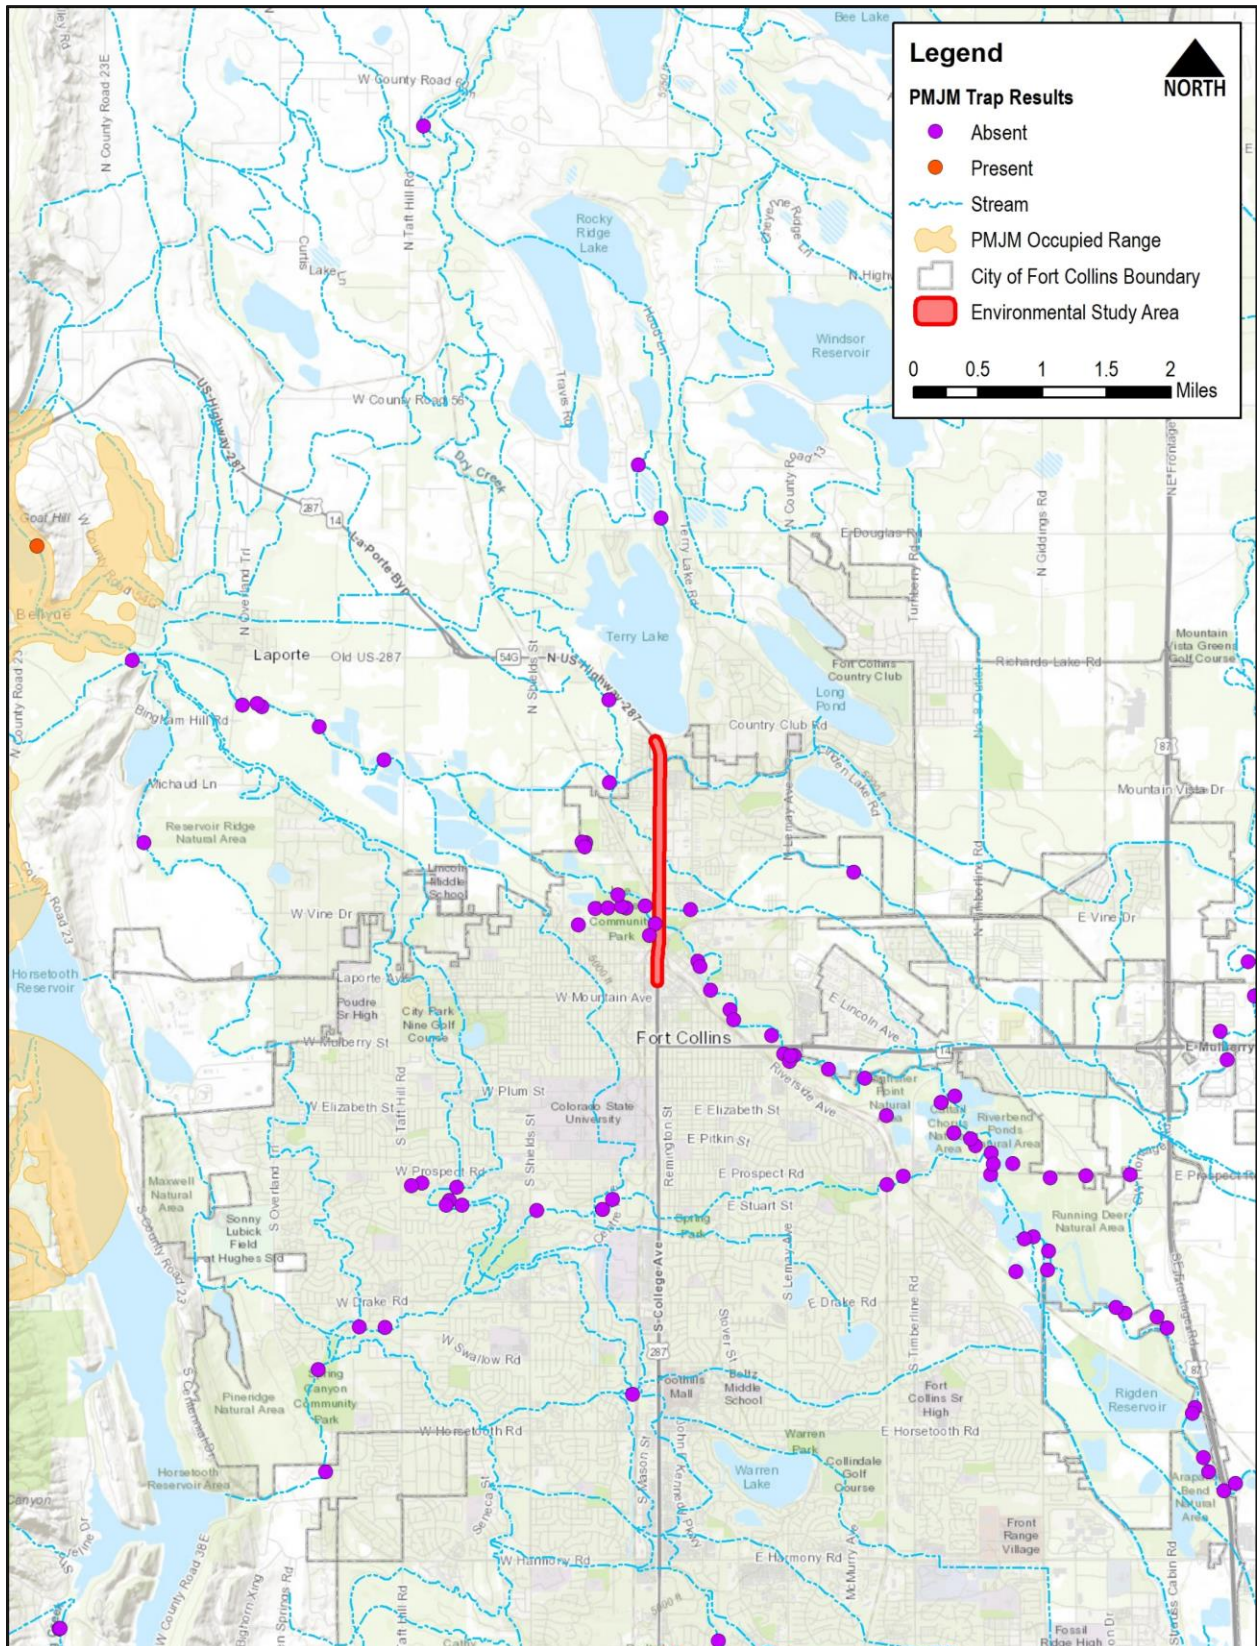
Figure 11. PMJM Trap Results

The study area is located within the CPW designated overall range of Preble’s meadow jumping mouse (PMJM) (CPW, 2020). However, the study area lies outside of the occupied range for PMJM. PMJM inhabits well developed riparian habitat with adjacent, relatively undisturbed grassland communities, and a nearby water source. Well-developed riparian habitat includes a dense combination of grasses, forbs, and shrubs; a taller shrub and tree canopy may be present. The habitat along the Cache La Poudre River, Lake Canal, Larimer and Weld Canal, and Terry Lake Canal within the study area appears to be too narrow to support PMJM and the area along the creek does not consist of a well-developed riparian area, nor does it have a relatively undisturbed grassland community adjacent to it. The nearest PMJM positive trap result (USFWS, 2021c) is located over 6-miles northwest along the Cache La Poudre River near Watson Lake. Trap results within or near the study area were all negative (see **Figure 11**). It is not likely that PMJM would be found within the study area, therefore the project is likely to have *No Effect* on PMJM.

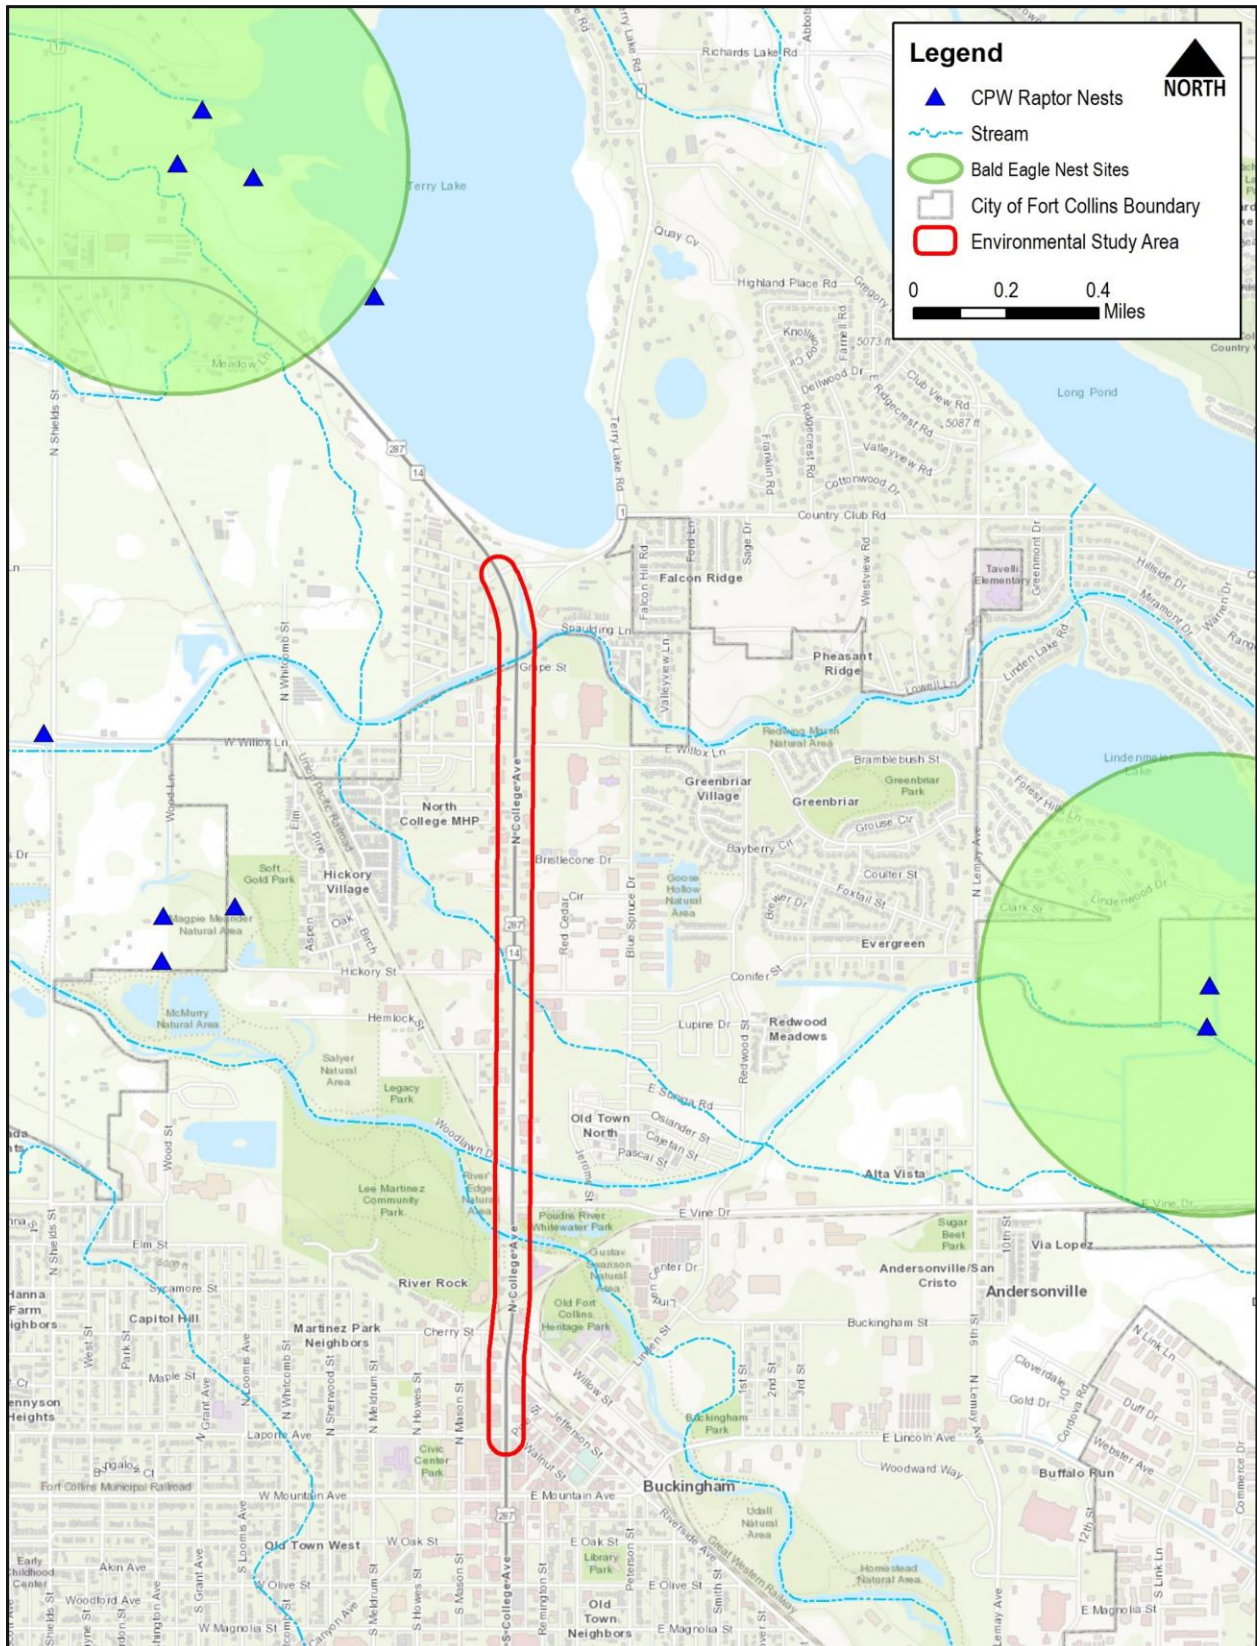
Figure 12. Raptor Nests

Bald Eagles (*Haliaeetus leucocephalus*) require mature trees near large, open bodies of water for nesting and winter roosting. No large water bodies are present in the study area of the project, but Terry Lake is located directly north. According to CPW SAM data (CPW, 2020b), there is a Bald Eagle winter foraging area found at the northern-most extent of the project near Terry Lake and the nearest known Bald Eagle nest is located approximately 1.0 mile to the northwest near Dry Creek and Terry Lake (see **Figure 12**).
