HISTORICAL COMMISSION STAFF REPORT January 14, 2025

Subject: Minor Development Review for exterior modifications to front

Location/APNs: 130 Mill St / APN 008-345-016

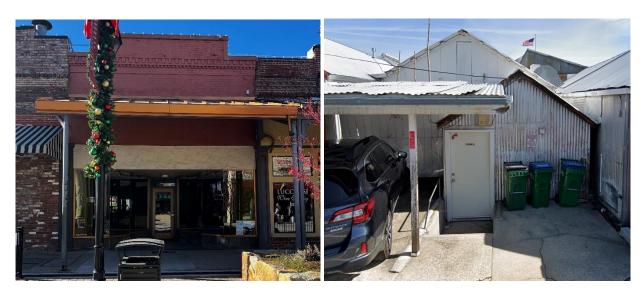
The assessment for the historical inventory recorded that the property consists of a single-story, exposed brick masonry commercial storefront. Character defining features of the building include a stepped parapet roof with metal flashing on the top, followed by a row of brick dentils and a row of dog- toothed course of bricks, below which is a contemporary metal sheeted veranda supported by steel columns, and below the veranda angled display windows, flanking a central door with a top light, and contemporary marble tile or granite skirt, and a stucco textured wall above the windows. The building is flanked on the right and left by single-story commercial storefronts sharing common walls.

Today, the façade of the building at 130 Mill Street is identical to the front façade image recorded at the time of the historical inventory. The rear façade was not photographed in the inventory.

Existing Front and Rear Facades of 130 Mill Street

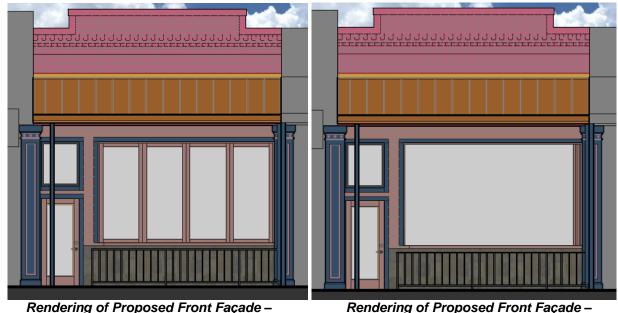
The applicant proposes to remove the existing front façade and set the modified façade back approximately 9+/- feet from the sidewalk to create a patio seating area in the recessed entryway. The new façade will relocate the existing central doorway to the southern (left) side. The door will be a full light cedar door with a new transom window above the door. A folding-style window with four vertical panes will be added. The windows can be opened and collapsed to create an open-air eating counter along the windowsill. Horizontal cedar lap siding is proposed on the new façade, with slate tile below the window. A new metal rail system will be installed between the patio area and the adjacent sidewalk. Existing decorative columns framing the recessed entry will remain. No changes are proposed to or above existing canopy.

Rendering of Proposed Front Façade - Windows Closed

Rendering of Proposed Front Façade – Windows Open

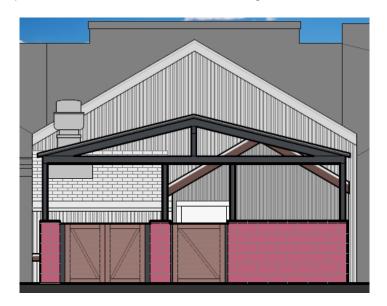
Under this option, the applicant proposes to maintain the existing corrugated metal and brick façade on the building. The portion of the existing canopy extending over the property line of 130 Mill Street will be removed and replaced with a new tube steel metal roof canopy with corrugated metal roofing to cover the barbeque and wood storage areas. The area will be enclosed by a new painted CMU wall with cedar wood gates.

Rendering of Proposed Rear Façade (Option A)

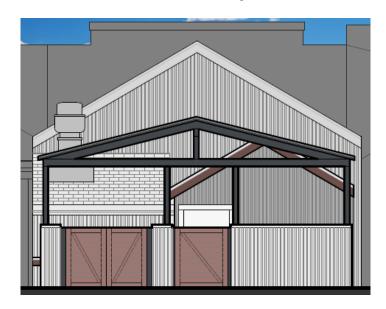
As with Option A, under Option B, the applicant proposes to maintain the existing corrugated metal and brick façade on the building. The portion of the existing canopy extending over the property line of 130 Mill Street will be removed and replaced with a new tube steel metal roof canopy with corrugated metal roofing to cover the barbeque and wood storage areas. However, unlike Option A, the enclosure will have a corrugated metal finish to match existing wall siding. The enclosure will still have cedar wood gates.

Rendering of Proposed Rear Façade (Option B)
