**BOARD OF ZONING APPEALS DIVISION I**

**Case Number:** 2025-DV1-065  
**Property Address:** 2929 Eagledale Drive (approximate address)  
**Location:** Wayne Township, Council District #11  
**Petitioner:** Grise Home & Property Group LLC, by Martin Jimenez  
**Current Zoning:** D-5  
**Request:** Variance of Development Standards of the Consolidated Zoning and Subdivision Ordinance to provide for a carport with a 0-foot side yard setback (5-foot setback required).  
**Current Land Use:** Residential  
**Staff Recommendations:** Staff recommends **denial** of this petition.  
**Staff Reviewer:** Michael Weigel, Senior Planner

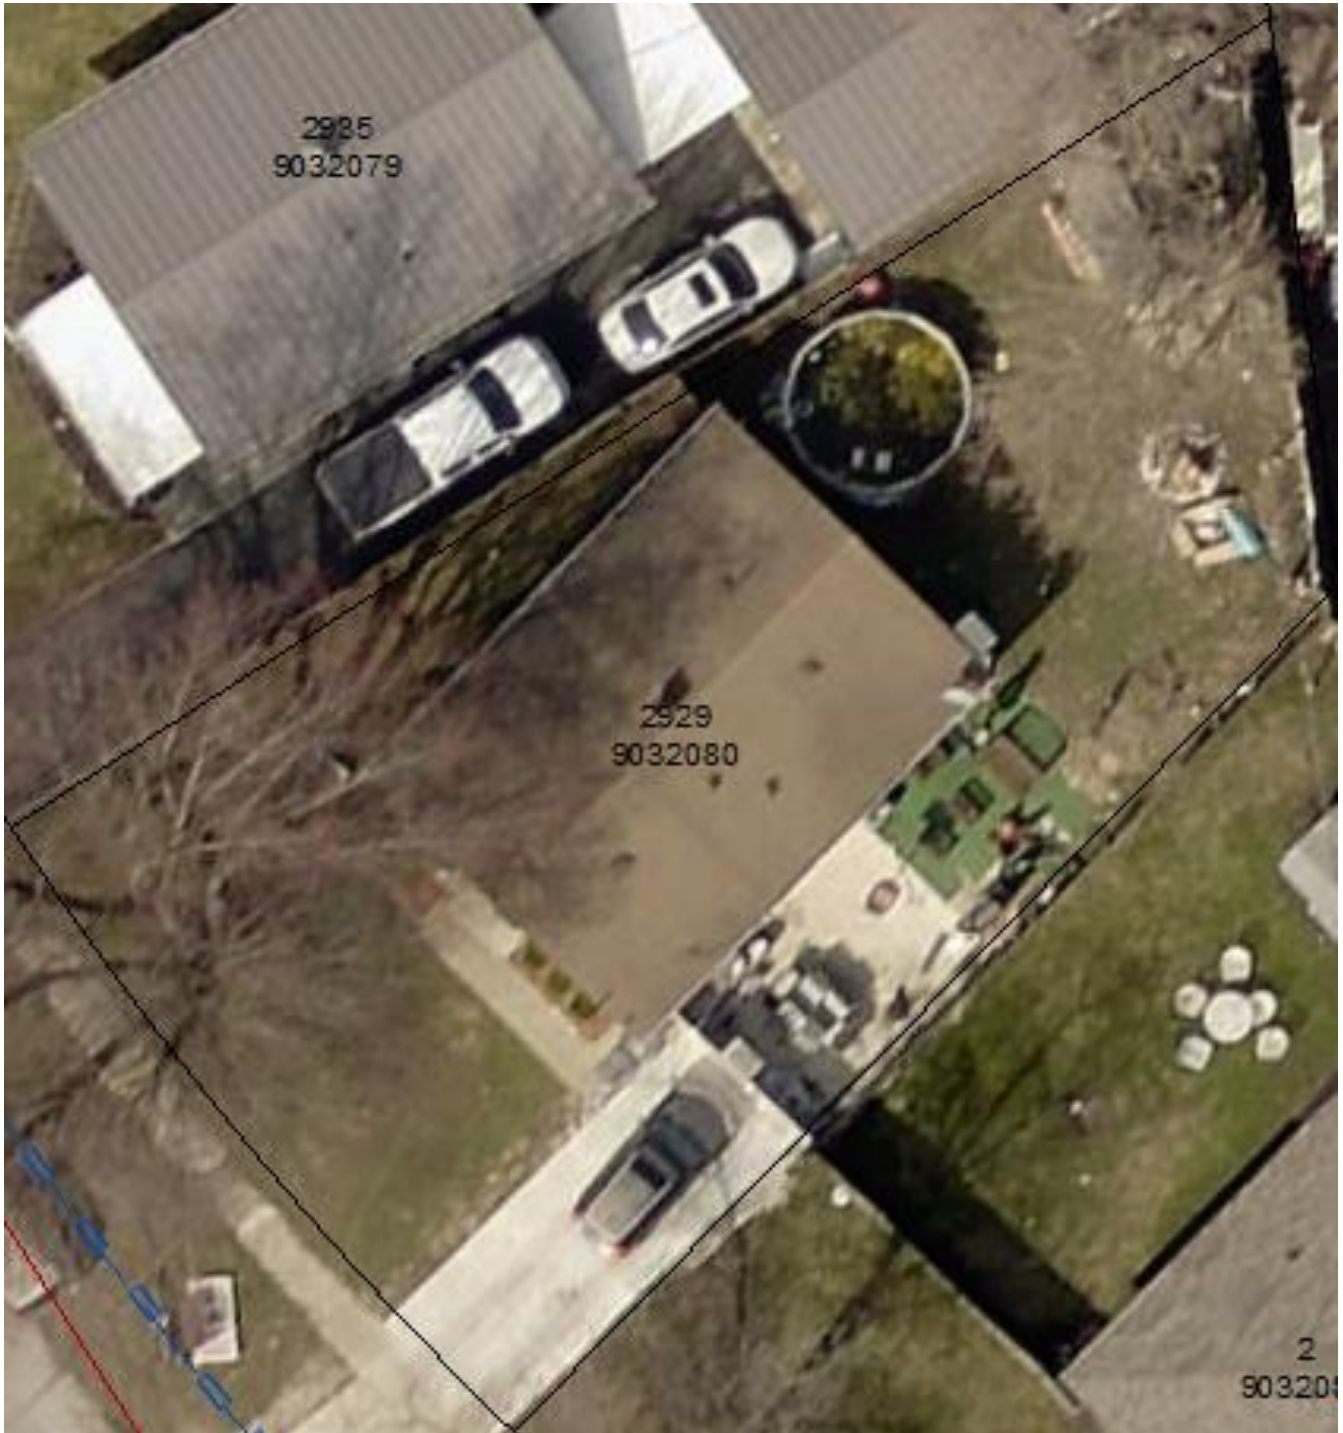
**2025DV1065 ; Aerial Map (zoomed, prior to carport placement)**

- Approval of this variance would relate to the setback encroachment that has resulted from placement of the carport without having permits in place. Although neither the notice of violation nor documentation provided by the applicant specified the precise setback of this improvement, aerial photography and staff’s visit seem to indicate that the carport would be directly adjacent to the border fence comprising the property boundary (resulting in a 0-foot setback where a 5-foot setback would be required).

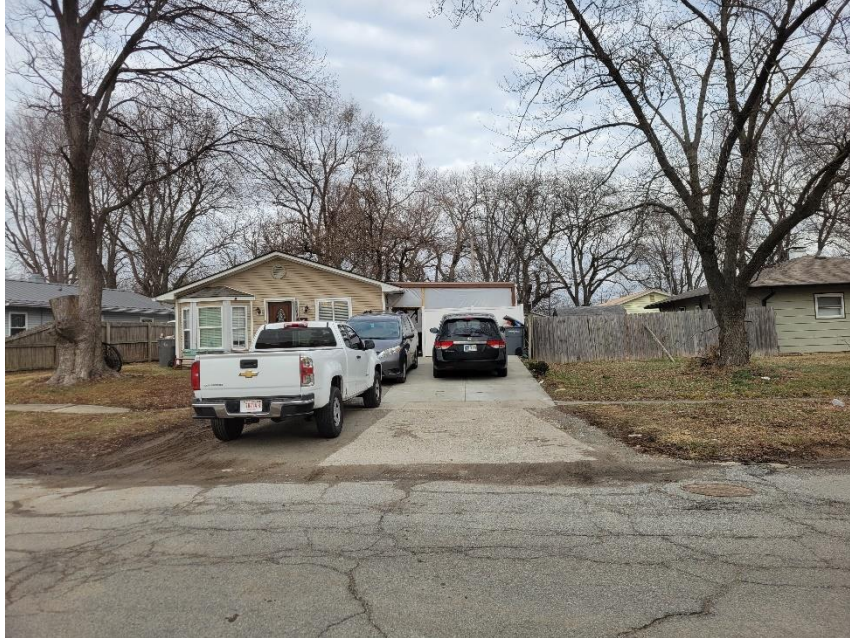
Photo 1: Subject Site Viewed from Southwest

- Staff would note that it doesn’t appear that the carport improvement is utilized for the parking of vehicles; instead, vehicles park on the driveway within the site’s front yard and the portion of the carport nearest the front property line is blocked by an opaque fence that appears to have been installed between 2019 and 2022. This fence and outdoor patio area predate the carport, and although the height of the fence was not cited within the violation staff notes that the maximum allowable height for this fence within a side yard would be 6 feet in height and that a fence exceeding that height could be citable.
