## **Agenda Item #2d**

### **Authorization to Seek Bids for Project 11-23, Rehabilitation of Horseshoe Park Storm Sewer**

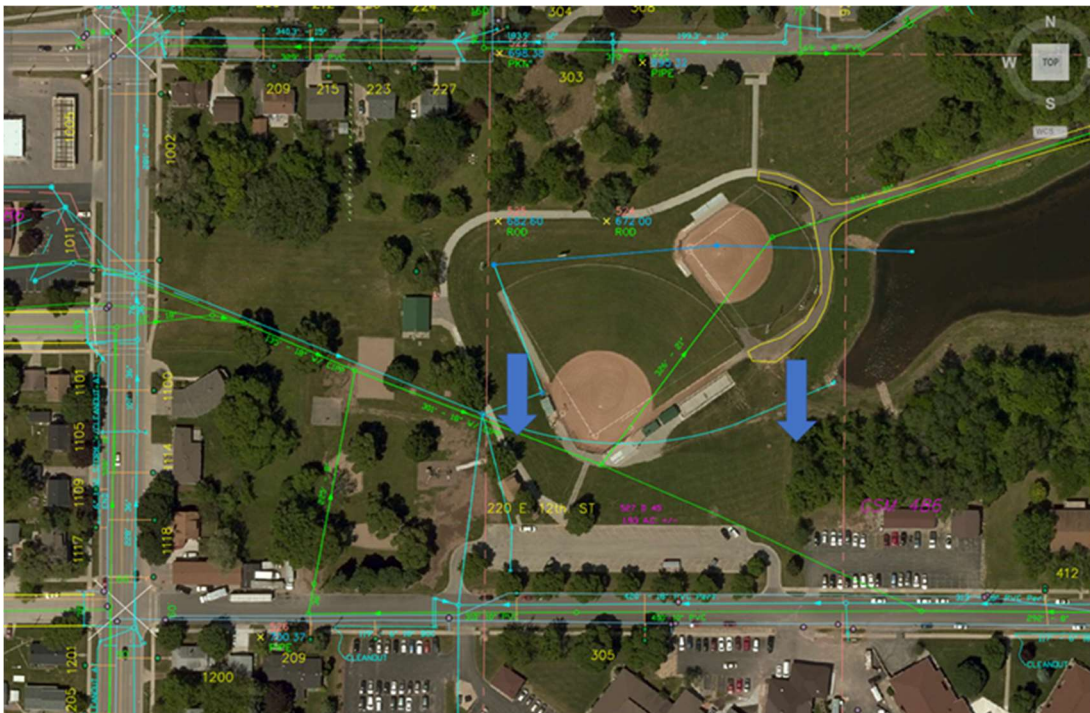
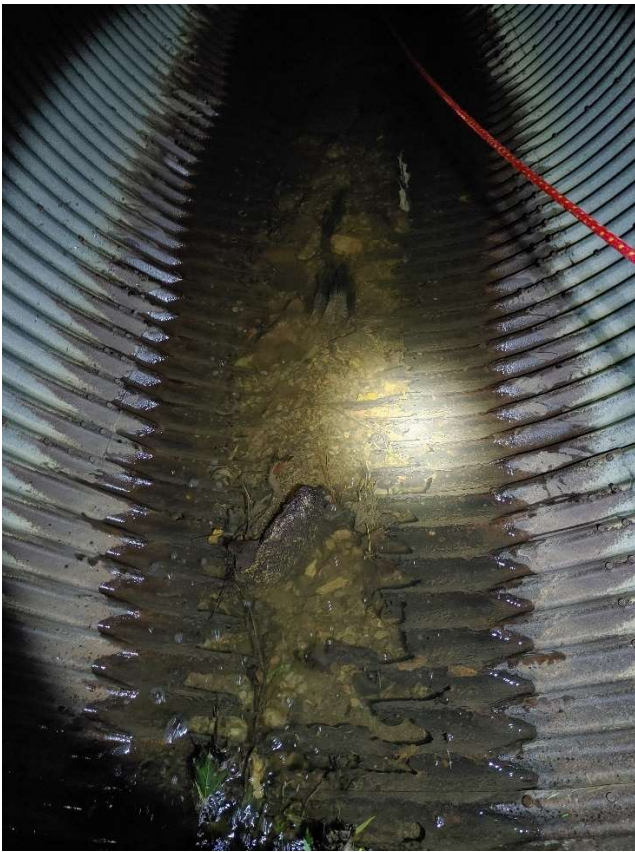
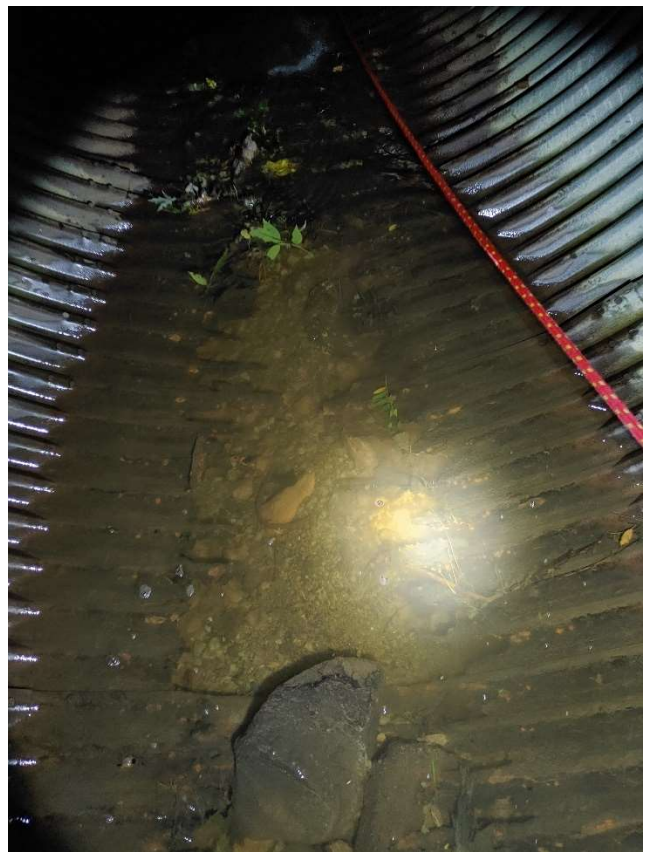
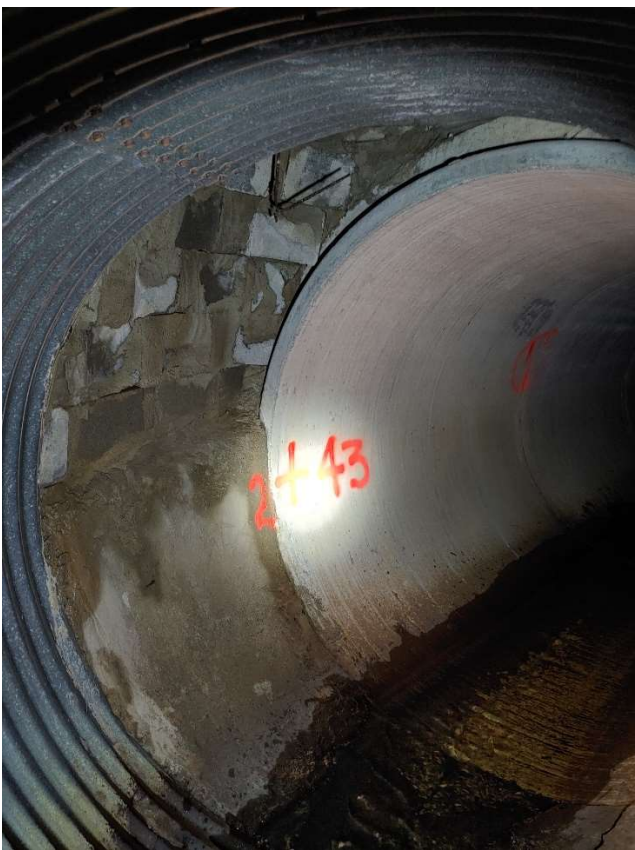
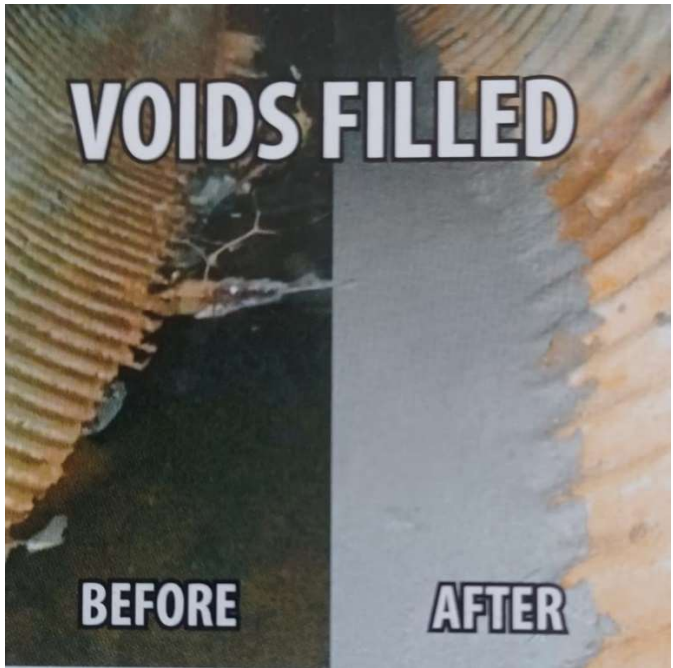
The flow line of the 72" Corrugated Metal Pipe (CMP) under Horseshoe Park has deteriorated and is allowing soil migration, leading to sink holes in the park. Photos of the pipe are attached. After assessing the pipe with staff and consultants we are recommending bidding out a contract to patch/rehabilitate the flow line of the pipe and make tuck-point repairs to structures in the system. In addition, we will be looking for alternate bids to install structural liner for the CMP sections.

- Authorize Engineering Department to seek bids for Project 11-23, Rehabilitation of Horseshoe Park Storm Sewer.
