## DEPARTMENT OF GROWTH MANAGEMENT

The Women's Club of Lake City Building

257 SE Hernando Ave

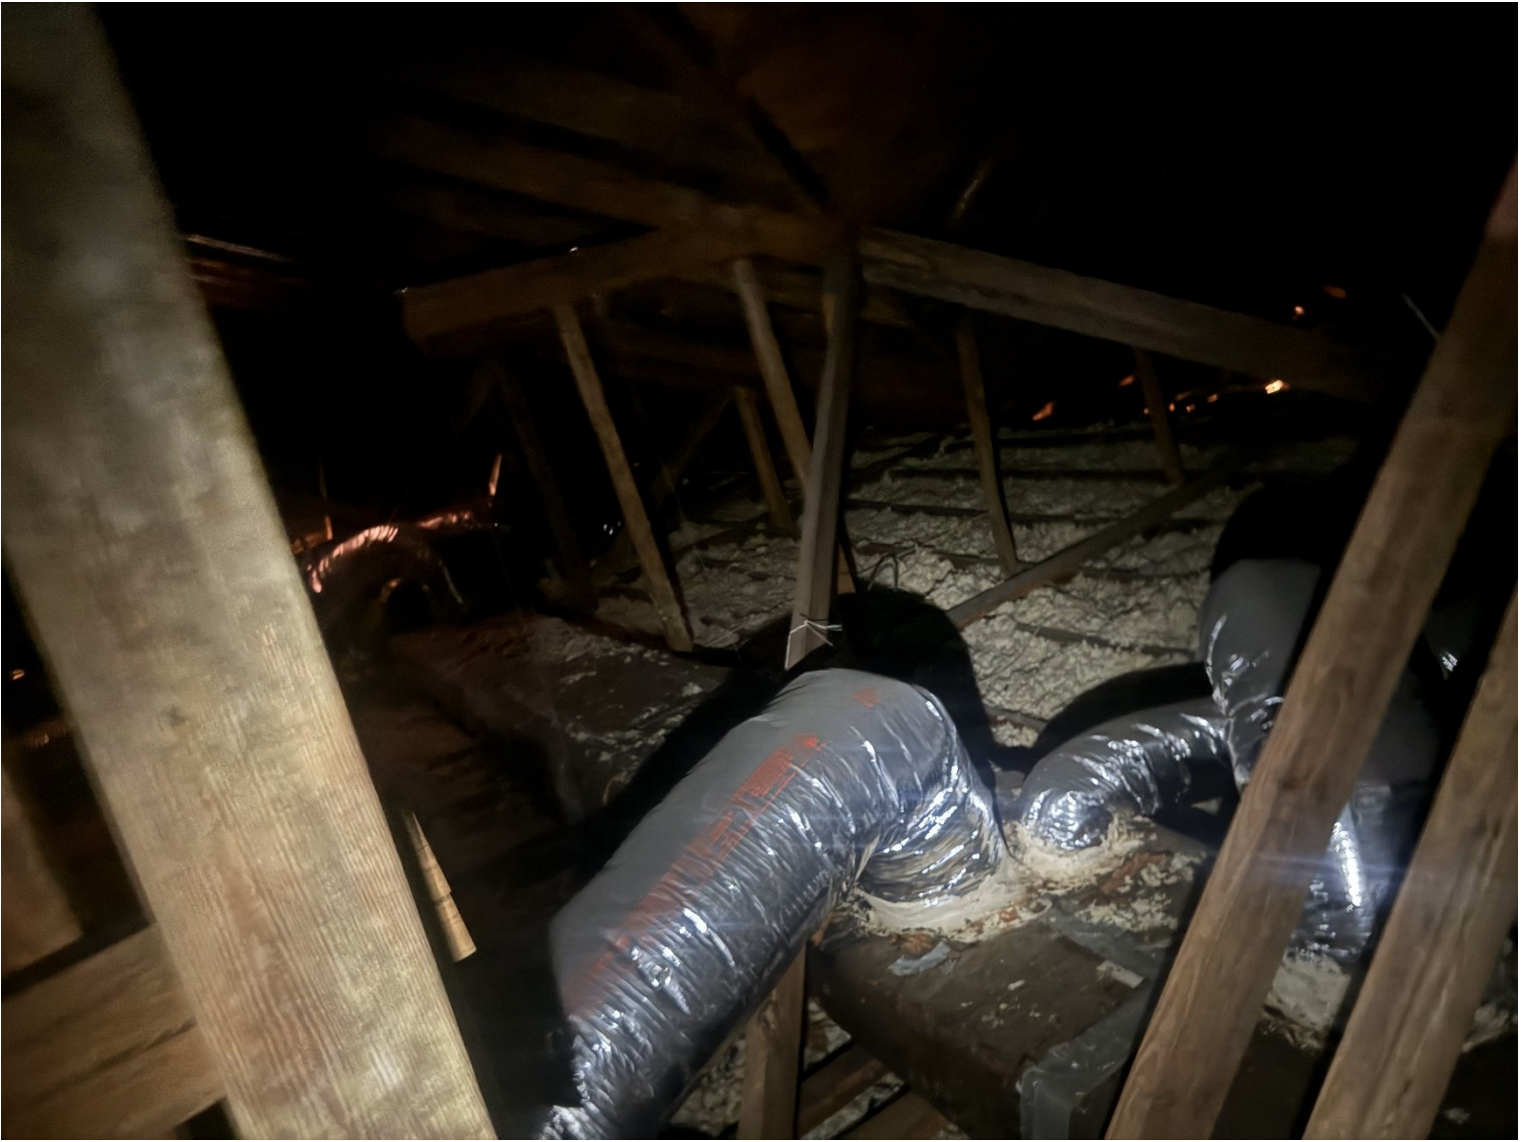
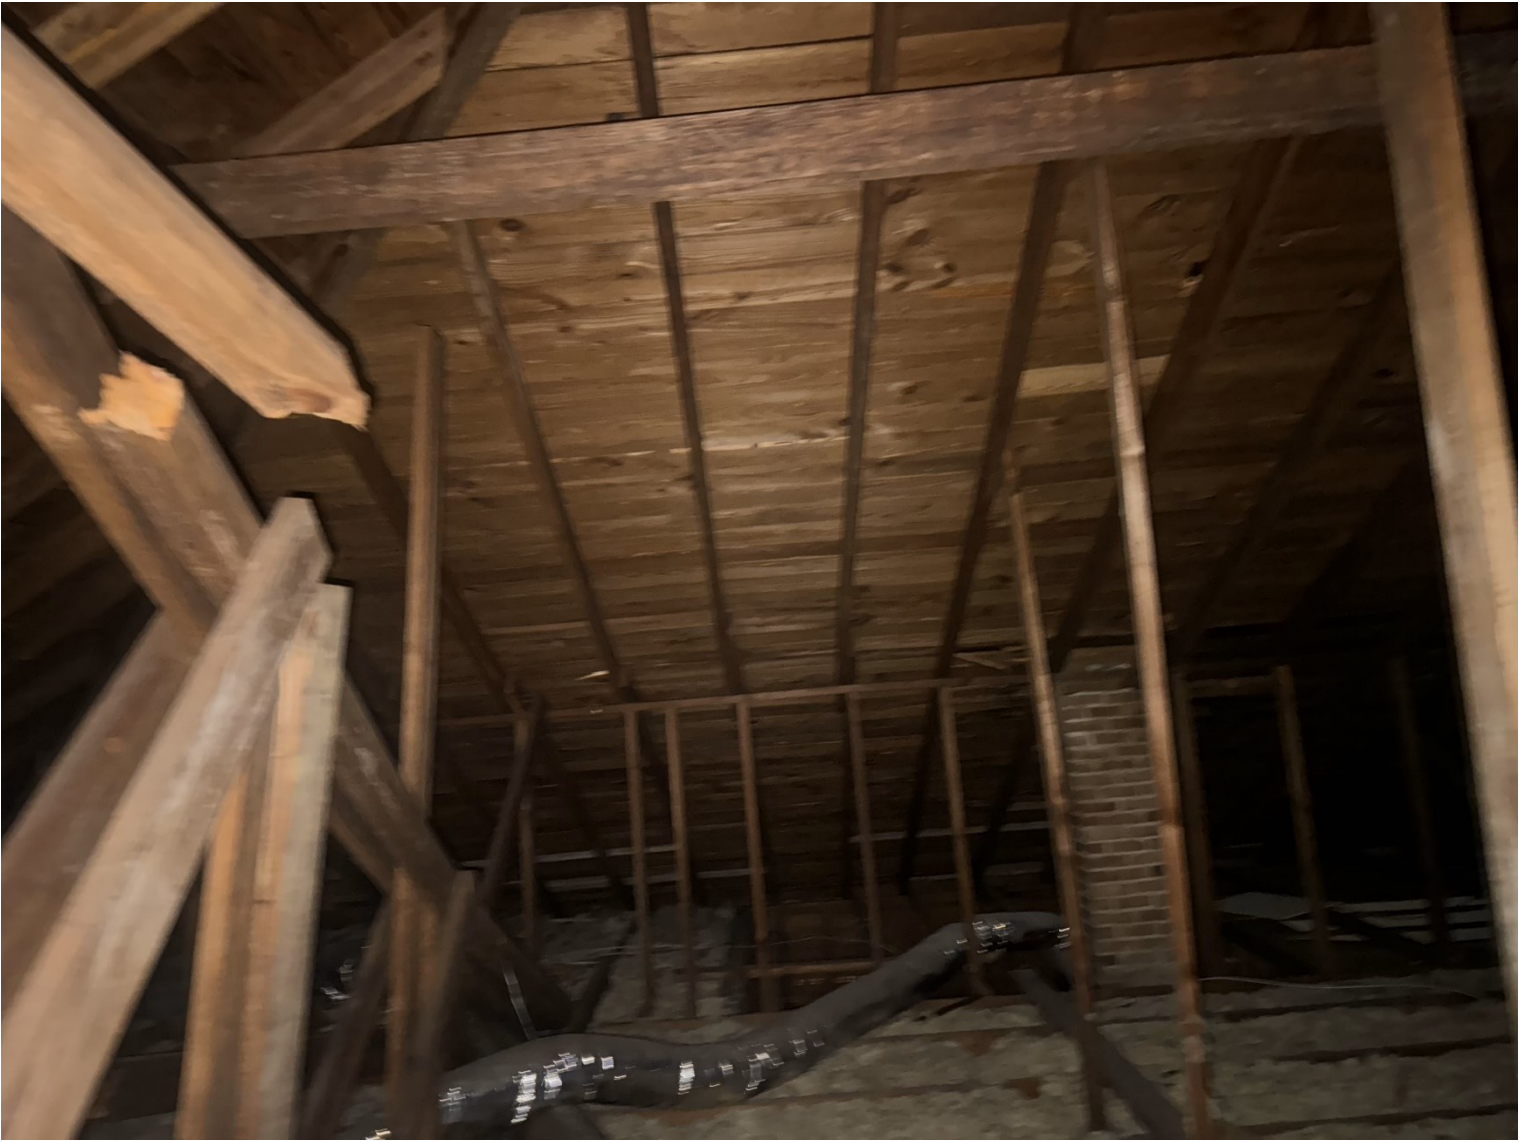
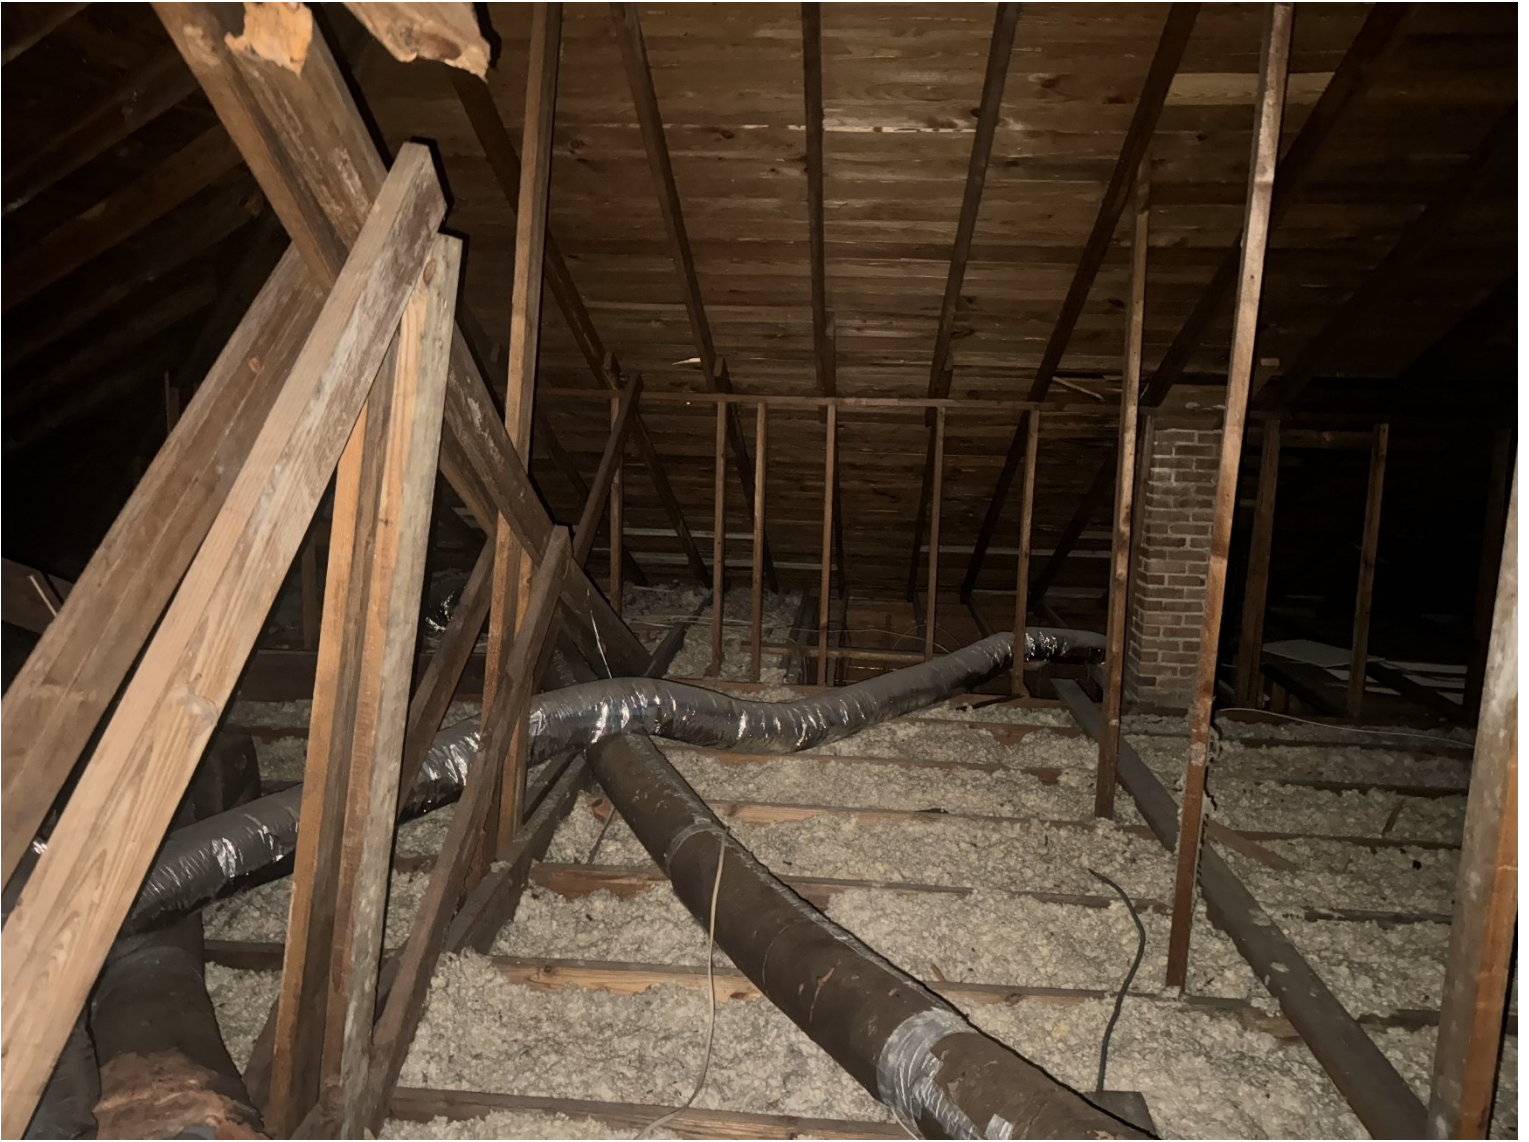
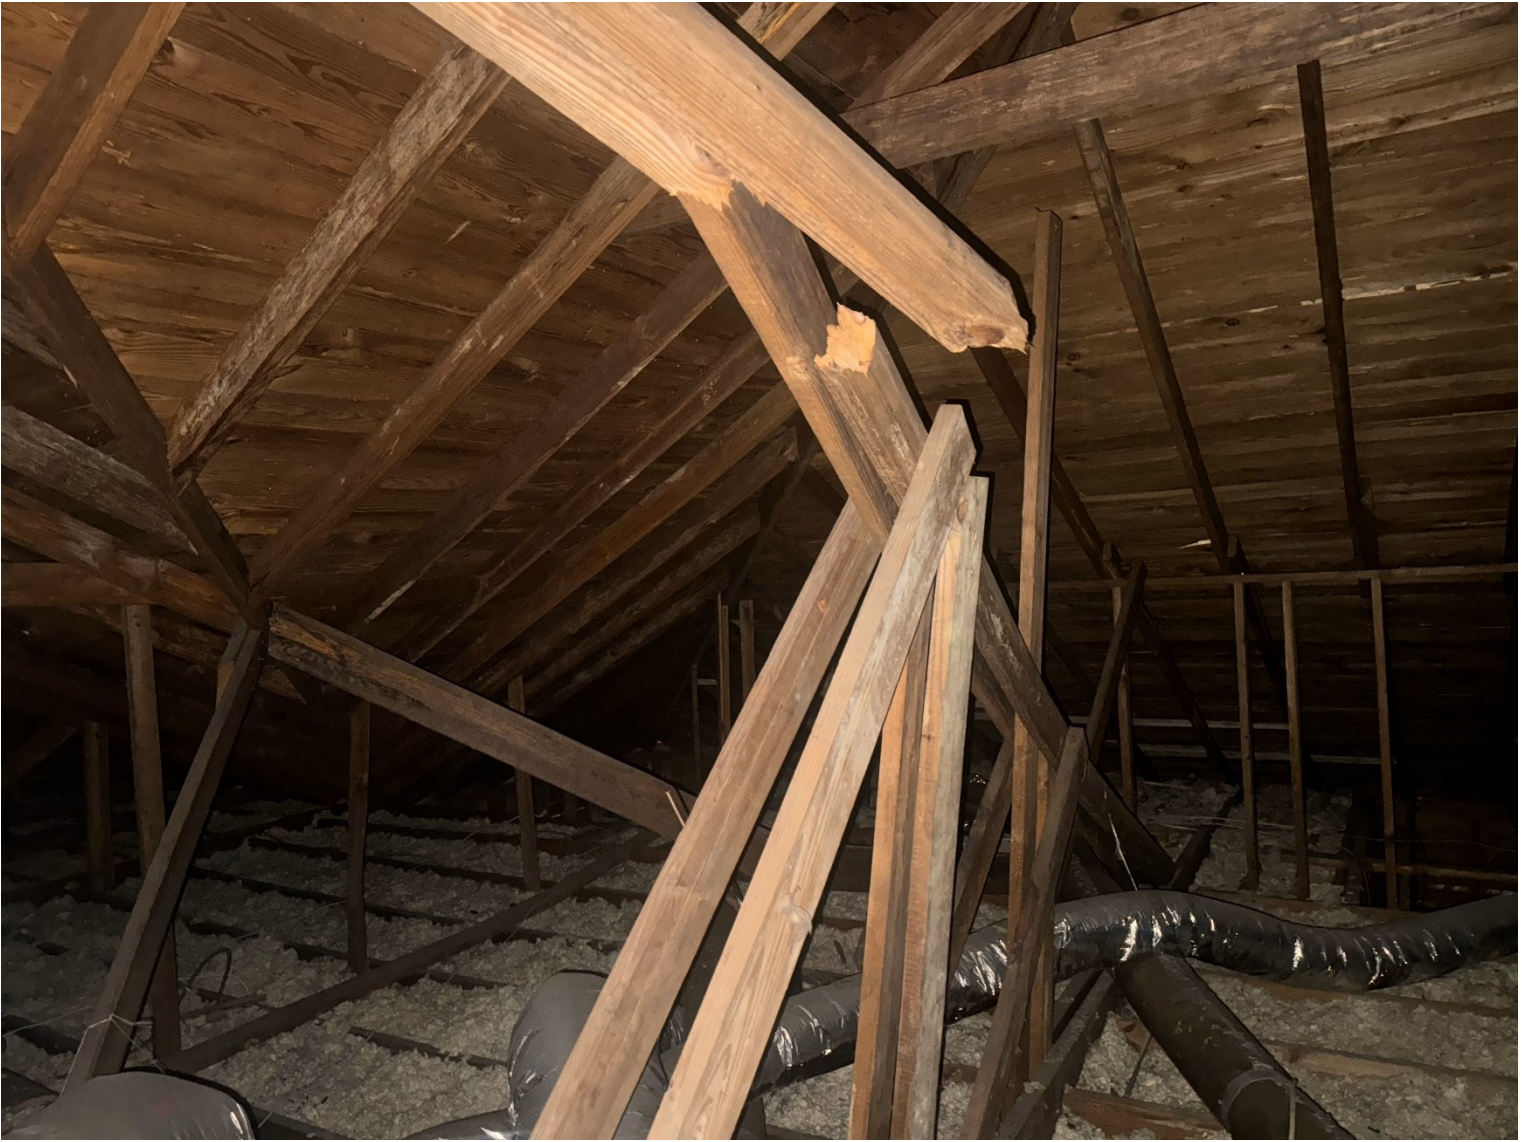
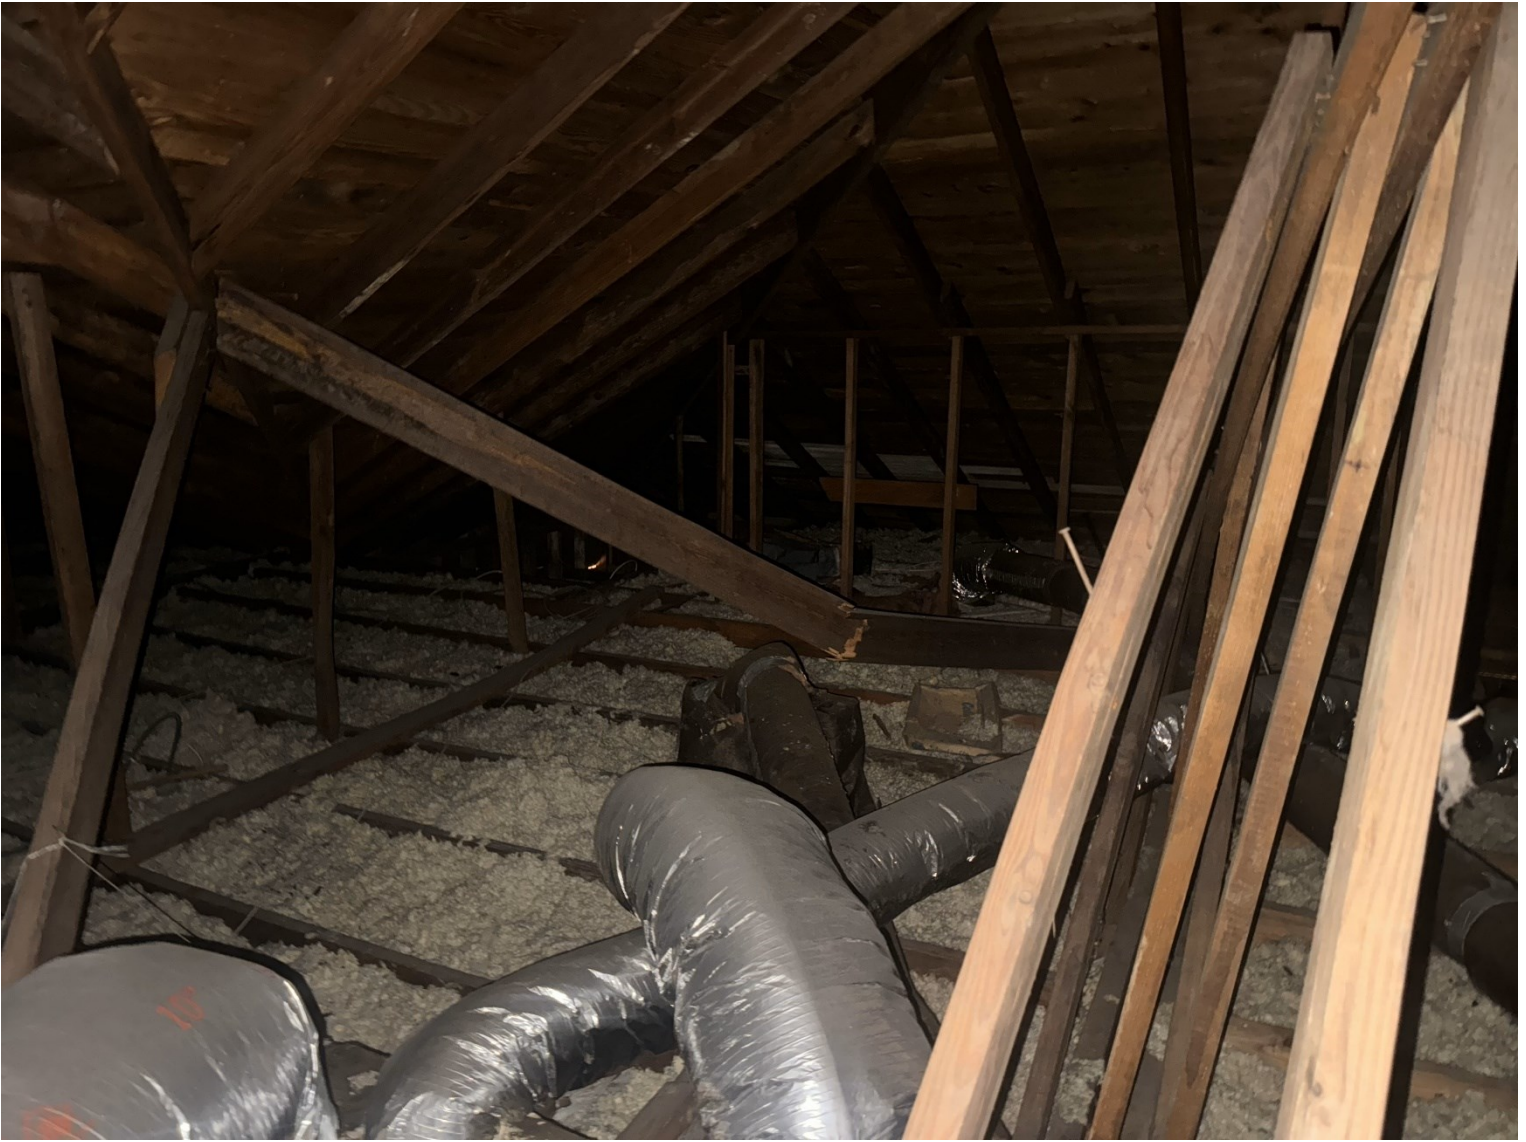
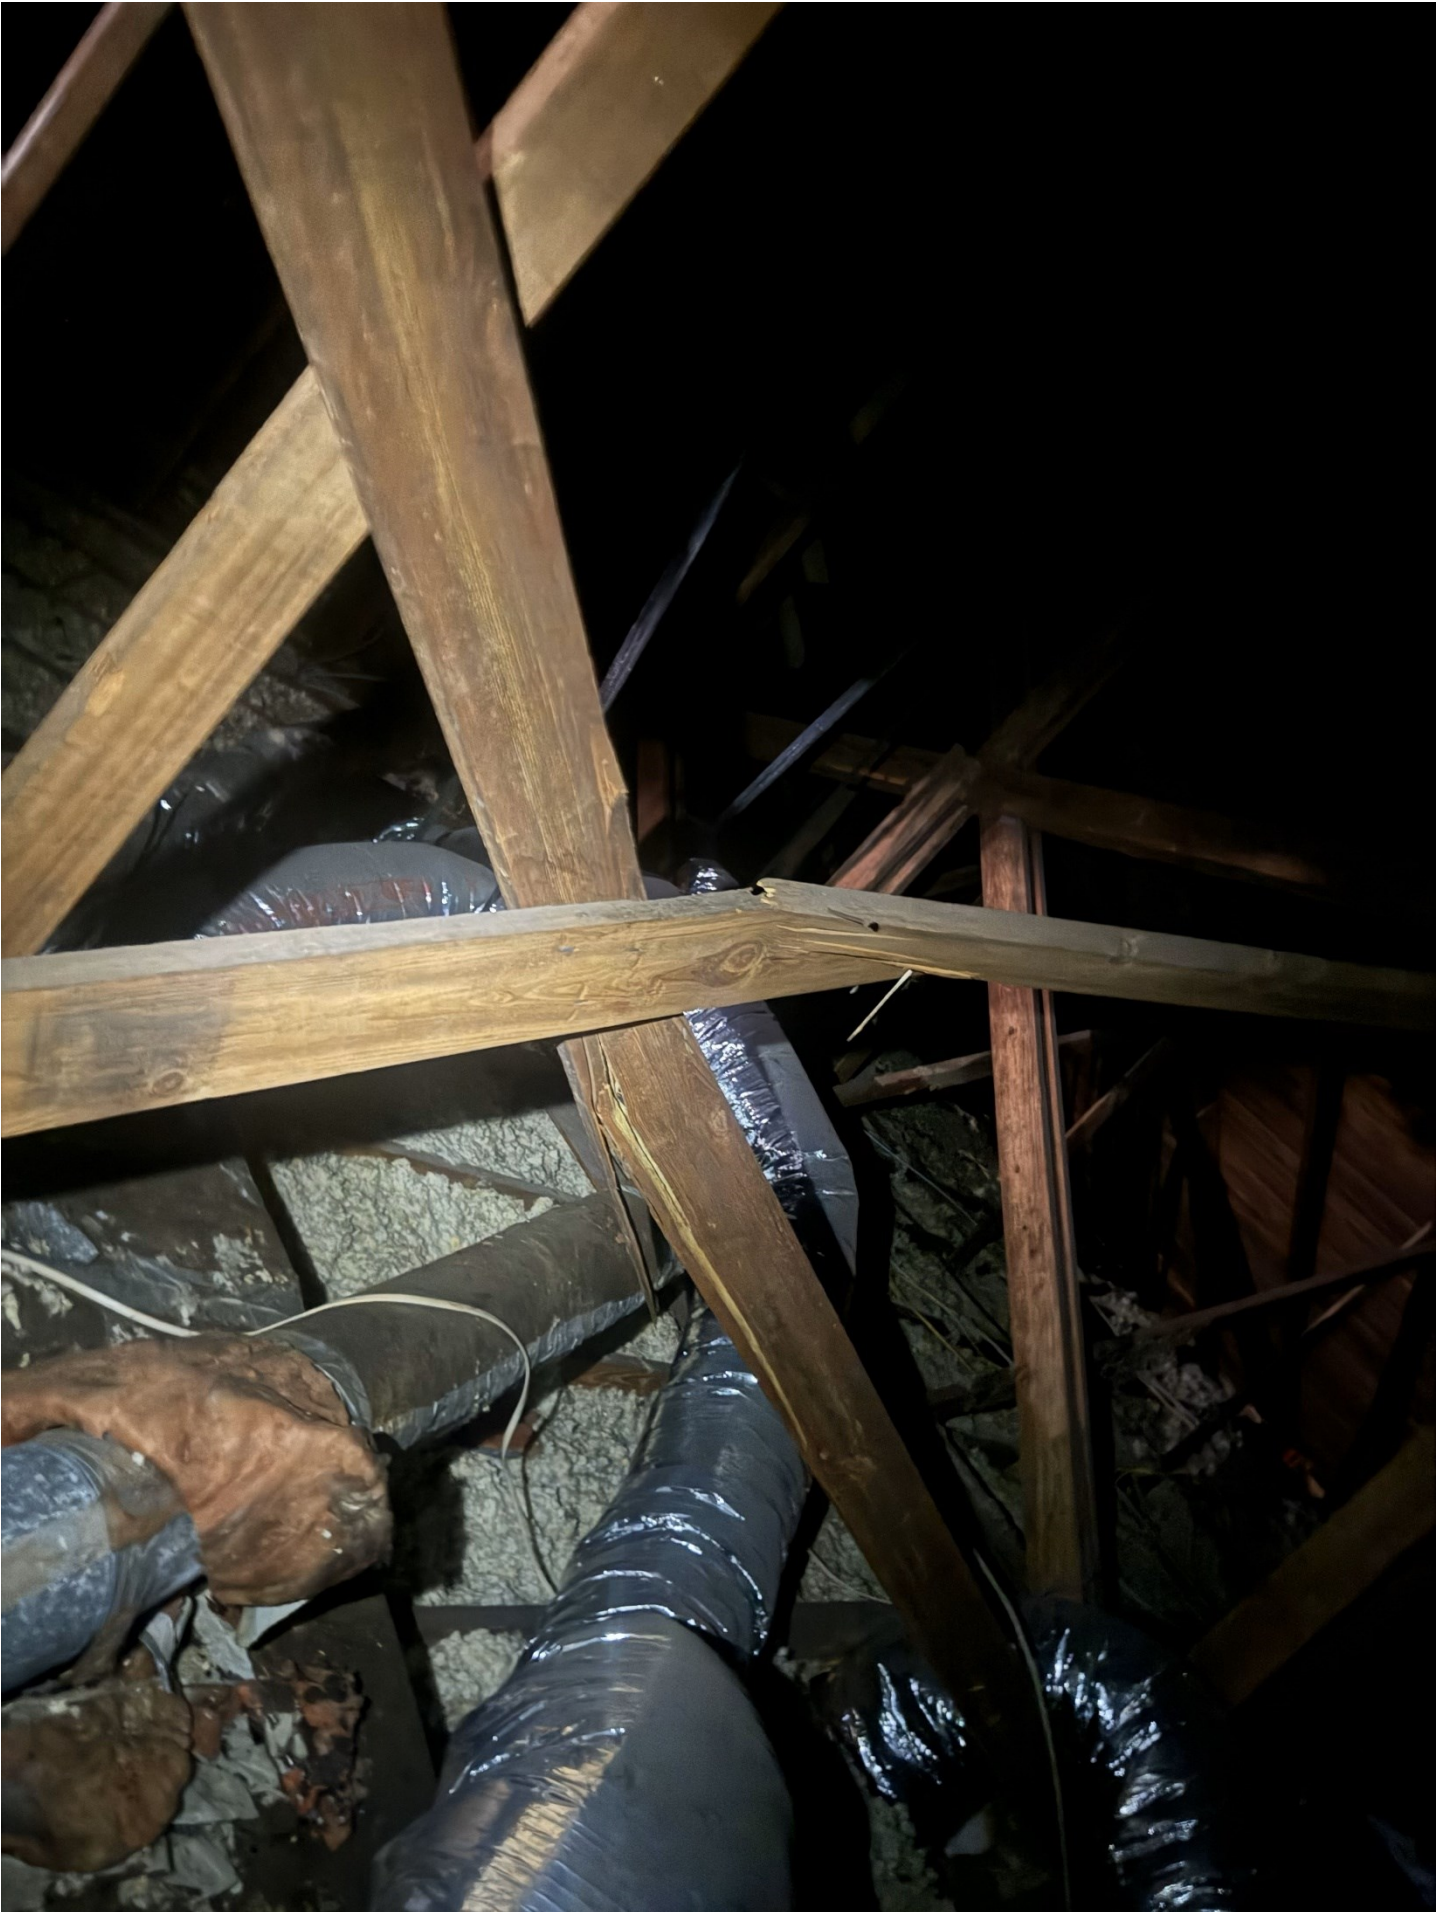
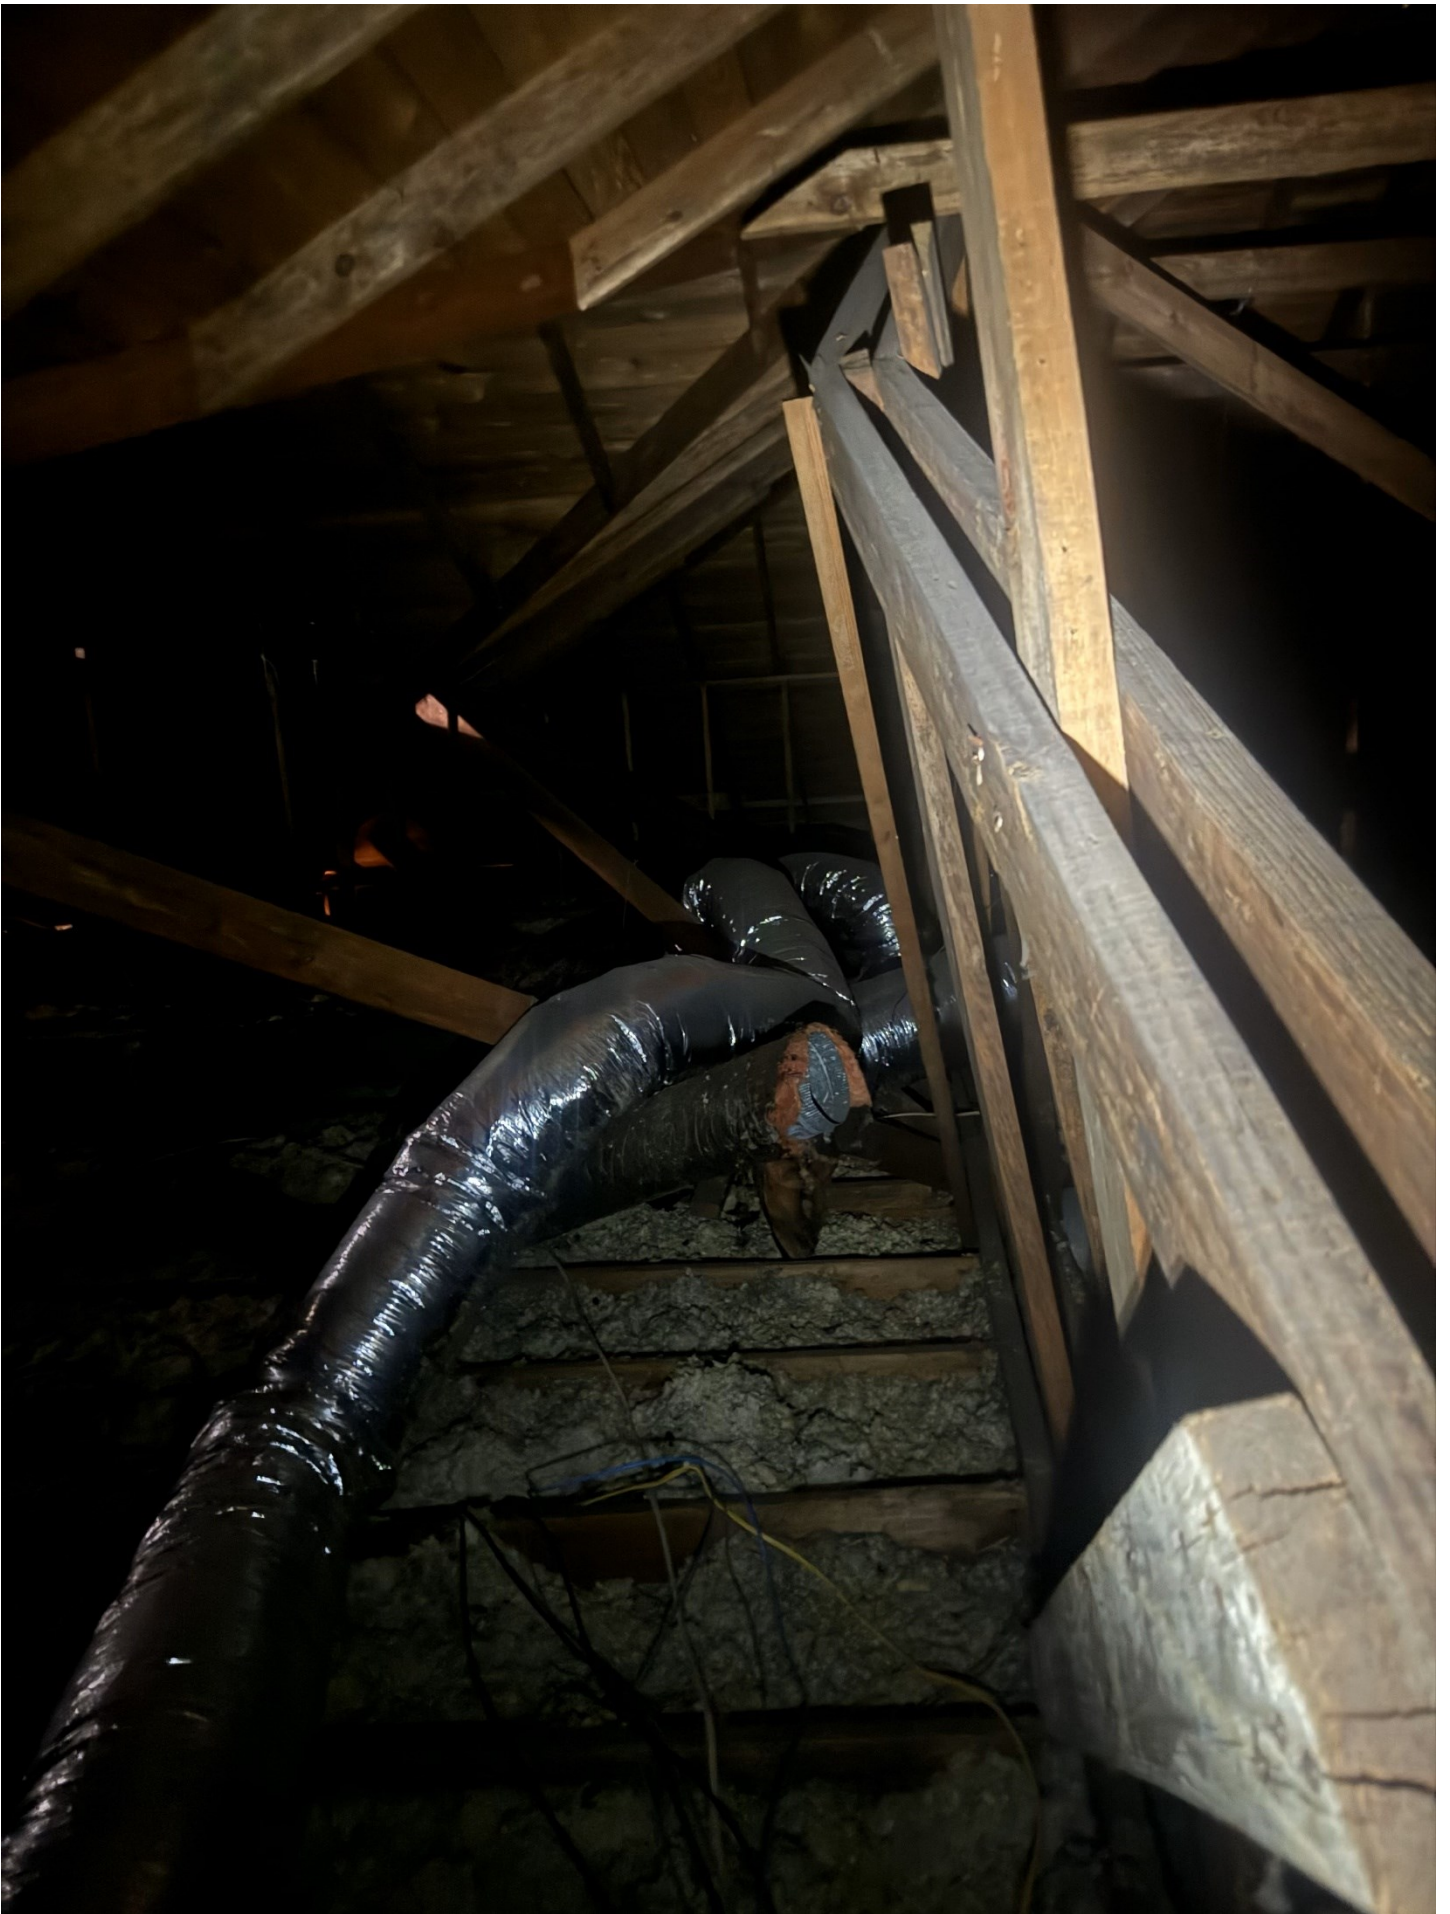
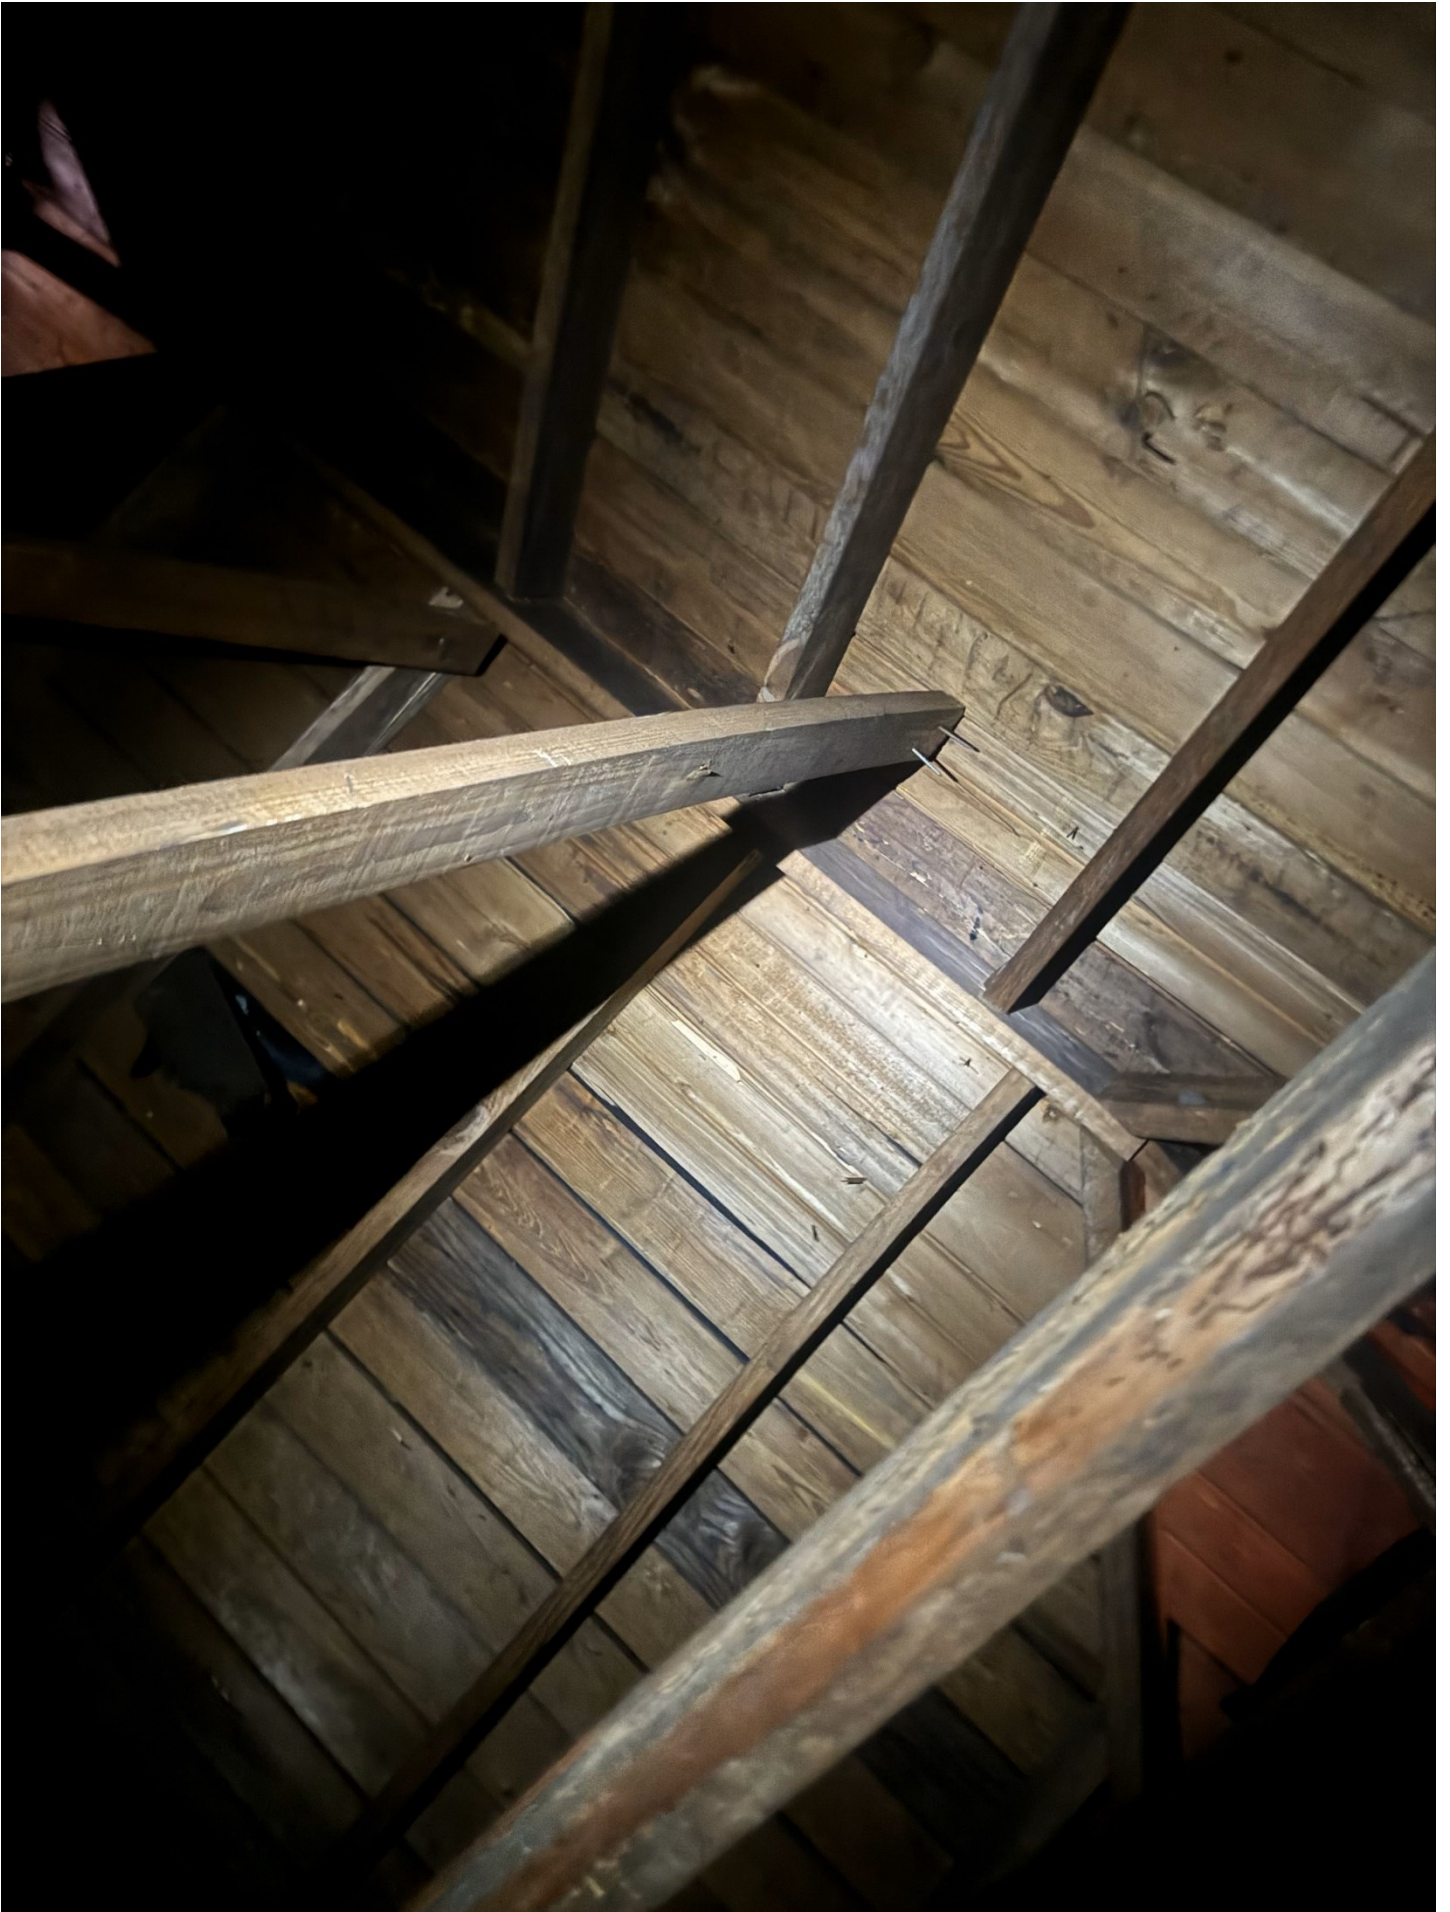
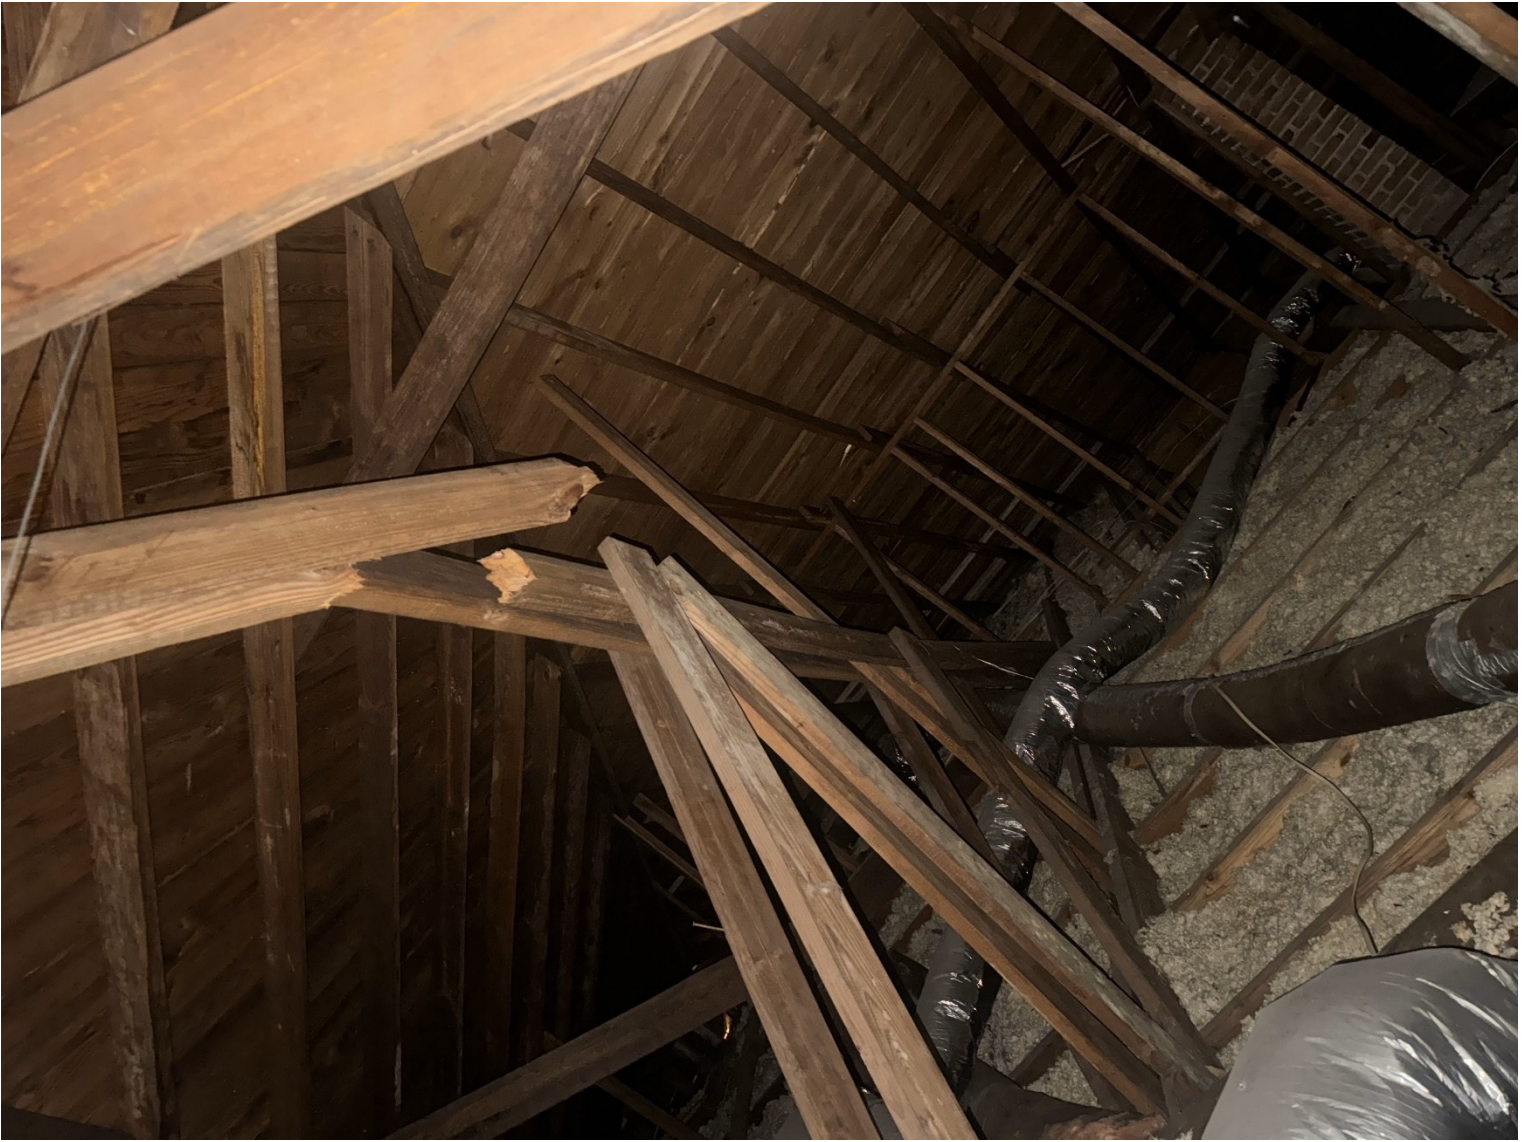
Upon investigation of the trusses, I found that three (3) trusses were broken along with supporting wood members attached to these trusses.

I found that when one truss failed causing, the weight that was being supported by that truss to be transferred to the next truss which in turn failed and the weight from the two failed trusses were now transferred to the third truss, which failed also under the added weight. The remaining trusses could fail at any time causing a catastrophic failure of the roof system.

Out of a safety concern of any occupants of this building, I have posted this building as non-occupiable until a structural engineer surveys the roofing system and determines the corrective action required.
