## Petition for Removal

918 Park Avenue, 8PB9607, as a locally designated historic landmark in the downtown retail district of the Town of Lake Park.

03.01.2023

RE:  
918 Park Avenue, Lake Park FL 33408  
Historic Preservation Consultant

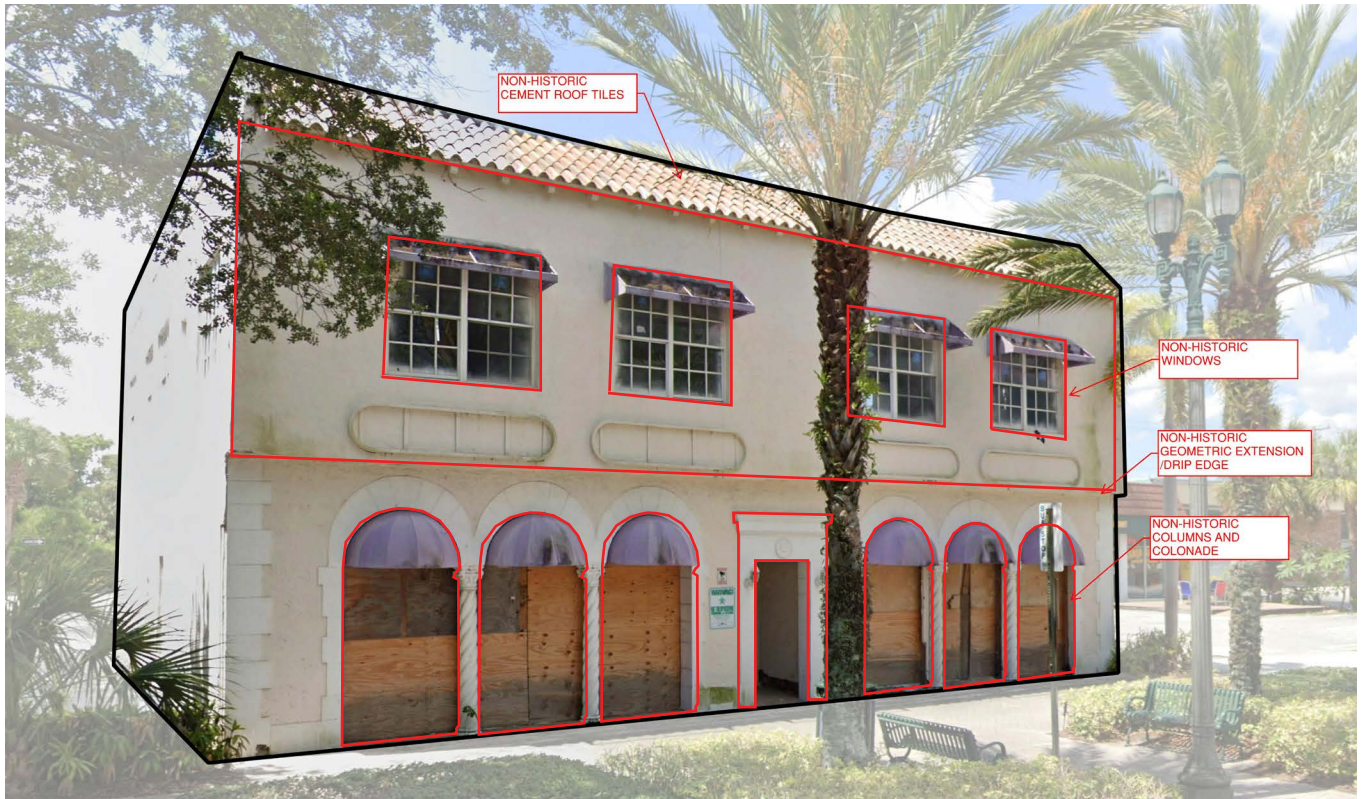
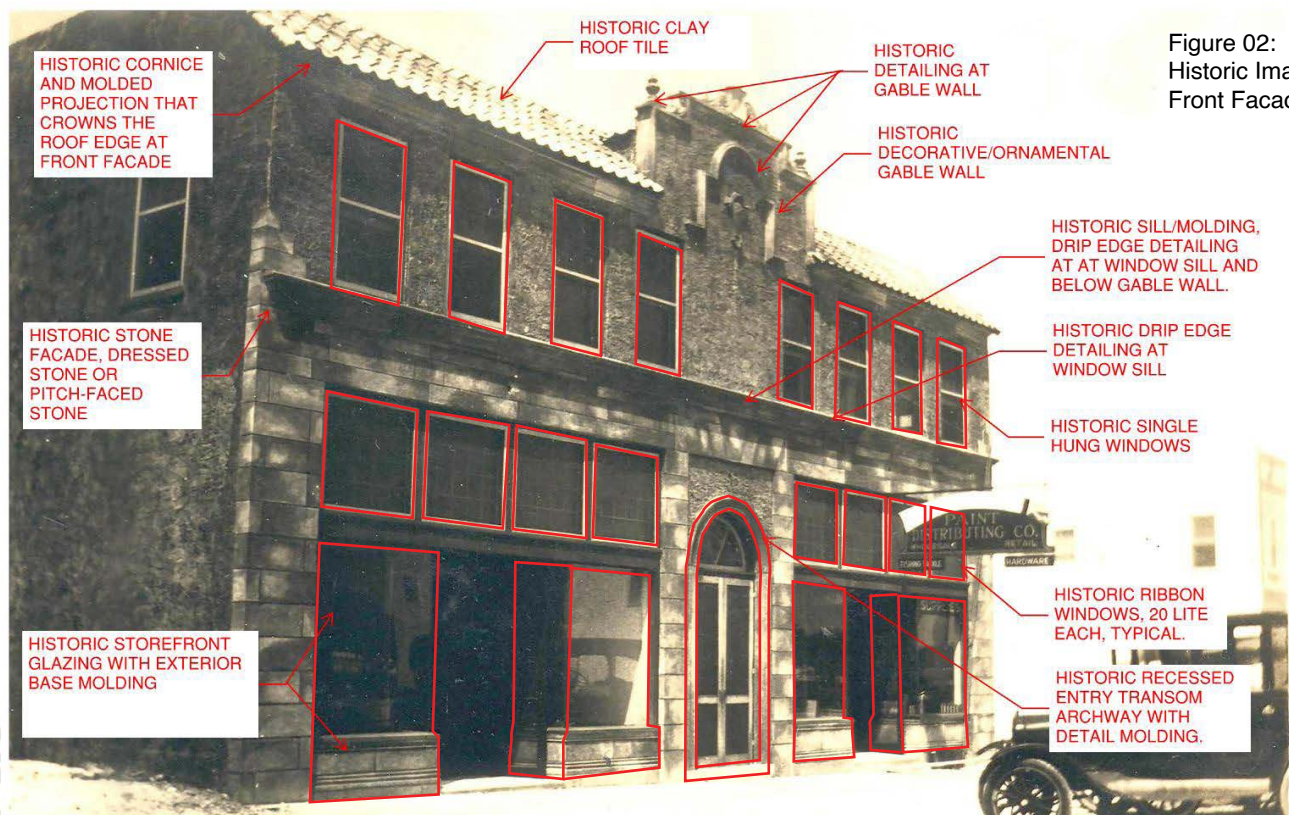
Figure 7: Existing - Front Facade

The majority of alterations and additions were built in the 1970's to facilitate the mix-use commercial aspect of the property. This includes the elimination and disturbance of the main street historic façade of the building (Refer to Figure 7) and a non-historic large addition at the rear (Refer to Figure 12).

For a street-side observer, the mix of historic and new materials on later additions to the structure makes it hard to discern which parts of the building are truly historic (Refer to Figure 7). The Standards also provide the following guidance, "New additions and adjacent or related new construction shall be undertaken in such a manner that if removed in the future, the essential form and integrity of the historic property and its environment would be unimpaired." The addition (rear) to the building has compromised the original structure and removal of significant architectural elements from the main north elevation, which includes altered and removal of historic fenestration, exterior stone, removal of storefronts, double hung windows, first floor transom windows, decorative gable end, quoining, and roofing materials (Refer to Figure 7 and Figure 8).

1. Refer to Historic Image (Figure 8)
2. Refer to Non-Historic Facade (Figure 7)
3. Refer to Non-Historic Addition (Figure 12)

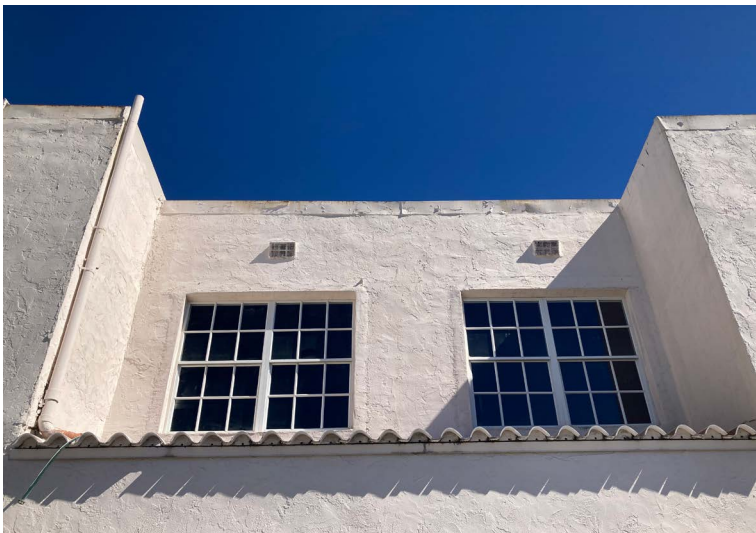
Figure 12: Existing Non-Historic Addition, south west elevation

The non-historic addition (rear) uses historic materials that have been salvaged or re-purposed from other buildings. The mix of historic and non-historic materials does not allow the additions to be distinguished as non-historic (Refer to Figure 12). Following the Standards, "To preserve a property's historic character, a new addition must be visually distinguishable from the historic building."
