# Tesla Megapack 2 XL

Fire Protection Engineering and  
UL 9540A Interpretation Report

# EXECUTIVE SUMMARY

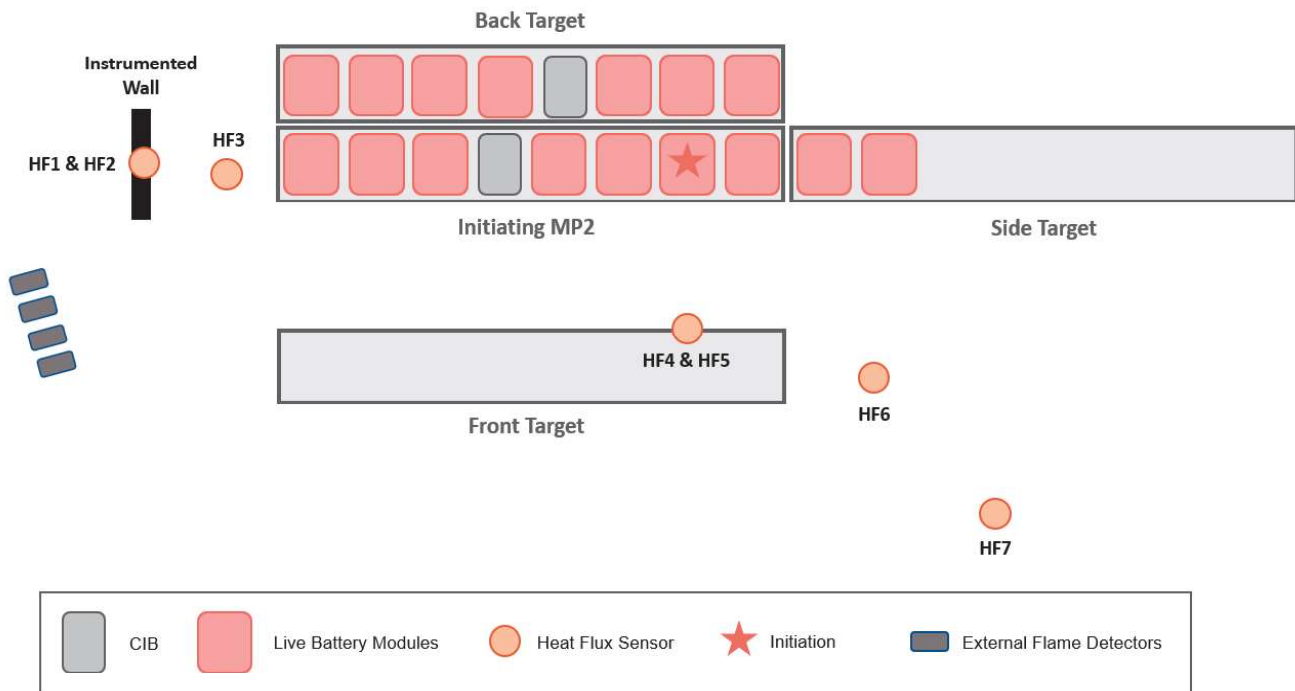
Figure 9 Instrumentation and target MP2 cabinet setup (top view).

Outside the initiating battery module and MP2 cabinet, three additional target MP2 cabinets were installed: (1) 6 inches (in) or 150 mm behind the initiating MP2; (2) 6 in (150 mm) to the side of the initiating MP2; and (3) 8 ft (2.44 m) in front the initiating MP2, as shown in Figure 9. The two target MP2 cabinets behind and to the side were populated with 100% SOC battery modules to simulate a multiple MP2 cabinet installation and to determine if thermal runaway and/or fire will propagate from one MP2 cabinet to adjacent cabinets at separation distances of 6 in (150 mm). Additionally, a combustible, instrumented wall (wood framing with plywood facing, painted black) was installed 5 ft (1.52 m) to the side of the initiating MP2 to demonstrate if fire could spread to a combustible surface (plywood wall) during the test.

Thermocouples were installed in the initiating battery module on the external surface of the initiating cells, inside the initiating MP2 cabinet, inside the target MP2 cabinets, on the instrumented wall, and on the exterior surfaces of all the MP2 target cabinets. Heat flux sensors were installed at distances of 3, 5, 8, 20, and 30 ft (0.91, 1.52, 2.44, 6.10, and 9.14 m) from the initiating MP2, as shown in Figure 9. Two external flame detectors and two thermal imagers were installed facing the initiating MP2 to demonstrate their functionality should flames exit the initiating MP2 during the test.

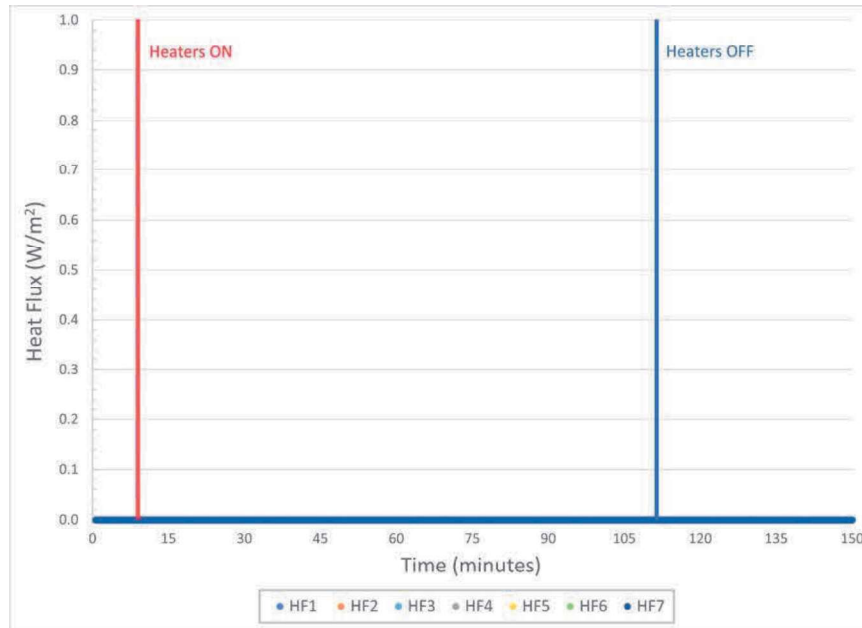
Figure 16 Heat flux measurements recorded during UL 9540A unit level fire testing.

Location	Maximum Heat Flux Recorded (W/m <sup>2</sup> )
HF1	0.0000013
HF2	0.0000013
HF3	0.0000014
HF4	0.0000016
HF5	0.0000014
HF6	0.0000016
HF7	0.0000013

The maximum heat flux recorded was 0.0000016 W/m<sup>2</sup>, which was recorded at both the front target and at a distance of 20 ft from the initiating MP2. Note, these heat flux values, in W/m<sup>2</sup>, are essentially reading no heat flux values at all, as would be expected given no flaming was observed outside the MP2 cabinet nor was the cabinet itself warmed enough to impose a heat flux on the sensors. These heat flux measurements indicate an exposure surface 3-5 ft (0.91-1.52 m) to the side, an adjacent MP2 cabinet 8 ft (2.44 m) in front, and other
