Notice of Exemption**Appendix E**

Project Title: 330 Distel Circle Residential Project

Project Applicant: EAH Housing

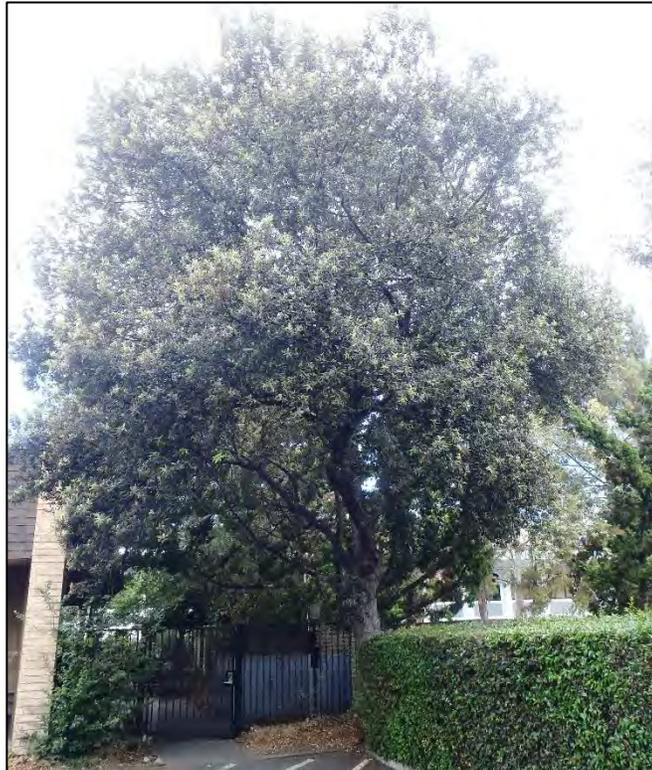
Nine (9) holly oaks made up the backbone of the landscaping, with #431-435 on the north side of the building and #440, 441, 445 and 450 (off-site) on the south side of the building. The majority of these were young to semi-mature, with trunk diameters from 7" to 15". Holly oak #433 was mature at 20" in trunk diameter and the only holly oak in good condition (**Photo 1**). Most had not been provided sufficient space for full development and were crowded by adjacent trees, producing one-sided crowns and leaning trunks. Seven holly oaks were in fair condition, #435 was in poor and #433 was in good condition.

Photo 1: Looking north at holly oak #433. This was the only holly oak on the site that was mature (20" in diameter) and in good condition.

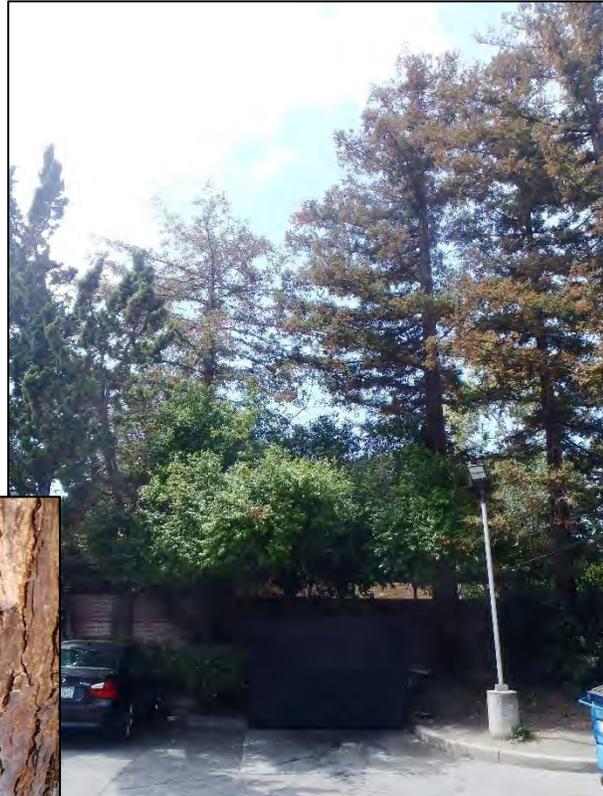
- Hollywood junipers #452 and 453. Both were in fair condition but leaned.
- Coast redwoods #454 and 456 were mature and in fair condition. Both had sparse canopies.
- Xylosma #455 was in fair condition, with a low canopy that extended W. over the fence.

Photo 2: Looking southwest at trees #452-456 (L to R). The row of off-site trees were in fair condition but had been planted close to the wall separating the two properties. Inset below shows the base of coast redwood #454, which was growing against the wall.

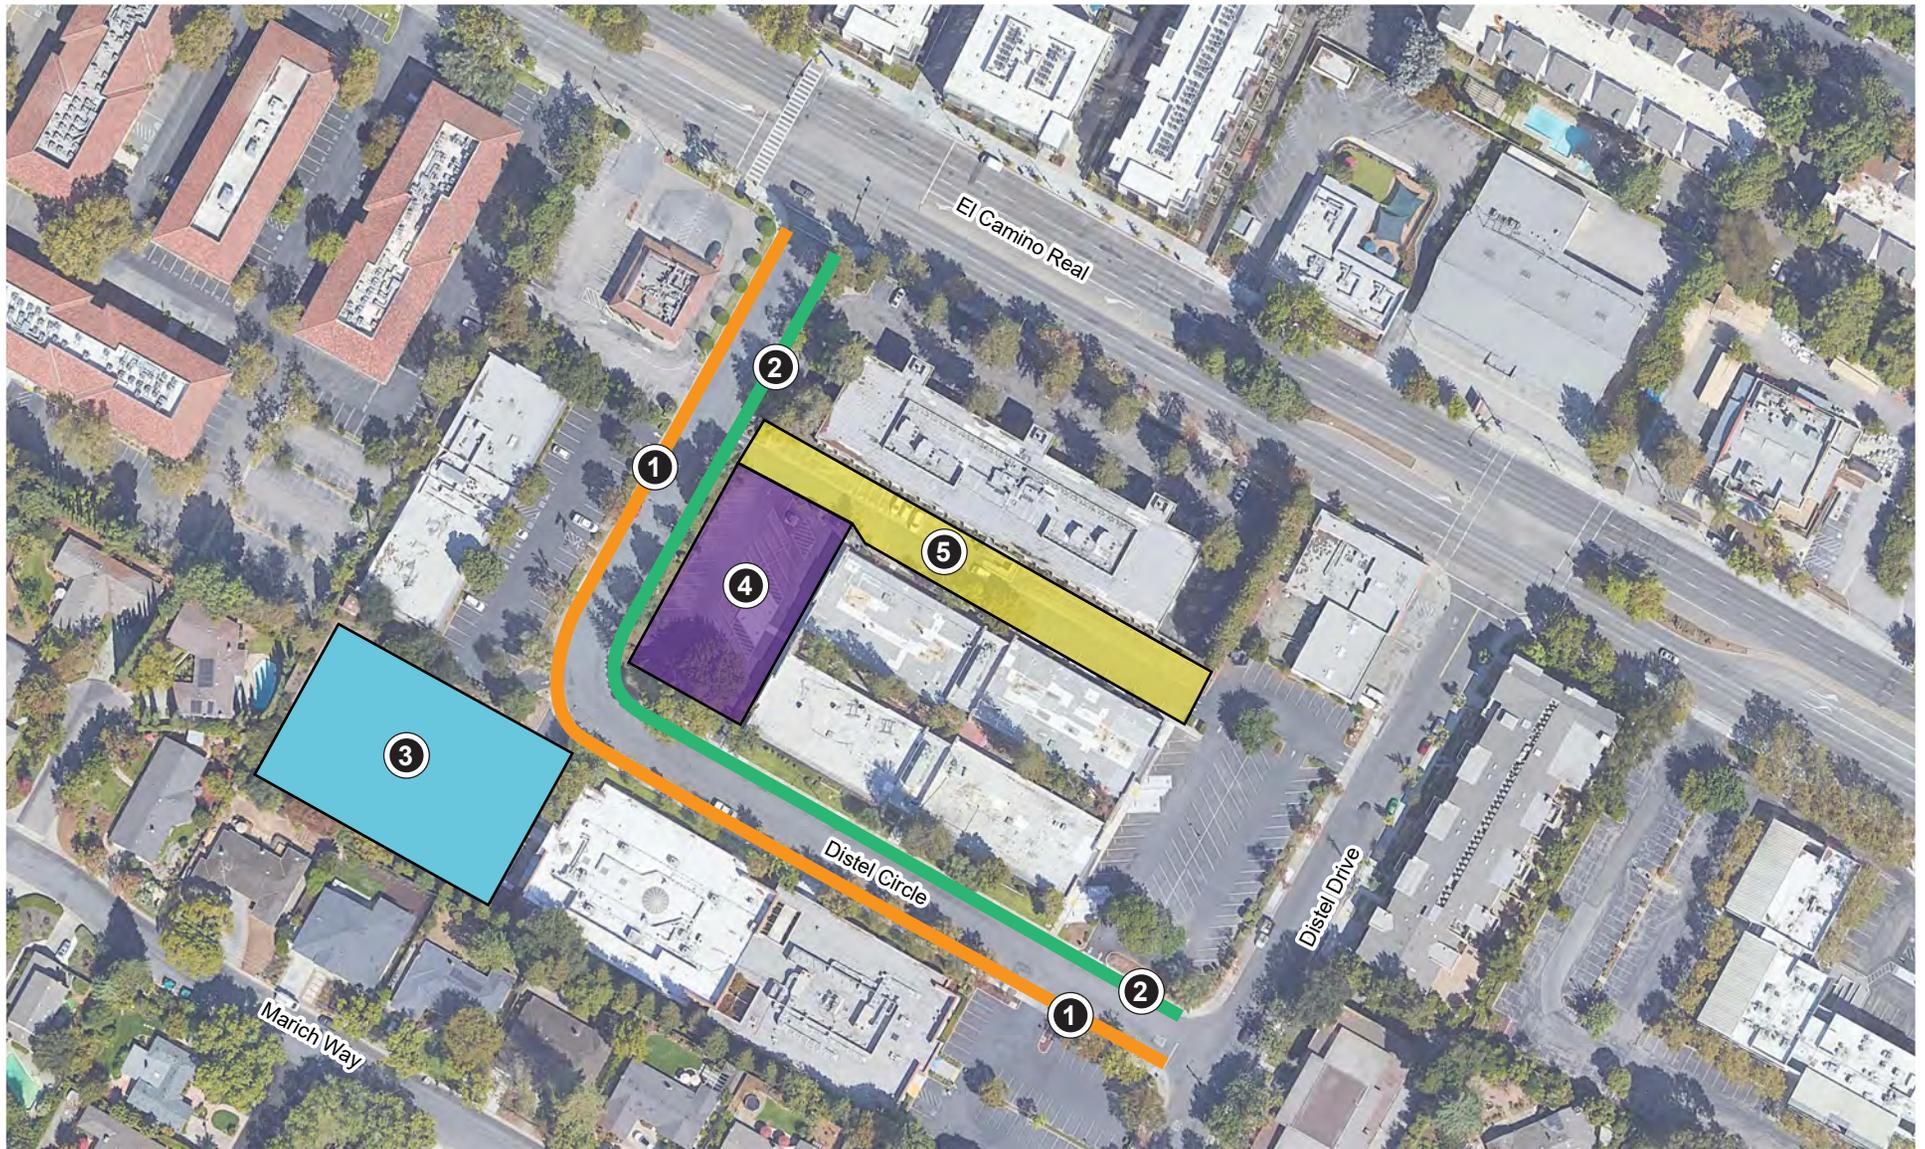
Figure 15
Parking Occupancy Count Locations

Recommendation: The project should add at least 6 Class II bicycle spaces.
