TOWN OF LOS GATOS
HISTORIC PRESERVATION COMMITTEE
REPORT

DATE: April 17, 2026
TO: Historic Preservation Committee
FROM: Joel Paulson, Community Development Director
SUBJECT: Consider a Request for Approval to Remove a Pre-1941 Property from the Historic Resources Inventory for Property Zoned R-1:10. **Located at 142 Wheeler Avenue.** APN 532-37-034. Request for Review PHST-26-011. Exempt Pursuant to CEQA Guidelines, Section 15061 (b)(3). Property Owner/Applicant: Rodd and Wendy Rowalt. Project Planner: Erin Walters.

SUBJECT: 142 Wheeler Avenue/ PHST-26-011

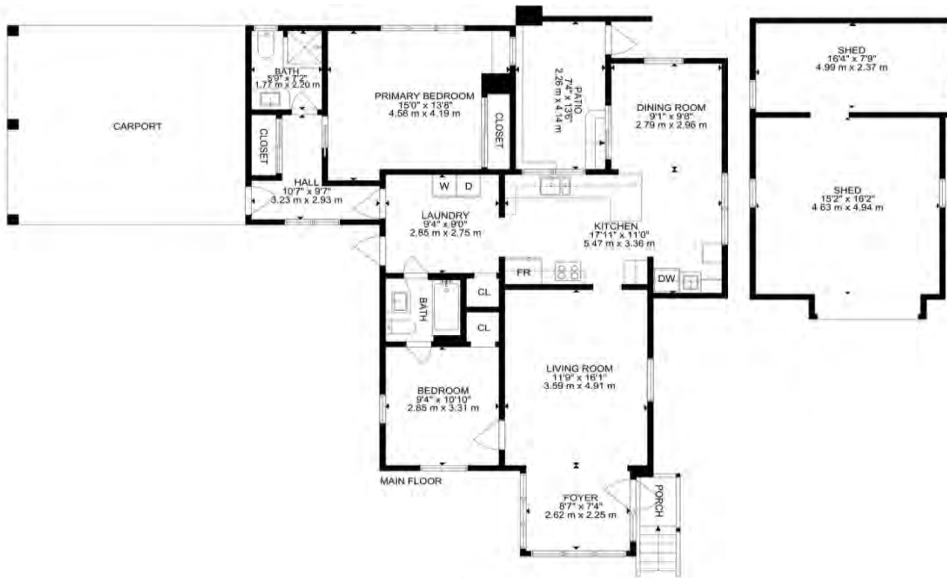
CROSS INTERNAL AREA
 MAIN FLOOR: 1042 SQ FT, 97 m²; EXCLUDED AREA: PATIO, 96 SQ FT, 9 m²; SHED: 396 SQ FT, 37 m²
 TOTAL: 1042 SQ FT, 97 m²
 (SIZE AND DIMENSIONS ARE APPROXIMATE, ACTUAL MAY VARY)

A direct comparison of the 1928 and 1944 Sanborn Fire Insurance Maps against the current floor plan reveals the property has been nearly doubled in size through a series of additions, the majority of which appear to be unpermitted and undocumented:

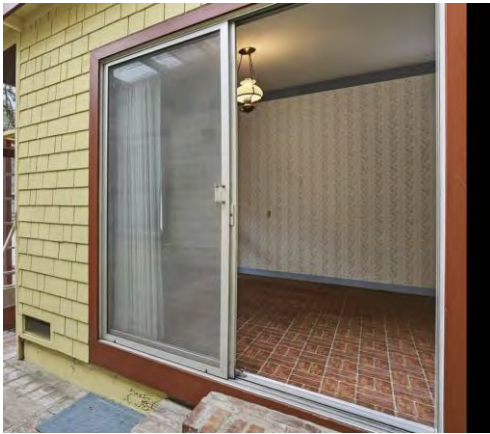
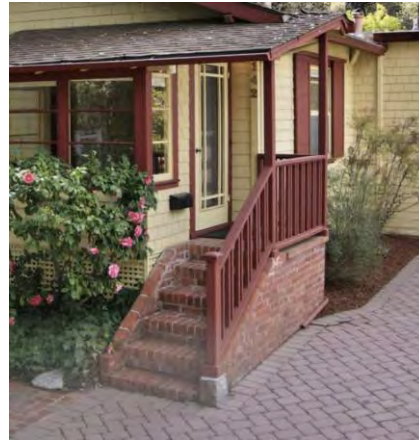
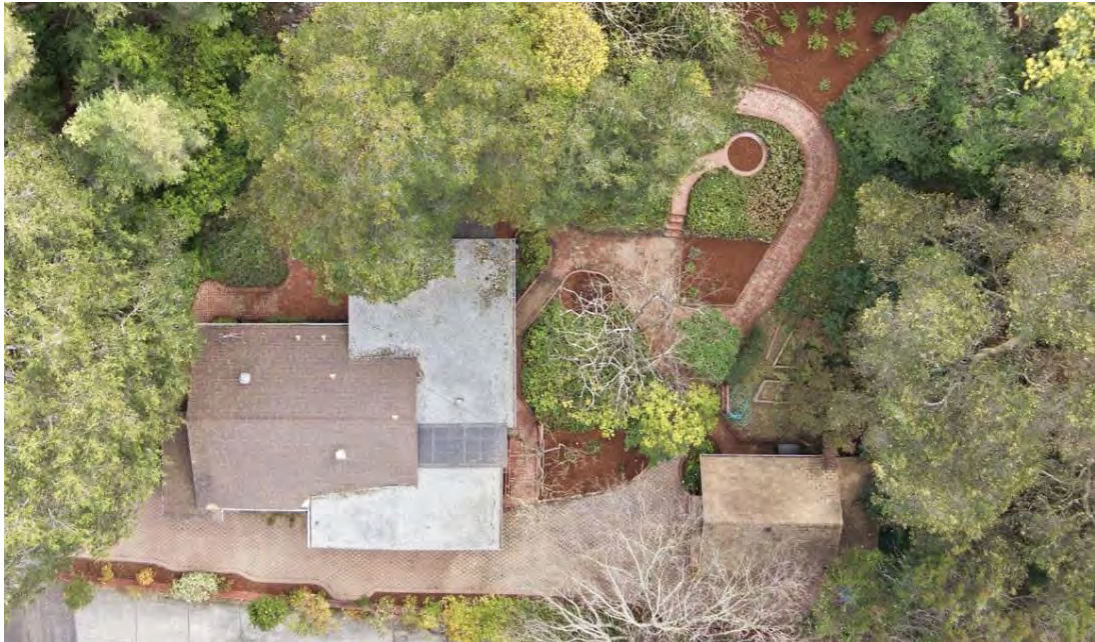
- Unpermitted dining room addition with modern sliding glass doors, not present in 1928 or 1944 Sanborn maps; inconsistent with the original Bungalow style
- Roof replacement or modification departs from the original roofline documented in historic records
- New porch
- Unpermitted bathroom addition added without Town permits or documentation, altering the original floor plan
- Expanded kitchen, laundry room not reflected in the original property footprint
