**Research Report**  
Agreement T1461, Task 78  
WSDOT Expansion Joint Ph 2

# **DESIGN AND TESTING OF MODULAR EXPANSION JOINT NOISE MITIGATION STRATEGIES**

University of Washington  
Department of Mechanical Engineering

December 2022

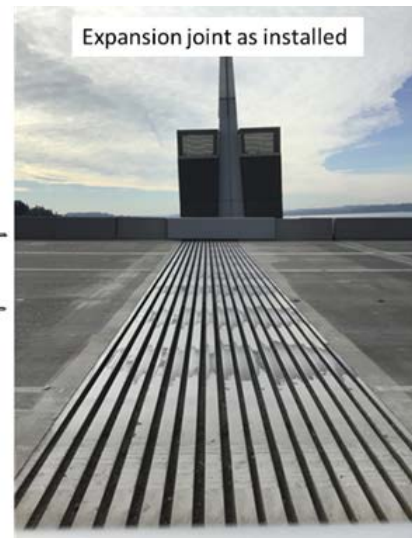
<b>Figure 1-1.</b> Expansion joint as designed (left) and installed (right). The I-beams run across the lanes to provide a continuous medium of traffic with the two sides of the bridge. ....	2
<b>Figure 1-2.</b> A) Computer aided design (CAD) model for the vehicle tire and I-beam design for simulation. B) A sharp pressure spike occurs as the tire rolls over the leading edge of the second I-beam. C) Visualization of peak pressure on the I-beam surface. ....	4
<b>Figure 1-3.</b> Overview of car-pass events using simultaneous noise and video recordings. Screenshots from high-speed video are assigned to specific parts of the noise recording using letters (A)-(I). ....	5
<b>Figure 2-1.</b> A) Single-layer elastomer chevron design with original moisture seal, installed between MEJ I-beams. B) Multi-layer design with an elastomer top layer and custom moisture seal. ....	7
<b>Figure 2-2.</b> A) Plot of maximum internal stress as the support structure fully compresses. B) Detailed visualization of stress over the surface of each chevron element throughout ....	9

To reduce the noise coming from the SR 520 bridge, we must consider the general design of the existing modular expansion joint (MEJ). The expansion joint consists of a closing box connected to a concrete block (one side of the bridge) and an opening box connected to the other side (Figure 1-1). A central beam runs between the boxes, leaving room toward the end of one box for expansion and contraction<sup>13</sup>. Supported on the central beam are the I-beams that protrude out of the sub-structures of the expansion joint, forming a travel surface with the rest of the bridge.

The main material used in the expansion joint is steel, with various hardening and grades in some critical regions, for example the shear studs that connect to the concrete. A gap exists between any two I-beams (including the edge beam and the first I-beam from each side). This gap changes width with the opening and closing of the expansion joint. A seal made of a flexible material (Neoprene) is mounted between each beam (below the surface of travel) to collect debris, dirt, water and/or any parts/particles that can potentially cause damage to the substructure of the expansion joint, as well as to keep untreated water and debris from entering Lake Washington. A large, enclosed cavity exists underneath the expansion joint on the east side to provide noise reduction and easy access to the expansion joints for servicing and replacing parts.

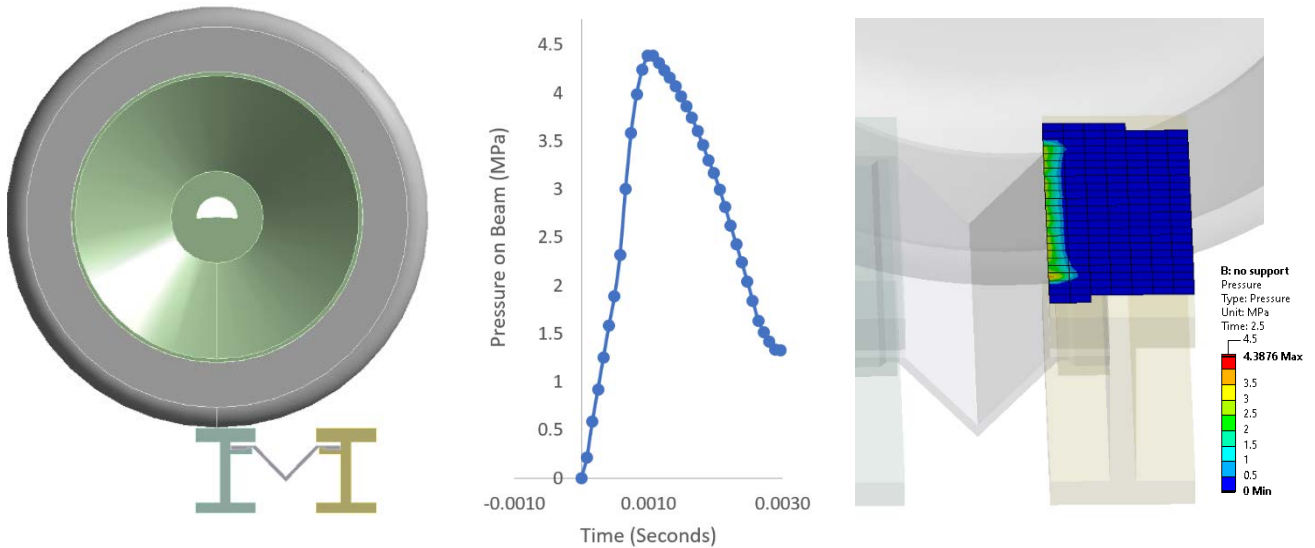
**Figure 1-2.** A) Computer aided design (CAD) model for the vehicle tire and I-beam design for simulation. B) A sharp pressure spike occurs as the tire rolls over the leading edge of the second I-beam. C) Visualization of peak pressure on the I-beam surface.

We simulated the deformation of the tire and the excitation pressure on the MEJ I-beams (Figure 1-2) with the help of a finite element model (see details in section 3. Methodology) of the tire and section of the expansion joint. As a tire rolls across the joint, it drops into the gap between the MEJ I-beams. As it meets the leading edge of the next I-beam, the tire accelerates upward, creating a pressure spike and exciting the structure and tire (Figure 1-2). By adding a structure that resists vertical deformation in the gap, we can support the tire as it rolls overhead, reducing the distance that the tire drops and subsequently reducing the pressure spike between the tire and the I-beam.

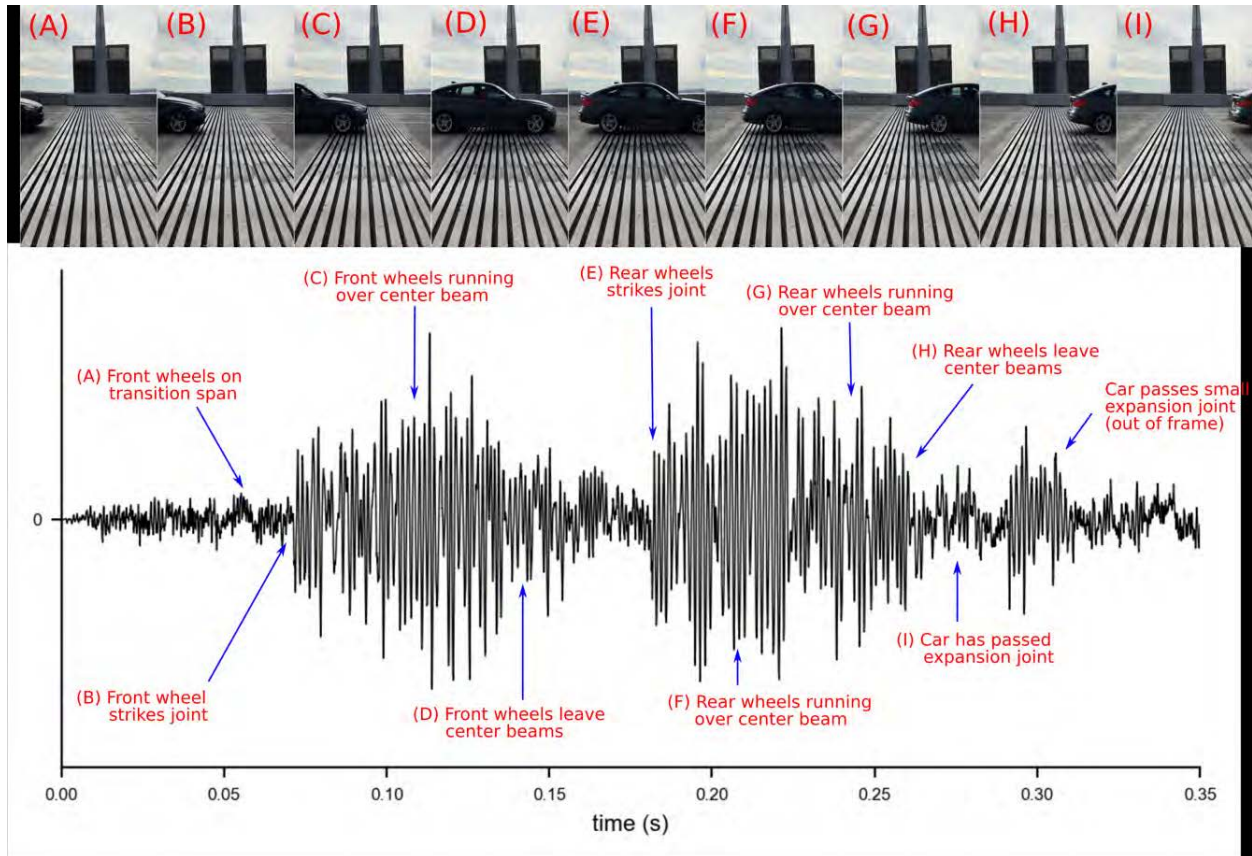
**Figure 1-3.** Overview of car-pass events using simultaneous noise and video recordings. Screenshots from high-speed video are assigned to specific parts of the noise recording using letters (A)-(I).

As a vehicle rolls over the expansion joint on the east side of the bridge, we observed in our measured noise data two distinct peaks in noise as each pair of tires (front and rear) strikes the beams of the MEJ. A third, smaller peak in noise occurs as the vehicle passes over a smaller joint slightly past the main joint. For testing, we considered a single event to be the time between the

front tires striking the first I-beam in the joint (Figure 1-3.B) and the vehicle completely passing the expansion joint (Figure 1-3.I). To evaluate smooth road noise, we sampled the audio directly before the vehicle rolled onto the expansion joint (before Figure 1-3.A)

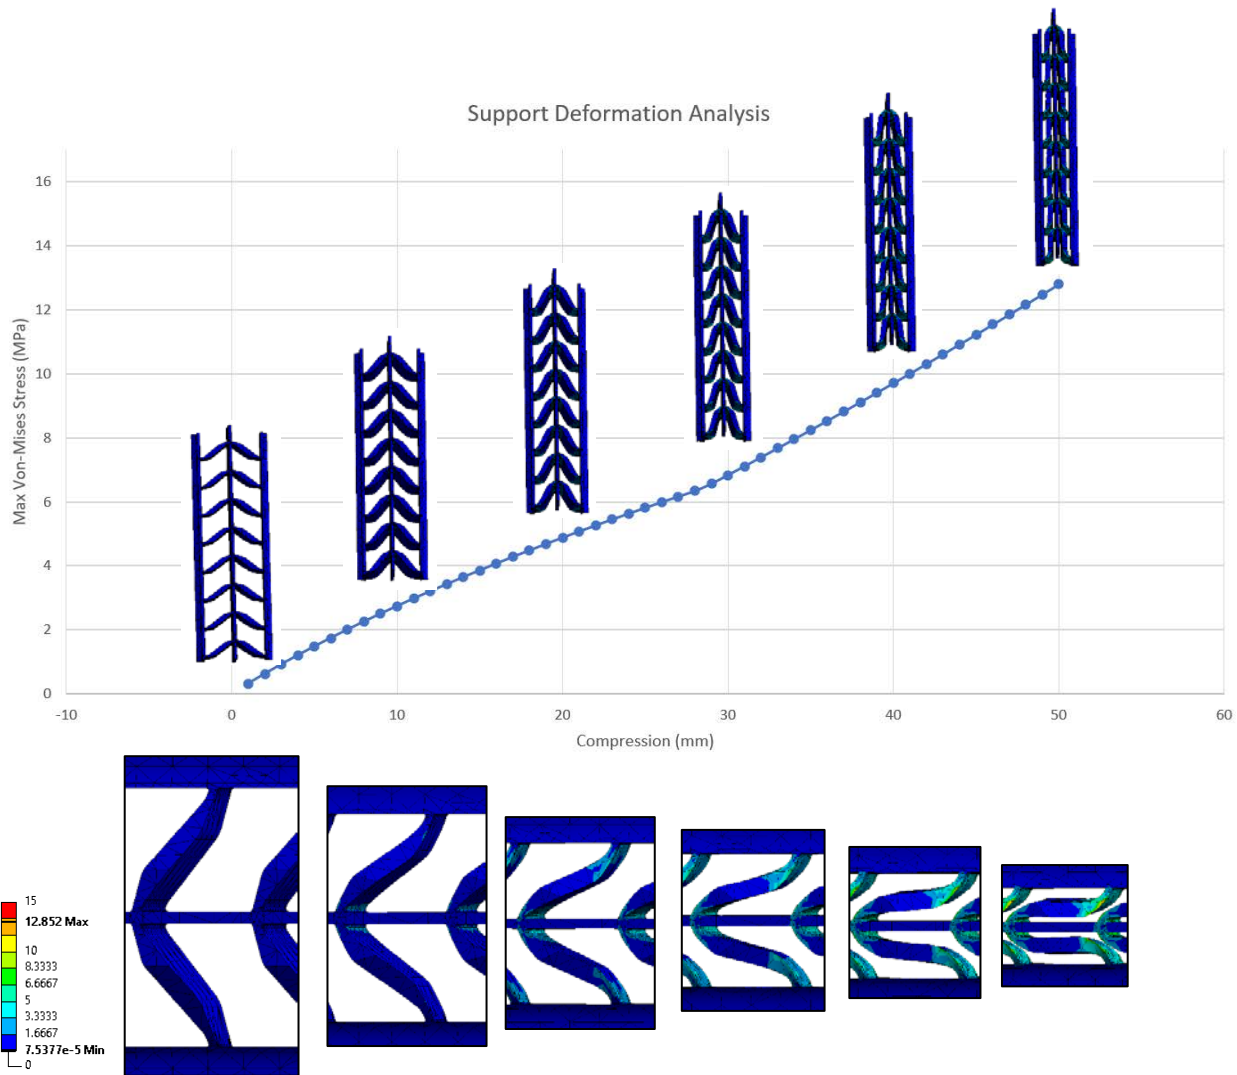
**Figure 2-2.** A) Plot of maximum internal stress as the support structure fully compresses. B) Detailed visualization of stress over the surface of each chevron element throughout

To select the support shape, we created a chevron with the thickest beam and flexure width possible while still adhering to space limitations. To optimize material, we tapered the edge of each beam to neatly mesh with surrounding components during compression. This design relies on glued connections at each beam edge and small geometric interference between the moisture seal and the chevrons. For initial prototyping and testing, we fabricated these joints out of a variety of high durometer elastomers with shore hardness values between 85A-95A. For initial models, we 3D printed structures from Ninjatek–Cheetah thermoplastic polyurethane (TPU). These prototypes exhibited desirable traits, but fused deposition modelling (FDM) 3D printing could not be scaled to fabricate enough durable samples for our test on the SR 520 bridge. To create a larger number of high-quality durable parts, we instead switched from 3D printing to urethane casting. This process creates high quality parts with many high durability and commercial-grade options. We selected 90A durometer urethane from BJB Enterprises called FP90 A/B. With this material, our finite element models showed enough strength to tolerate complete compression of the structure within the MEJ's normal working limits (Figure 2-2). To test the structure's behavior in extreme conditions when the joint fully closed (a gap of 0 in.), we compressed a Ninjaflex chevron support using an Instron universal testing system with a force of 180 KN. This caused the support to squeeze to a final width of 0.164 in. and expand outward toward the edges of the test plates.

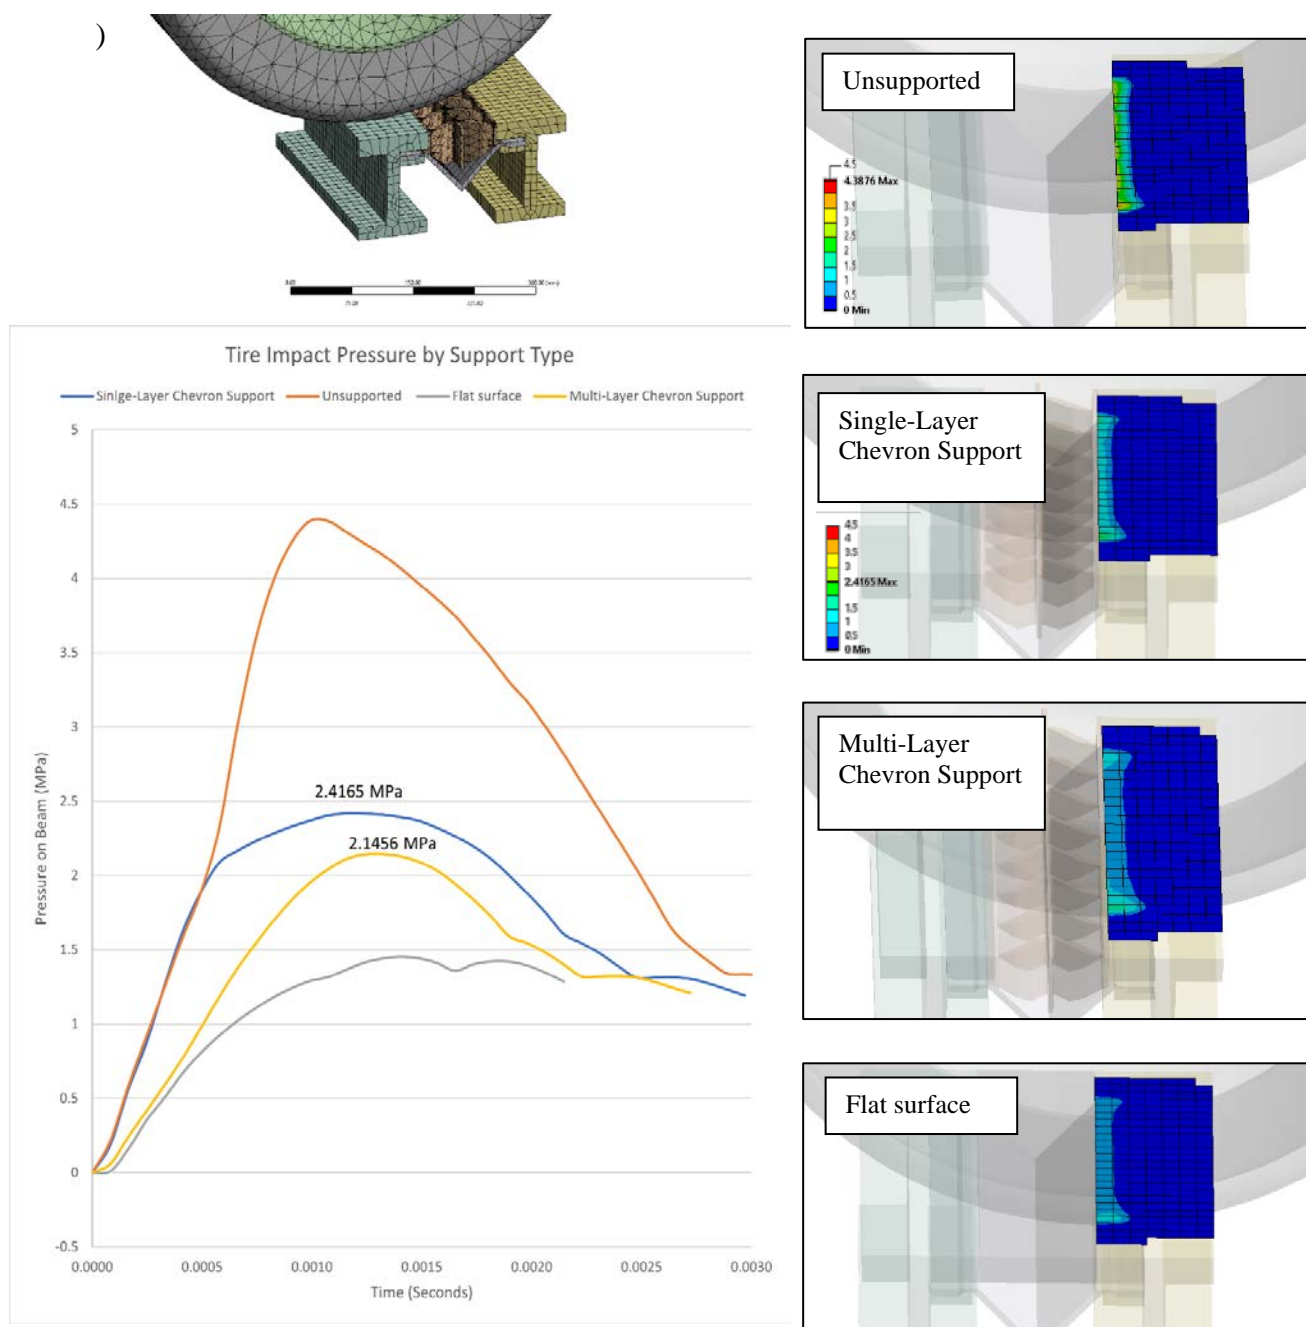
**Figure 2-6.** A) Mesh for the FEA of the rolling tire. B) Pressure curves as the tire strikes the leading edge of the second beam. C) Visualizations of the pressure on the edge of the beam for each treatment option.

While both designs have potential to significantly reduce noise created by the Washington SR 520 modular expansion joints, we weighed practical considerations for implementing each support structure. We used finite element models to compare the influence of each on the resulting pressure spike caused by the tire on the beam edge. For the completely unsupported gap, the tire creates a sharp increase in pressure, with a peak of 4.39 MPa. For a perfectly flat road, the pressure of the tire rolling over the flat surface still creates a pressure spike but a much lower one, topping out at 1.45 MPa. If we consider the unsupported version to be the worst-case scenario, and the supported to be the best case, we can look at the percentage pressure reduction for each of the options.

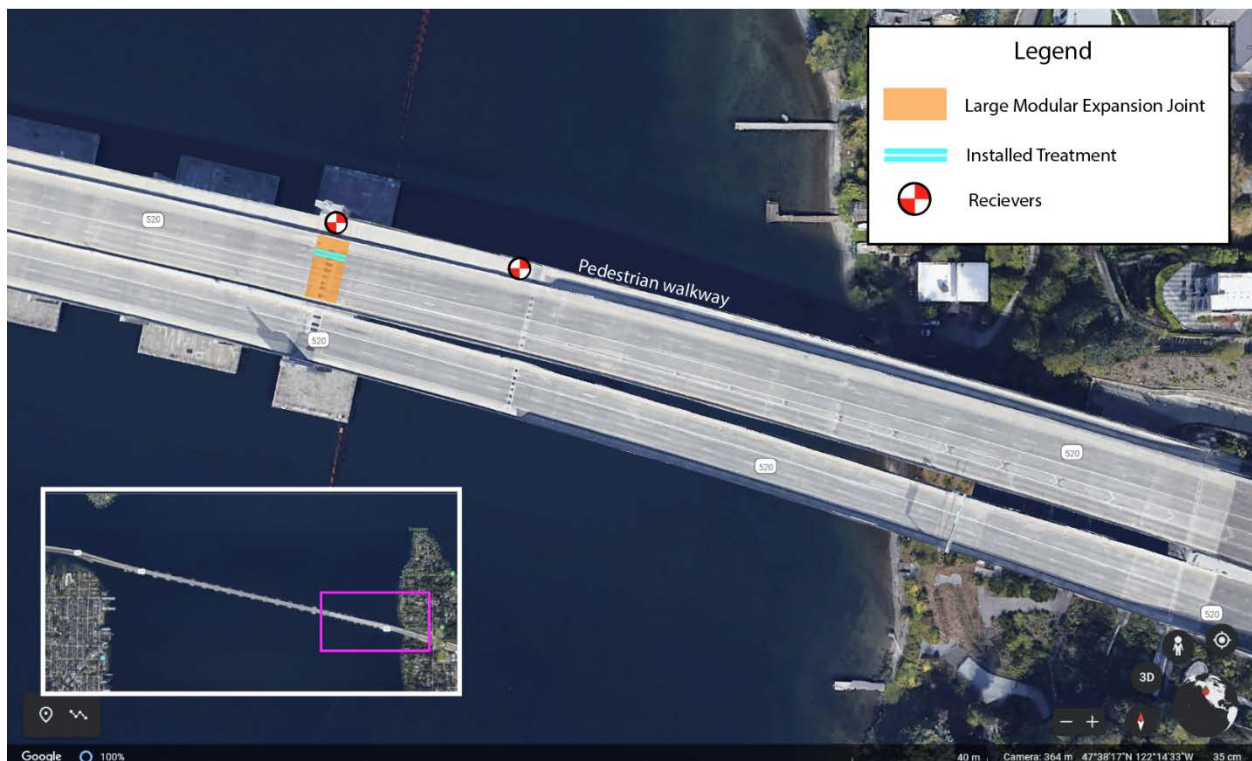
**Figure 4-5.** Map showing expansion joint and sound measurement locations.

the MEJ was a lower frequency and quieter than the unsupported section (SM Video). At a distance of 160 feet in front of the joint, the noise from the supported lane became very difficult to discern from that of general roadway traffic (SM Video). We measured the overall ESD for both the control and the initial results for the support; additionally, we subtracted the background noise of roadway traffic directly before each event to show the contrast of the impact noise from the general noise of the bridge (figures 4-5, 4-6).

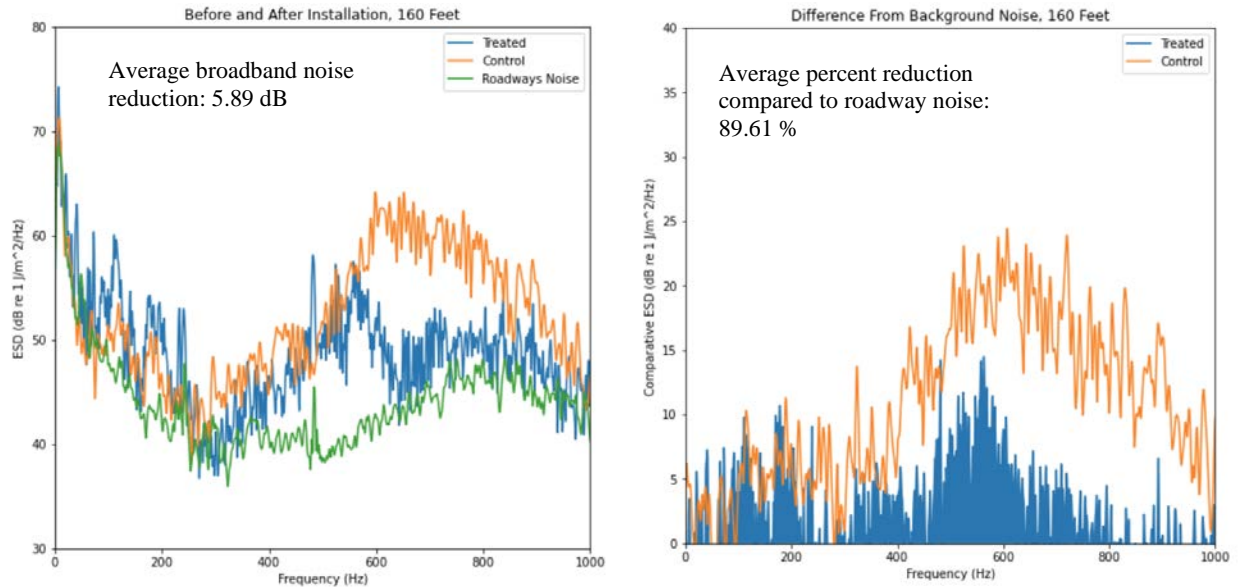
**Figure 4-6.** Comparison between control and initial results at a distance of 160 feet.

As shown in figures 4-6 and 4-7, a significant spike in energy occurred between 500 Hz and 900 Hz for the control testing. These results mirror those presented by the findings in the UW's phase 1 *Modular Expansion Joint Noise Mitigation Study*<sup>14</sup>. As humans, we perceive this frequency range to be relatively loud in comparison to lower frequency signals, and shifting or diminishing this peak has been a primary objective for an effective solution. Both directly beside the MEJ and 160 feet in front of the MEJ, we saw significant reductions in broadband RMS, especially in the problem frequency region of 500 to 900 Hz. In the full spectrum 0- to 15000-Hz frequency range, we saw the most significant differences occur in the 0- to 1000-Hz frequency

range. Matching our qualitative observations, the sound recorded directly beside the MEJ changed less significantly with the installation of the supports than the sound recorded 160 feet in front of the MEJ. Comparing event recordings to background noise, we saw a 56.0 percent reduction in broadband RMS directly beside the MEJ and an 89.61 percent reduction in broadband RMS at 160

feet in front of the MEJ. It should be noted that the peak at the 500 to 900 Hz interval was reduced by approximately 10 dB. At a distance farther than 160 feet the effective noise attenuation made it difficult to distinguish between general roadway noise and the noise from the supported expansion joint. As a result, accurate post processing became very difficult, and we could not clearly select events since the other lanes with untreated expansion joints were also open to traffic.

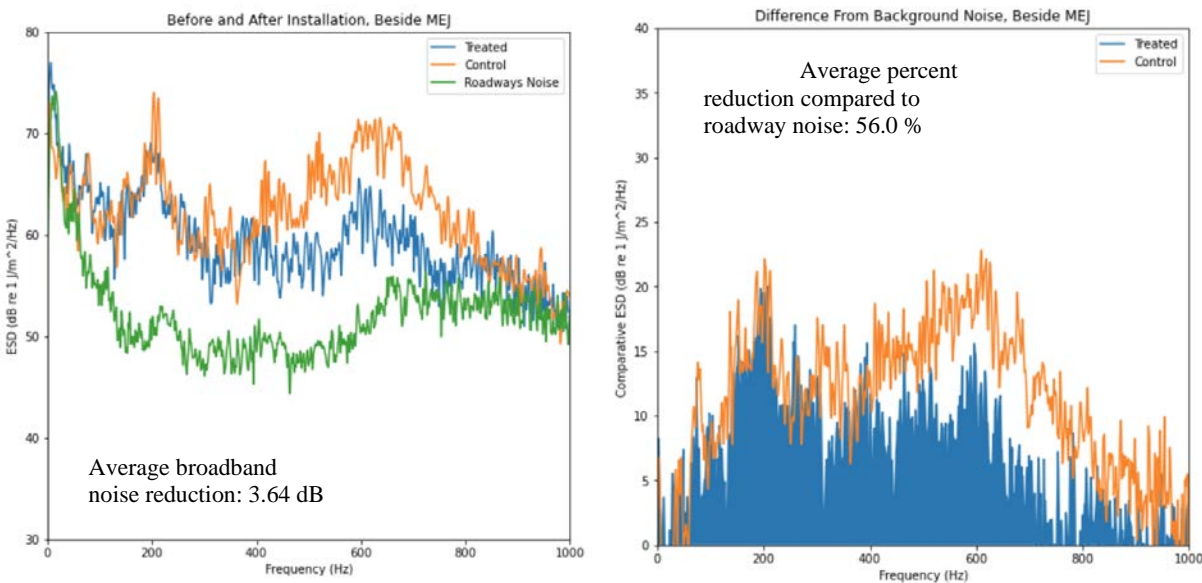
**Figure 4-7.** Comparison between control and initial results directly beside the MEJ.

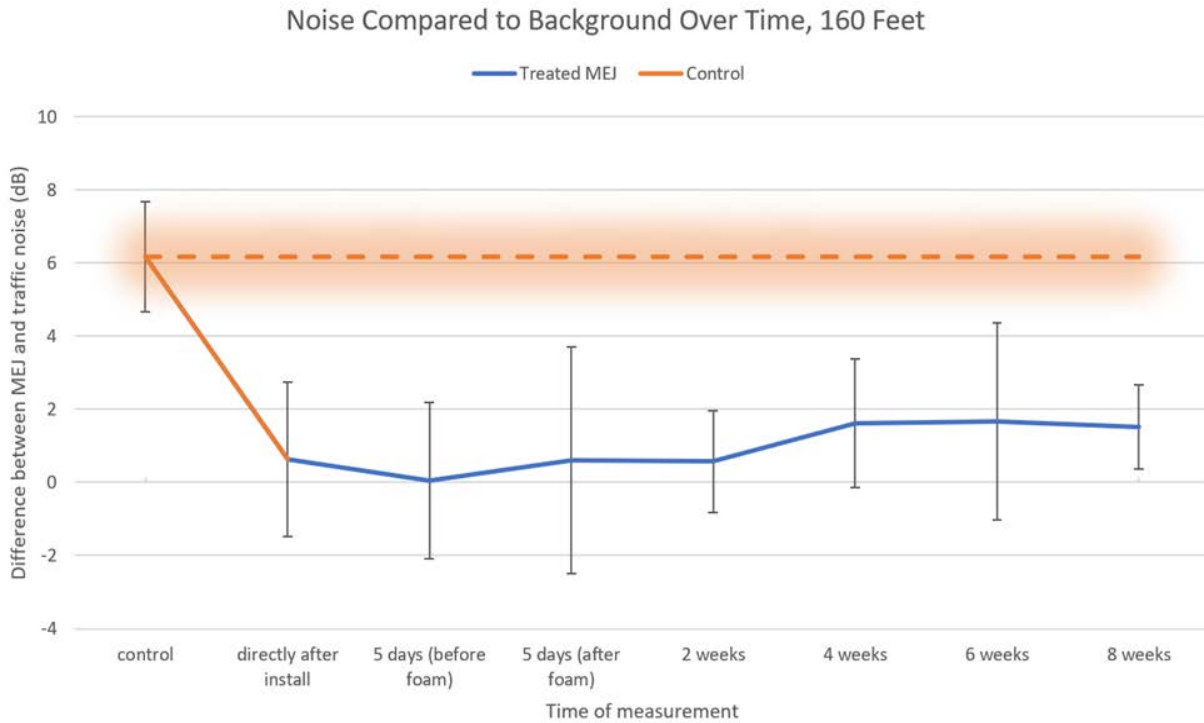
**Figure 4-8.** Comparison between roadway noise and MEJ noise over a two-month period at a distance of 160 feet. Error bars represent standard deviation of measurements.

Comparing the difference between the supported MEJ section and the control allowed us to observe general trends in the performance of the MEJ treatment over time. As shown in Figure 4-8, directly after installation at a distance of 160 feet, the difference between standard roadway noise and supported MEJ was less than 1 dB, which is generally considered imperceptible<sup>18</sup>. Throughout the entirety of testing, the difference in sound levels remained below 2 dB, which is considered to be barely perceptible<sup>18</sup>. At these levels, the surrounding neighborhood would experience no perceivable difference in noise between the bridge roadway and the expansion joint.

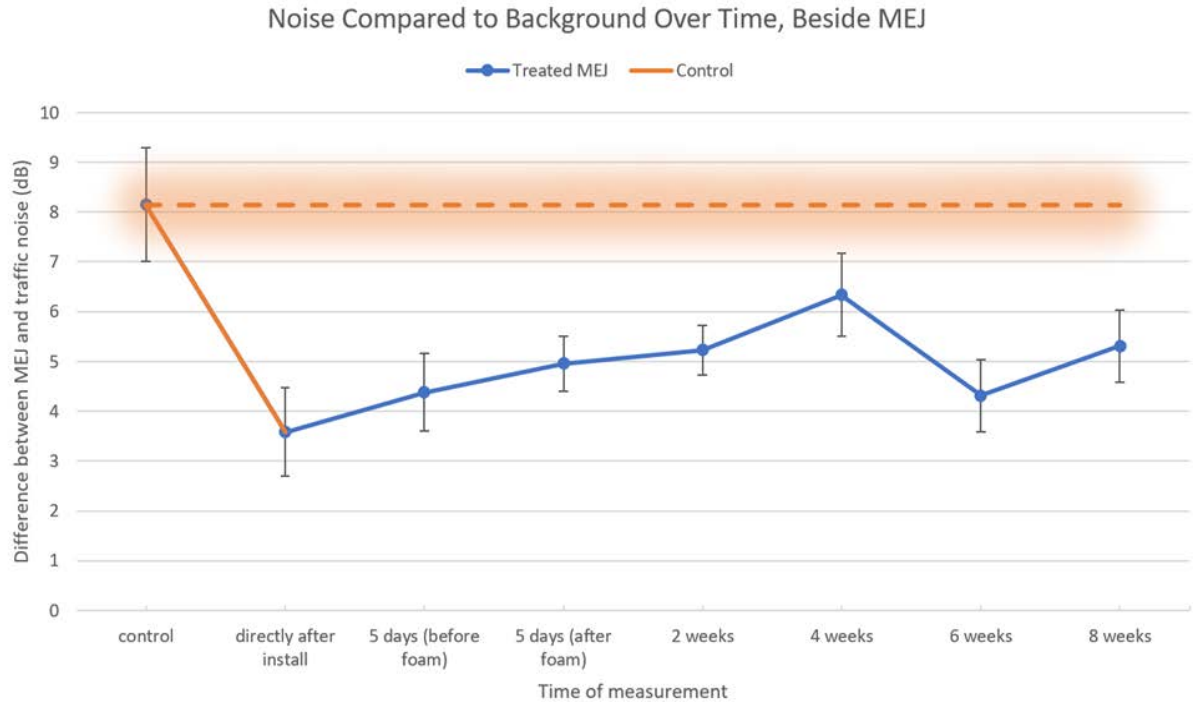
**Figure 4-9.** Comparison between roadway noise and MEJ noise over a two-month period directly beside the MEJ. Error bars represent standard deviation of measurements.

As shown in Figure 4-9, the noise directly beside the MEJ was significantly more noticeable but still greatly improved from the original configuration. With no support, the difference between MEJ and roadway noise was over 8 dB, which is fairly close to the 10-dB threshold that generally denotes double the perceived noise level<sup>18,19</sup>. Throughout the duration of the study, the noise of cars driving over the supported expansion joint increased but remained well below the noise of the original control testing.

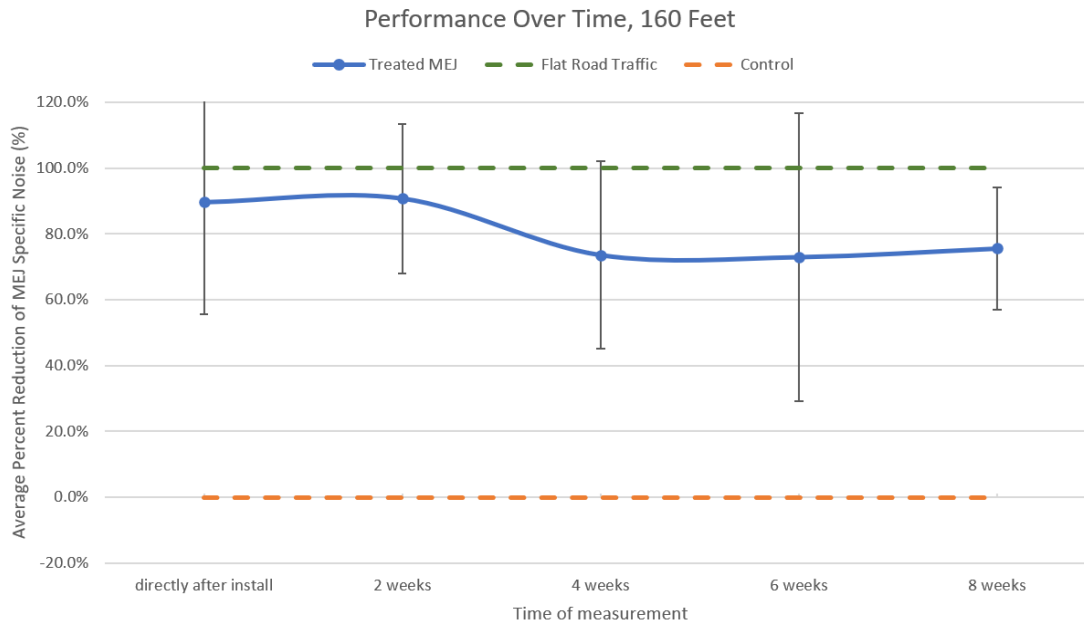
**Figure 4-10.** Comparison between untreated MEJ noise and the installed treatment over a two-month period at a distance of 160 feet.

Here  $RMS_c$  is the noise in dB of the control MEJ,  $RMS_{rc}$  is the noise of the road in front of the control MEJ,  $RMS_s$  is the noise of the supported MEJ, and  $RMS_{rs}$  is the noise of road in front of the supported MEJ. As seen in figures 4-8, 4-9, and 4-10, the MEJ treatment performed best during the first two weeks of implementation at both 160 feet and directly beside the MEJ. Between week 2 and 4 we observed a slight increase in MEJ impact noise. From week 4 to week 8, we measured some variation in treatment noise but observed no clear trend in the data. Throughout the two-month period, noise measurements remained lower than that of the sinus plate at both distances.

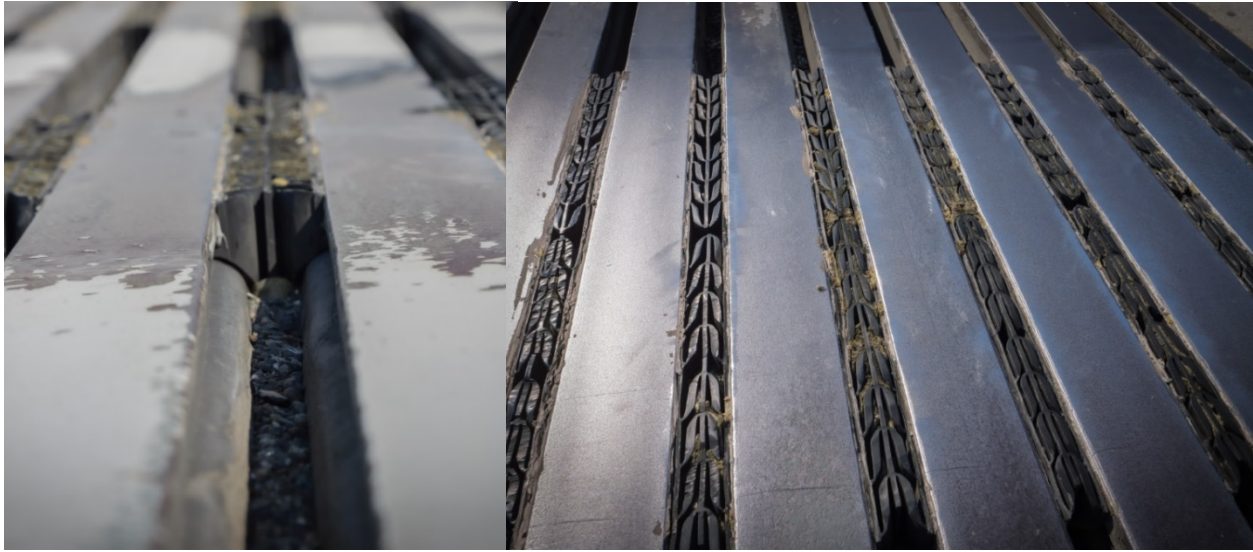
**Figure 4-11.** Over one month of installation, gravel and debris started to fill up the unsupported portion of the joint (left), while we observed no debris in the chevrons themselves. While the chevrons remained in good condition, some foam had been pulled from the supports after one month of wear (right).

Approximately four weeks after installation, we closely inspected the supports during a scheduled bridge closure. First, we observed the rubber supports to be in roughly the same condition as when we initially trimmed their height after installation. Supports that had been damaged within the first few days of installation remained in place, but some of the glued connections appeared to have failed, and the flexible joints appeared severely compromised. In contrast, the replacement supports that had been trimmed flat at the time of installation remained in exceptionally good condition. In many of the supports, the foam also experienced significant wear. This likely occurred because of a combination of imprecise application of the foam during installation and wear of the soft material. The previously damaged supports appeared to show a more pronounced loss of foam (Figure 4-11) than the intact replacement joints (Figure 4-3). We also noted deposition of large amounts of gravel inside the MEJ gaps since we had cleared out debris four weeks earlier (Figure 4-11). While this was clearly apparent in the spaces with no added treatment (Figure 4-11), the gaps within supports themselves had virtually no build-up of debris.
