# **Ecological No Net Loss Assessment Report**

**Jain Residence  
8315 Overlake Drive West  
Medina, WA 98039**

**January 2024**

Permits are being applied for a moorage cover.

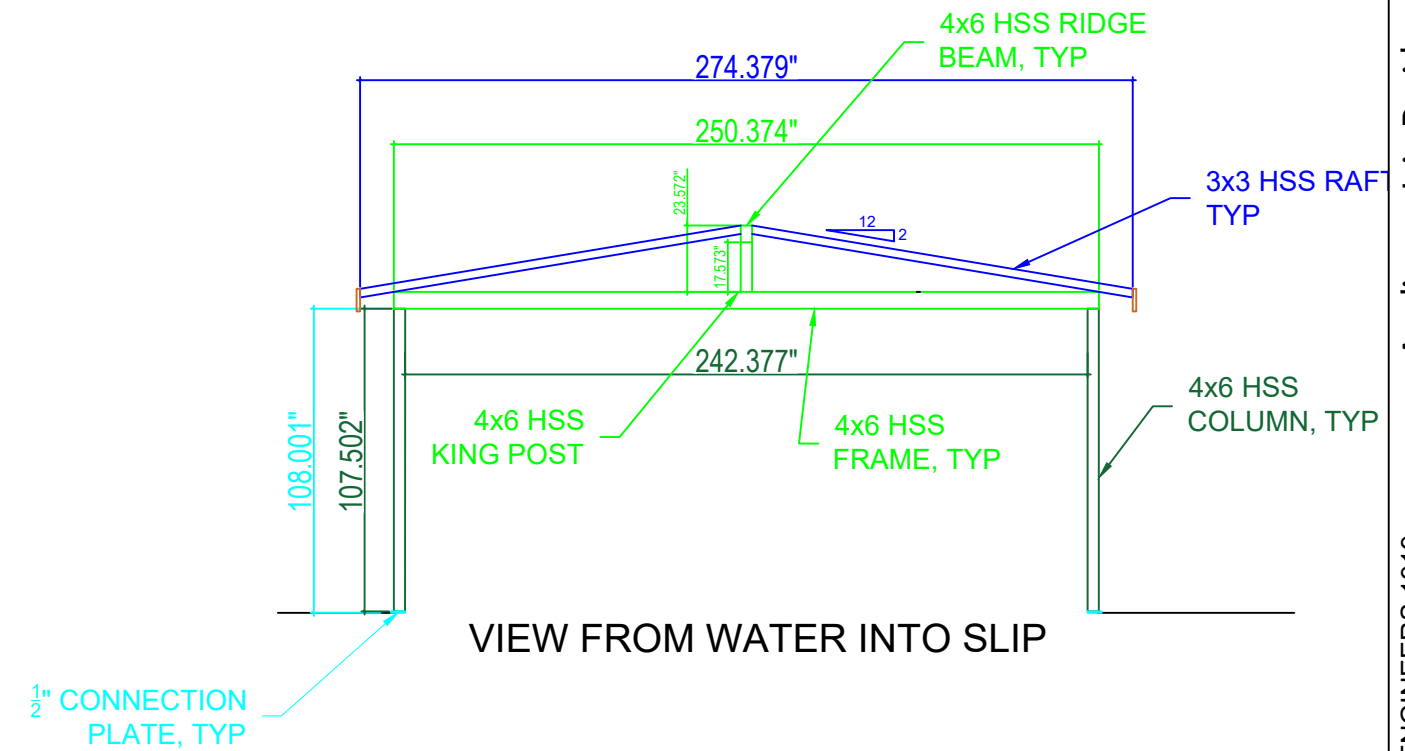
# FRAMING PLAN

VIEW FROM WATER INTO SLIP

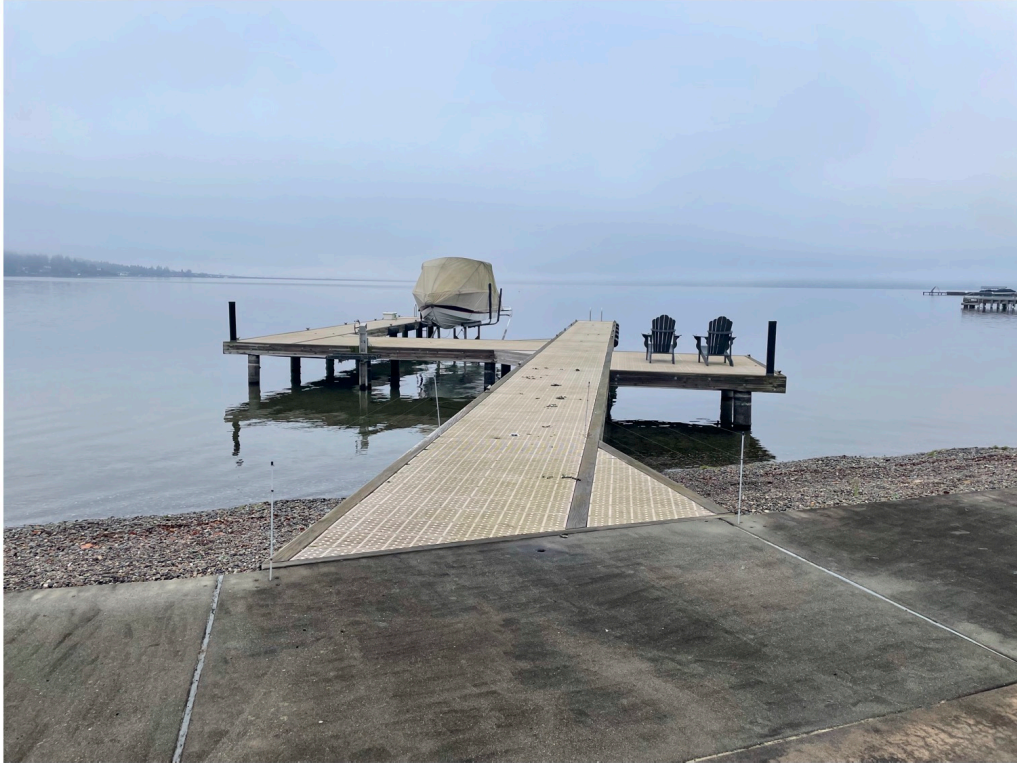
Photo 1 - Existing dock looking waterward.

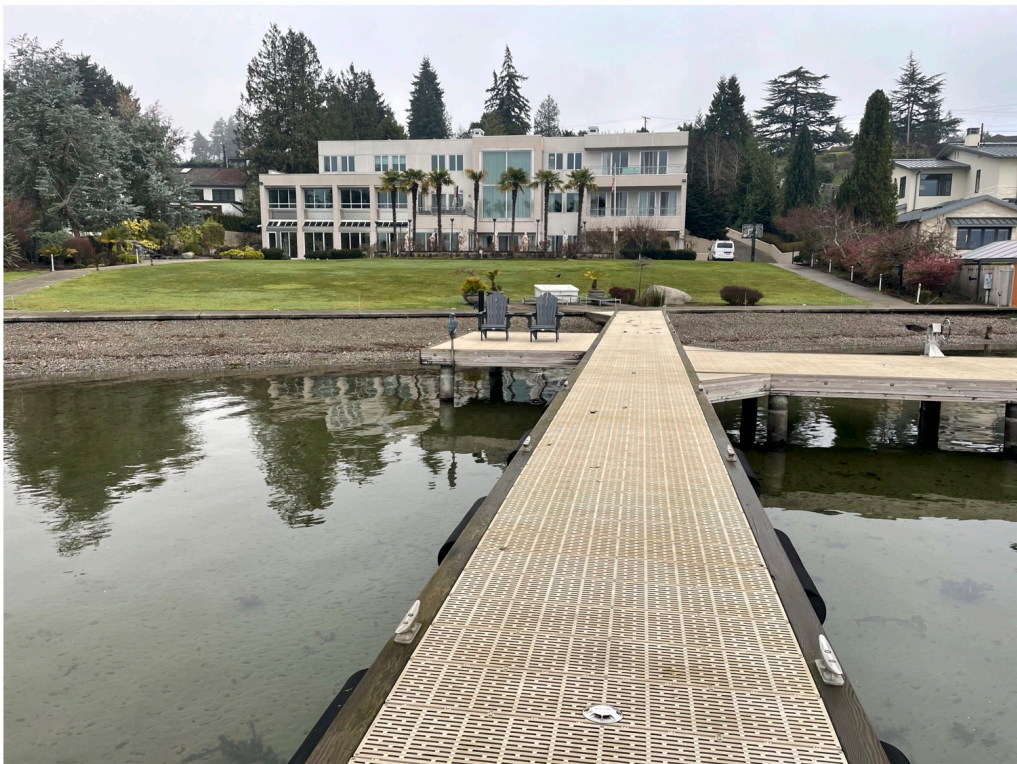
Photo 2 - Existing dock looking landward.

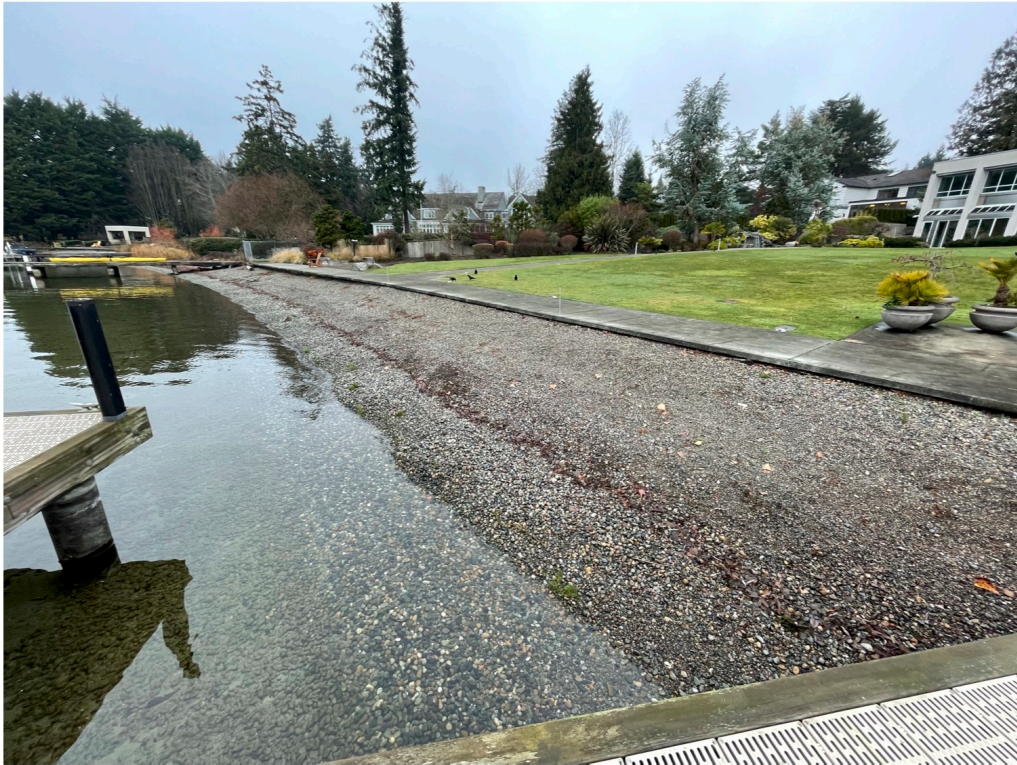
Photo 3 - Existing shoreline conditions looking north.

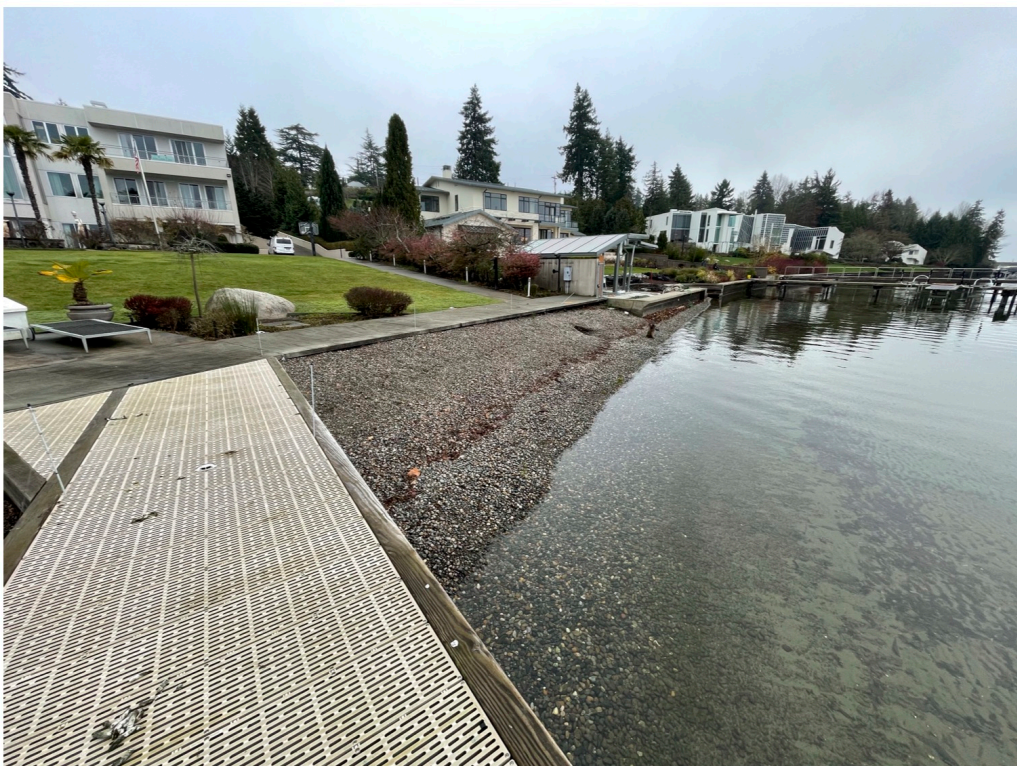
Photo 4 - Existing shoreline conditions looking south.

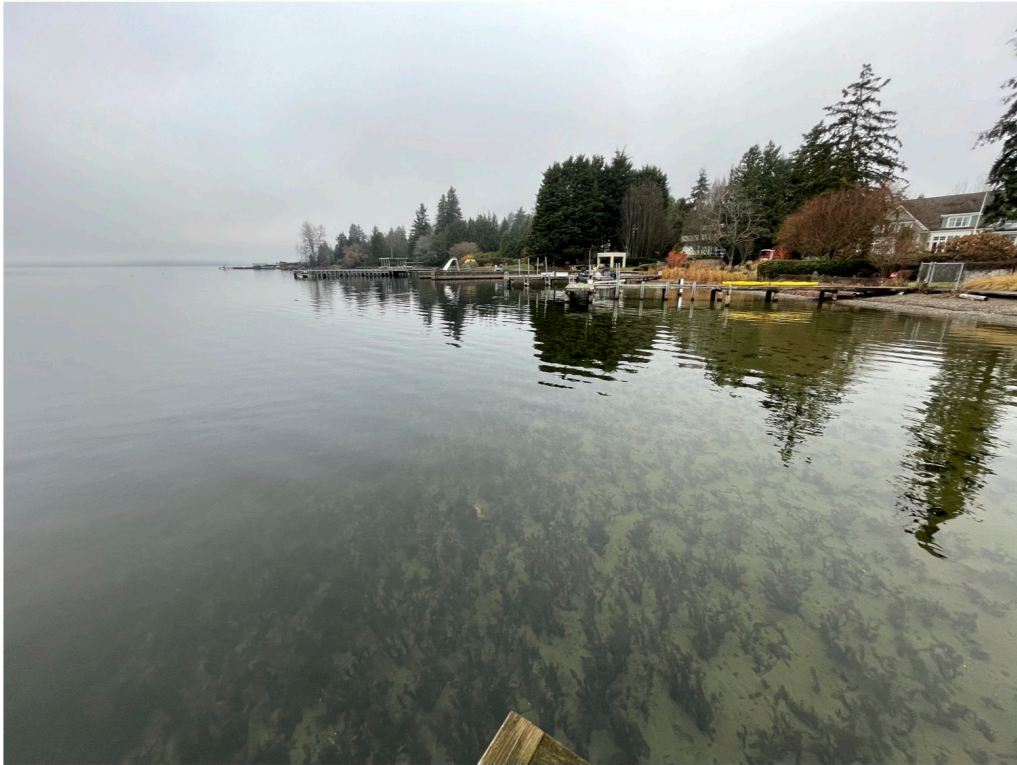
Photo 5 - Existing conditions north of site.

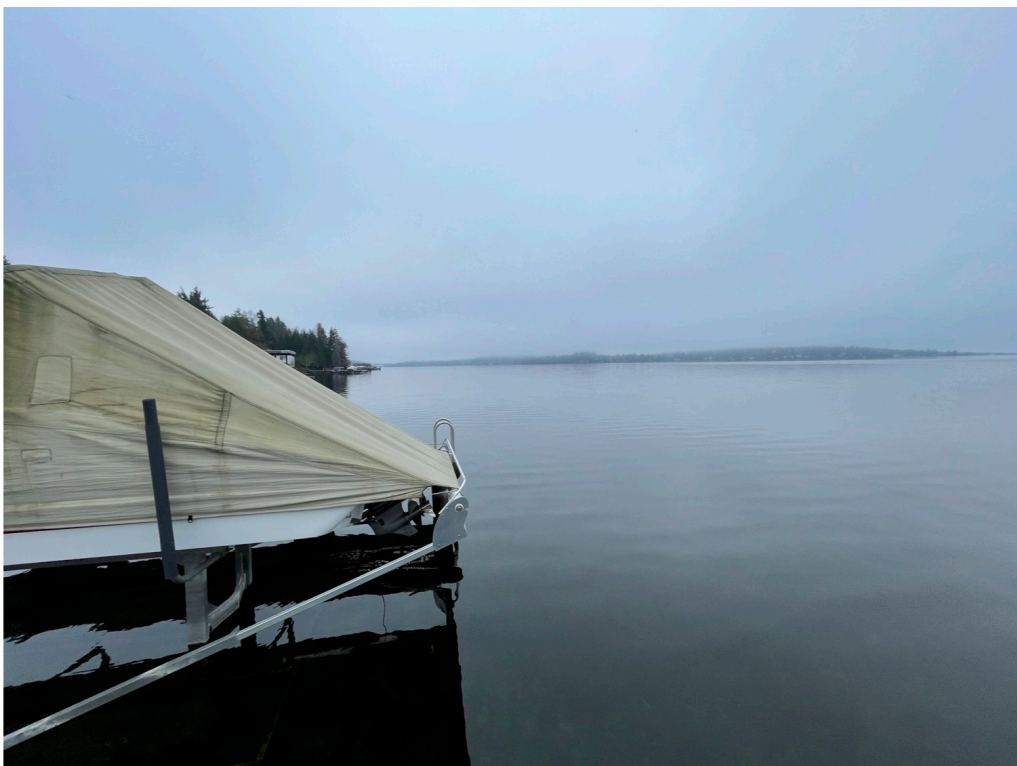
Photo 6 - Existing shoreline conditions looking south.
