# HRSDS Sewer Interceptor

**HRSDS Sewer Lining Project**  
**ESTIMATE OF TOTAL PROJECT COSTS**  
**REVISED: 10/21/2024**

This executive summary provides a general overview of the basis-of-design (BOD) report on the Huron Rouge Sewage Disposal System (HRSDS) Novi Trunk Extension No. 1 Sewer Rehabilitation project. This BOD presents our evaluations and recommendations for rehabilitating the sewer reaches within the HRSDS Novi Trunk Extension No. 1 Contract Nos. 1 and 2. The discussion and conclusions provided herein should be considered together with and in the context of the overall project. Throughout this report, this project will be referenced as the “HRSDS Rehabilitation Project”.

This BOD report summarizes our evaluations and recommendations for the rehabilitation of the HRSDS Novi Trunk Extension No. 1 Contract Nos. 1 and 2. Specifically, this report presents our evaluations and recommendations of sewer lining options including liner type and location of sewer rehabilitation, repairs for addressing the existing leaks at various locations along the alignment, bypass pumping options and requirements during flow diversion, manhole access and associated easement requirements, a

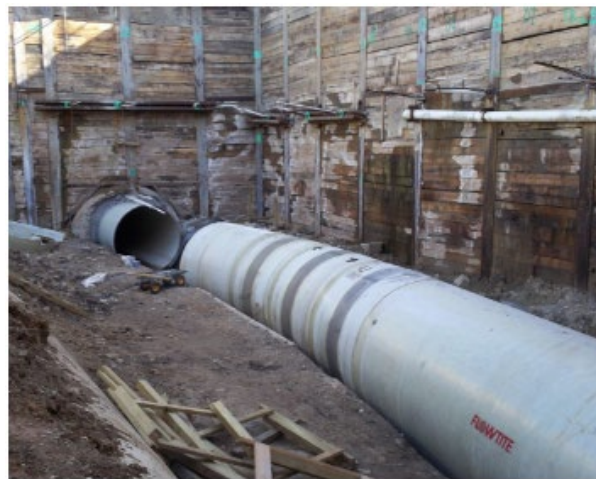
**Figure 3: Thompson Flowtite Pipe Installation (Photo Courtesy of Thompson Pipe Group Presentation)**

manufacturers providing flush joints that provide a relatively homogenous outside diameter (OD) measurement. The FRP liner products are also flexible and able to navigate minor deflections in the alignment and minor sags/offsets. Due to similar manufacturing methods, the FRP liners can also be cut to almost any length necessary for the installation conditions. These lengths range from 20 feet for the long segment installations, to 2-3 feet for the manhole-to-manhole installations, except for Hobas pipe (which comes in minimum 5-foot sections). For the long segment installations, the FRP liners are able to line through multiple manholes at once for lengths ranging from 1,500 to 5,000 feet if an access structure is constructed. Depending on the installation type, the Hobas, Thompson Pipe Group, QuakeWrap, and Superlit claim that their products can be installed in live flow conditions; however, construction of bulkheads and grouting the annular space will require some form of temporary storage or bypass pumping, either externally or internally using a plug and flow-through pipe. Prior to the installation of the FRP slip-liners, minimal surface preparation of the host pipe is required, with typical requirements including jetting to remove settled debris and obstructions that could interfere with lining insertion.

There are some limitations to the FRP slip-liners as well, including the need to excavate for the reinstatement of lateral blind taps. Other considerations include repairing the FRP liners will require fiberglass lamination, humidity control, and require bypass pumping. Furthermore, product manufacturing locations should also be considered. QuakeWrap Stifpipe can be manufactured as close as possible to the jobsite, Hobas is manufactured in Texas, and Thompson and Superlit liners are both manufactured in Turkey. The cost and lead times for shipping will play a role in the overall cost consideration of the project.

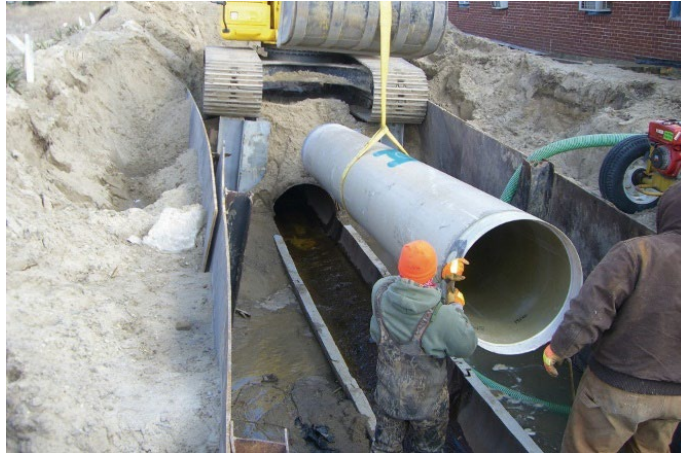
**Figure 4: Hobas Pipe Installation** *(Photo Courtesy of Hobas Pipe USA Website)*

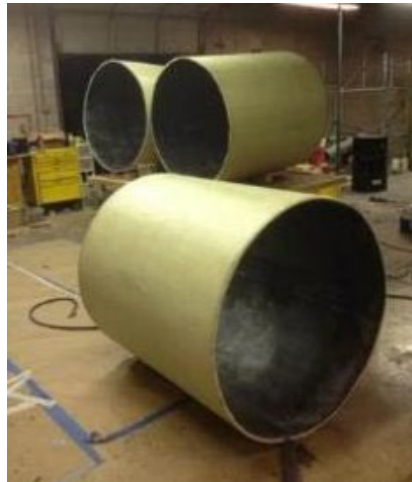
**Figure 5: QuakeWrap StifPipe** *(Photo Courtesy of QuakeWrap Presentation)*

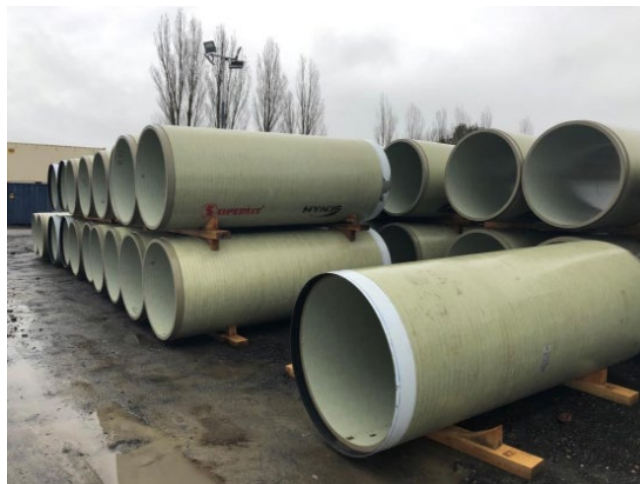
**Figure 6: Superlit Pipe** *(Photo Courtesy of Superlit GRP Presentation)*

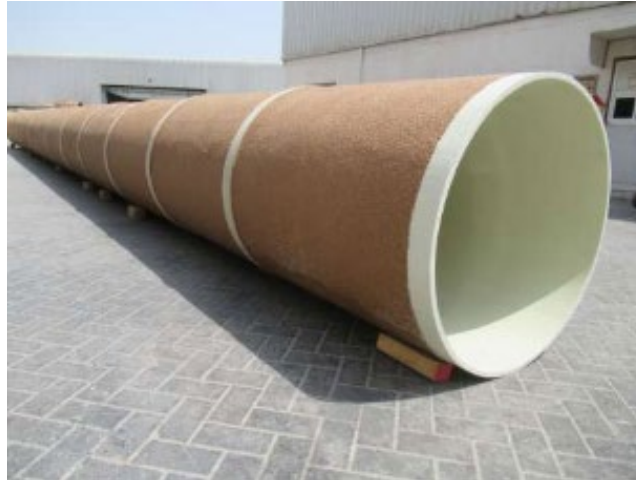
**Figure 7: Channeline Pipe** *(Photo Courtesy of Channeline International Website)*

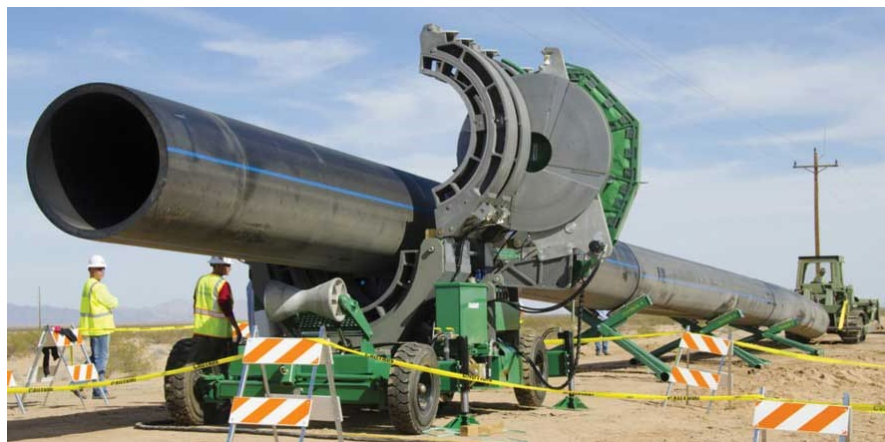
**Figure 8: Fusion-Welded HDPE Pipe** *(Photo Courtesy of Trenchless Technology Magazine Website)*

**High Density Polyethylene Pipe** - We also considered three types of HDPE slip-liners for the HRSDS rehabilitation: fusion-welded HDPE, threaded HDPE segmental jack pipe, and Spirolite HDPE slip-liner (Figures 8-10). Due to the installation method of pulling longer sections of pipe into place that would require larger insertion shafts/pits, the fusion-welded HDPE liner method would be recommended only for the long lining sections with liner distances able to be pulled the entire lengths of the straight sections which range in length from 546 ft to 3,388 ft, while the 2-to-3-foot-long threaded HDPE pipe sections would be ideal in the manhole-to-manhole designated installations. The flexibility of the fusion welded HDPE pipe also enables the liner to navigate minor alignment changes and sags/offsets with relative ease. The fusion-welded HDPE slip-liner can also be installed in two methods: the traditional pull-in-place method or the compression-fit method, which takes an HDPE pipe with an OD slightly larger than the host pipe and compresses it during installation. The compression-fit pipe is then released once it reaches the termination point and expands into a tight-fitting, grout-less liner. The compression-fit requires the same launching and receiving pits as the traditional pull-in-place HDPE liner. The Spirolite HDPE slip-liner is similar to the ThreadLiner product, but with installation requirements similar to the FRP products. The ThreadLiner and the Spirolite products can also be installed in live flow conditions depending on the pulling configuration but will likely require some level of flow bypass or storage for annulus grouting operations and will also require excavation to reinstate lateral blind tap connections.

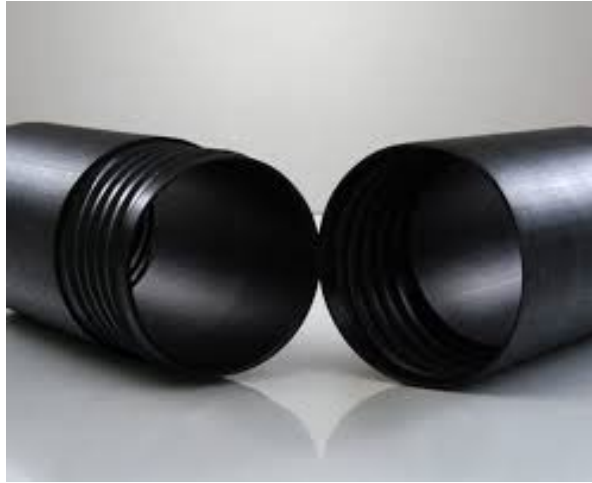
**Figure 9: ThreadLiner HDPE Pipe** (*Photo Courtesy of ISCO Website*)

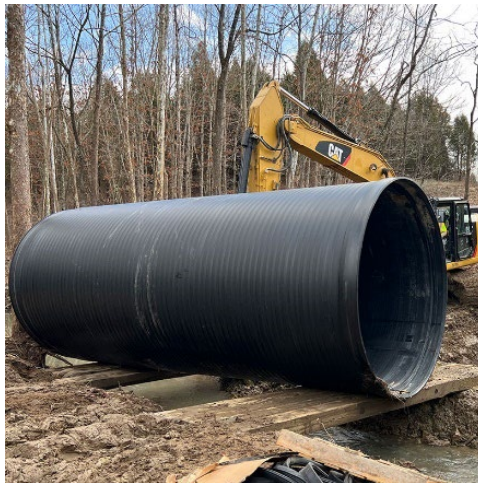
**Figure 10: Spirolite HDPE Pipe** (*Photo Courtesy of ISCO Website*)

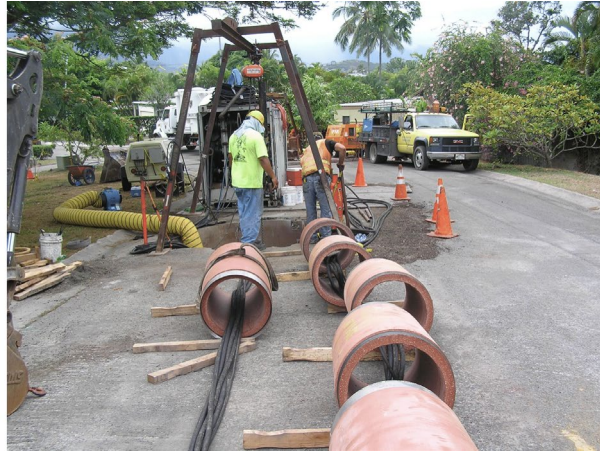
**Figure 11: Logan Clay Pipe Installation** *(Photo Courtesy of Logan Clay Pipe Presentation)*

**Logan Clay Pipe** - Another slip-lining product that was evaluated for the HRSDS rehabilitation project was Logan Clay Pipe (Figure 11). The jacked-in-place clay slip-liner is fabricated with stainless steel collars to allow for greater axial load during pushing or pulling slip-lining installations. Due to the weight per foot and the more rigid joints of this product which do not allow for significant deflection, manhole-to-manhole reaches would be the only likely installation method for this liner. A minimal footprint is required for installation of the clay jack pipe slip-liner, with a winch on the upstream end of the reach to pull the liner into place, plus a way to lower the liner sections into the sewer at the downstream end being the only equipment necessary onsite, unless a shaft is constructed, and jacking equipment is used. While Logan Clay Pipe has many potential benefits, they currently only manufacture a maximum diameter of 24 inches for their jack pipe product.

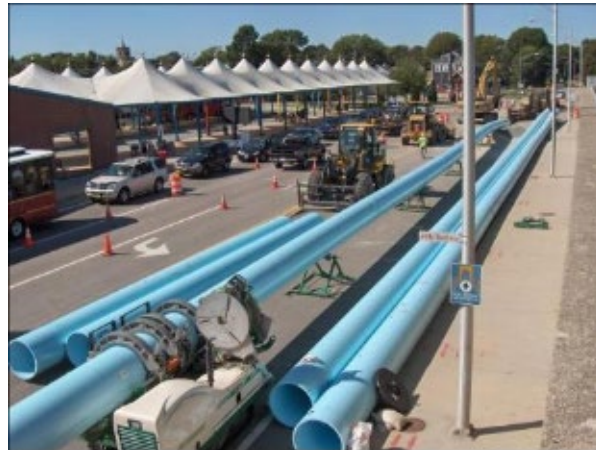
**Figure 12: Fusible PVC Pipe** *(Photo Courtesy of Underground Solutions Presentation)*

**Polyvinyl Chloride Liners:** Underground Solutions presented two PVC slip-lining products: Fusible PVC and Vylon PVC slip-liner (Figures 12 and 13). The fusible PVC product is very similar to the fusion-welded HDPE product discussed earlier in this section. The Vylon PVC slip-liner is installed in a similar manner to FRP and Spirolite HDPE products.

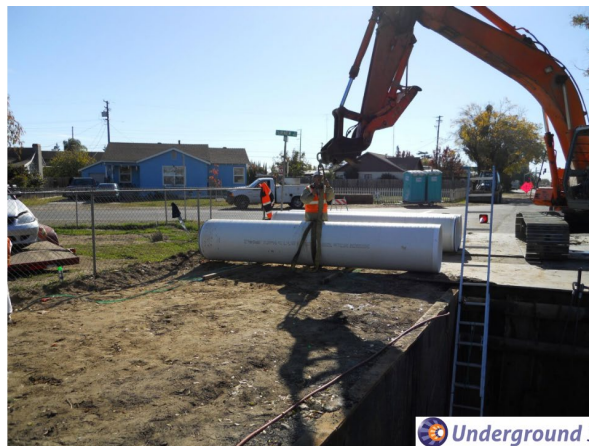
**Figure 13: Vylon PVC Slip-Liner Installation** *(Photo Courtesy of Underground Solutions Presentation)*

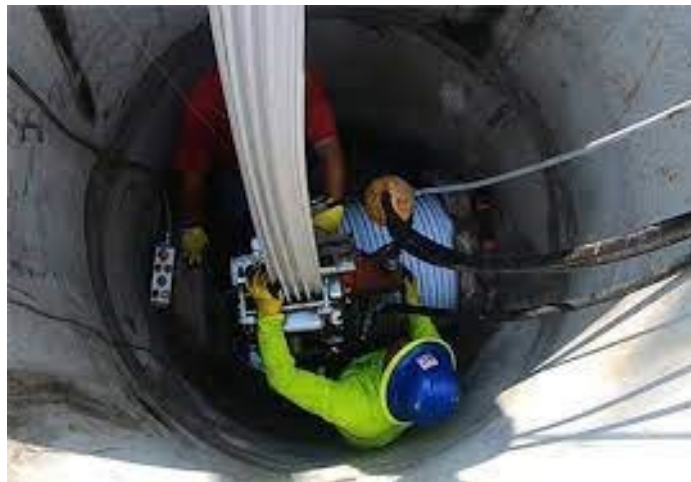
Figure 14: Sekisui SPR-EX Liner Installation (Photo Courtesy of Sekisui Website)

**Sekisui SPR-EX** - The SPR-EX product consists of placing the winding machine at an existing manhole where it creates a smaller diameter liner until it reaches the receiving manhole. At the receiving end, the liner is then torsionally restrained, and the secondary locking mechanism is removed, allowing the liner to expand by continuing to wind it until it is tight-fitting with the host pipe. A disadvantage of the SPR-EX product is that only one spool can be installed at time and spools cannot be spliced together. This results in a maximum installation length of approximately 250 feet; therefore, this product is only recommended for short reaches of the sewer.

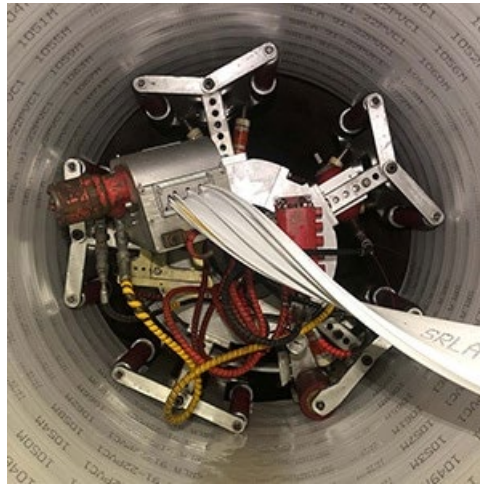
**Figure 15: Sekisui SPR-TF/RO Liner Installation (Photo Courtesy of Sekisui Presentation)**

**Sekisui SPR-TF/RO** - The SPR-TF/RO product uses a winding machine that travels along the length of the reach to be lined while placing a tight-fit liner. The SPR-TF/RO product allows for spools to be spliced together, so the maximum installation length is only limited by the hydraulic hoses and pressure required to power the winding machine.

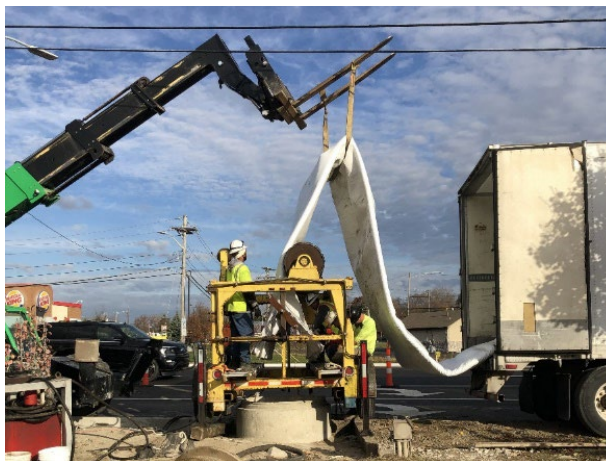
**Figure 17: CIPP Felt Liner Inversion during Elizabeth Lake Road Sinkhole Sewer Rehabilitation**

**Polyester Felt or Fiberglass CIPP** - The flexible liners used for CIPP, commonly referred to as tubes, are constructed of either polyester felt or fiberglass. Recent development of technologies allows for tubes that are reinforced with various high tensile fibers capable of increasing the overall strength of the finished CIPP. The benefit of using fiberglass tubes is the higher strength and flexible modulus provided by the fibers, and the ability to reduce the wall thickness/weight of the finished CIPP liner. The lower weight also helps with material handling and increases the length of liner that can be transported to the jobsite. During SAK's CIPP presentation, SAK provided design wall thicknesses ranging from 15 mm to 24 mm for a felt tube, and 7.5 mm to 10mm for a fiberglass tube. The downside of using fiberglass instead of felt is the added cost of materials. Additionally, recent environmental concerns have arisen in regard to the styrene used in CIPP resins. Styrene releases a strong scent during the curing process of CIPP; however, the NASSCO released statements claiming that the styrene resins used in CIPP products are safe to use given the proper health and safety procedures are followed during installation and that notification is provided to nearby homeowners who may be affected. As an alternative, styrene-free products have since been developed to alleviate the concerns around styrene, however these products add costs to the CIPP manufacturing process.

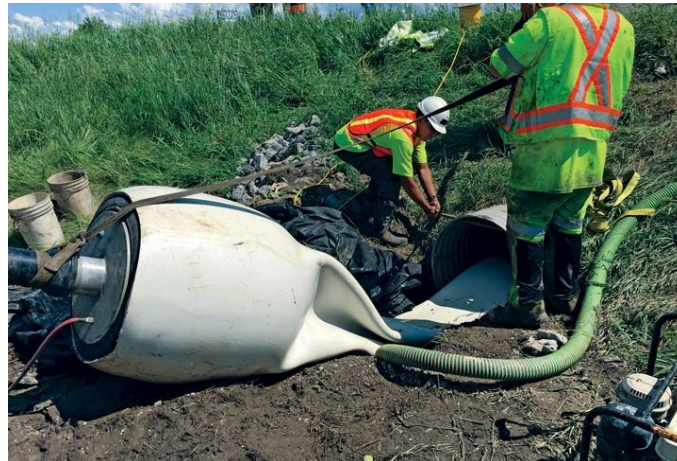
**Figure 18: NovaForm PVC Liner** *(Photo Courtesy of Trenchless Technologies Website)*

**NovaForm** - NovaForm is a styrene-free expand-in-place PVC liner which is a type of Fold-and-Form lining (Figure 18). Currently, for sewers in the diameter range of the HRSDS, only 30-inch NovaForm PVC liners are available and can be "overexpanded" to fit a 36-inch diameter host pipe. Based on the observed section loss in the host pipe, one of the design requirements is that the lining system used is a fully structural liner. The thinning of the 30-inch diameter PVC wall thickness to fit the 36-inch diameter presents a concern to the structural capacity of this lining system. An additional concern is the fact that NovaForm has only been installed of lengths up to 400 feet to date, and several reaches within the HRSDS alignment have lengths exceeding 400 feet between manholes.

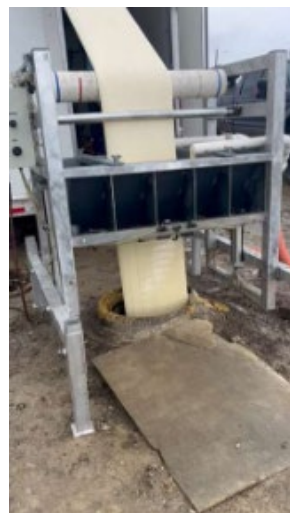
**Figure 19: RigidSeal Pipeline Installation** *(Photo Courtesy of RigidSeal Presentation)*

**RigidSeal** - A new type of CIPP lining system is the RigidSeal product that uses a thermoplastic liner coated in a proprietary structural expanding polyurethane grout. The liner is “wet out” with grout at the entrance of the access shaft or manhole and is pulled into place similar to other CIPP products (Figure 19). Once the liner reaches the end of the lining segment, both ends are sealed and pressurized air is added to expand the liner into shape while the polyurethane grout sets up and creates a bond with the existing host pipe. The use of structural polyurethane grout also allows for the penetration through any defects in the host pipe to seal leaks or fill small voids during installation, which reduces the surface preparation required prior to installation. A concern with this experimental product is that there are no industry standards for design or compressive strength testing, combined with the fact that the largest installed diameter to date is 18 inches.

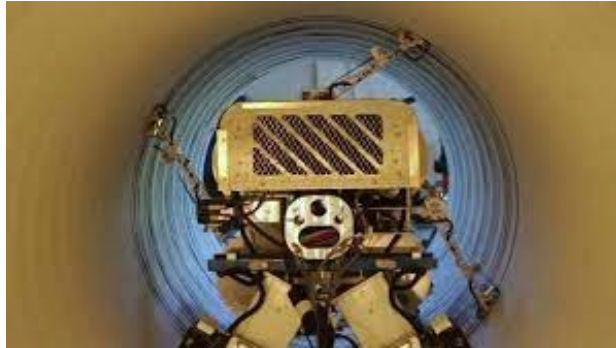
**Figure 20: SippTech MICP Liner Installation (Photo Courtesy of SippTech Website)**

**SippTech** - SippTech is a manufactured-in-place composite pipe (MICP) rehabilitation solution (Figure 20). They currently only provide rehabilitation solutions for 48-inch diameter pipes or larger. The robotic applicator would need 100% bypass and a larger access structure than the existing manholes. No annulus space is produced in this rehabilitation method, so no grouting would be required, and the composite liner material is corrosion and abrasion resistant. Due to the size limitations, this technology doesn't meet the finished diameter requirement of this project.

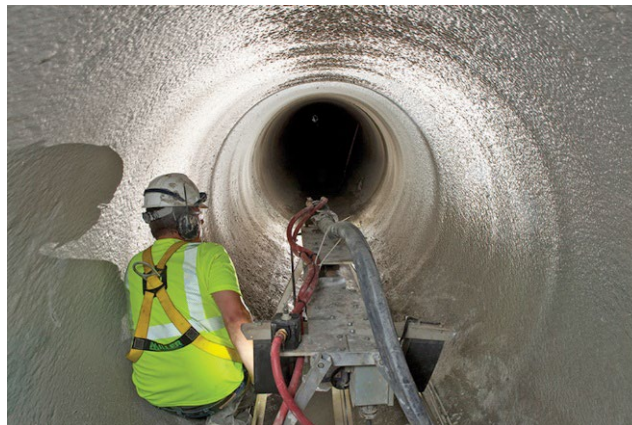
**Figure 21: Spray-On Liner/Coating Installation (Photo Courtesy of Municipal Sewer & Water Magazine Website)**

Many spray-on/coating liner systems consist of either a cementitious based material, an epoxy-based material, fiber reinforced polymer, polyurethane, or a composite of a cementitious material with an epoxy topcoat. Spray-on/coating liners are typically used as a repair type rehabilitation where the liner is used to restore the existing concrete surface and provide corrosion protection (Figure 21). Spray-applied linings can generally be divided into two categories: Structural and non-structural; both typically provide some level of corrosion protection. For the spray-on/coating liner systems that provide structural improvement, the level of structural improvement depends on the specific loading, liner thickness, and host pipe conditions.

The performance of the spray-on/coating liner systems are all highly dependent on the condition of the substrate to which they are applied. The adhesion of a spray-on/coating lining to the substrate is considered a mechanical bond rather than a chemical bond, and the substrate should be prepared following International Concrete Repair Institute (ICRI) Requirements. This includes surface roughness, cleanliness, and moisture requirements for a proper bond for longevity. Most spray-on/coating liners are tolerant of moisture in the concrete; however, none of the spray-on/coating liner systems tolerate active infiltration. Additionally, performance of spray-on/coating linings is also affected by the cure time prior to the introduction of flow. Cure time can be affected by the air and substrate temperature at the time of application.
