# 32 PRESERVATION BRIEFS

## Making Historic Properties Accessible

Thomas C. Jester and Sharon C. Park, AIA

U.S. Department of the Interior  
National Park Service  
Cultural Resources  
Heritage Preservation Services

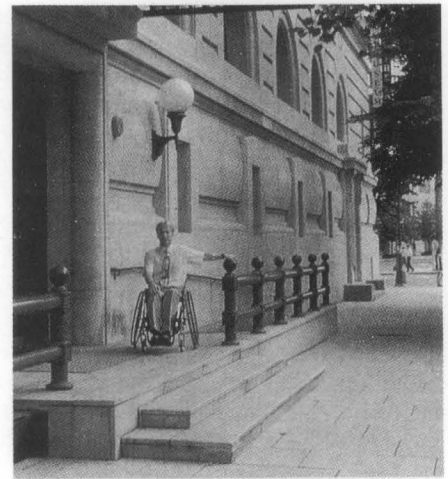
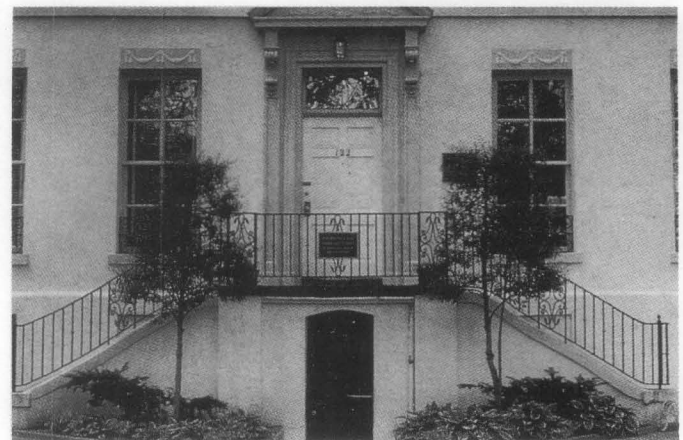
Figure 1. It is important to identify the materials, features, and spaces that should be preserved when planning accessibility modifications. These may include stairs, railings, doors, and door surrounds. Photo: National Park Service files.

decorative ornamental hardware, and narrow pathways and corridors, pose barriers to persons with disabilities, particularly to wheelchair users (See Figure 1).

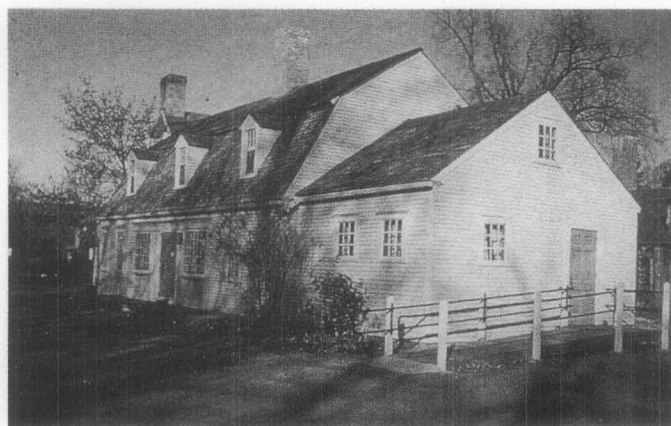
Figure 7. This ramp is convenient for visitors with disabilities and preserves the building's historic character. The design is also compatible in scale with the building. Photo: William Smith.

**Incorporating Ramps.** Permanent ramps are perhaps the most common means to make an entrance accessible. As a new feature, ramps should be carefully designed and appropriately located to preserve a property's historic character (See Figure 7). Ramps should be located at public

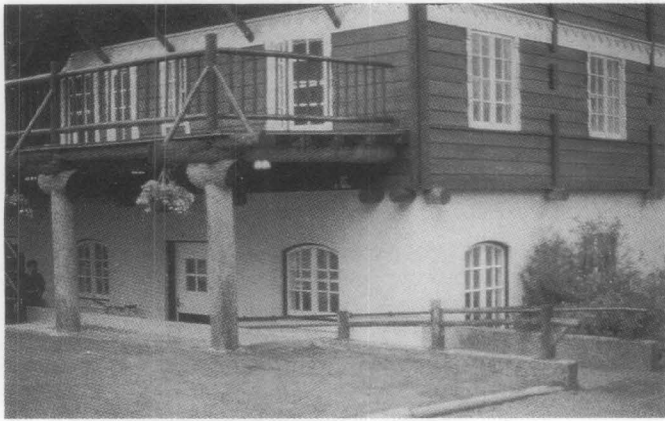
Figure 8. A new below-grade ramp provides access to Lake MacDonald Lodge in Glacier National Park. Photo: Thomas Jester

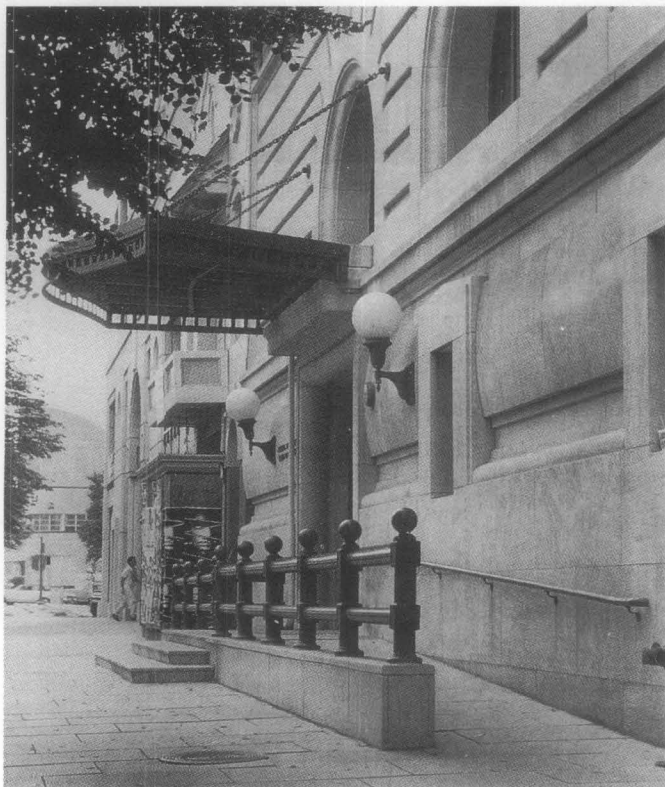
Figure 9. This ramp was created by infilling the window-well and slightly modifying the historic railing. The ramp preserves this building's historic character. Photo: Thomas Jester.

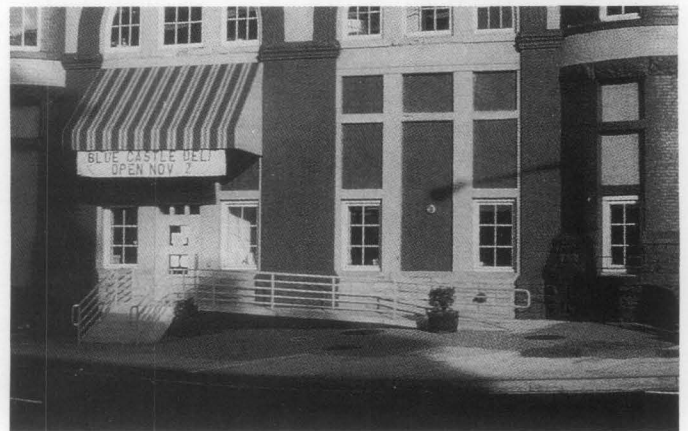
Figure 11. Simple, contemporary railings that extend beyond the ramp slope make this ramp compatible with the industrial character of this building. Photo: Thomas Jester.

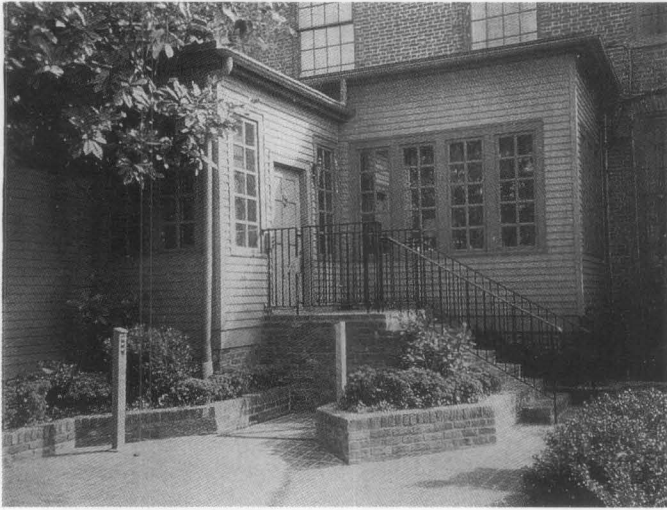
Figure 14. At the Lieutenant Governor's Mansion in Frankfort, Kentucky, a retracting lift (b) was installed to minimize the visual effect on this historic building when not in use (a). Photos: Aging Technology Incorporated.

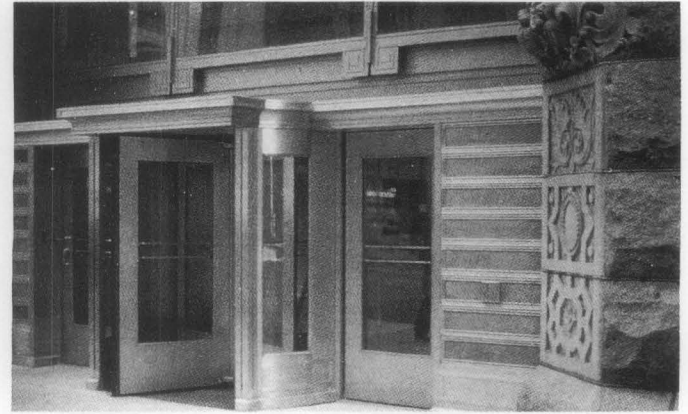
Figure 16. During the rehabilitation of the Rookery in Chicago, the original entrance was modified to create an accessible entrance. Two revolving doors were replaced with a new one flanked by new doors, one of which is operated with a push-plate door opener. Photo: Thomas Jester.

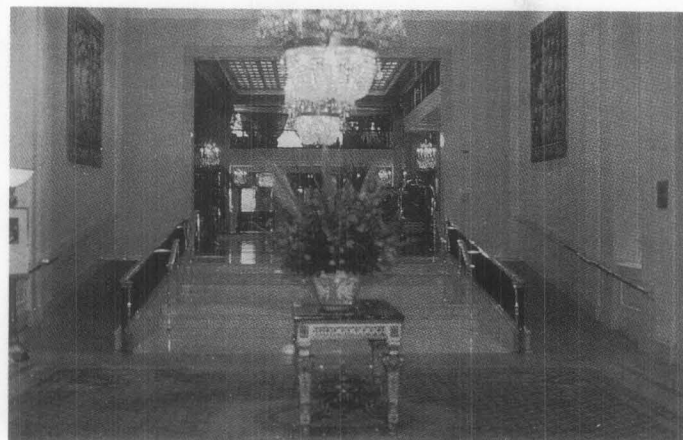
Figure 18. Symmetrical ramps at the Mayflower Hotel in Washington, D.C., provide access to the hotel's lower level. The design for the ramps respects the historic character of this landmark building. Photo: Thomas Jester.

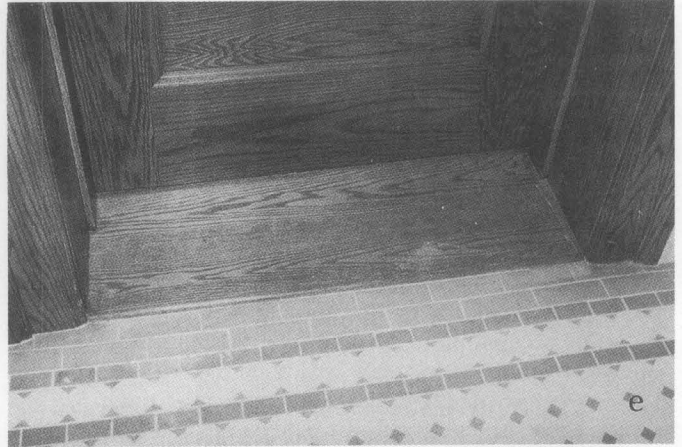
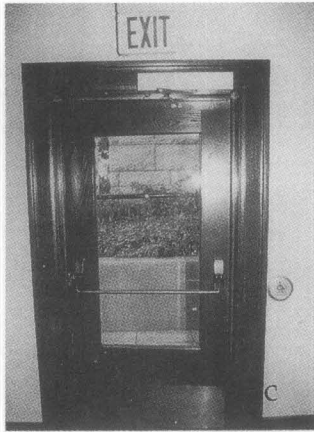
The Orange County Courthouse (a), located in Santa Ana, California, was rehabilitated in the late 1980s as a county museum. As part of the rehabilitation, the architect sensitively integrated numerous modifications to increase accessibility. To preserve the building's primary elevation, a new public entrance was created on the rear elevation where parking spaces are located. A ramp (b) leads to the accessible entrance that can be opened with a push-plate automatic door-opener (c). Modifications to interior features also increased accessibility. To create an accessible path of travel, offset hinges (d) were installed on doors that were narrower than 32 inches (81.3 cm). Other doors were rethreaded to reduce the door pressure. Beveling the 1" high thresholds (e) reduced their height to approximately 1/4 inch (.64 cm). The project architect also converted a storeroom into an accessible restroom (f). The original stairway, which has open grillwork, was made more accessible by applying slip-resistant pressure tape to the marble steps (g). And the original elevator was upgraded with raised markings, alarm lights, and voice floor indicators. Photos: Milford Wayne Donaldson, FAIA.

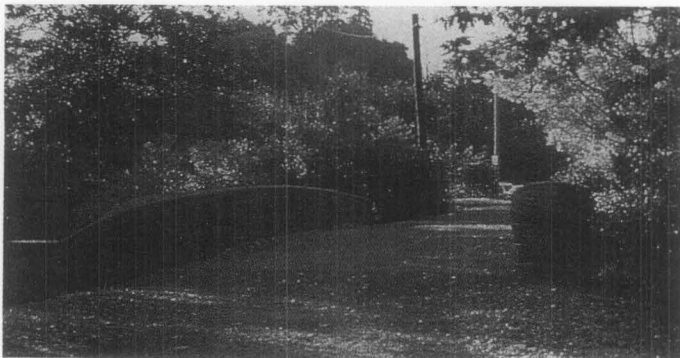
(a.) To improve accessibility in Boston's Emerald Necklace Parks, standard asphalt paving was replaced in selected areas with an imbedded aggregate surface that is more in keeping with the landscape's historic appearance. Photo: Charles Birnbaum.

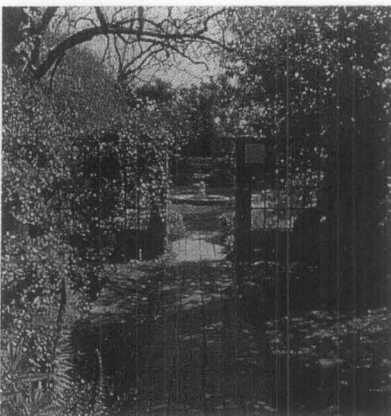
(b.) The Friendly Garden at Ranchos Los Alamitos, a historic estate with designed gardens in southern California, was made accessible with limited widening of its existing approach path. Photo: Ranchos Los Alamitos Foundation.

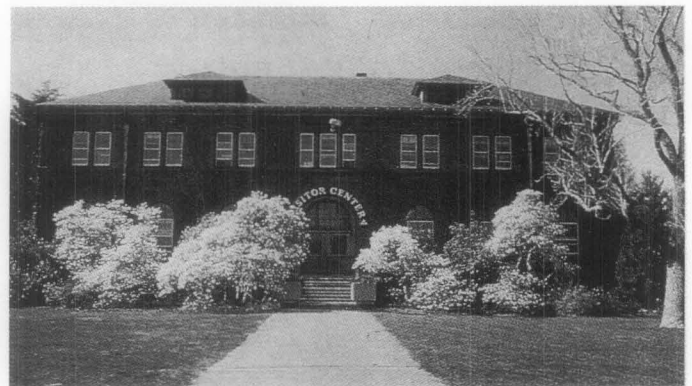
(c.) Hunnewell Visitor's Center before rehabilitation, revealing the altered landscapes. Photo: Jennifer Jones, Carol R. Johnson and associates.

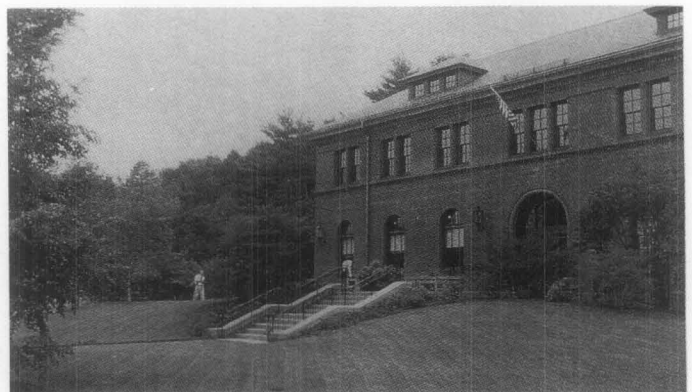
(d.) Hunnewell Visitors Center's entrance following rehabilitation, integrating an accessible path (left), platform, and new steps. Photo: Charles Birnbaum.

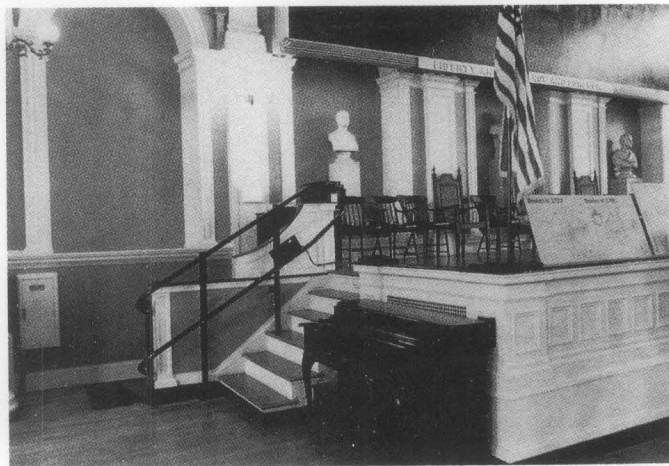
Figure 19. Inclined lifts can sometimes overcome interior changes of elevation where space is limited. This lift in Boston's Faneuil Hall created access to the floor and stage level of the State Room. Photo: Paul Holtz.

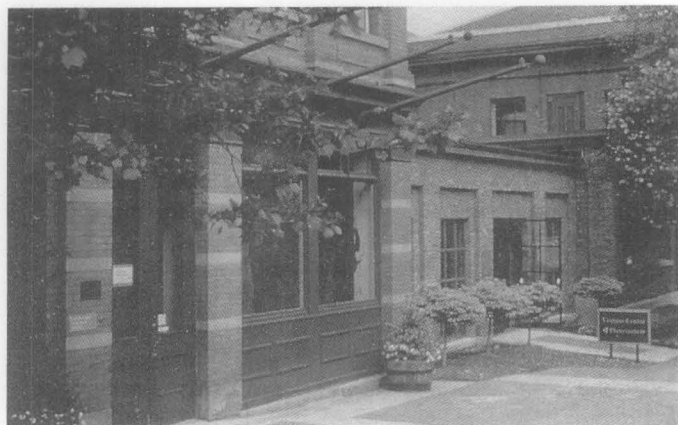
Figure 23. New additions to historic buildings can be designed to increase accessibility. A new addition links two adjacent buildings used for the Albany, New York, Visitor’s Center, and incorporates an accessible entrance, restrooms, and signage. Photo: Clare Adams.

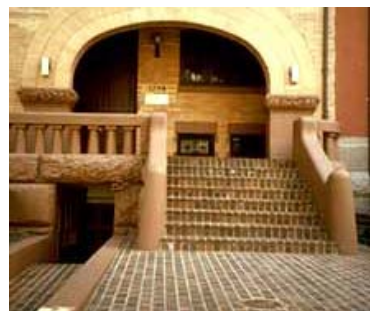
A significant entrance may be difficult to modify. Although a special challenge, sensitive changes can almost always be made to provide access while preserving the unique historic character. Photo: NPS files.

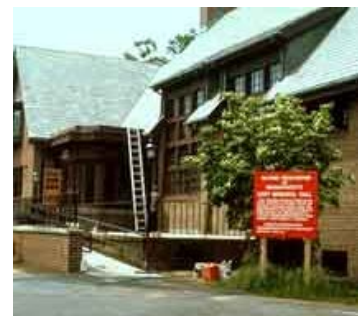
This accessibility ramp is compatible with the historic building in scale and materials. Photo: William Smith.

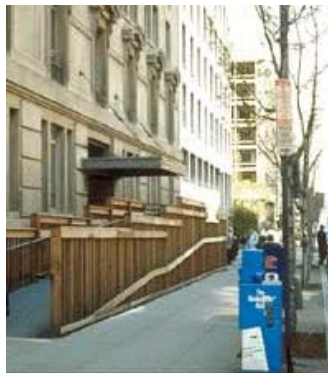
The ramp's scale and materials are inconsistent with the historic character of the building. Photo: NPS files.

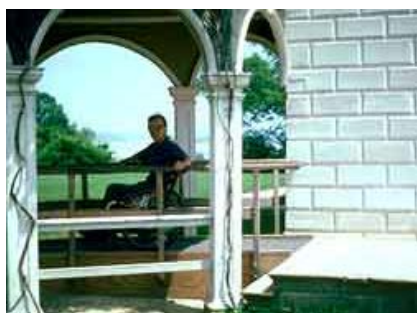
The significant building site is now accessible to people with disabilities (note steps in front of ramp). Photo: NPS files.

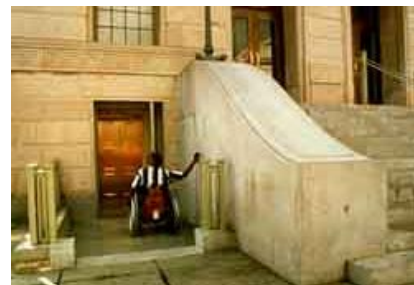
A new elevator entrance was provided next to the stairs to provide universal access to the services inside. Photo: Courtesy, GSA.

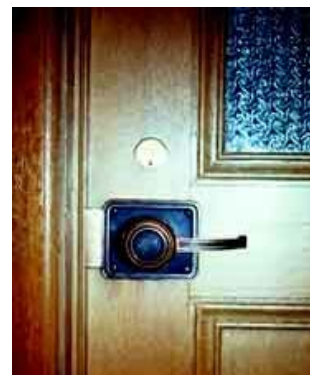
This door handle has been retrofitted to meet ADA requirements. Photo: NPS files.

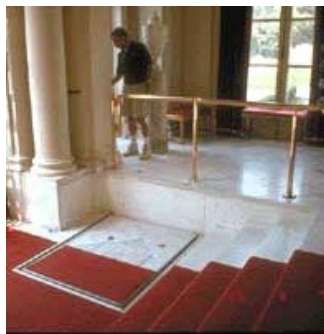
A retractable lift for this historic building foyer was created using "like" materials. Photo: NPS files.

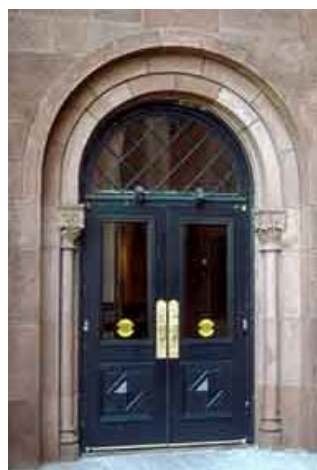
The automatic door to this museum building is a practical solution for
