CIRSA Loss Control Property Survey Recommendations

Entity: Palmer Lake, Town of	Loss Control Rep: Nicholas Paoli	Survey Date: August 11, 2022
--	--	--

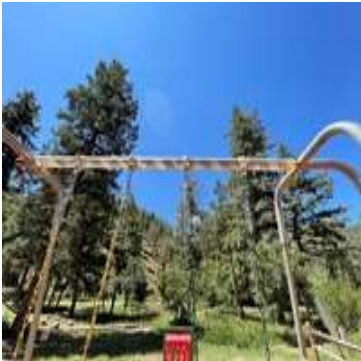
2022-08-02- Parks & Playgrounds - Swing S Hooks
 Glen Park: Clamp the "S" Hooks on the swings to the correct opening, or replace them with clevis style fasteners. The CPSC Public Playground Safety Handbook suggest clamping the swing S-hooks shut so that the maximum opening is less than the thickness of a dime to help reduce the potential drawstring entanglement hazard.

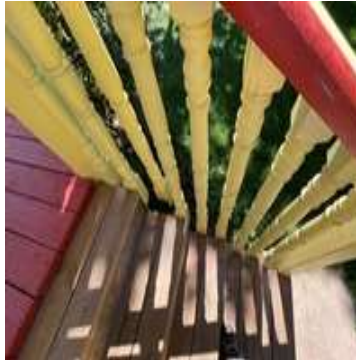
2022-08-03- Facility/Premises - Loose Handrail

Gazebo: The handrail on the gazebo located near town hall is loose and showing signs of deterioration. Repair/replace the handrail as needed.

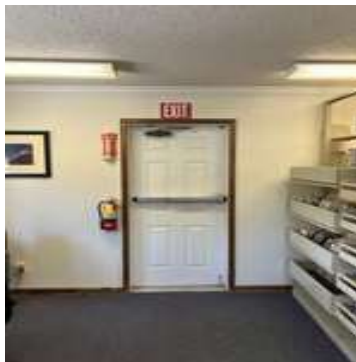
2022-08-04- Life Safety - Emergency Lights

Library & Museum: The library and museum should have emergency lights installed to allow occupants to safely exit the building in the event of an emergency. Add emergency lights to the interior of the building.
