1713 Palm Dr. Pictures

1713 Palm Dr. Details

Inspection Checklist

Date:08/18/2025

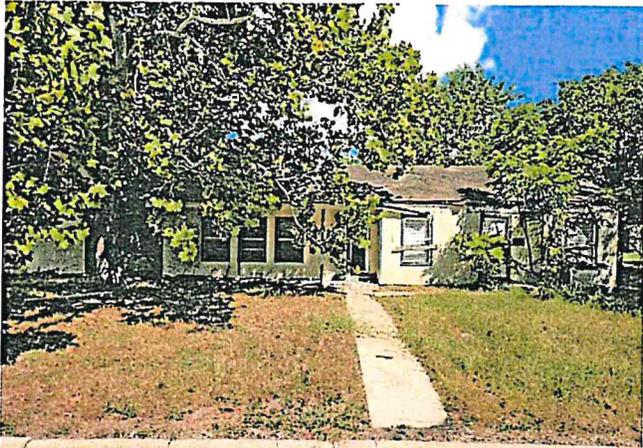
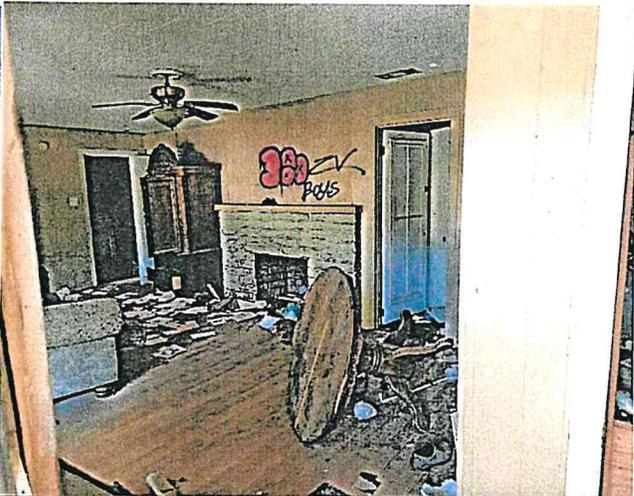
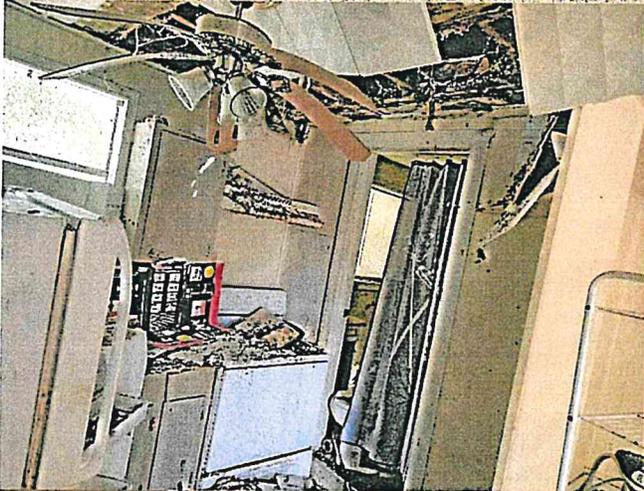
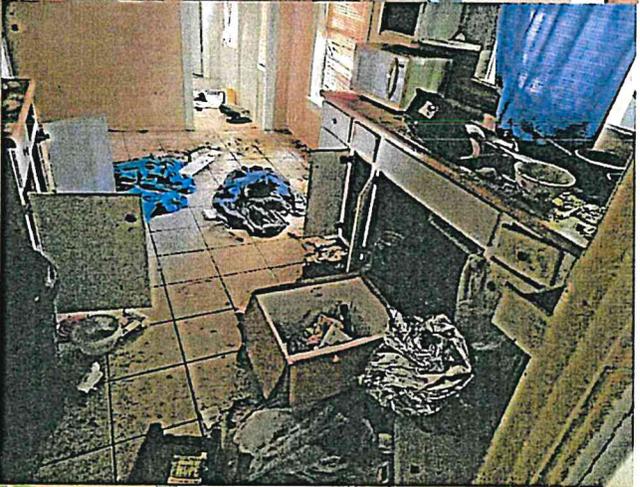
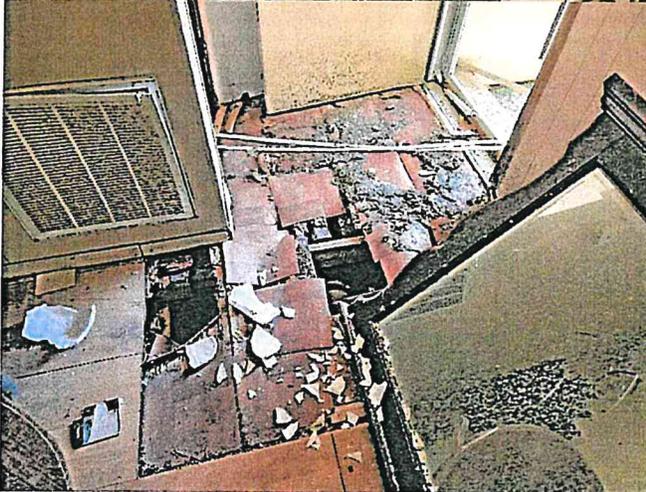
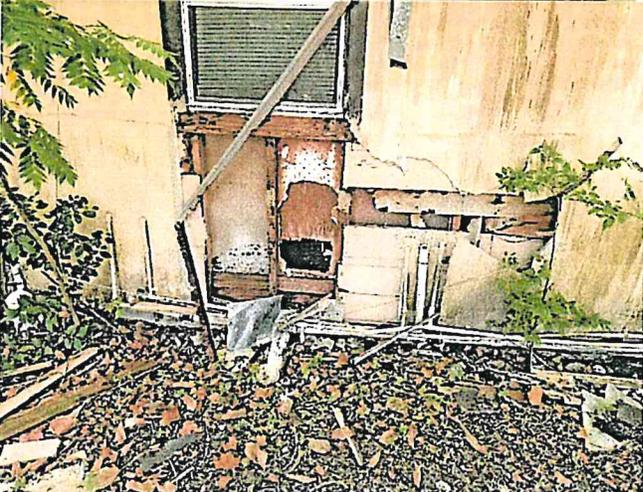
Pass	Fail	Violation/Deficiency	Location of violation
Roof properly maintained		X	Holes in roof shingles heavily deteriorated.	
Improper Walls, partitions or other vertical supports		X	Exterior and interior walls in severe state of deterioration	
Fireplaces or chimneys properly maintained		N/A		
Unsecure building: vacant and open.		X	Windows and doors broken entire home unsecured	
Lack of required rails, stairs, steps and/or balconies		N/A		
Lack of or improper exterior wall coverings		X	Exterior wall coverings deteriorated	
Hazardous wiring		X	Wiring damaged	
Hazardous plumbing		X	Plumbing damaged	
Hazardous mechanical equipment		N/A		
Sanitation:		X	Trash and rotten food on interior	
Lack of or improper connection to required sewage disposal		N/A		
Lack of or improper garbage and rubbish storage		X	No trash or rubbish storage on property. Trash and rubbish strewn across floor.	
Standing or stagnant water		N/A

Improper Ceiling or Ceiling supports		X	The ceiling is falling in in several locations.	
Improper Flooring or floor supports		X	The floor is giving way in several locations.	
Improper Foundation		N/A		
Vermin/Insects		X	The city has had to abate Bees in the walls previously	
Dampness of habitable space		X	Due to the unsecured nature and the deteriorated roof the interior of the home is damp and water damaged.	
Lack of electrical lighting		X	No Electrics	
Hot and Cold Water		X	No Water	
Lack of or Improper Kitchen		X	No water and no electric.	
Lack of or Improper bathroom		X	No hot or cold water	
Dead trees, tree limbs, holes, excavations or other conditions reasonably capable of causing injury to a person.		X	Uneven ground and debris.

- This property was shown to council on 9/16/2024. The result being the owner was given a six-month period to bring forward a plan.
- I received an email from the owner on 9/16/2024 with intentions of selling or fixing the property. I was in touch with the property owner off and on for roughly 8 months however the property has been broken into even more and I have not heard from them in 4 or so months.
- The property has also yet to be secured.
- Staff recommends the property owner be given 30 Days to bring this property into compliance or the city will proceed with demolition and place a lien on the property.
