# 306 W MLK

## Inspection Checklist

*This inspection was completed in accordance with Sec. 12-287 of the City of Port Lavaca Code of Ordinances.*

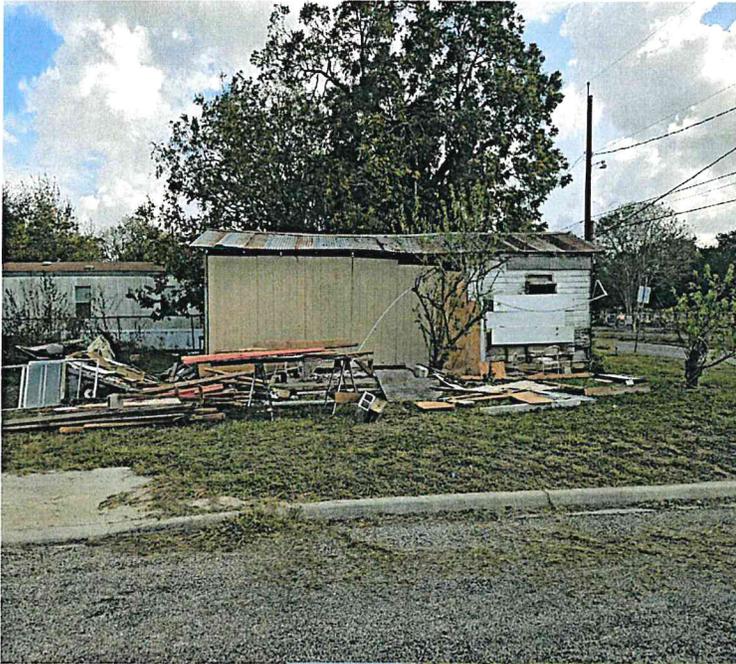
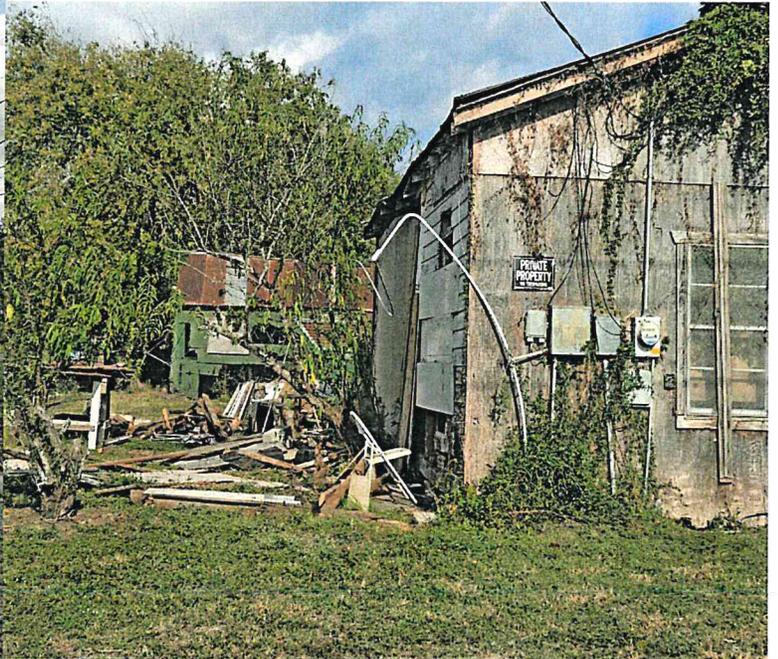
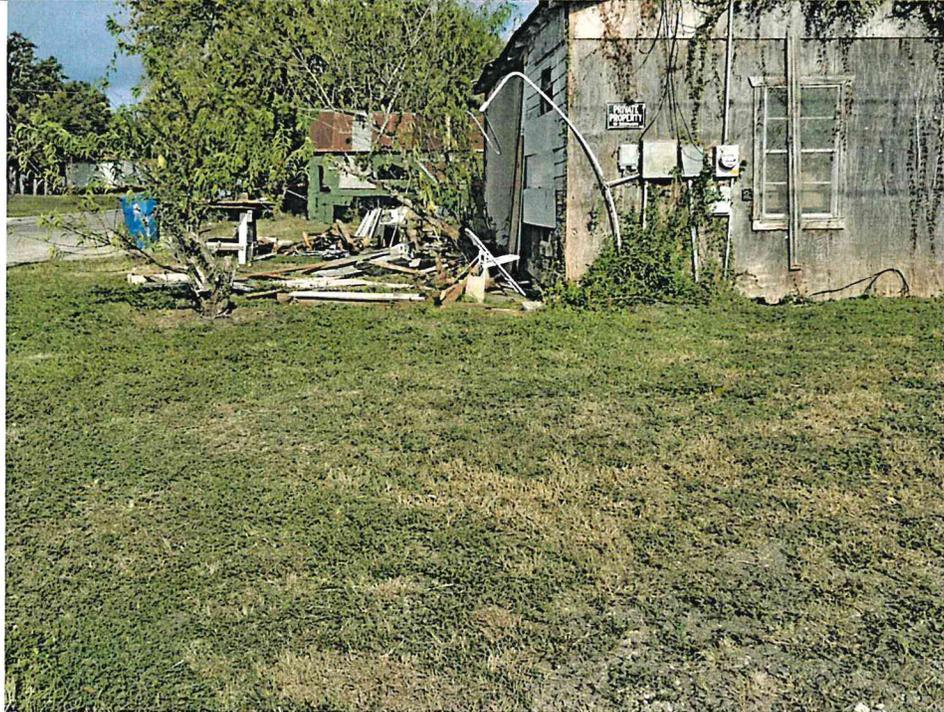
Pass	Fail	Violation/Deficiency	Location of violation
Roof properly maintained		X	Poor Condition and rusty	
Improper Walls, partitions or other vertical supports		X	Bottom of building in poor condition	
Fireplaces or chimneys properly maintained		N/A		
Unsecure building: vacant and open.	X			
Lack of required rails, stairs, steps and/or balconies	X			
Lack of or improper exterior wall coverings		X	Wall coverings mismatched and improperly aligned	
Hazardous wiring		X	Wiring on outside of building out of compliance	
Hazardous plumbing			Unable to verify	
Hazardous mechanical equipment			Unable to verify	
Sanitation:		X	Accumulations on property	
Lack of or improper connection to required sewage disposal			Unable to verify	
Lack of or improper garbage and rubbish storage		X	No rubbish storage or disposal	
Standing or stagnant water	X			
Improper Drainage	X			
Improper Occupancy	X			
Inadequate exits	X			
Improper Fireplace or Chimney	X

Improper Ceiling or Ceiling supports		X	Walls in disrepair	
Improper Flooring or floor supports		X	Flooring supports in disrepair	
Improper Foundation	X			
Vermin/Insects		X	Evidence of insect damage	
Dampness of habitable space	X			
Lack of electrical lighting	X			
Hot and Cold Water		X	No Water	
Lack of or Improper Kitchen		X	No Water	
Lack of or Improper bathroom		X	No Water	
Dead trees, tree limbs, holes, excavations or other conditions reasonably capable of causing injury to a person.		X	Tripping hazards on property

Nothing has changed on this property since late November of 2024.

The City Council ordered the property owner to obtain a necessary building permits and bring the building into code compliance by the owner on or before February 12th 2025 by 11:59 Pm.

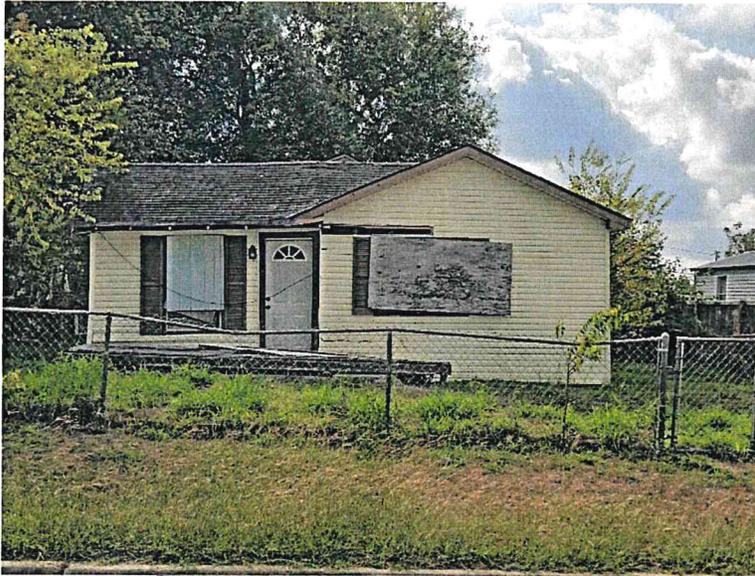
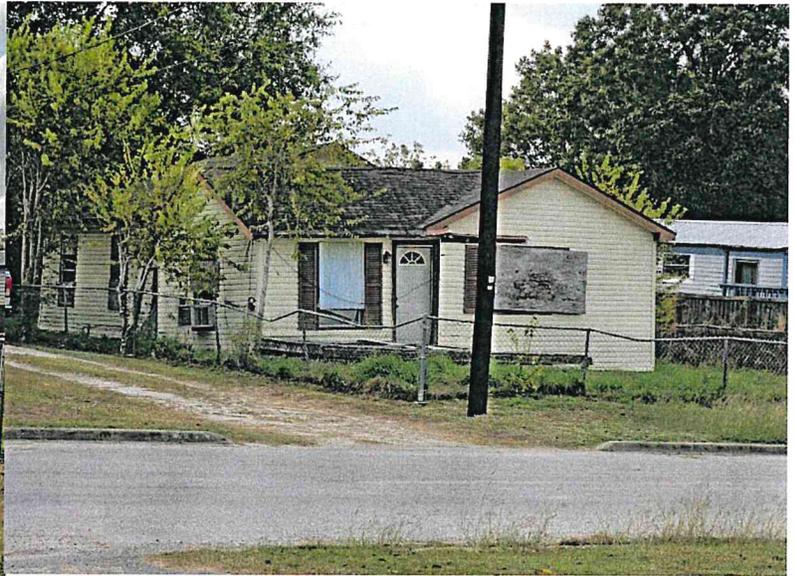
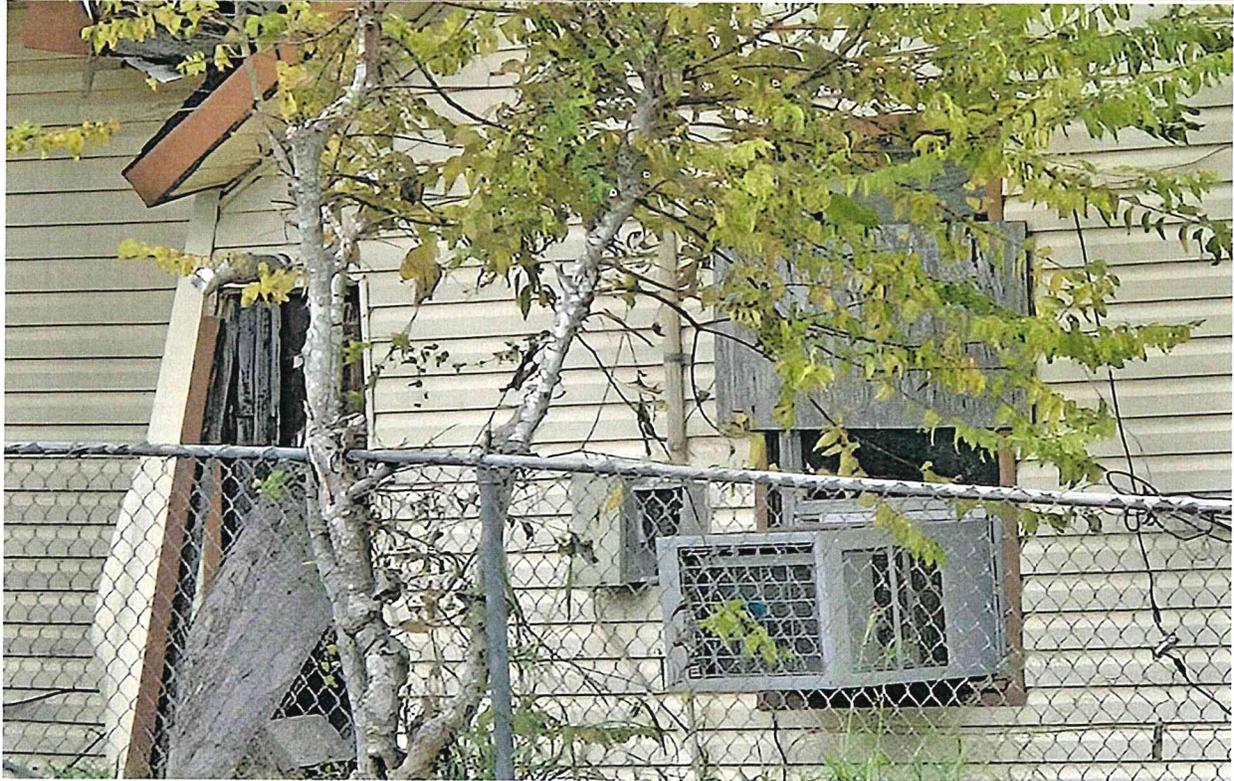
# 515 N. Nueces

Yes	No	Condition/ Type	Code Reference
Roof properly maintained		X	too much weight roof bowing and caving	
Walls, partitions or other vertical supports split, lean, list or buckle due to defective material, deterioration, or improper construction.	X		Entire house is sinking into ground	
Fireplaces or chimneys properly maintained		X	No chimney	
Unsecure building: vacant and open.	X		back doors open windows broken	
Lack of required rails, stairs, steps and/or balconies		X	deck solid only on steps	
Lack of or improper exterior wall coverings		X		
Hazardous wiring		X		
Hazardous plumbing		X		
Hazardous mechanical equipment		X		
Sanitation:		X	windows left broken	
Lack of or improper connection to required sewage disposal		X		
Lack of improper garbage and rubbish storage	X		no trash receptacle	
Standing or stagnant water		^		
Infestation of insects rodents or vermin	X		House open to elements	
Dead trees, tree limbs, holes, excavations or other conditions reasonably capable of causing injury to a person.		X

The home is still sinking into the ground and tearing itself in half.

plan has been executed and the condition of the house has degraded severely as pictured the water heater has collapsed out of

the building. The home is in a severe state of sinking into the ground

This property is hereby declared substandard and will allow the property owner ninety (90) days to work with

Development Services to arrive at a written renovation plan and if no such plan is executed, then this property will again go before

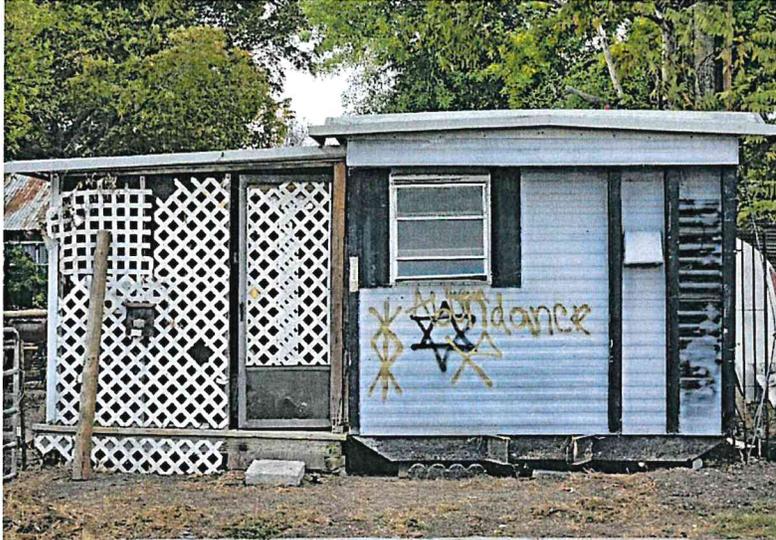
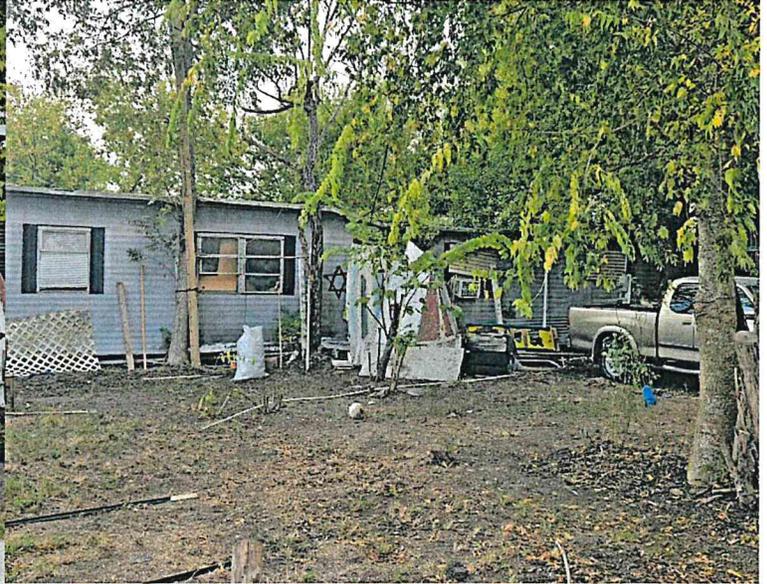
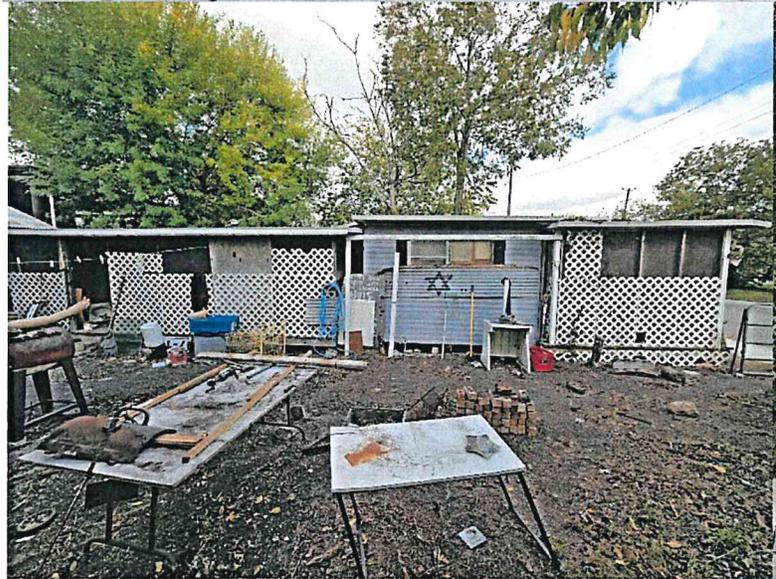
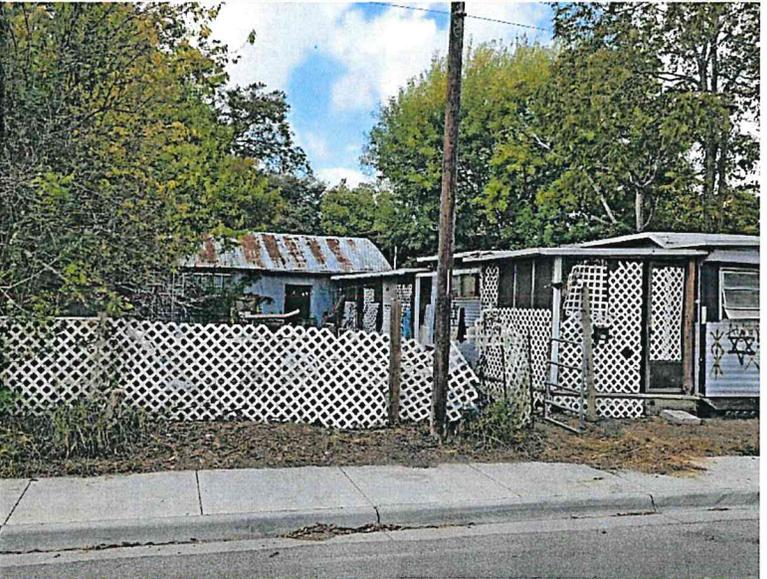
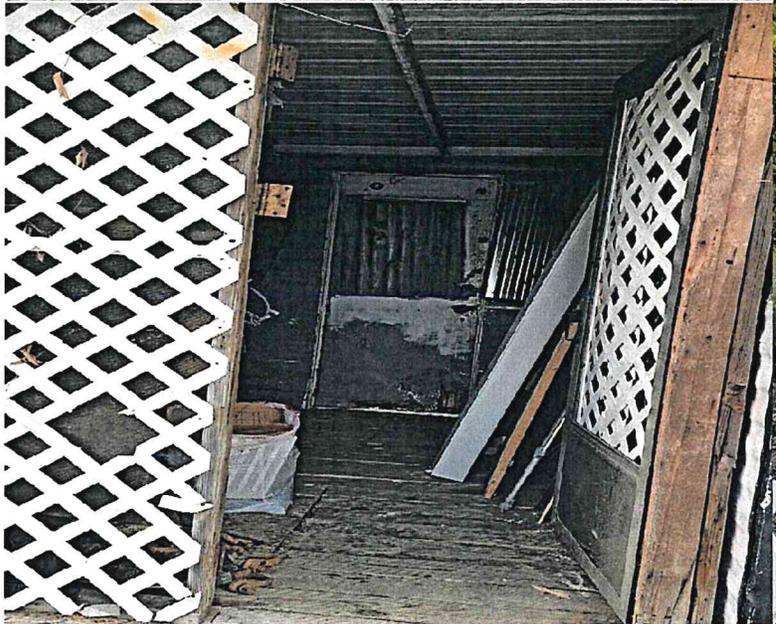
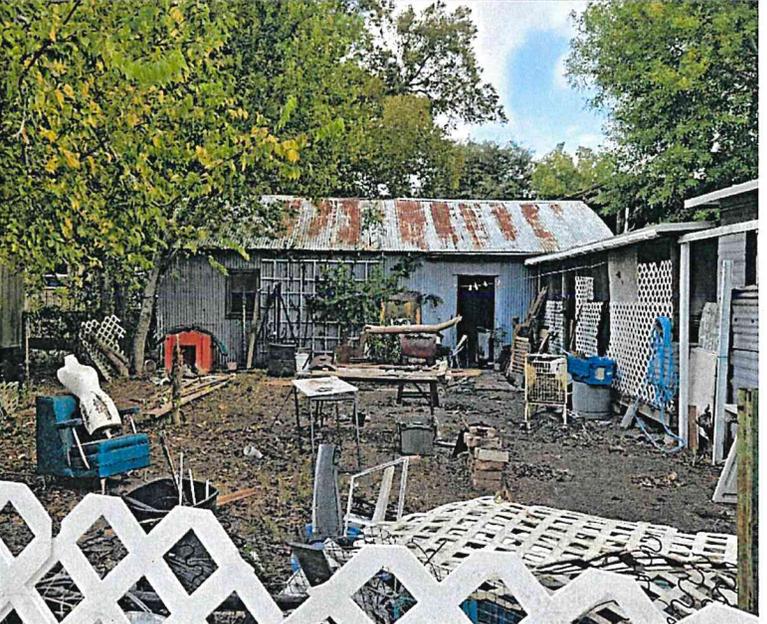
# 215 E George Pictures

Pass	Fail	Violation/Deficiency	Location of violation
Roof properly maintained	X			
Improper Walls, partitions or other vertical supports	X			
Fireplaces or chimneys properly maintained		N/A		
Unsecure building: vacant and open.	X		Doors damaged property not vacant	
Lack of required rails, stairs, steps and/or balconies	X			
Lack of or improper exterior wall coverings		X	Exterior wall coverings warping and coming off exposing paneling underneath	
Hazardous wiring			Unable to verify	
Hazardous plumbing		X	Plumbing broken	
Hazardous mechanical equipment			Unable to verify	
Sanitation:		X	Property is very unkempt	
Lack of or improper connection to required sewage disposal			Unable to verify	
Lack of or improper garbage and rubbish storage		X	No rubbish storage	
Standing or stagnant water	X			
Improper Drainage	X			
Improper Occupancy	X			
Inadequate exits	X			
Improper Fireplace or Chimney	X

Improper Ceiling or Ceiling supports			Unable to verify	
Improper Flooring or floor supports		X	Floor coverings missing or damaged	
Improper Foundation	X			
Vermin/Insects		X	Evidence of rodents and vermin	
Dampness of habitable space	X			
Lack of electrical lighting			Unable to verify	
Hot and Cold Water		X	No water	
Lack of or Improper Kitchen		X	No water or electric	
Lack of or Improper bathroom		X	No toilet or shower properly installed	
Dead trees, tree limbs, holes, excavations or other conditions reasonably capable of causing injury to a person.		X	Holes and other tripping hazards on property

**They have not had water on this property since 2023.**

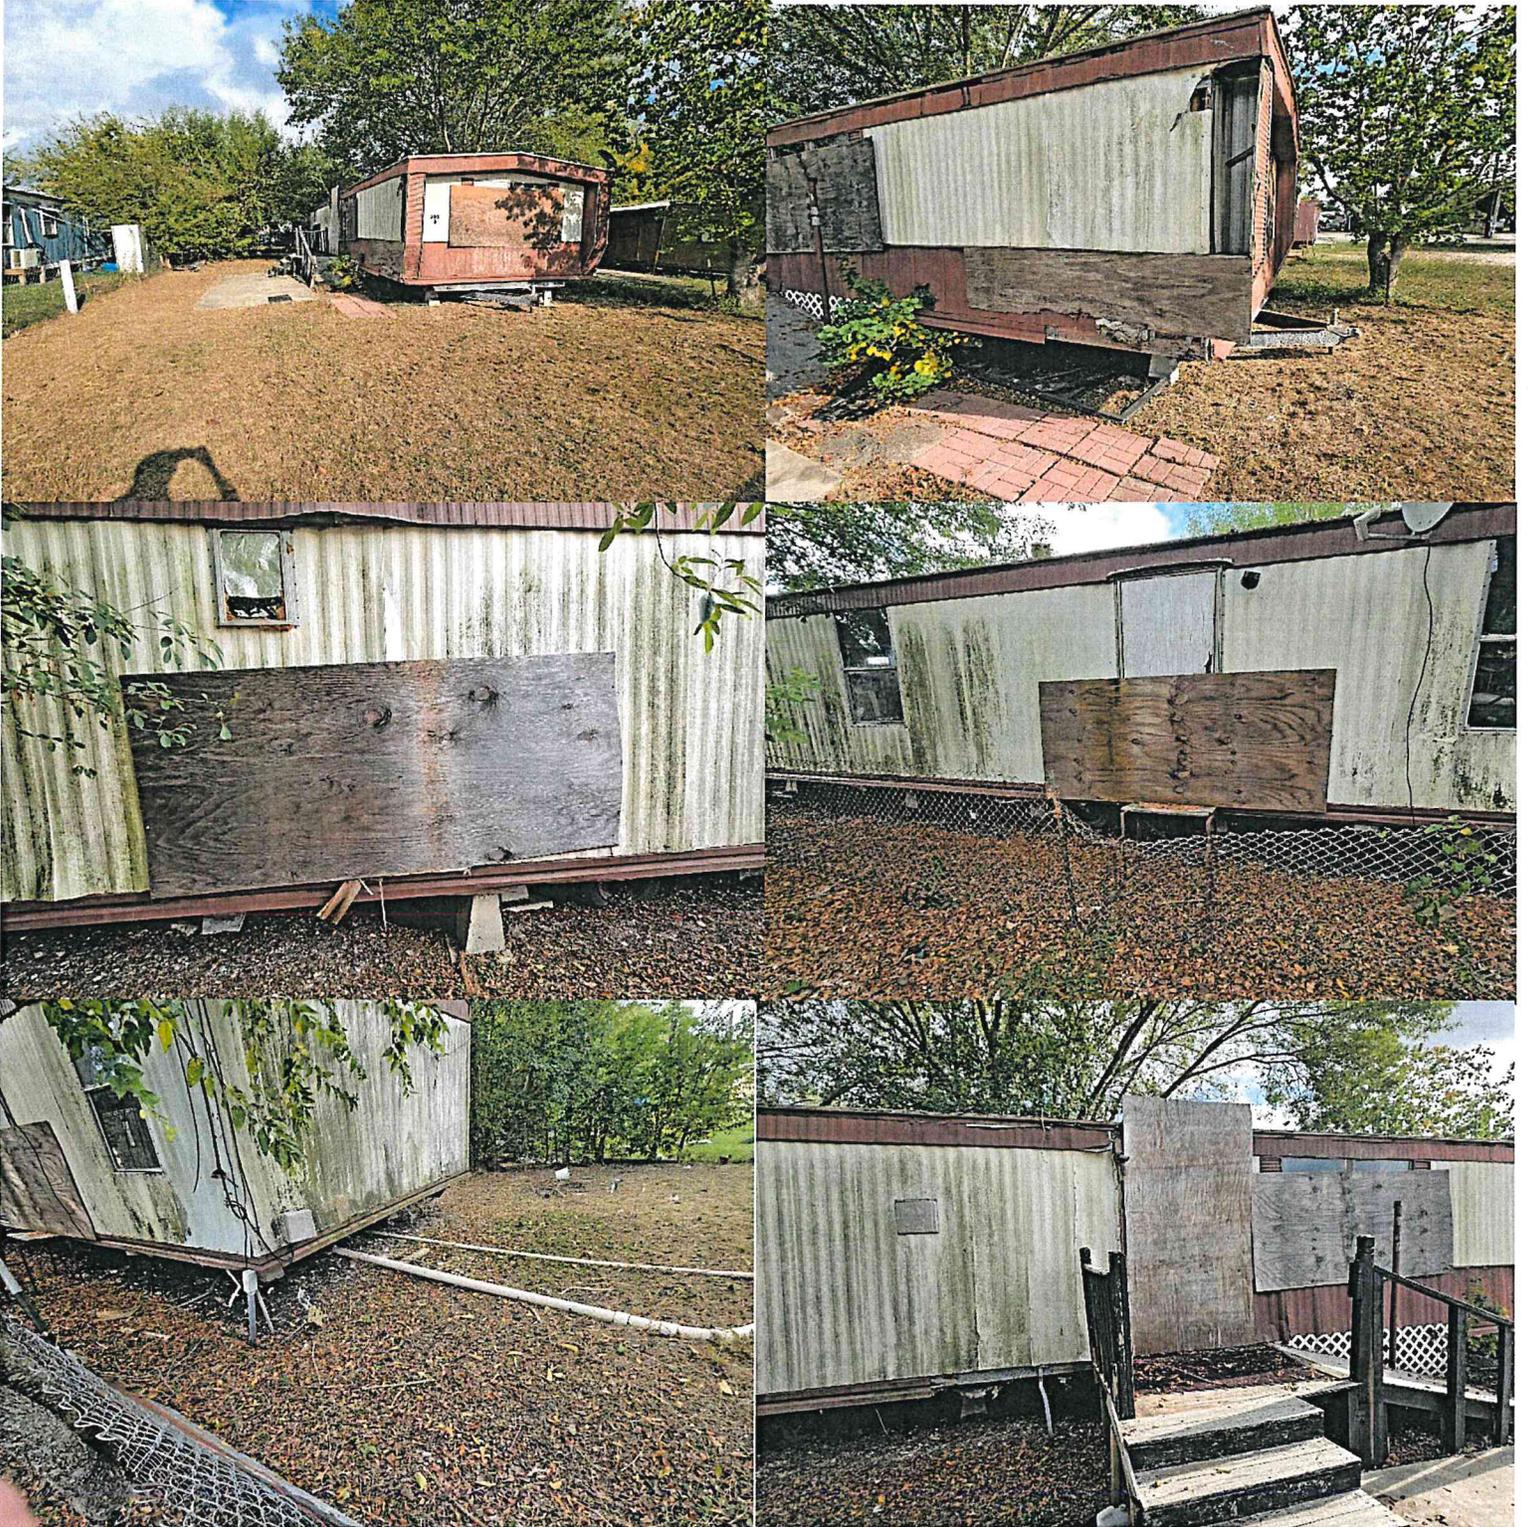
# 502 N San Antonio Trlr #3

Pass	Fail	Violation/Deficiency	Location of violation
Roof properly maintained	X			
Improper Walls, partitions or other vertical supports		X		
Fireplaces or chimneys properly maintained		N/A		
Unsecure building: vacant and open.	X		Windows broken in several places	
Lack of required rails, stairs, steps and/or balconies		X	Stairs at front door sinking and broken	
Lack of or improper exterior wall coverings		X	Exterior wall coverings warping and coming off exposing paneling underneath	
Hazardous wiring			Unable to verify	
Hazardous plumbing	X			
Hazardous mechanical equipment			Unable to verify	
Sanitation:	X			
Lack of or improper connection to required sewage disposal			Unable to verify	
Lack of or improper garbage and rubbish storage		X	No rubbish storage	
Standing or stagnant water	X			
Improper Drainage	X			
Improper Occupancy	X			
Inadequate exits	X			
Improper Fireplace or Chimney	X

Improper Ceiling or Ceiling supports	X			
Improper Flooring or floor supports		X	Floor coverings missing or damaged	
Improper Foundation	X			
Vermin/Insects		X	Evidence of rodents and vermin	
Dampness of habitable space	X			
Lack of electrical lighting		X	No electric	
Hot and Cold Water		X	No water	
Lack of or Improper Kitchen		X	No water or electric	
Lack of or Improper bathroom		X	No toilet or shower properly installed	
Dead trees, tree limbs, holes, excavations or other conditions reasonably capable of causing injury to a person.		X	Holes and other tripping hazards on property

This property is vacant and has no water or electricity.

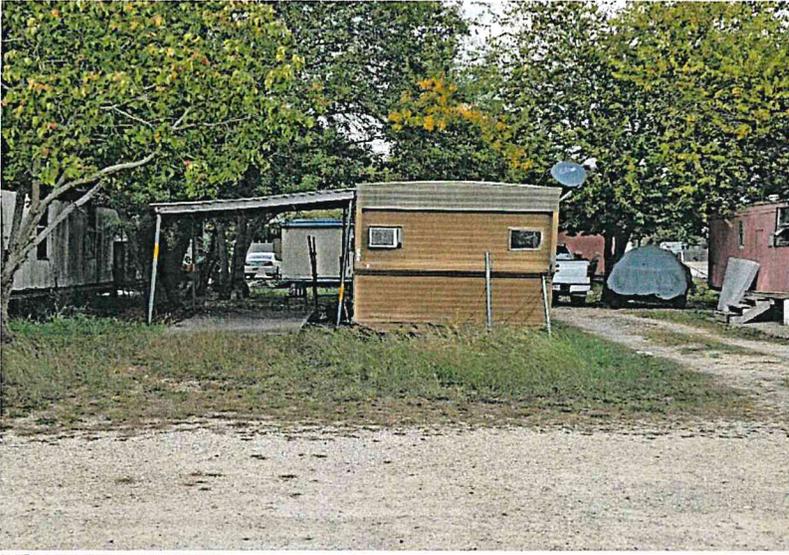
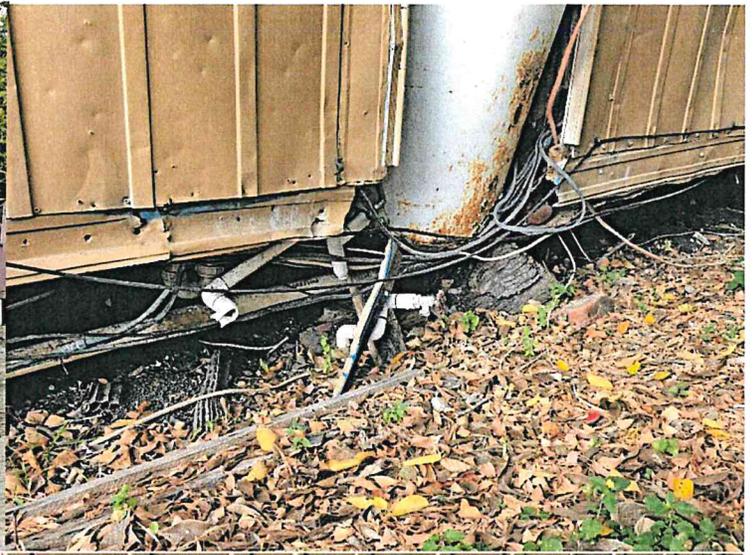
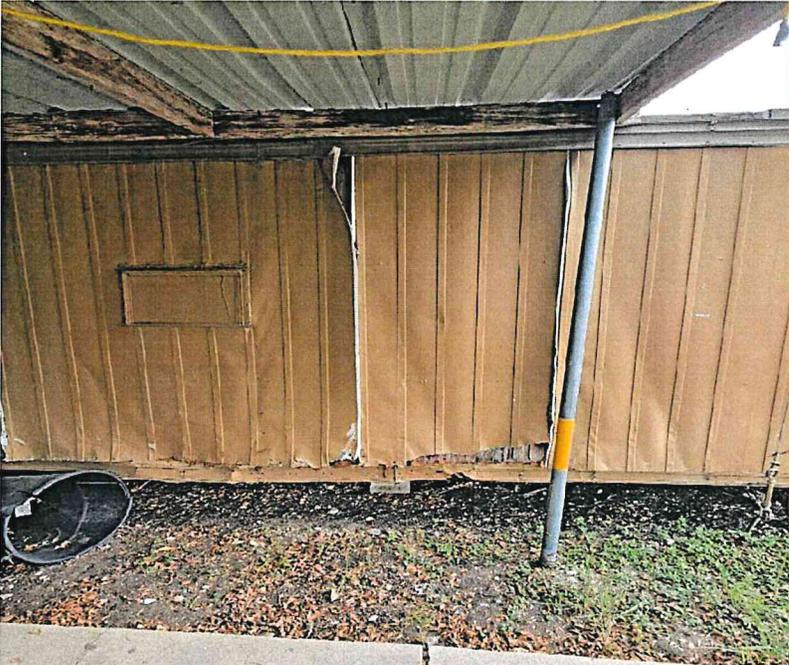
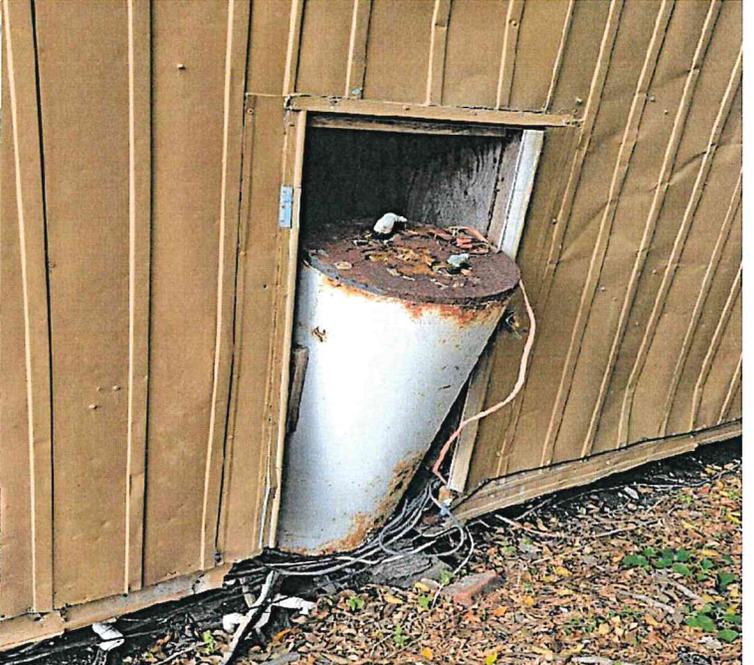
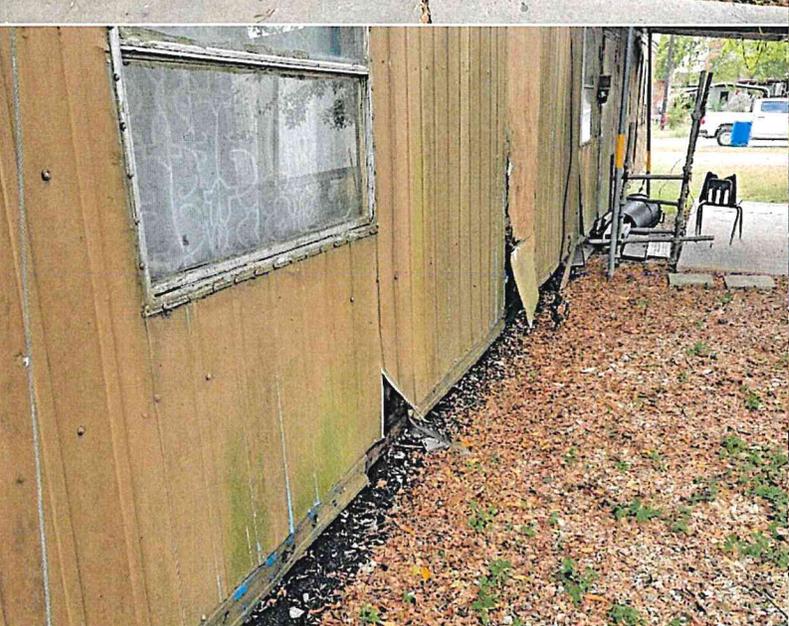
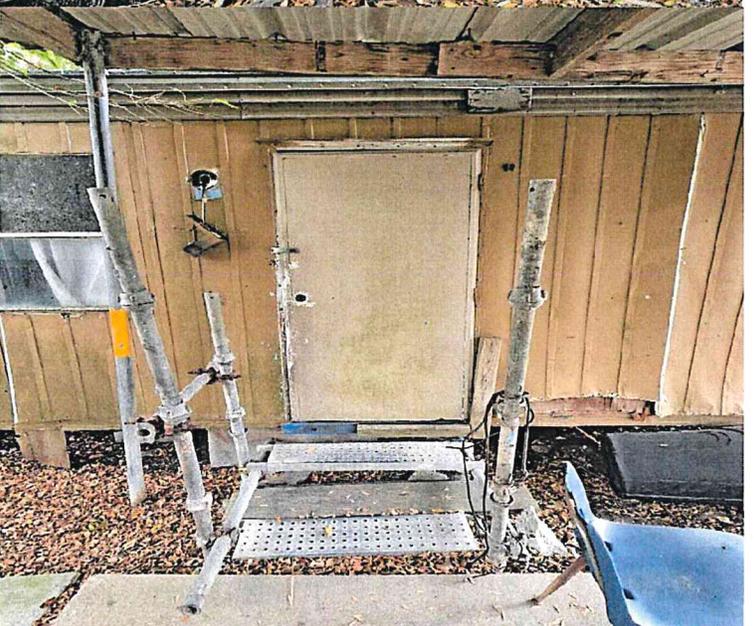
# 502 N San Antonio St. Trlr #2

Pass	Fail	Violation/Deficiency	Location of violation
Roof properly maintained	X			
Improper Walls, partitions or other vertical supports		X		
Fireplaces or chimneys properly maintained		N/A		
Unsecure building: vacant and open.	X		Windows broken in several places	
Lack of required rails, stairs, steps and/or balconies		X	Stairs at front door sinking and broken	
Lack of or improper exterior wall coverings		X	Exterior wall coverings warping and coming off exposing paneling underneath	
Hazardous wiring			Unable to verify	
Hazardous plumbing		X	Water heater falling out of structure	
Hazardous mechanical equipment			Unable to verify	
Sanitation:	X			
Lack of or improper connection to required sewage disposal			Unable to verify	
Lack of or improper garbage and rubbish storage		X	No rubbish storage	
Standing or stagnant water	X			
Improper Drainage	X			
Improper Occupancy	X			
Inadequate exits	X			
Improper Fireplace or Chimney	X

Improper Ceiling or Ceiling supports	X			
Improper Flooring or floor supports		X	Floor coverings missing or damaged	
Improper Foundation	X			
Vermin/Insects		X	Evidence of rodents and vermin	
Dampness of habitable space	X			
Lack of electrical lighting		X	No electric	
Hot and Cold Water		X	No water	
Lack of or Improper Kitchen		X	No water or electric	
Lack of or Improper bathroom		X	No toilet or shower properly installed	
Dead trees, tree limbs, holes, excavations or other conditions reasonably capable of causing injury to a person.		X	Holes and other tripping hazards on property

This property is vacant has no water or electric.
