Exhibit F
Case No. Z19-0005

Alders at Prosper

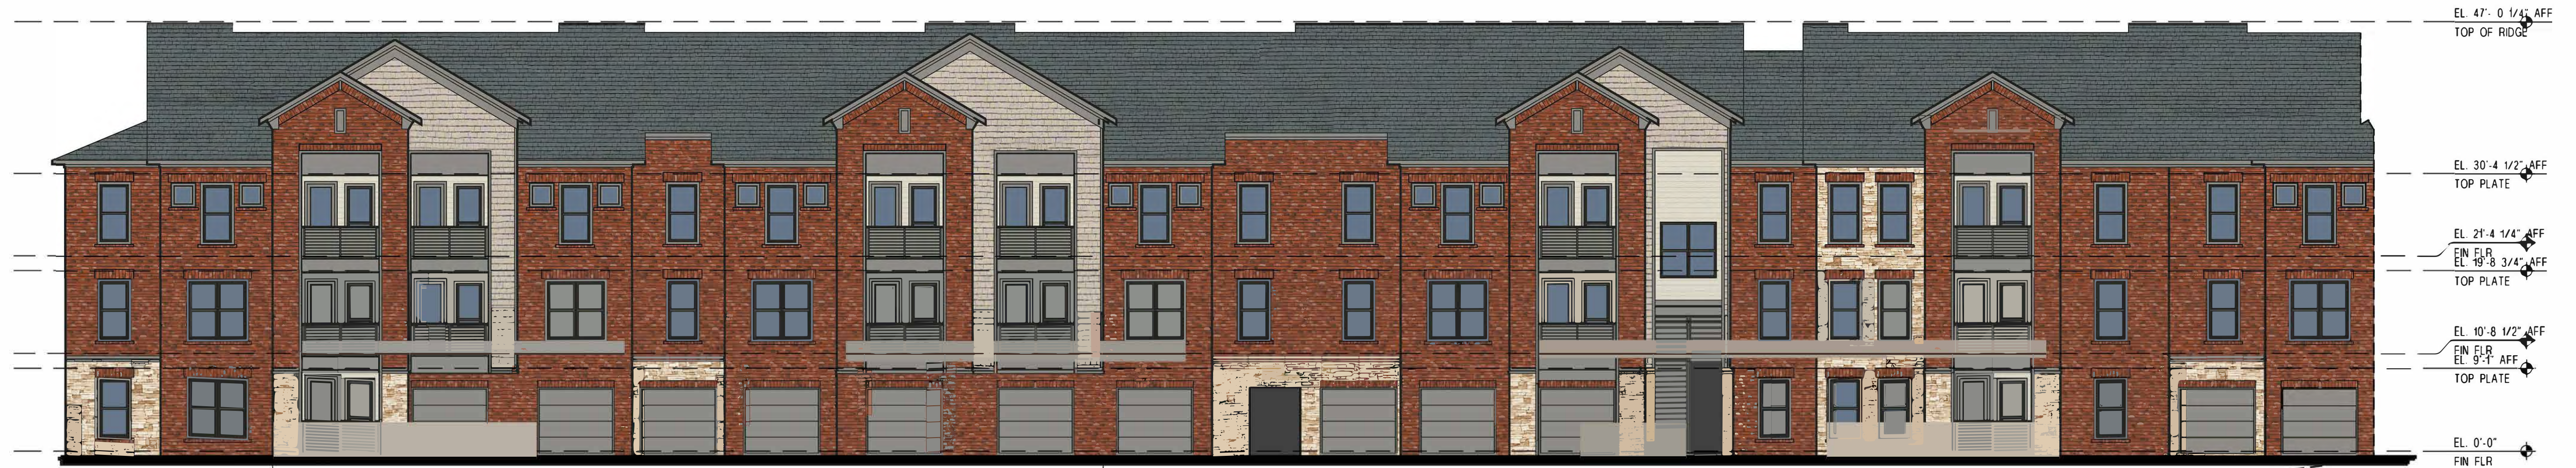
09 Elevation
SCALE: 3/32" = 1'-0"

PERCENTAGE	MATERIAL
16%	GRANBURY STONE
79%	'OLD TOWN' BRICK
5%	CEMENT FIBER BOARD

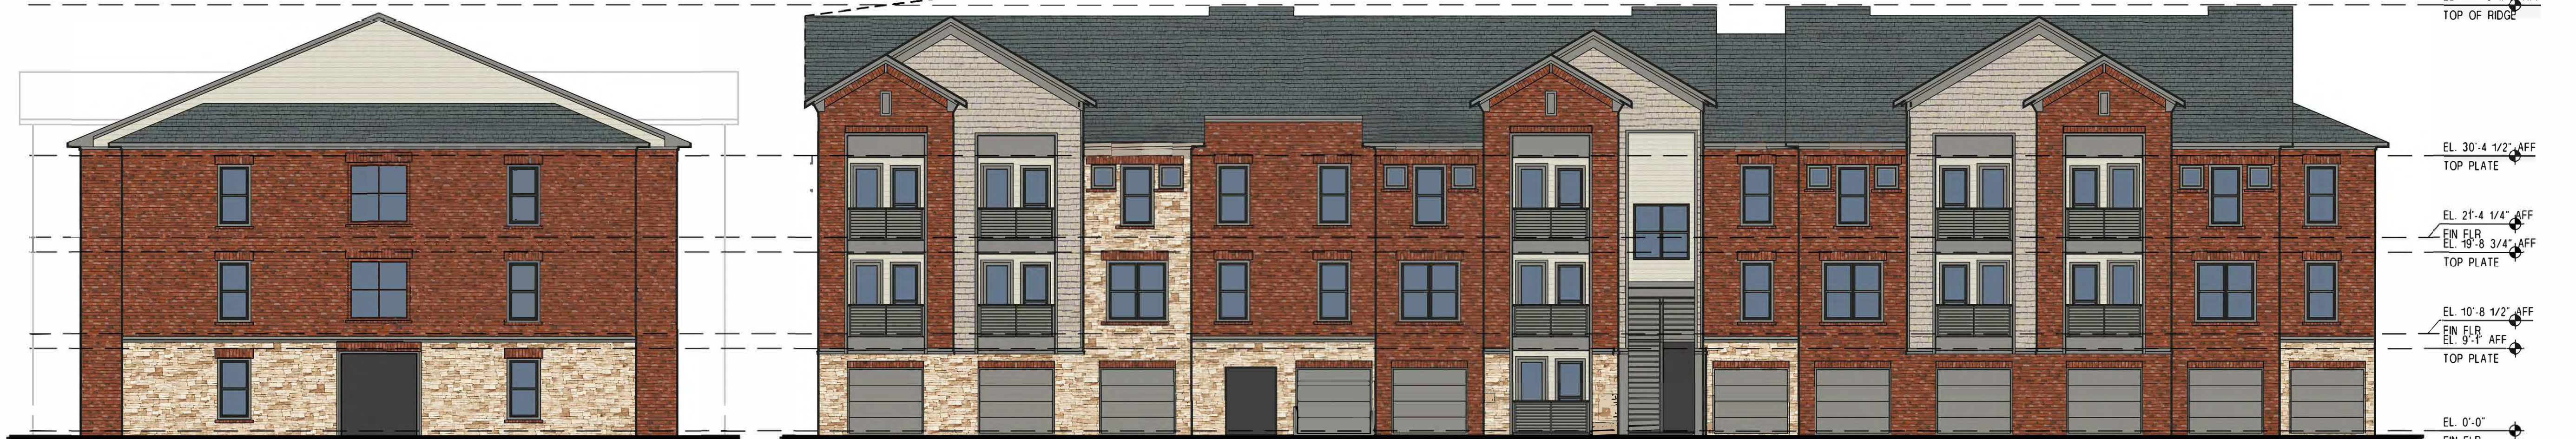
07 Elevation
SCALE: 3/32" = 1'-0"

PERCENTAGE	MATERIAL
20%	GRANBURY STONE
78%	'OLD TOWN' BRICK
2%	CEMENT FIBER BOARD

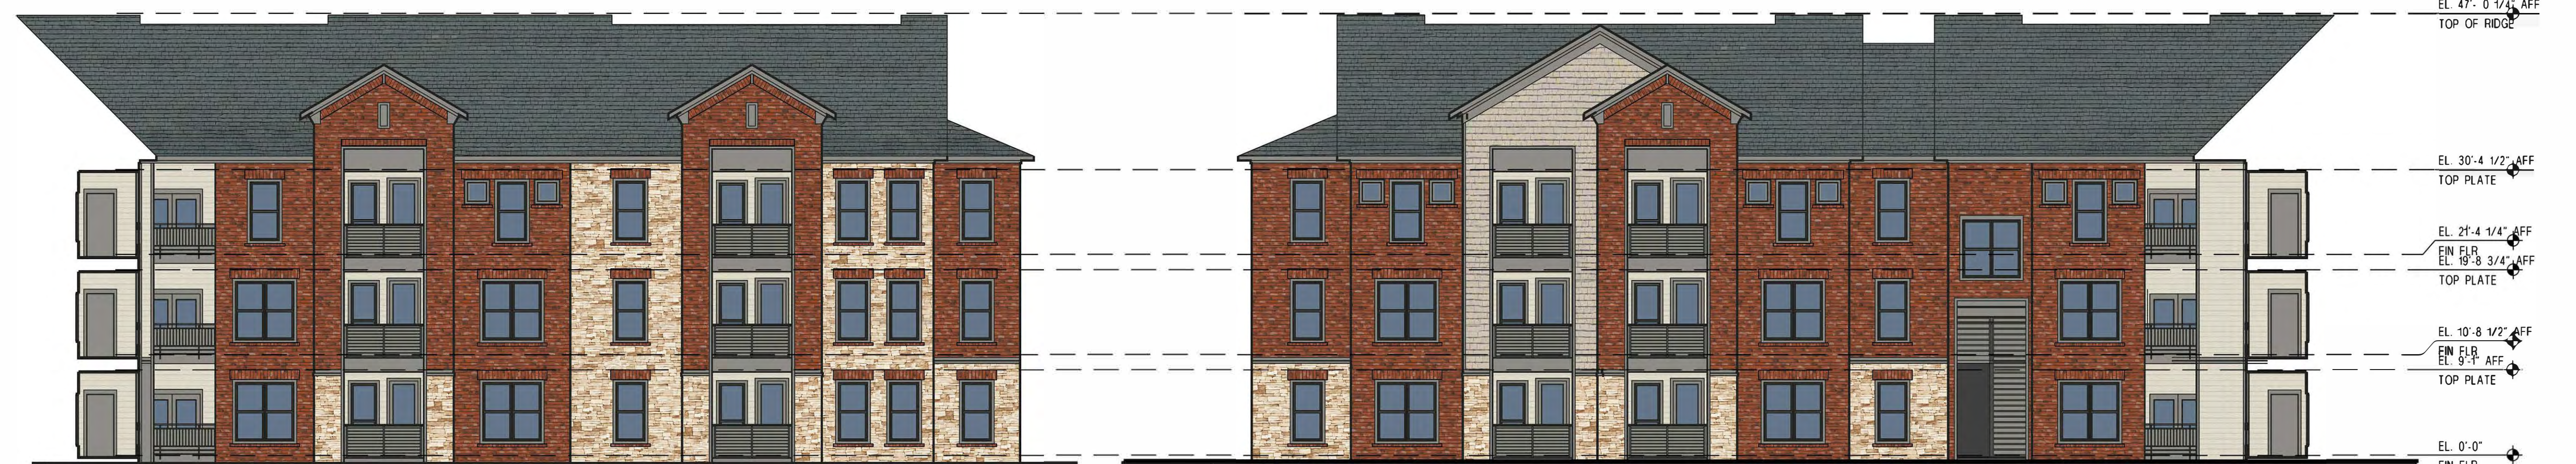
02 Elevation
SCALE: 3/32" = 1'-0"

PERCENTAGE	MATERIAL
34%	GRANBURY STONE
65%	'OLD TOWN' BRICK
1%	CEMENT FIBER BOARD

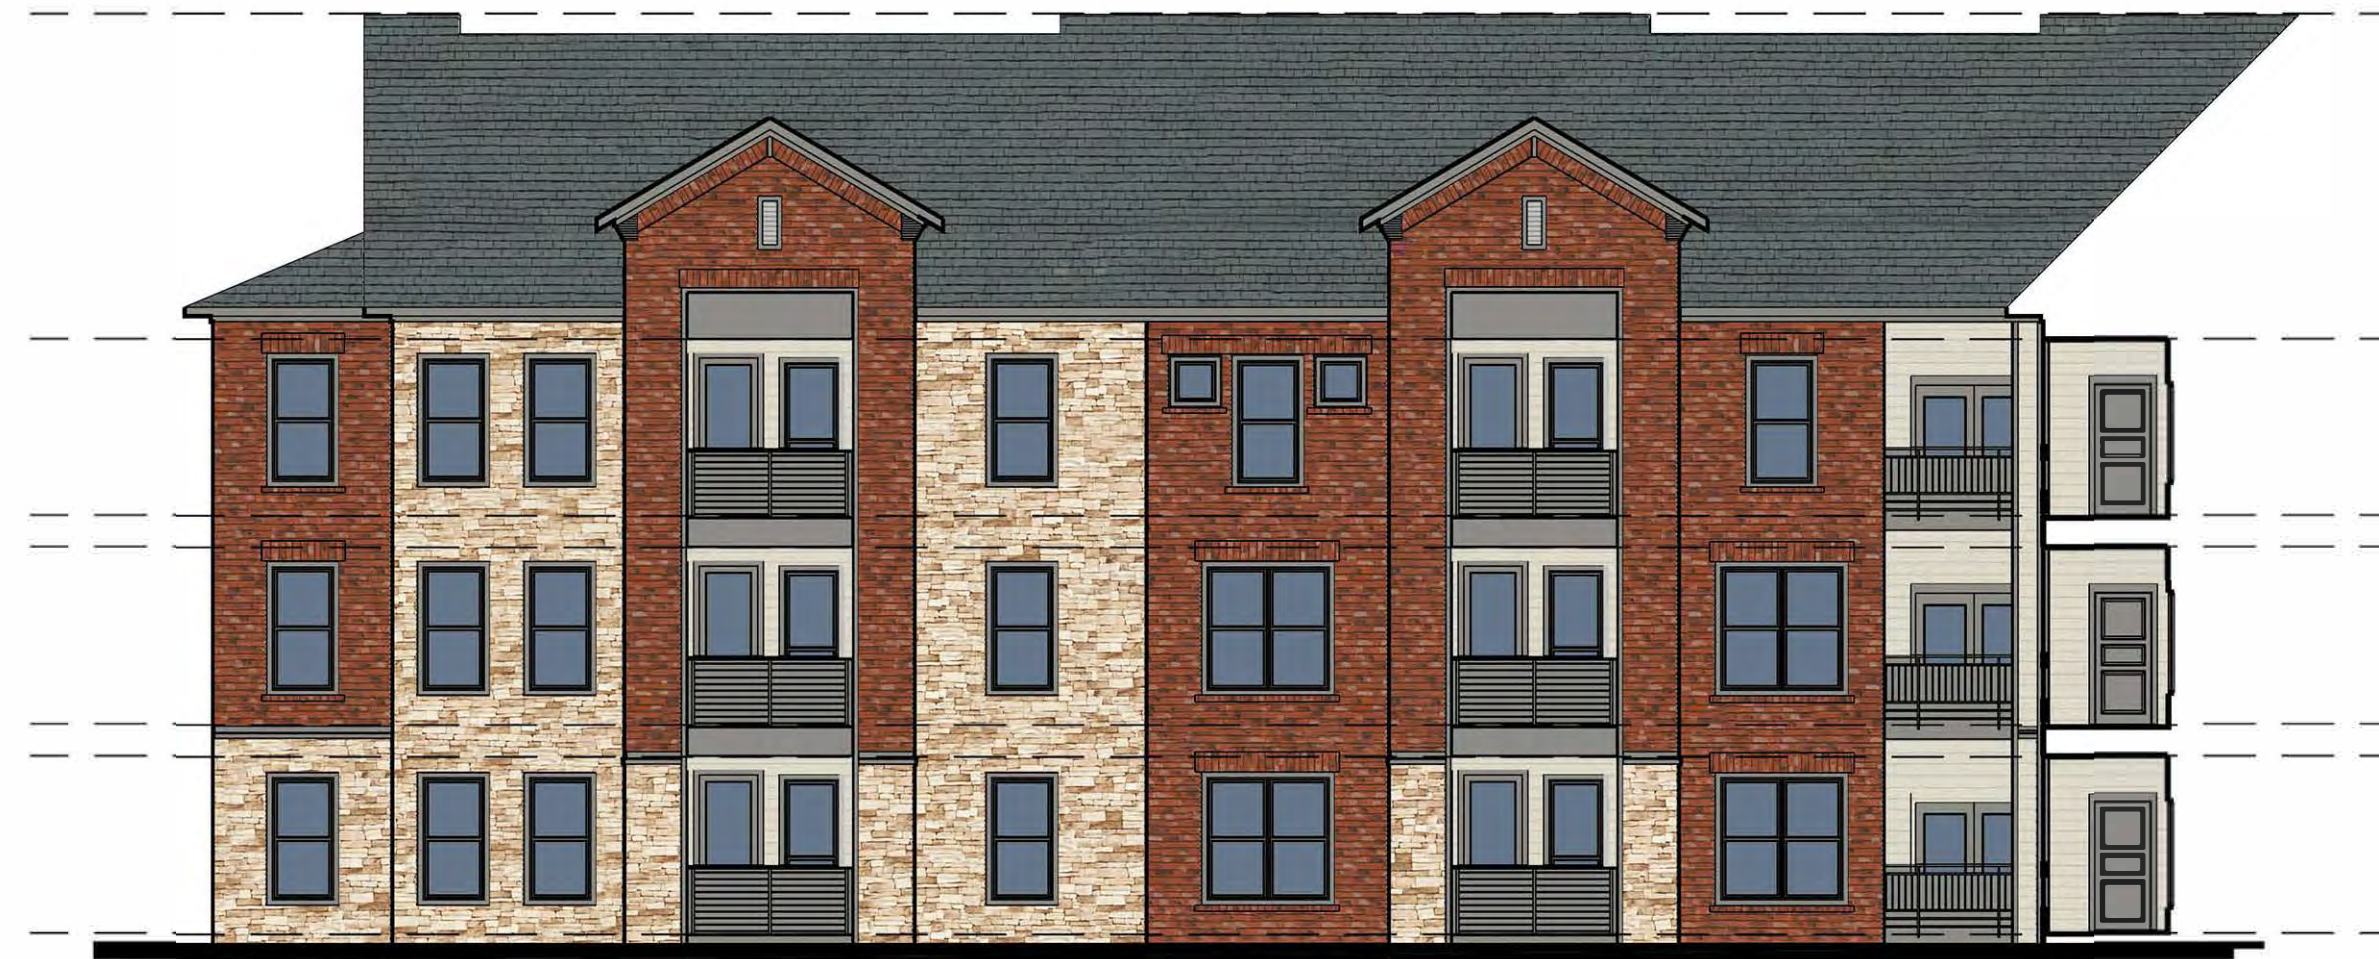
11 Elevation
SCALE: 3/32" = 1'-0"

PERCENTAGE	MATERIAL
40%	GRANBURY STONE
59%	'OLD TOWN' BRICK
1%	CEMENT FIBER BOARD

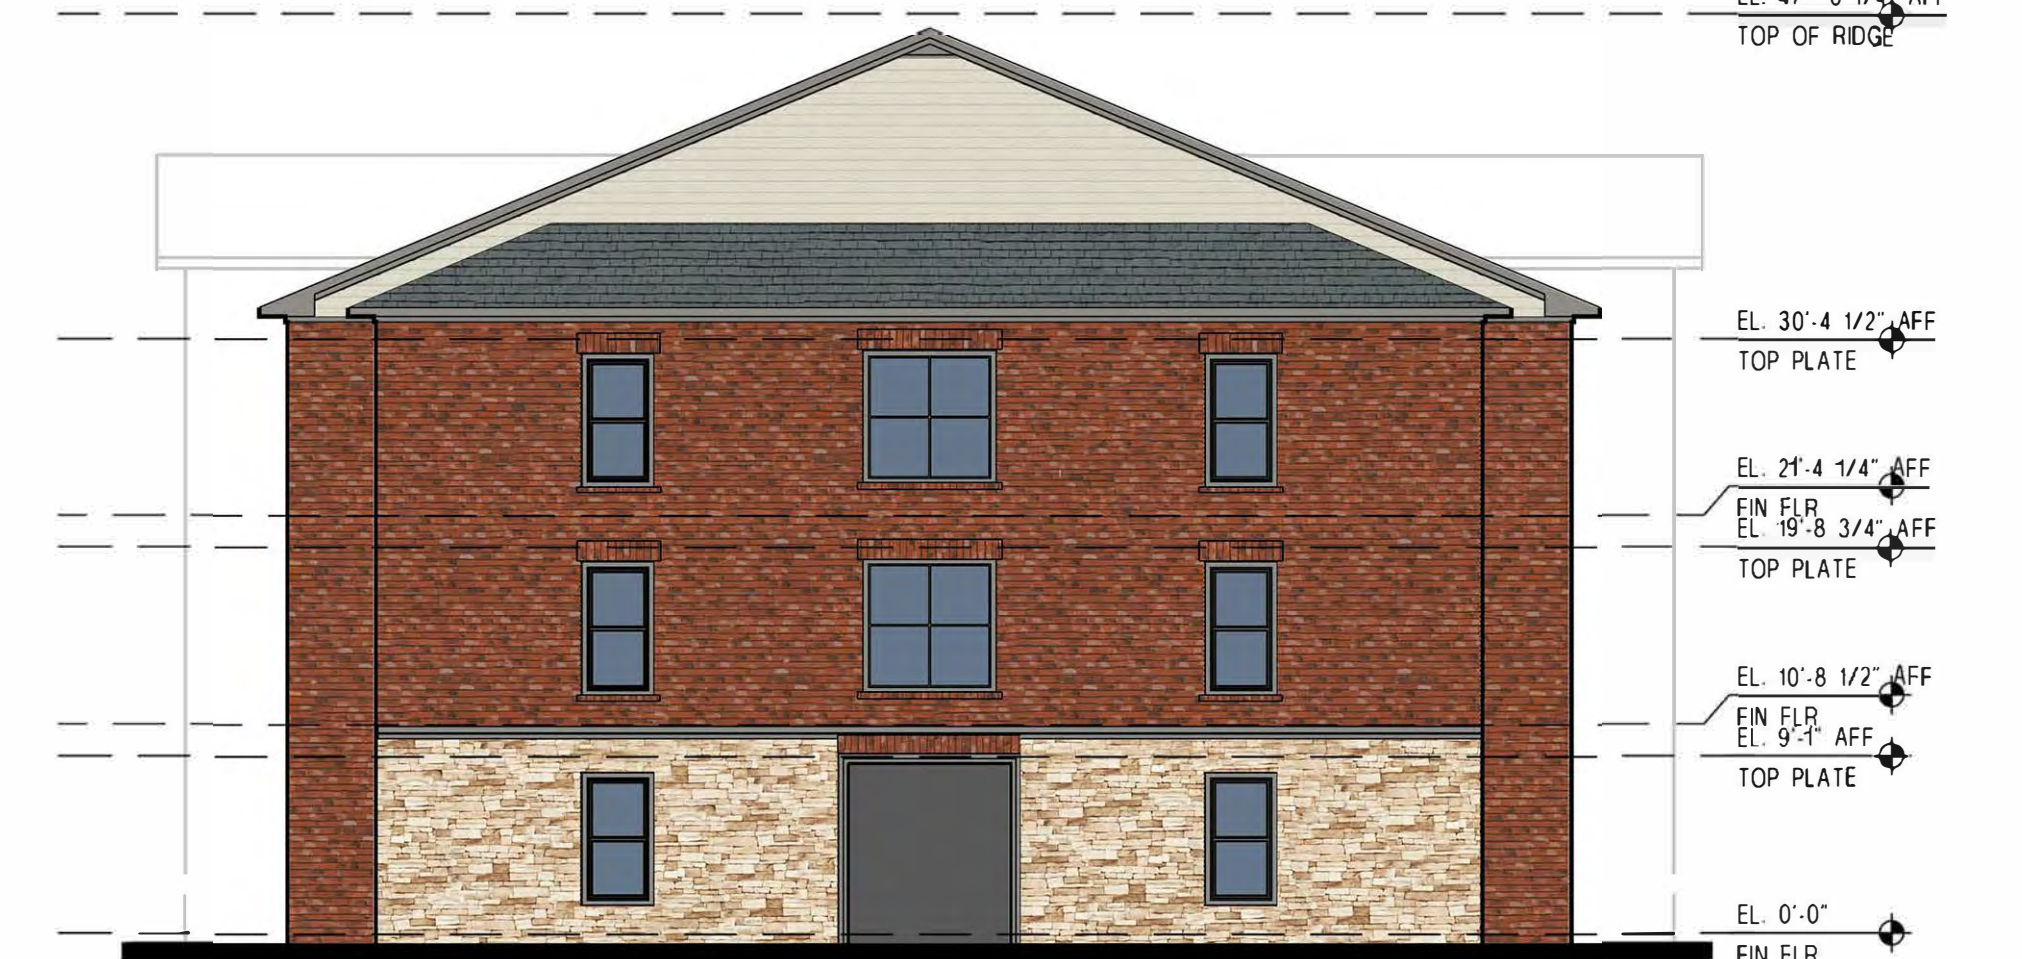
09 Elevation
SCALE: 3/32" = 1'-0"

PERCENTAGE	MATERIAL
20%	GRANBURY STONE
78%	'OLD TOWN' BRICK
2%	CEMENT FIBER BOARD

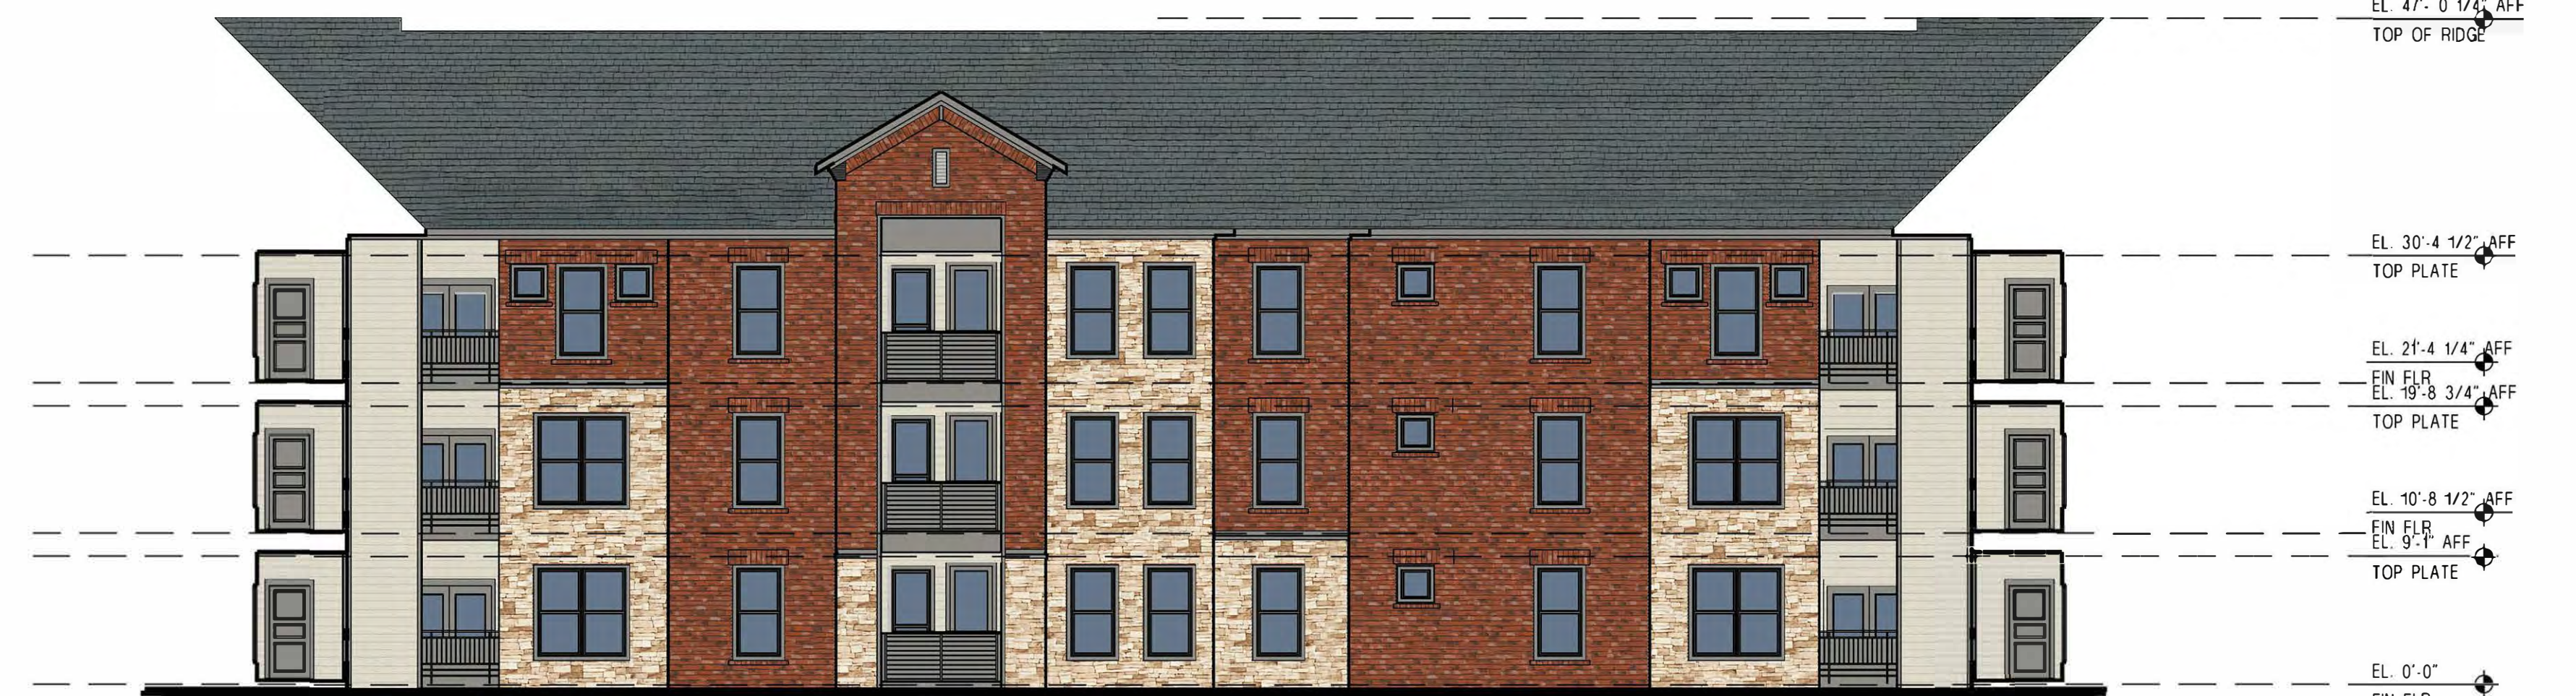
05 Elevation
SCALE: 3/32" = 1'-0"

PERCENTAGE	MATERIAL
37%	GRANBURY STONE
59%	'OLD TOWN' BRICK
4%	CEMENT FIBER BOARD

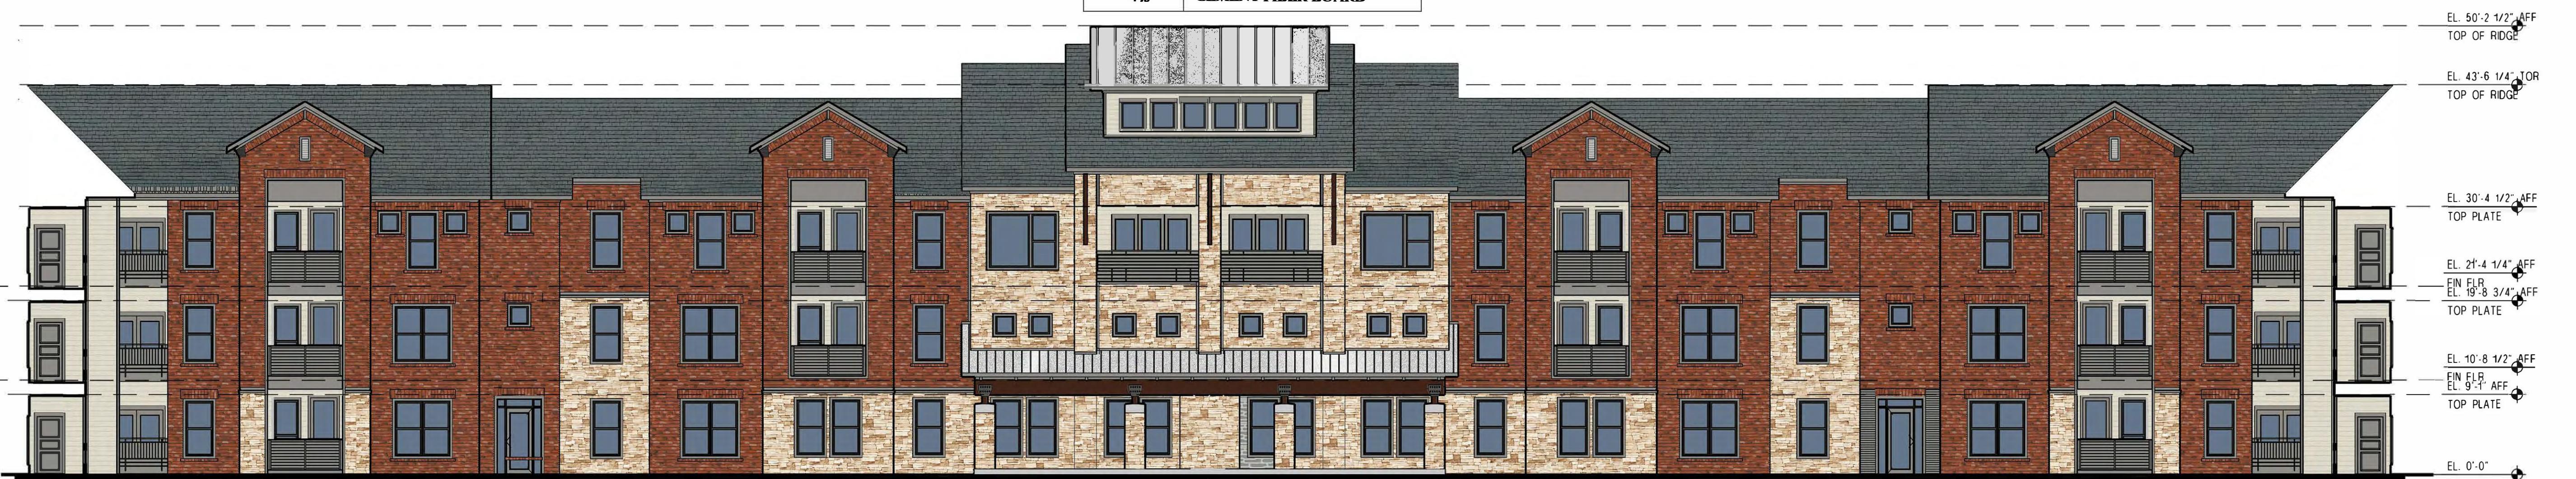
01 Elevation
SCALE: 3/32" = 1'-0"

PERCENTAGE	MATERIAL
41%	GRANBURY STONE
57%	'OLD TOWN' BRICK
2%	CEMENT FIBER BOARD

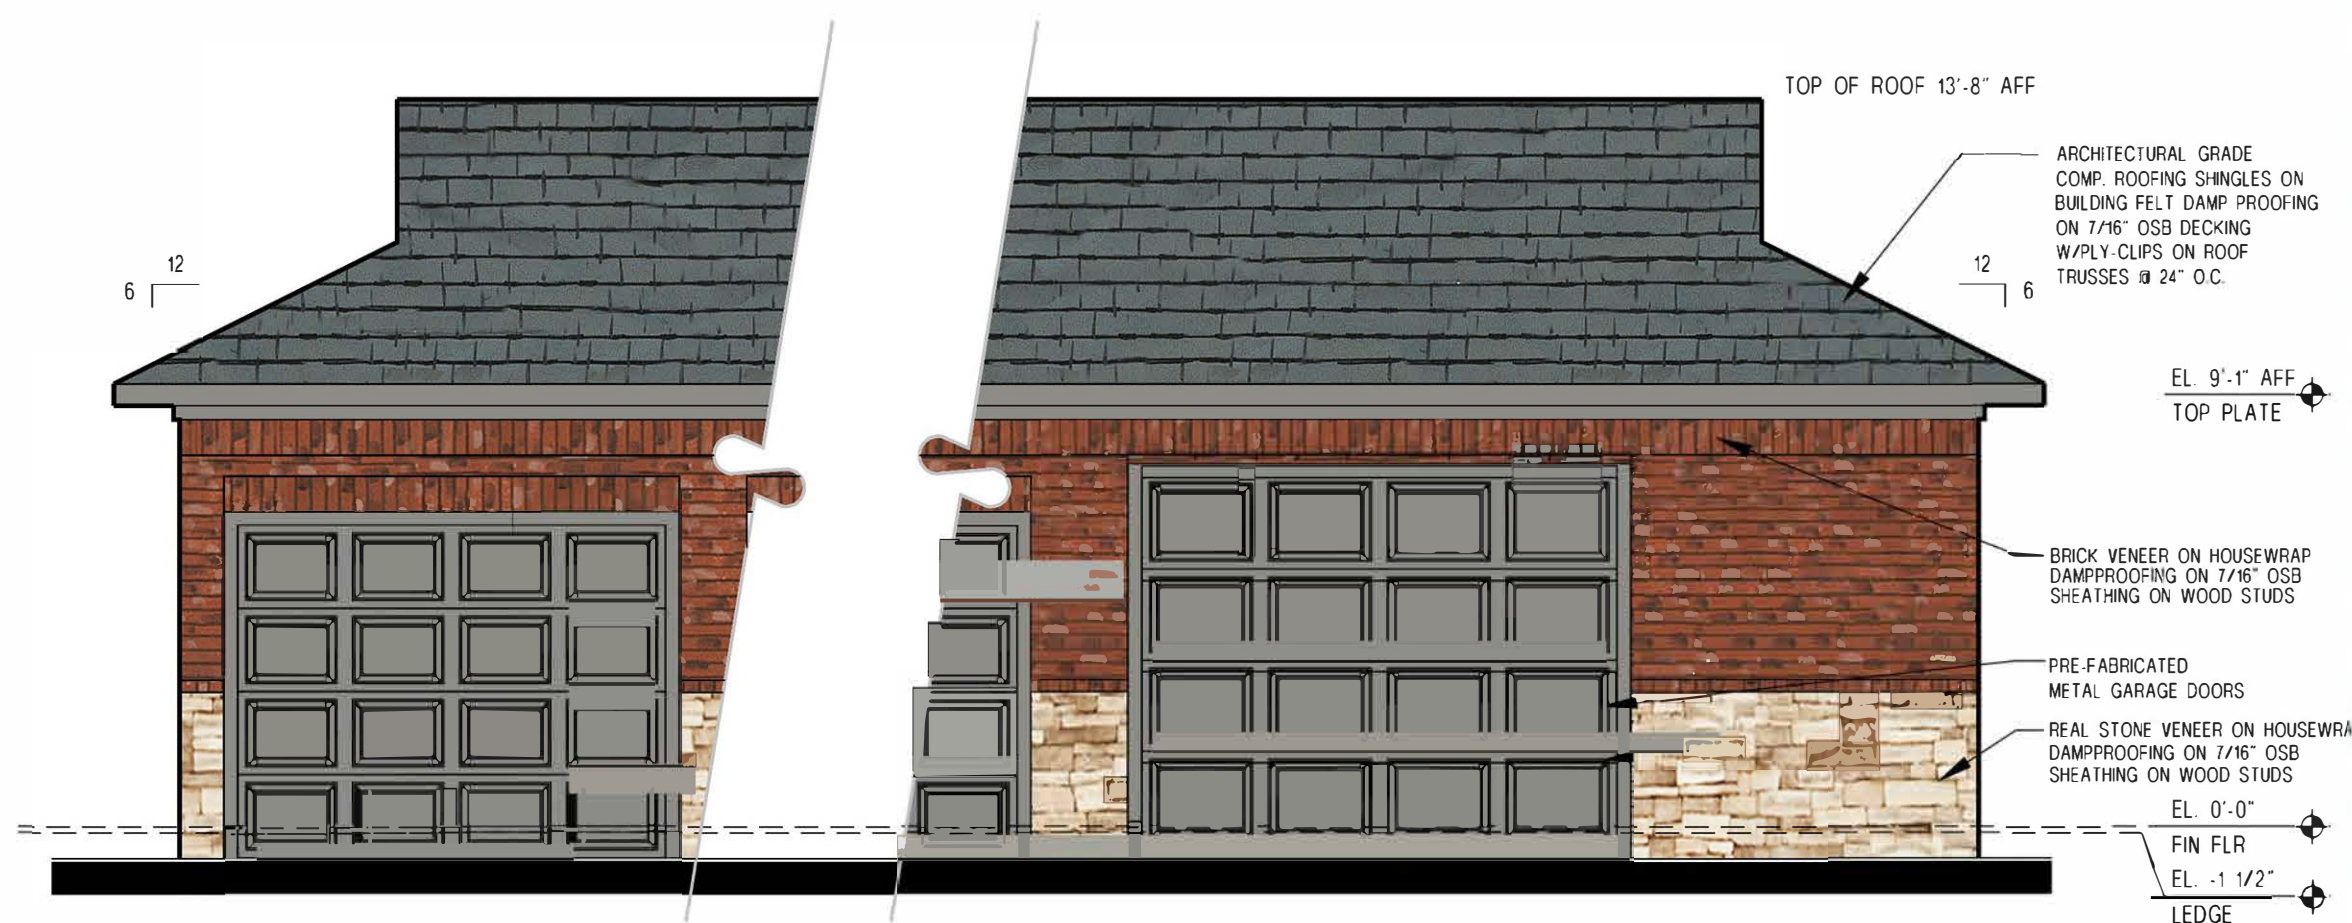
16 Detached Garage Elevation - With HC Bay
SCALE: 3/8" = 1'-0"

PERCENTAGE	MATERIAL
78%	'OLD TOWN' BRICK
22%	GRANDBURY STONE

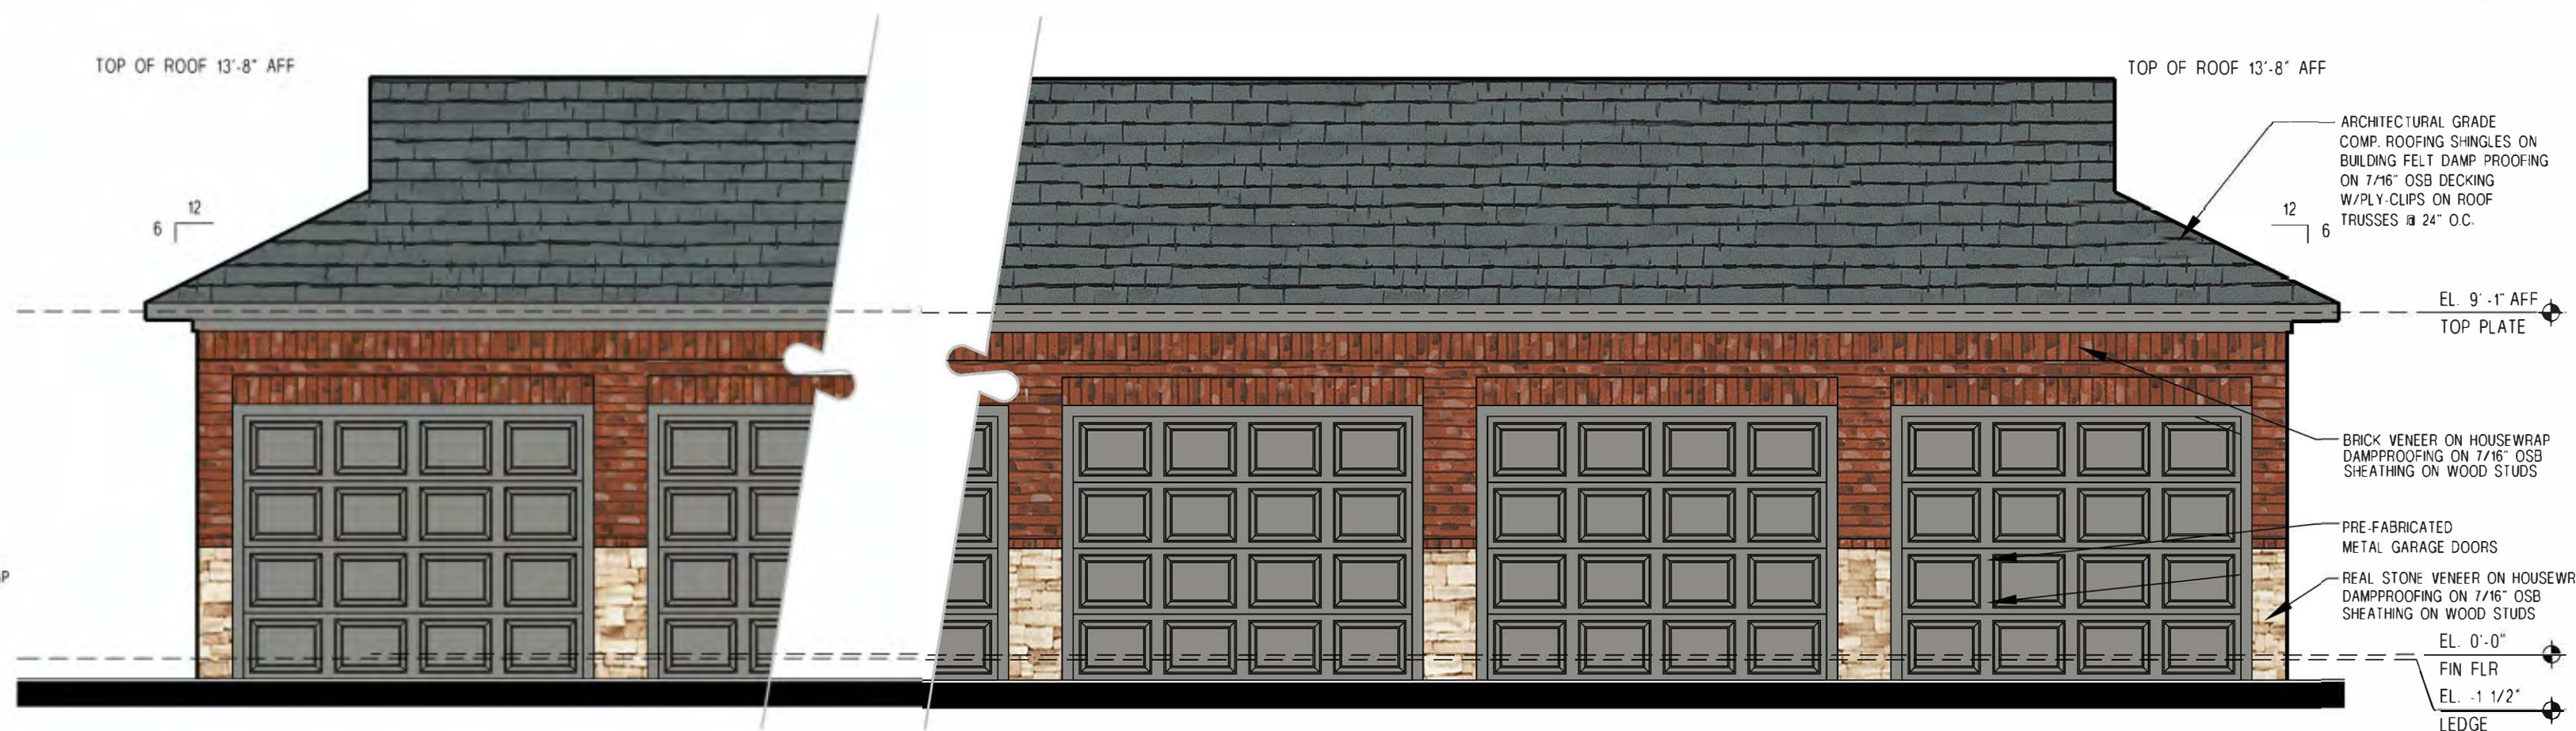
13 Detached Garage Elevation
SCALE: 3/8" = 1'-0"

PERCENTAGE	MATERIAL
82%	'OLD TOWN' BRICK
18%	GRANDBURY STONE

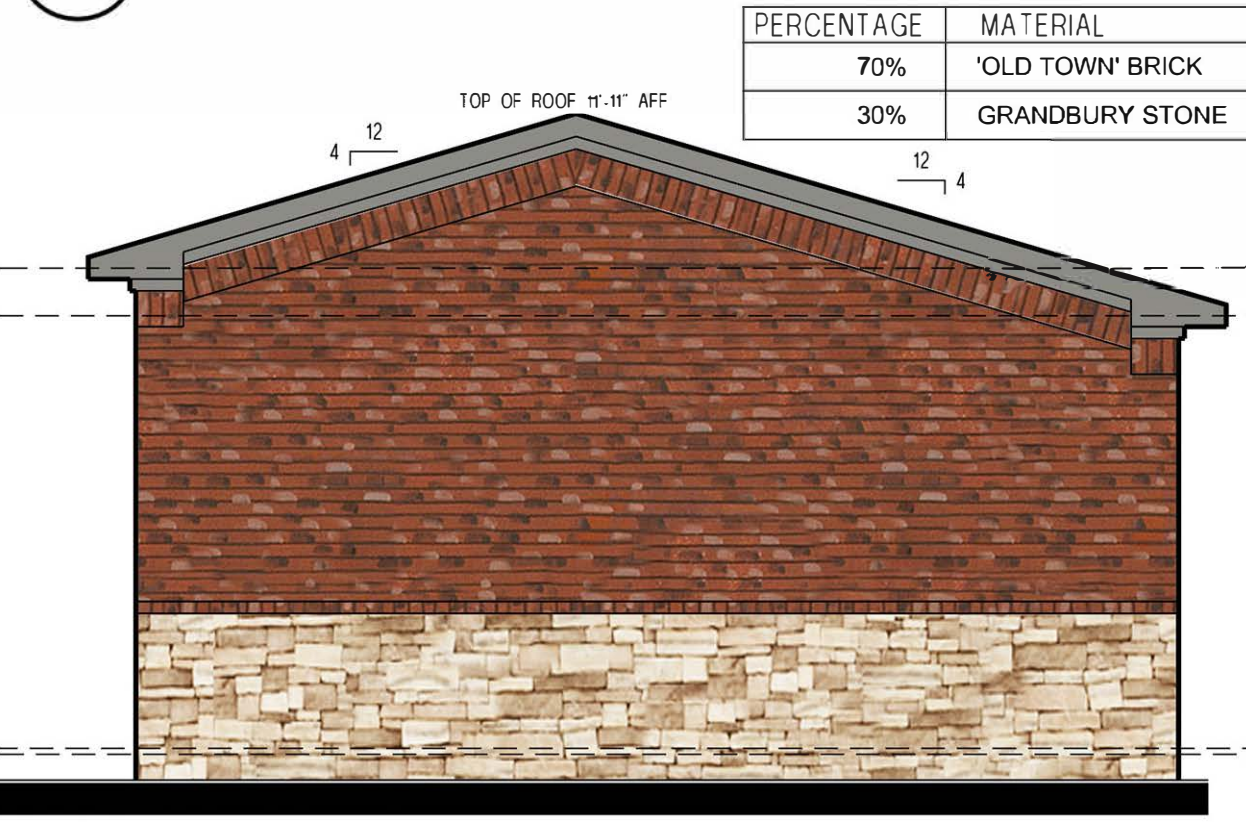
12 Side Elevation - Boiler / Maint.
SCALE: 3/8" = 1'-0"

PERCENTAGE	MATERIAL
70%	'OLD TOWN' BRICK
30%	GRANDBURY STONE

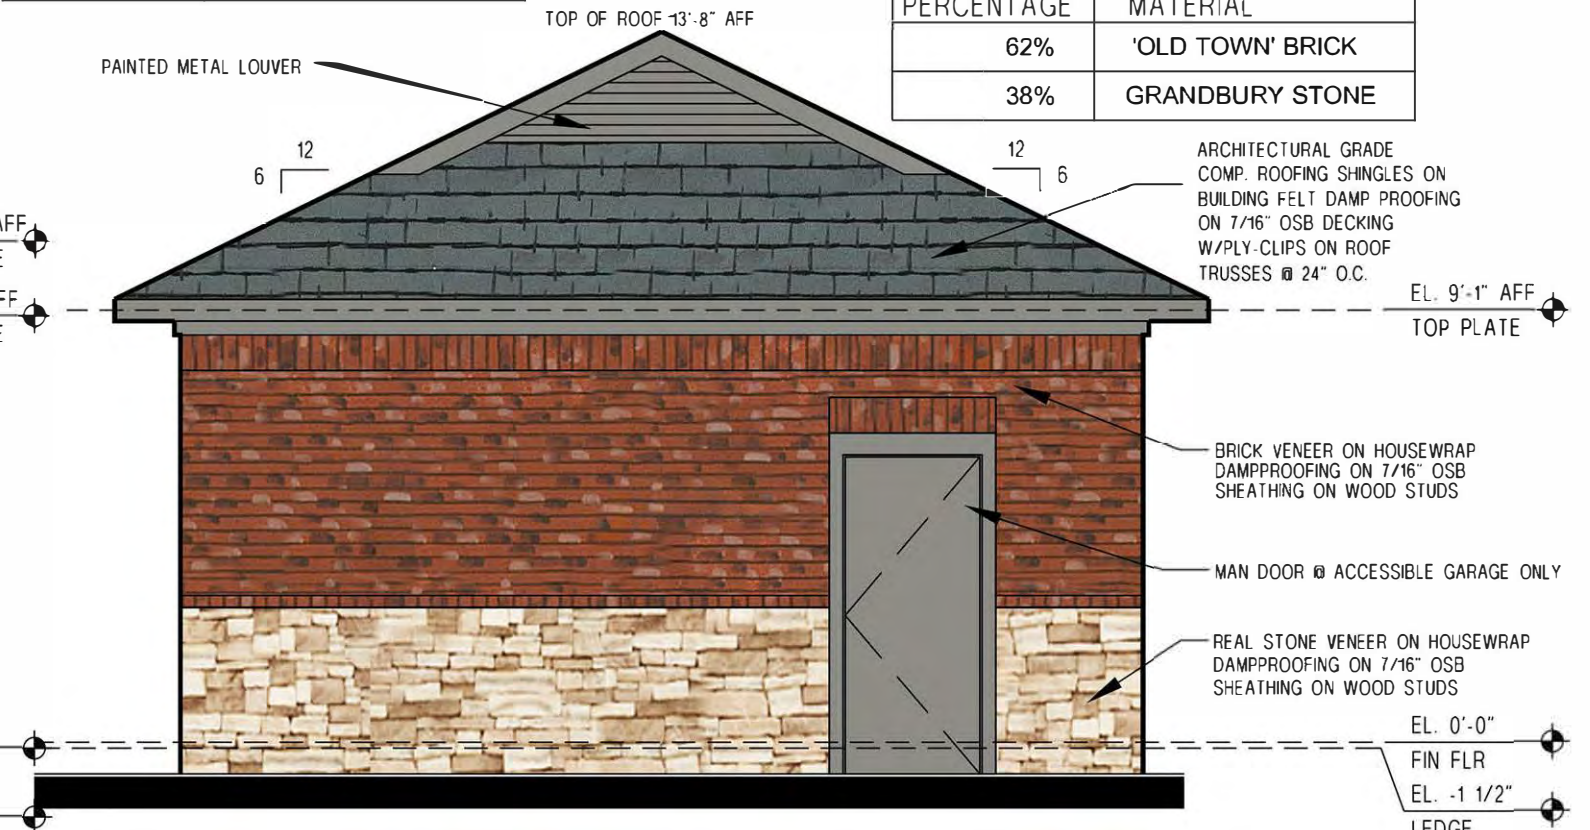
11 Typ. Detached Garage Elevation - Side
SCALE: 3/8" = 1'-0"

PERCENTAGE	MATERIAL
62%	'OLD TOWN' BRICK
38%	GRANDBURY STONE

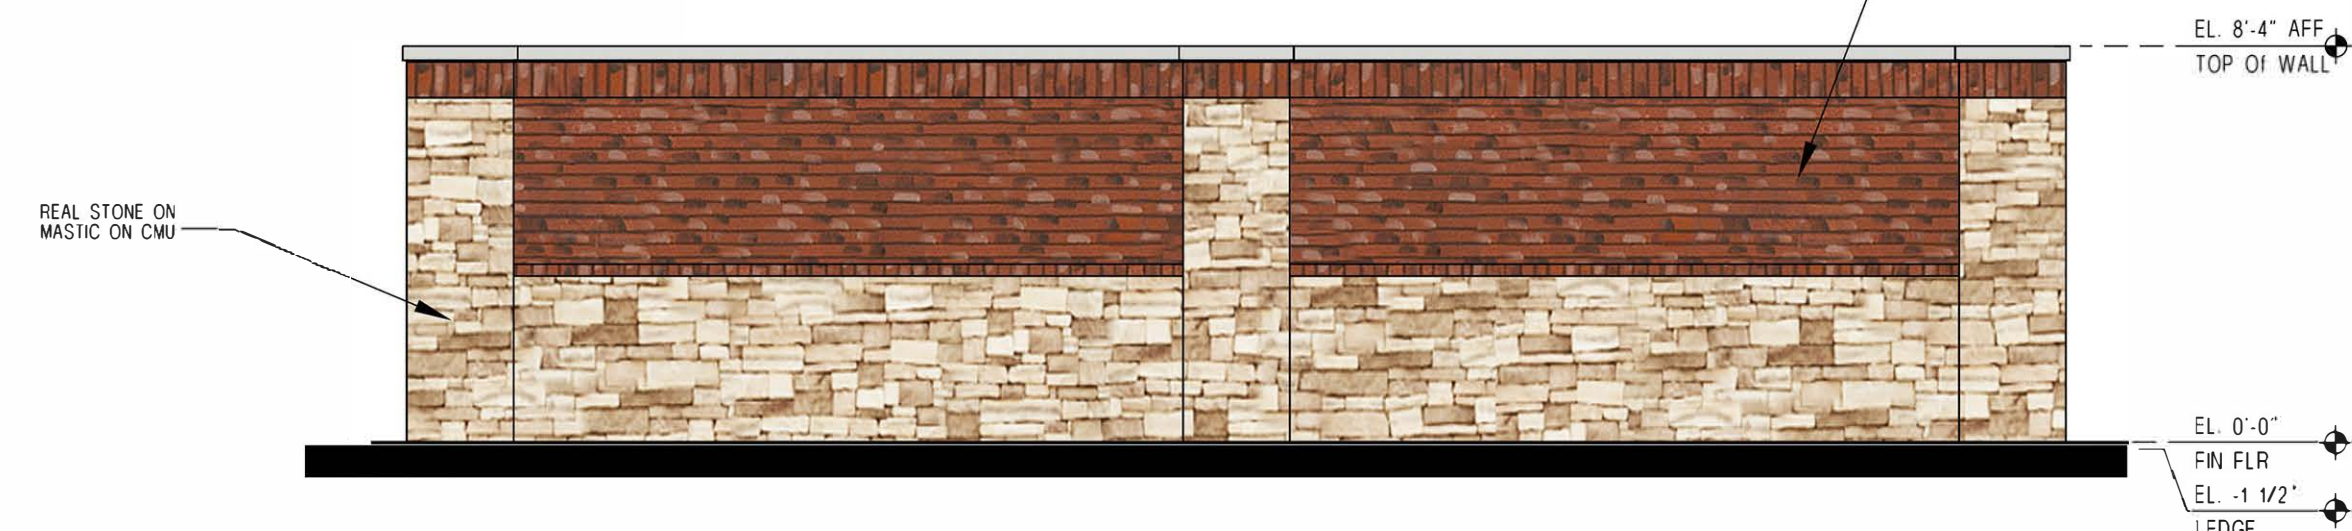
09 Elevation Side - Trash
SCALE: 3/8" = 1'-0"

PERCENTAGE	MATERIAL
47%	'OLD TOWN' BRICK
53%	GRANDBURY STONE

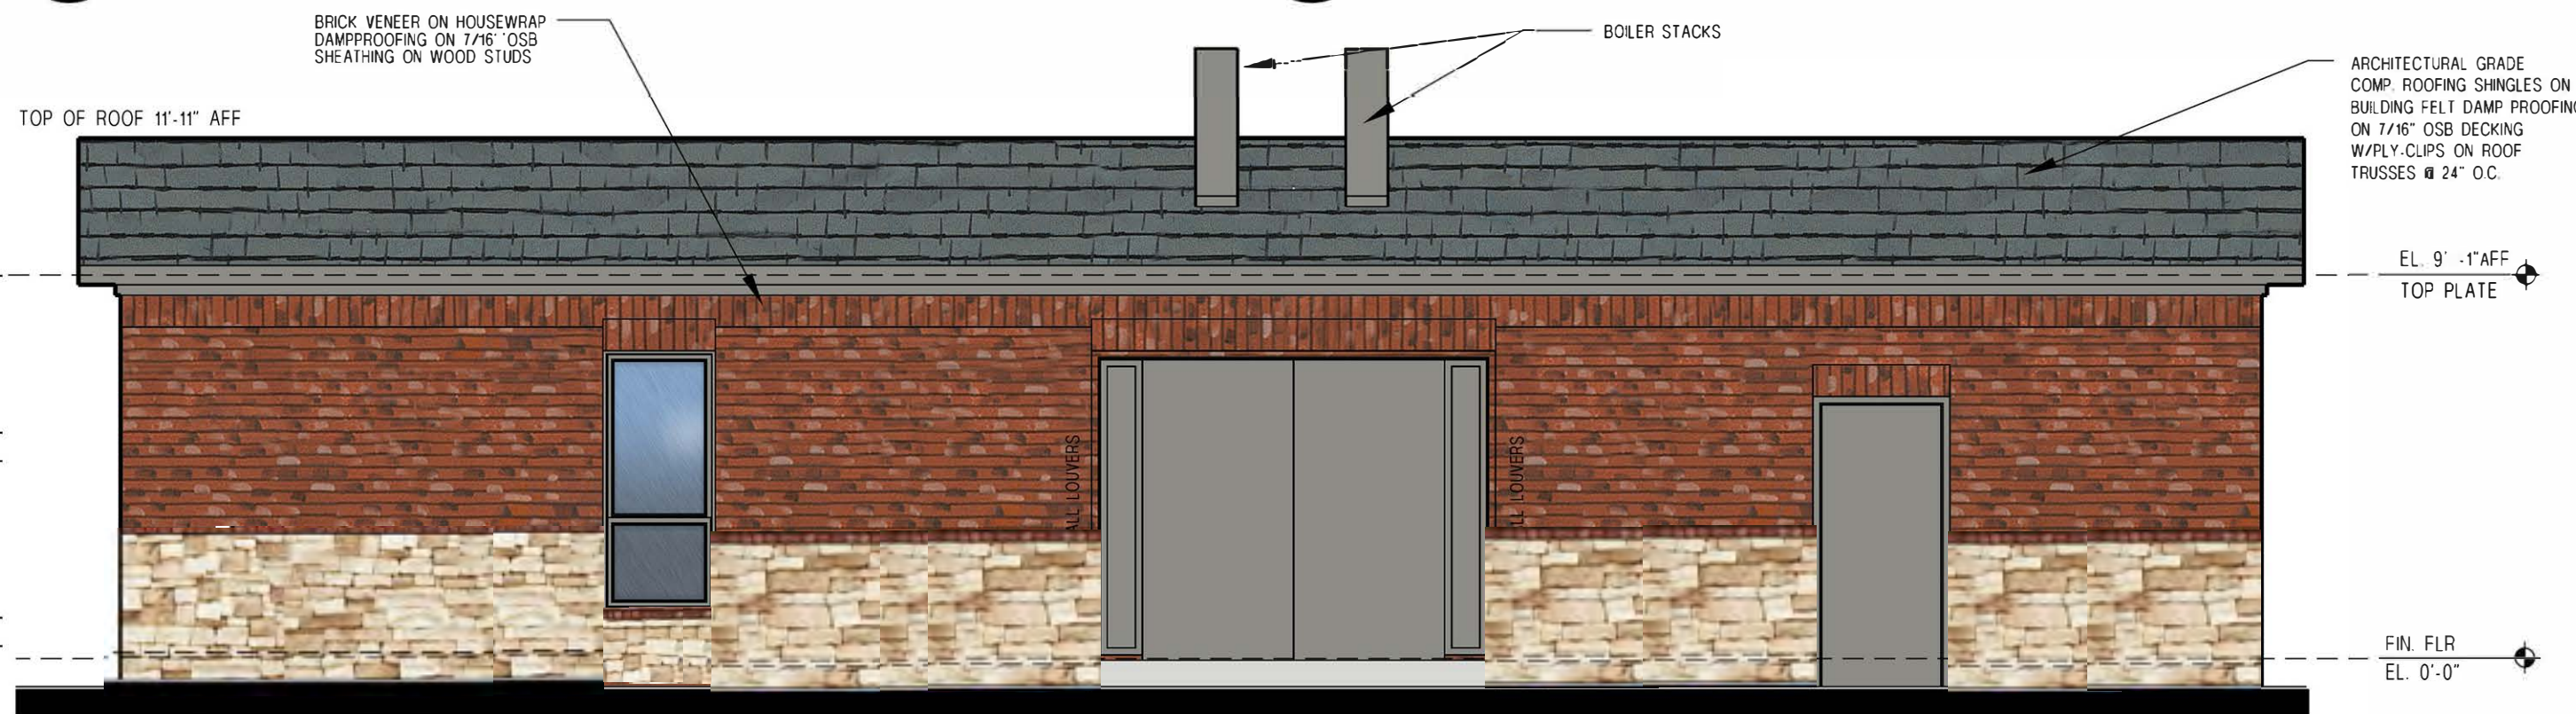
07 Rear Elevation - Boiler / Maint.
SCALE: 3/8" = 1'-0"

PERCENTAGE	MATERIAL
100%	'OLD TOWN' BRICK
0%	GRANDBURY STONE

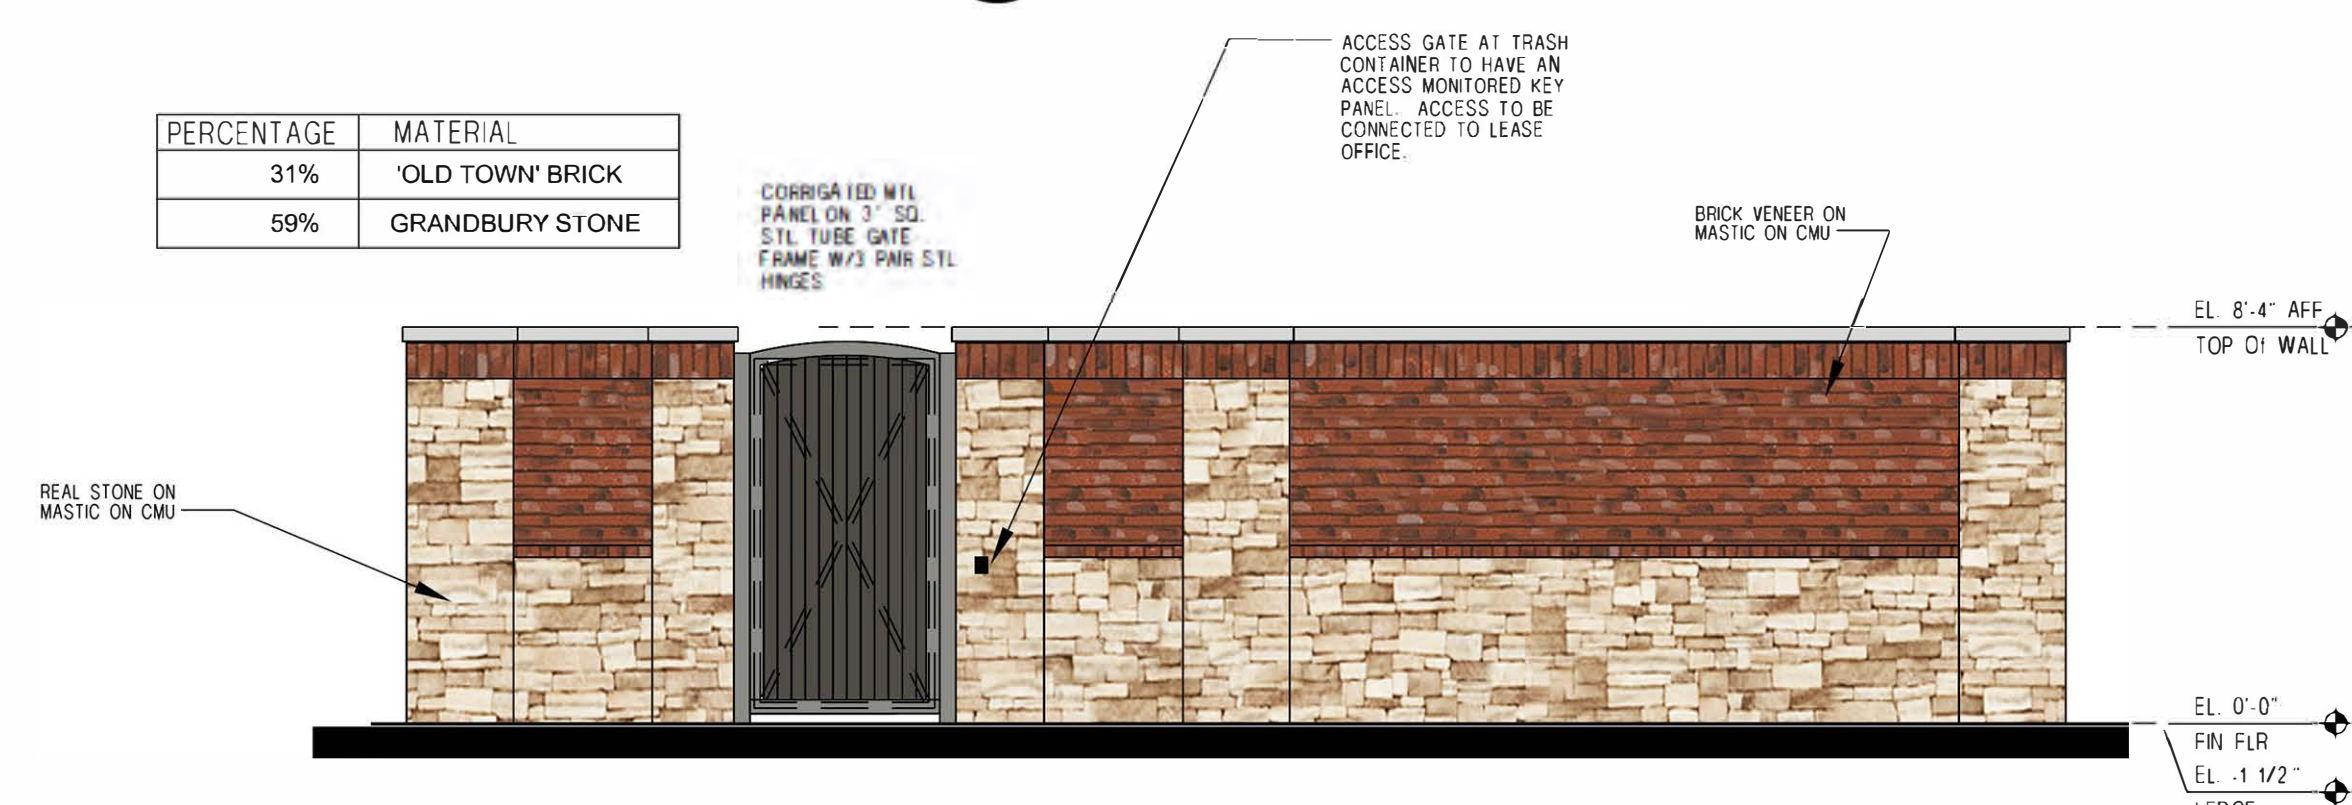
05 Elevation Entry Side
SCALE: 3/8" = 1'-0"

PERCENTAGE	MATERIAL
31%	'OLD TOWN' BRICK
59%	GRANDBURY STONE

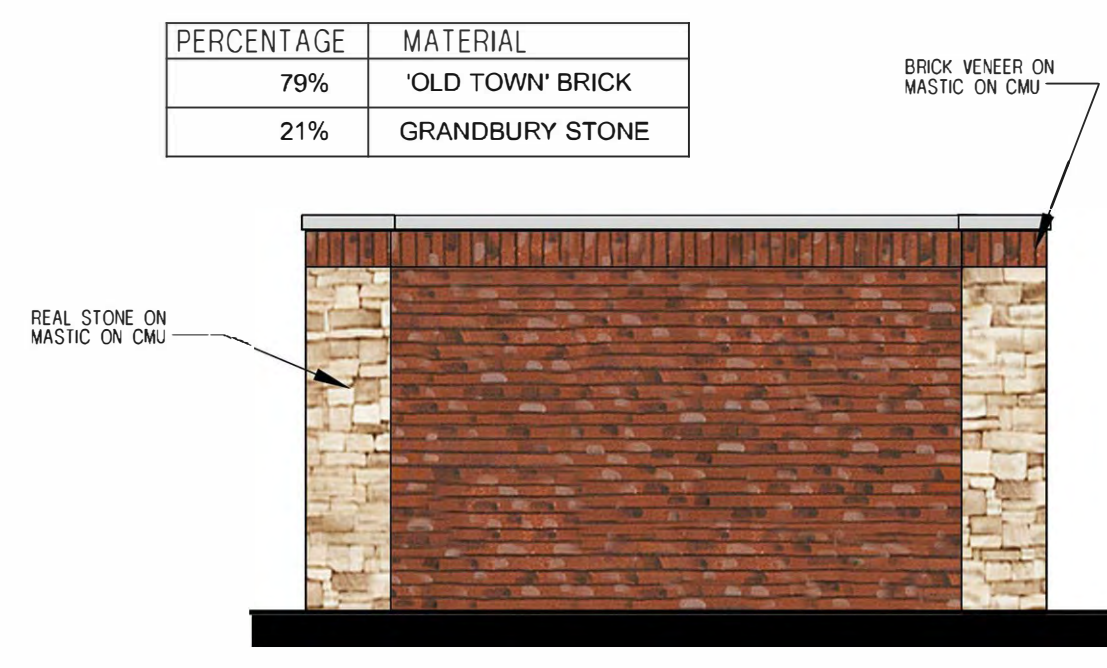
02 Rear Elevation
SCALE: 3/8" = 1'-0"

PERCENTAGE	MATERIAL
79%	'OLD TOWN' BRICK
21%	GRANDBURY STONE
