Exhibit F
Case No. Z19-0005

Alders at Prosper

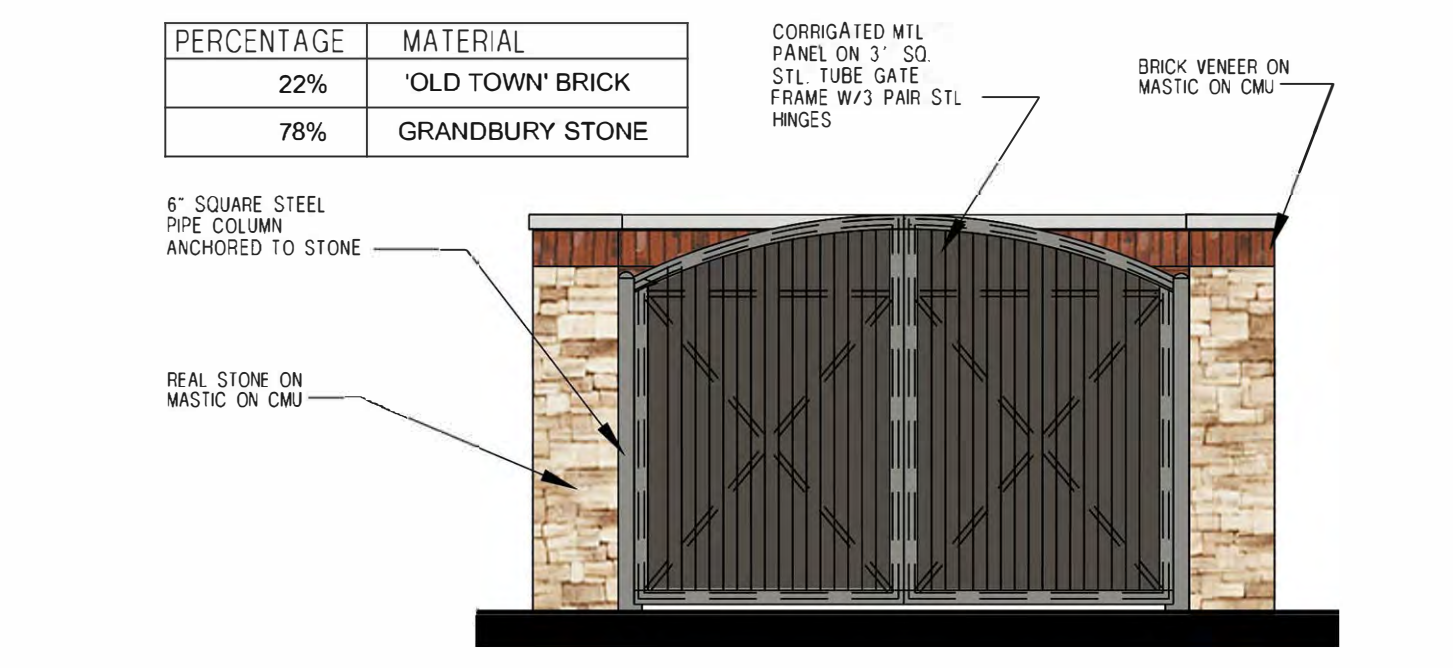
01 Front Gate
SCALE: 3/8" = 1'-0"

PERCENTAGE	MATERIAL
22%	'OLD TOWN' BRICK
78%	GRANDBURY STONE

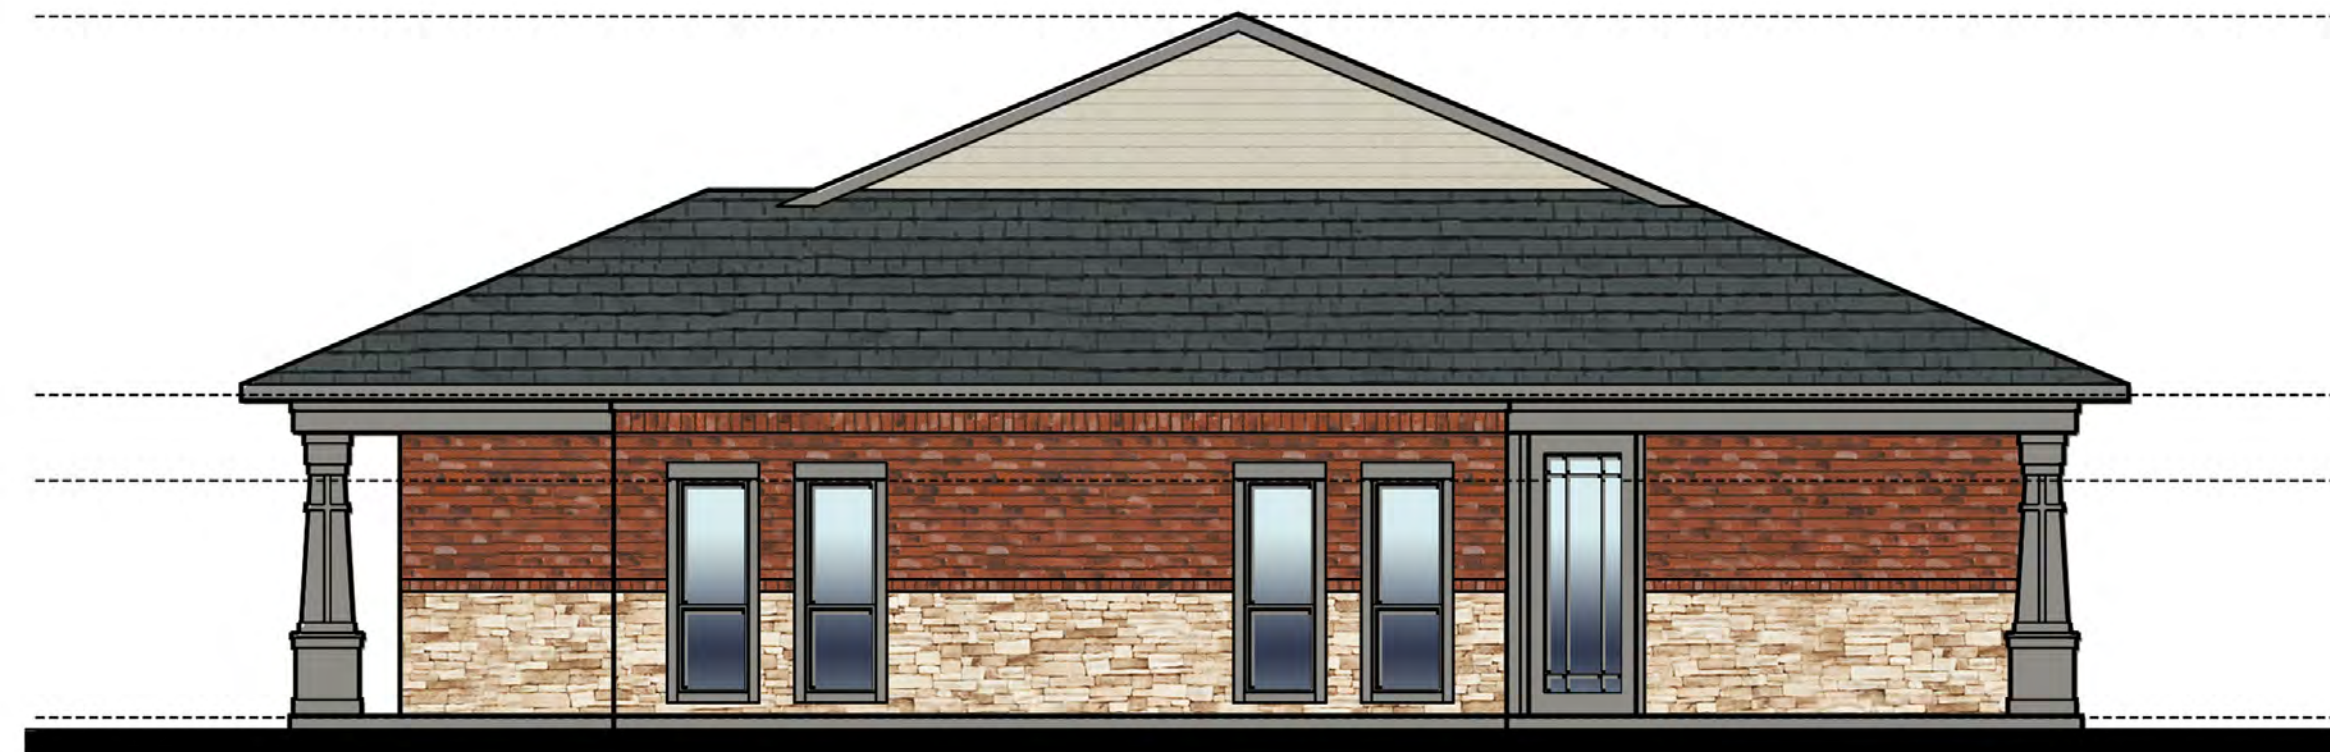
04 Side Elevation
SCALE: 1/8" = 1'-0"

PERCENTAGE	MATERIAL
43%	GRANBURY STONE
1%	WOOD SIDING
0.1%	HARDIE PANEL
55.9%	"OLD TOWN" BRICK

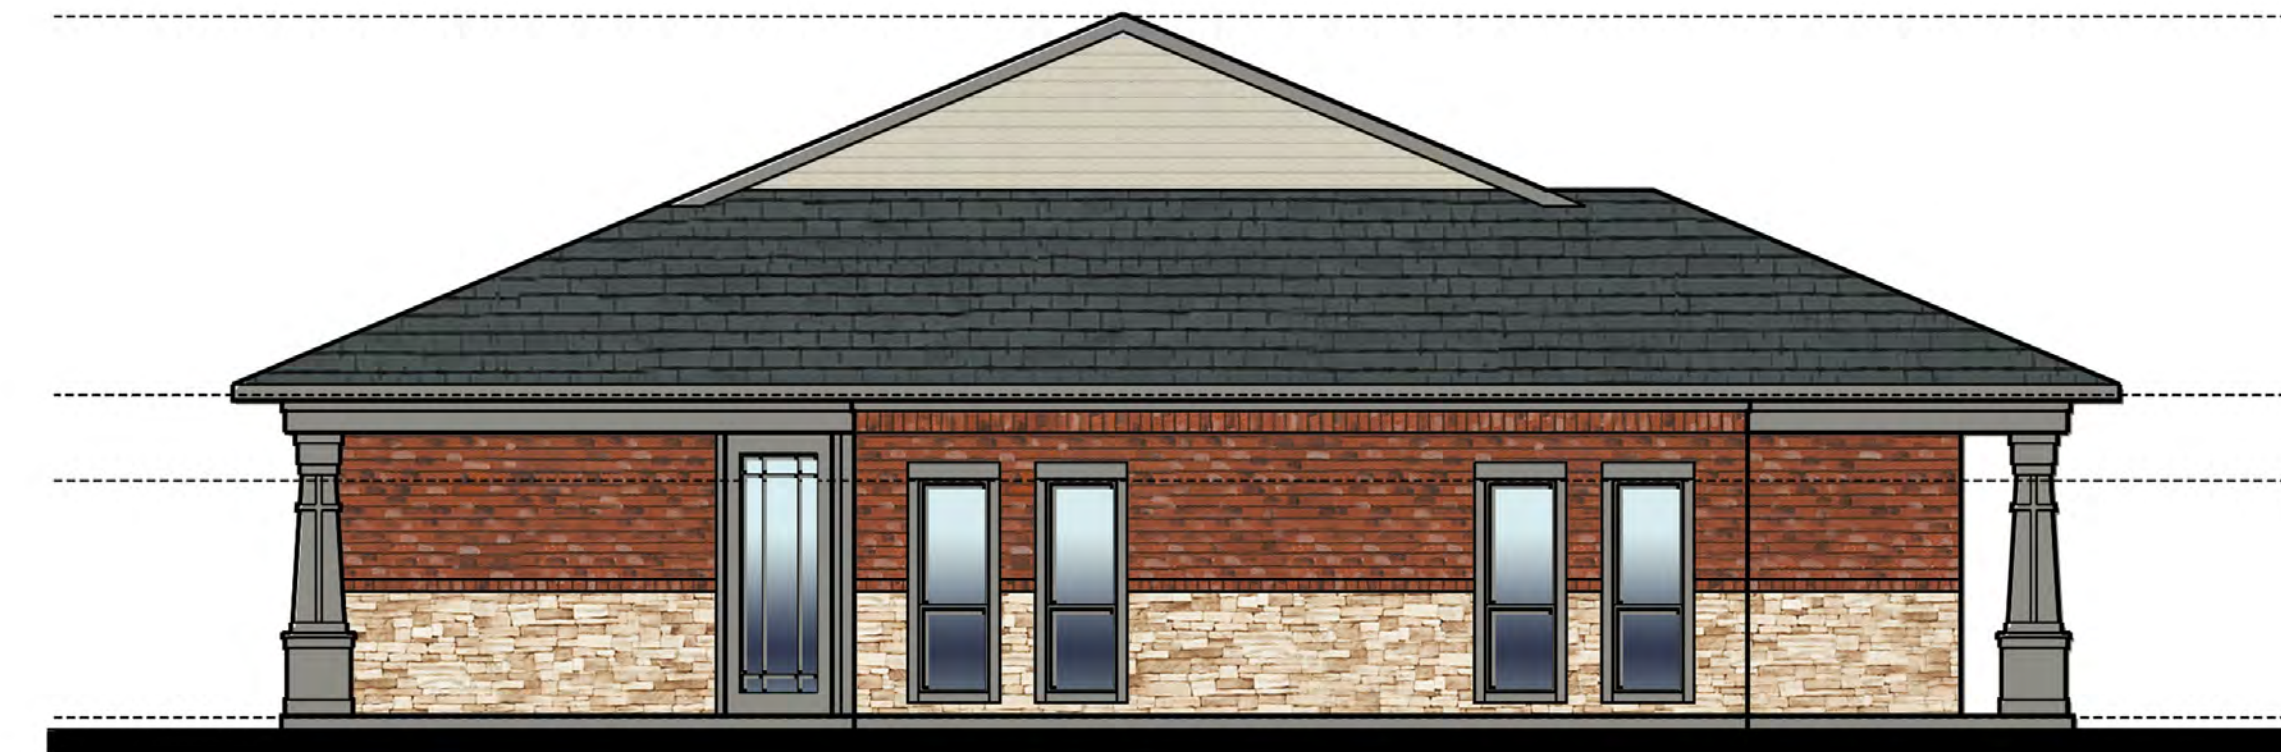
03 Side Elevation
SCALE: 1/8" = 1'-0"

PERCENTAGE	MATERIAL
43%	GRANBURY STONE
1%	WOOD SIDING
0.1%	HARDIE PANEL
55.9%	"OLD TOWN" BRICK

EL. 19'-8 3/4"
TOP OF RIDGE

EL. 9'-1" AFF
TOP PLATE

EL. 6'-8"
WINDOW HEAD

EL. 0'-0"
FIN FLR

EL. -1 1/2"
BRICK LEDGE

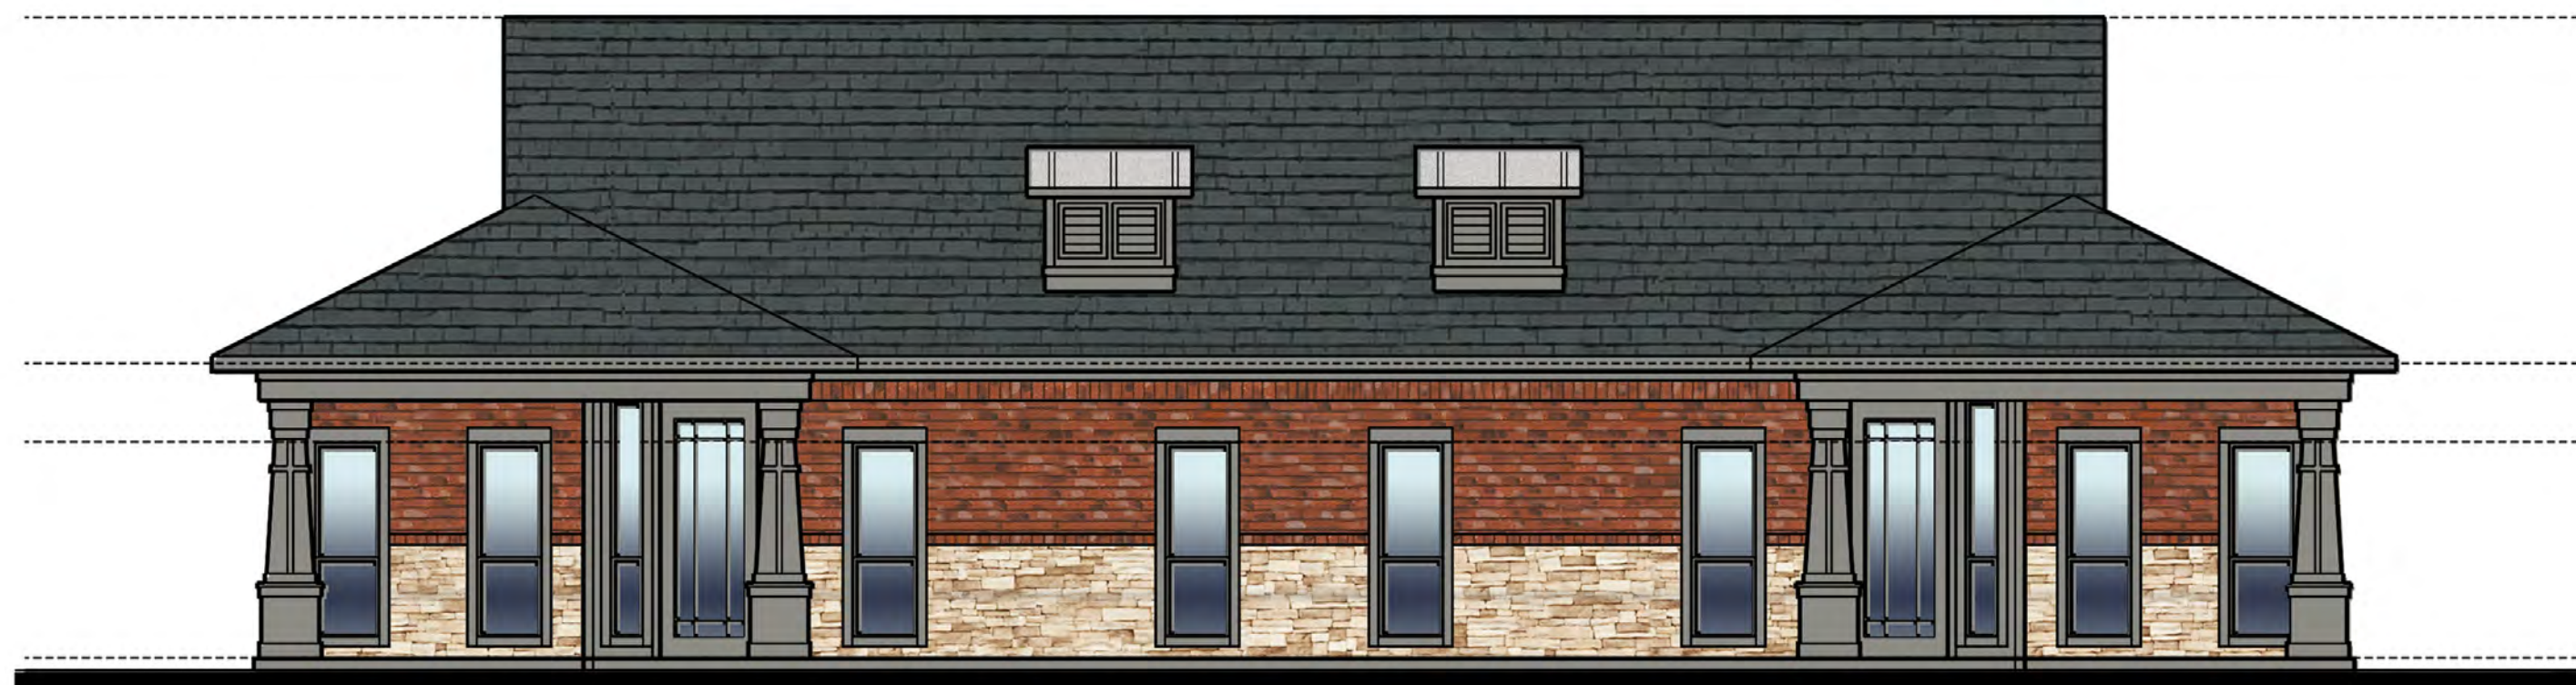
02 Elevation
SCALE: 1/8" = 1'-0"

PERCENTAGE	MATERIAL
39.7%	GRANBURY STONE
0%	WOOD SIDING
0.1%	HARDIE PANEL
60.2%	"OLD TOWN" BRICK

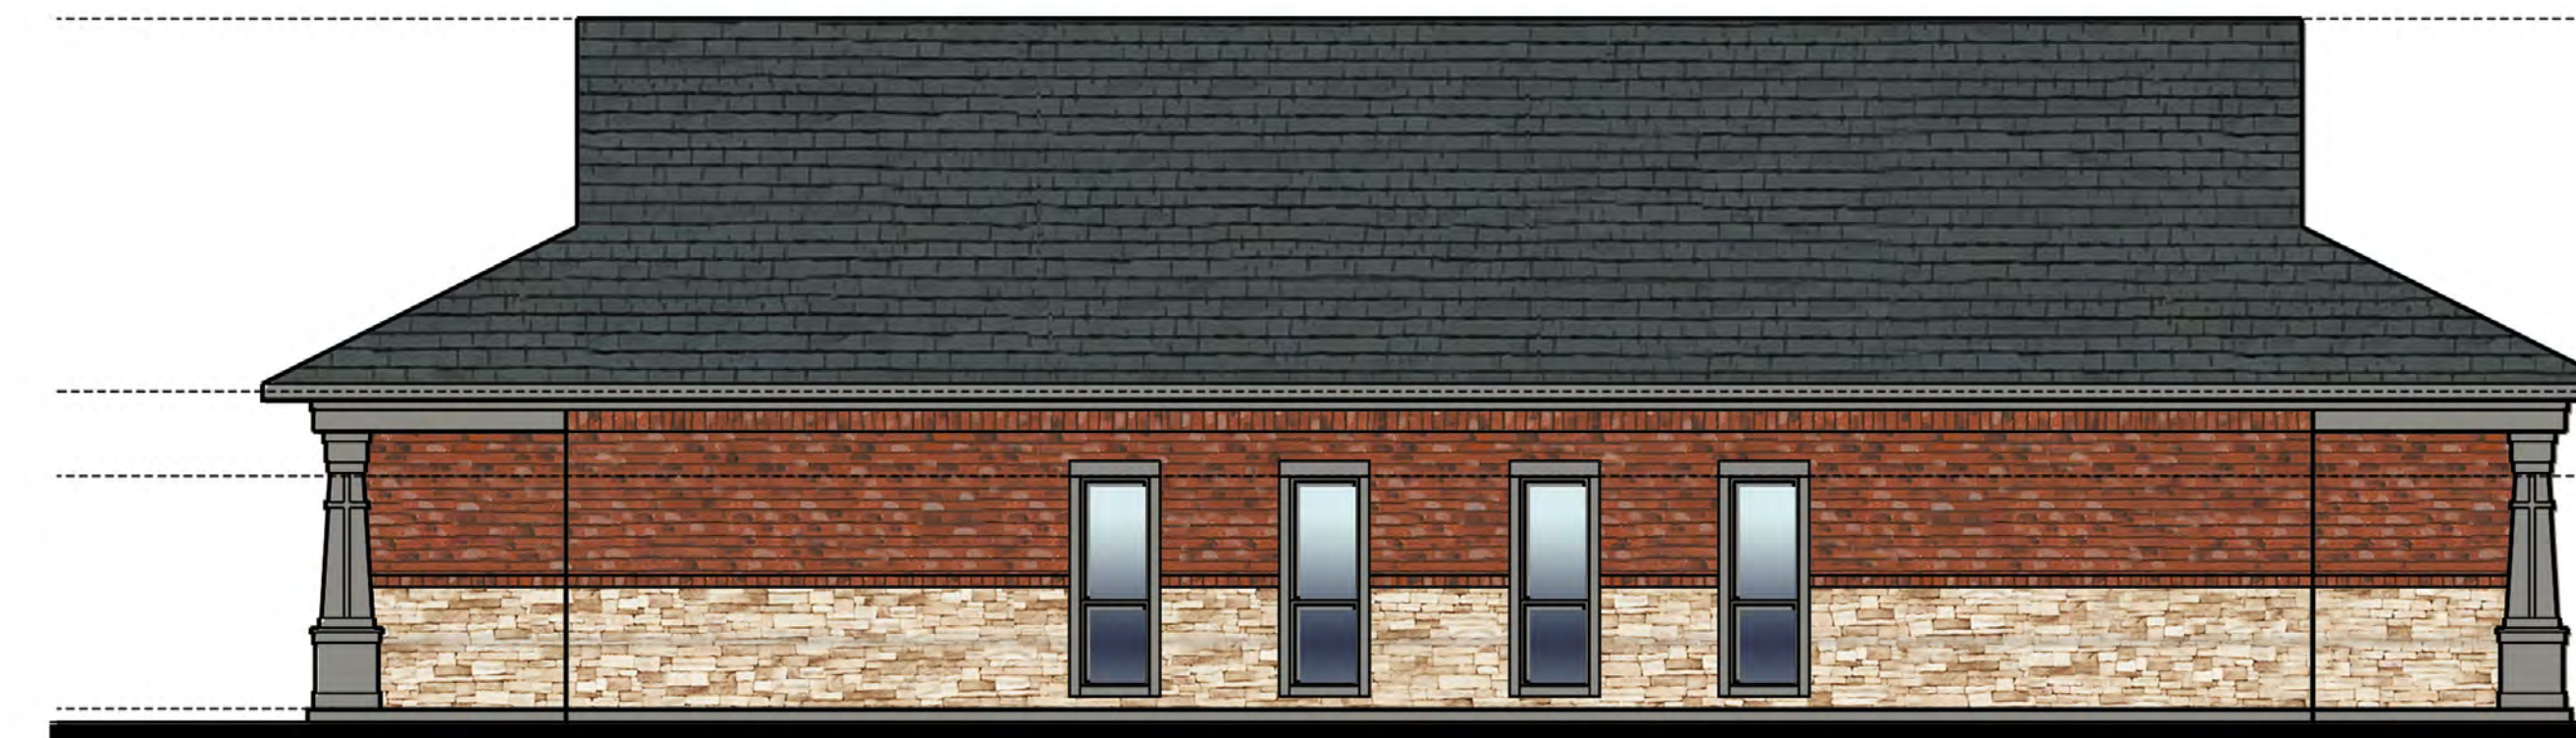
01 Rear
SCALE: 1/8" = 1'-0"

PERCENTAGE	MATERIAL
40.4%	GRANBURY STONE
0%	WOOD SIDING
0.1%	HARDIE PANEL
59.5%	"OLD TOWN" BRICK

EL. 19'-8 3/4"
TOP OF RIDGE

EL. 9'-1" AFF
TOP PLATE

EL. 6'-8"
WINDOW HEAD

EL. 0'-0"
FIN FLR

EL. -1 1/2"
BRICK LEDGE
