# **James Orr Coating Inspection**

**Exterior Power Washing**

**150,000 Gallon Water Spheroid**

**Ridgeway Water Utility, Ridgeway, WI**

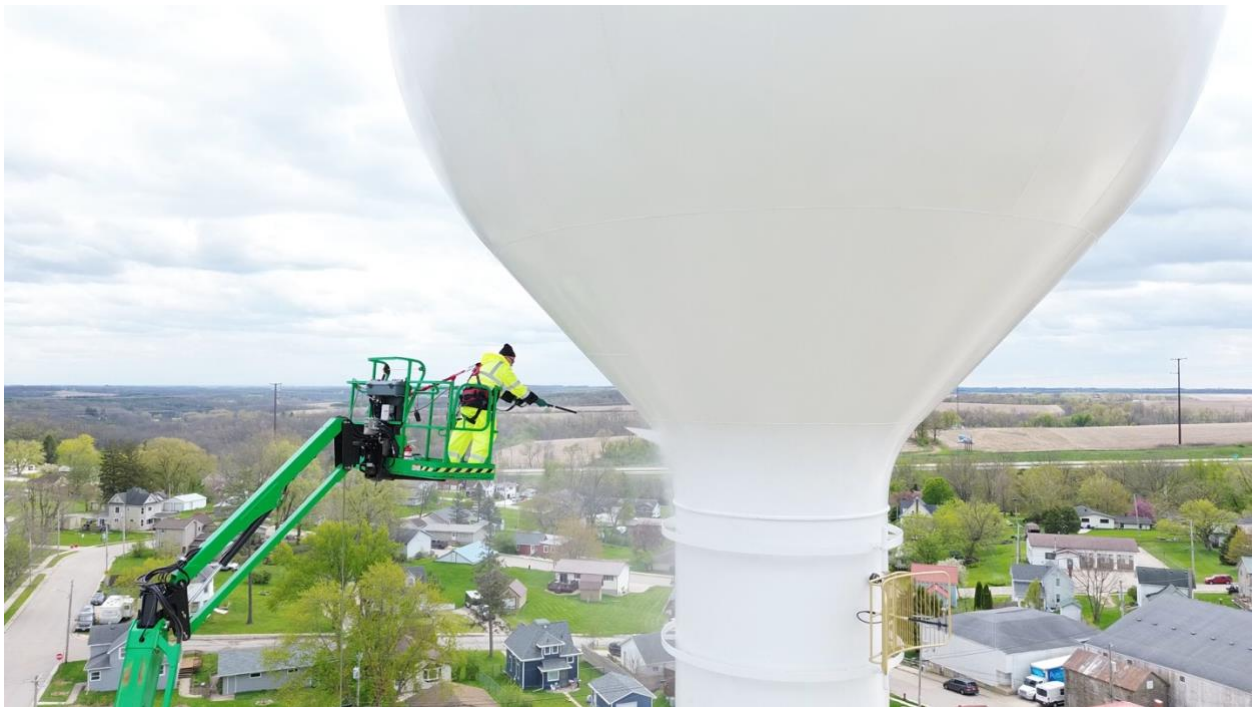
**Worker Power Washing to Remove Dirt and Mildew**

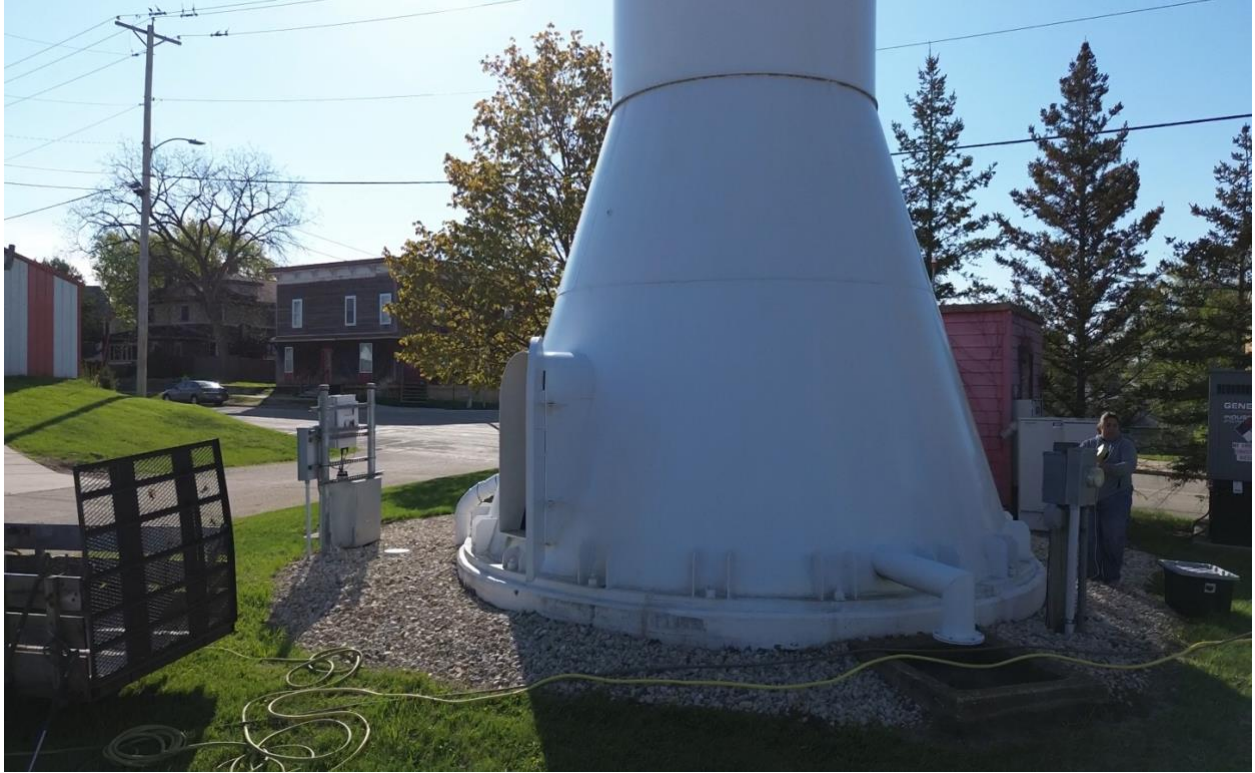
**Base Cone Before Power Washing**

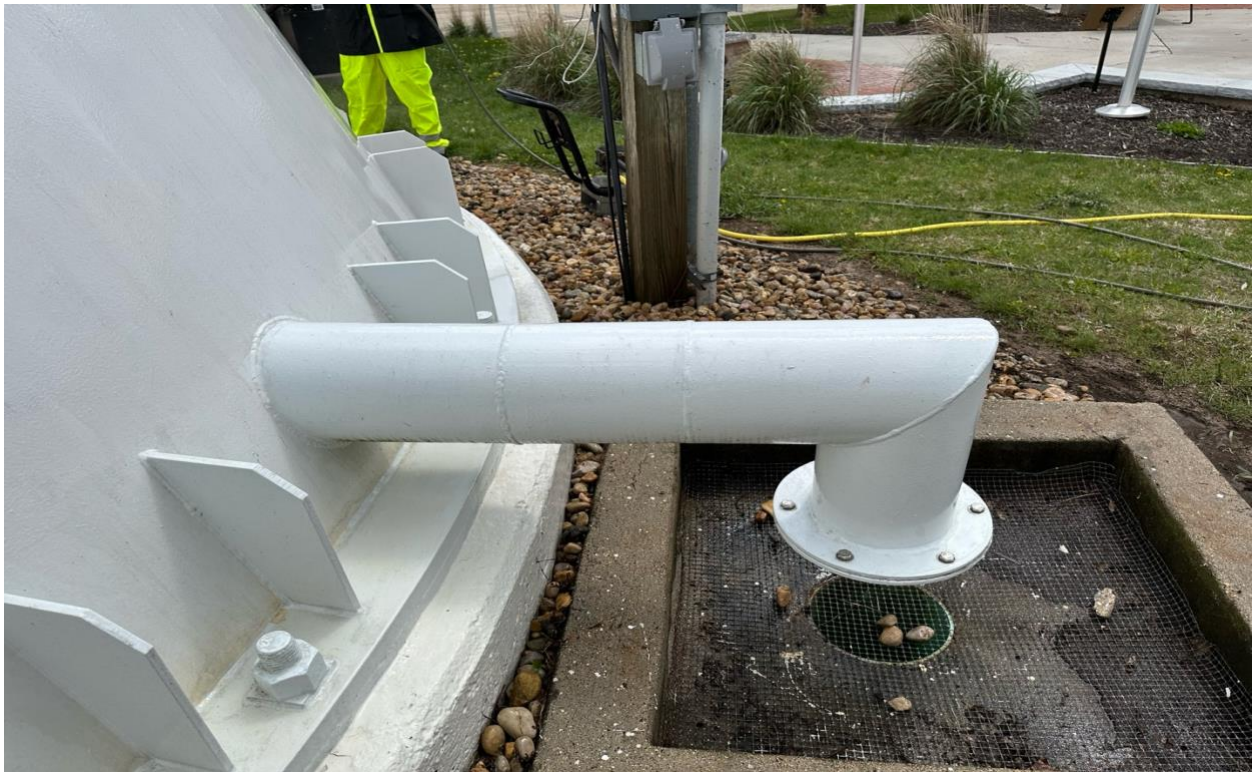
**Base Cone After Power Washing**
