Bill Date: January 31, 2025 (for 12/23/2024 - 01/23/2025)

**From:** Andrew Van Winkle <avw@braidx.com>  
**Date:** Wednesday, October 8, 2025 at 19:15  
**To:** Veronica Hernandez <vhernandez@rollingwoodtx.gov>  
**Cc:** Michelle Van Winkle <mvw@braidx.com>  
**Subject:** Re: Van Winkle, Water Bill. FW: Clarification on Appeals Process

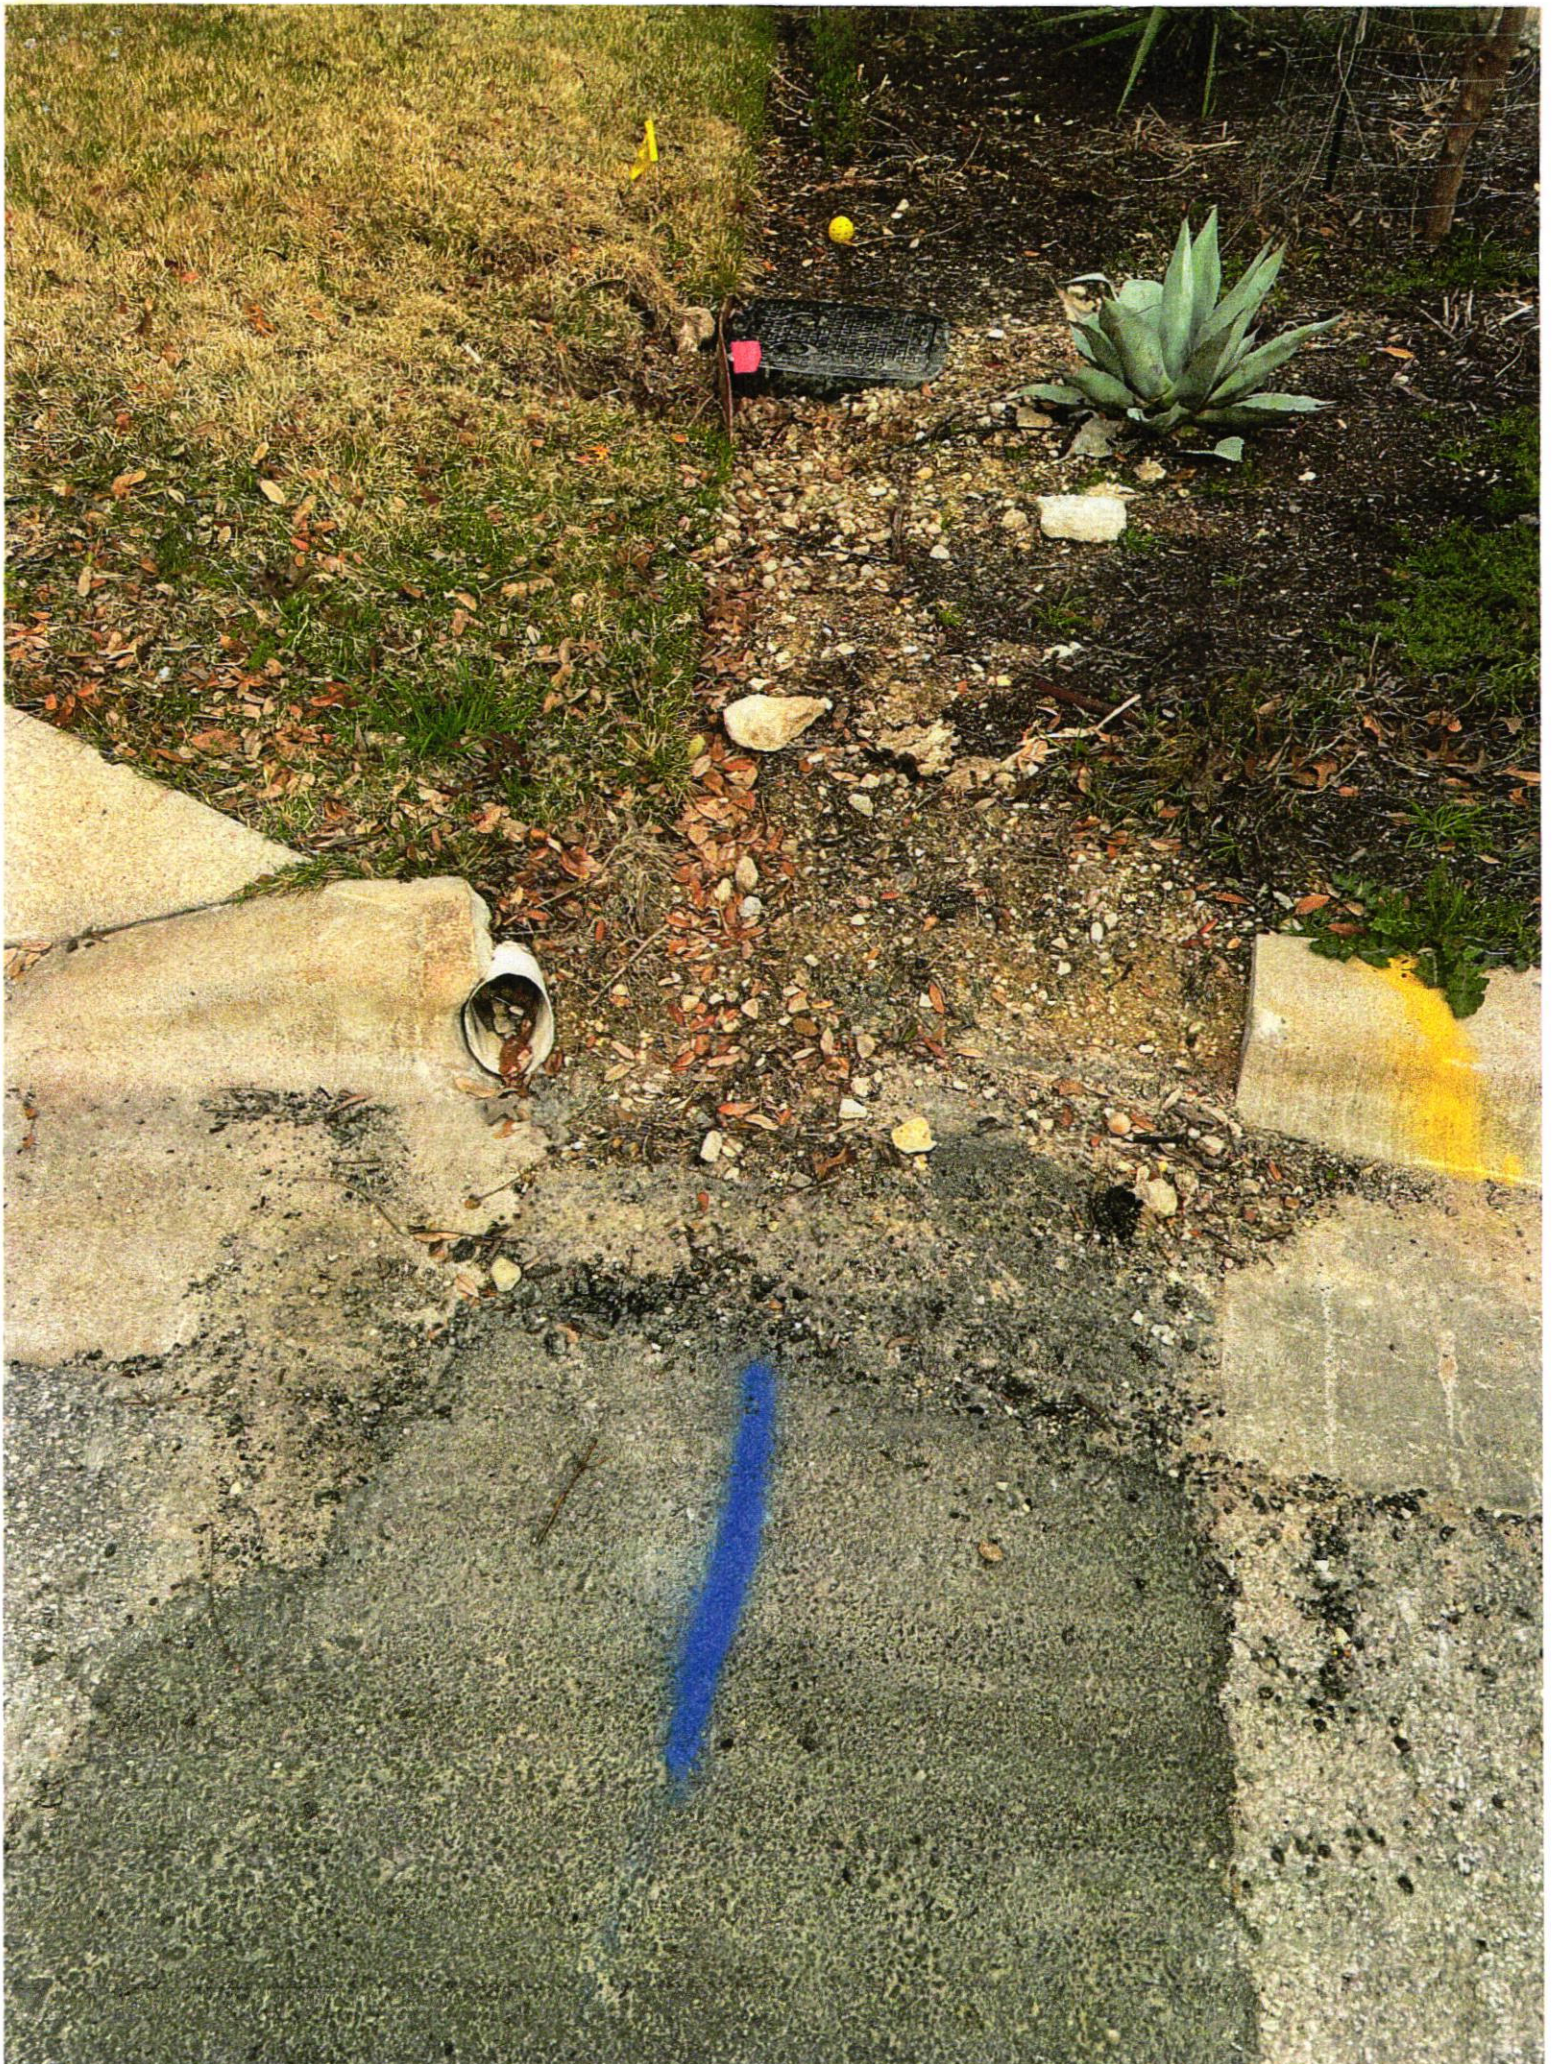
1. Attached are the materials I printed and handed to the Utility Commission Members at the meeting tonight.
  - Original Adjustment Request which was submitted February 6, 2025.
  - Photo showing the location of the leak relative to the water meter and the trench dug by RW's Utility Contractor to connect the new water line to our meter.
  - Water Bill dated January 31, 2025
  - My calculations dollar amounts related to our adjustment request.

The Utility Commission's information packet regarding our appeal includes a picture which clearly shows a smooth groove ground deep into the outer wall of our water line and shows a fracture through the full wall of the pipe that is connected to and perpendicular that smooth groove.

- Clearly, this groove was made by a circular cutting/grinding tool, and not by something like a sign, shovel, pick axe or other landscaping tool striking our water line.
- A groove ground deeply into the outer wall of a PVC pipe substantially weakens that pipe – making it highly susceptible to developing a fracture anytime thereafter. This is further corroborated by the fact that the volume of leak increased over time. Therefore, if the water utility contractors ground the groove into our pipe anytime (days or many weeks) before the leak began then it is reasonable to assign responsibility for the ensuing fracture connected to that groove to the utility contractor.
