STAFF REPORT

AGENDA ITEM TITLE: Sherman Hotel Major Certificate of Approval – 121 G Street

REQUEST: The request is to receive a Certificate of Approval on the following external work that is being proposed for the Sherman Hotel.

Elongate 3 window openings to replace the windows with doors.

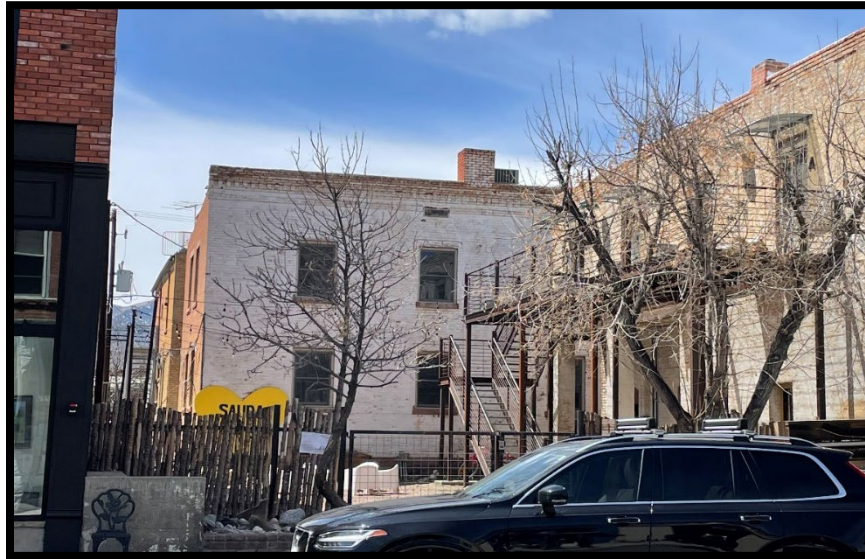
View of Subject Building from across First Street.

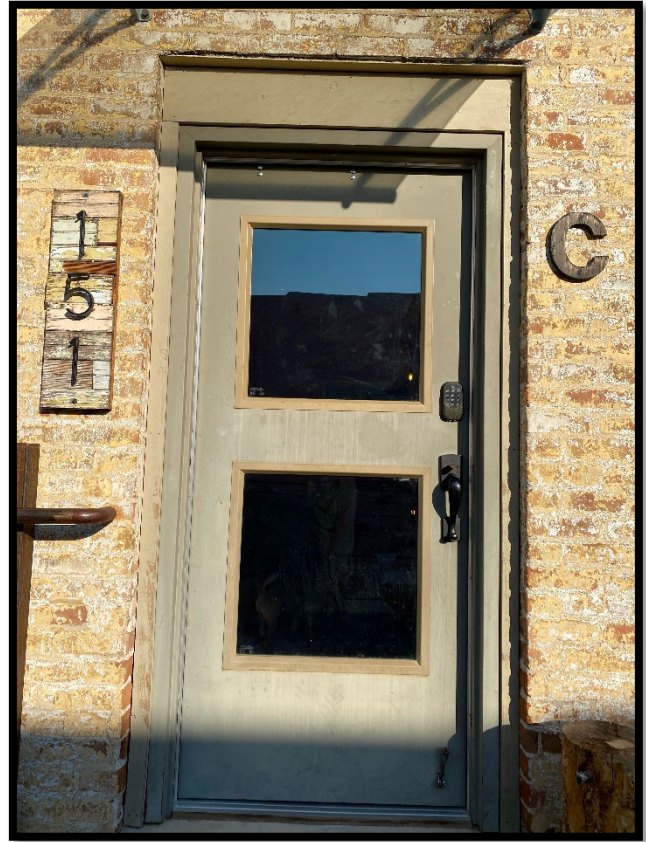
similar appearance to the original door. The proposal is to match the doors that were previously approved at this site and are currently being utilized as the second floor balcony doors facing this same courtyard from the 151 First Street Building. This is a photo of the current and proposed door:

1. That the Commission **APPROVE** elongating three window openings to accommodate doors that match the existing 2nd floor balcony doors on 151 West First Street.
