STAFF REPORT

MEETING DATE:	August 27, 2020
AGENDA ITEM TITLE:	Argys Brothers Garage – 223 E. First Street - Major Certificate of Approval
AGENDA SECTION:	Application Public Hearing

REQUEST: The purpose of the request is to receive approval for exterior alterations to the back wall of the structure at 223 E. First Street. The applicant is requesting to increase the 8'x8' garage door opening to allow for a 12'x12' garage door opening on the rear (south) wall of the building.

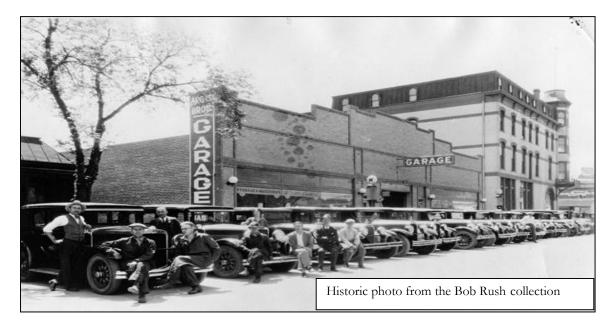
- 2. According to the Architectural Inventory Form statement of significance for this property: "This building is associated with the development of automobile-related service buildings in downtown Salida, having been erected in the 1920s to house the Argys Brothers Garage, an automobile sales and service firm. The Argys Brothers' automobile business continued in this building for more than half a century. The building is an extremely well preserved example of an automobile dealership, and is notable for its stepped parapet, decorative brickwork, large display windows with clerestories, and intact entrances. The building is potentially eligible to the National Register."

This building maintains substantial integrity. The façade of the building remains unchanged. The rear wall (south) has been stuccoed and windows have been added. Some windows have been replaced on the sides.

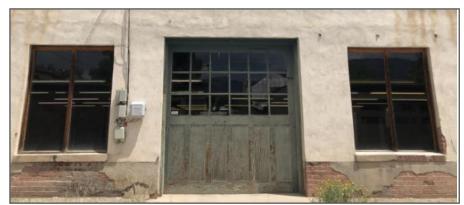
3. The applicant is requesting to enlarge the existing garage door opening on the rear (south) wall adjacent to the alley. The current opening is 8'x8' and the applicant is requesting to increase the opening to 12'x12'.

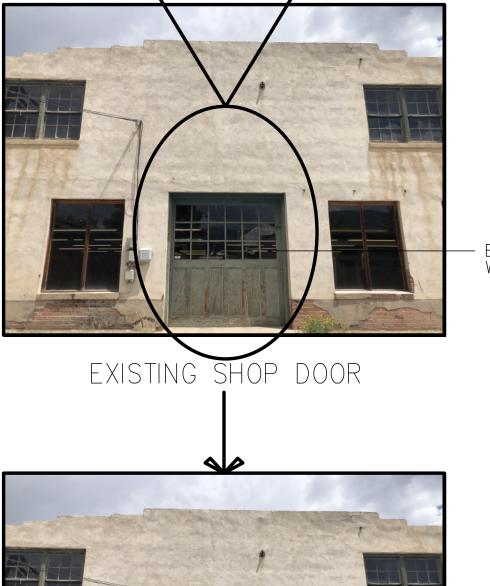
EXISTING 8'X8' ROLLER WOOD SHOP DOOR

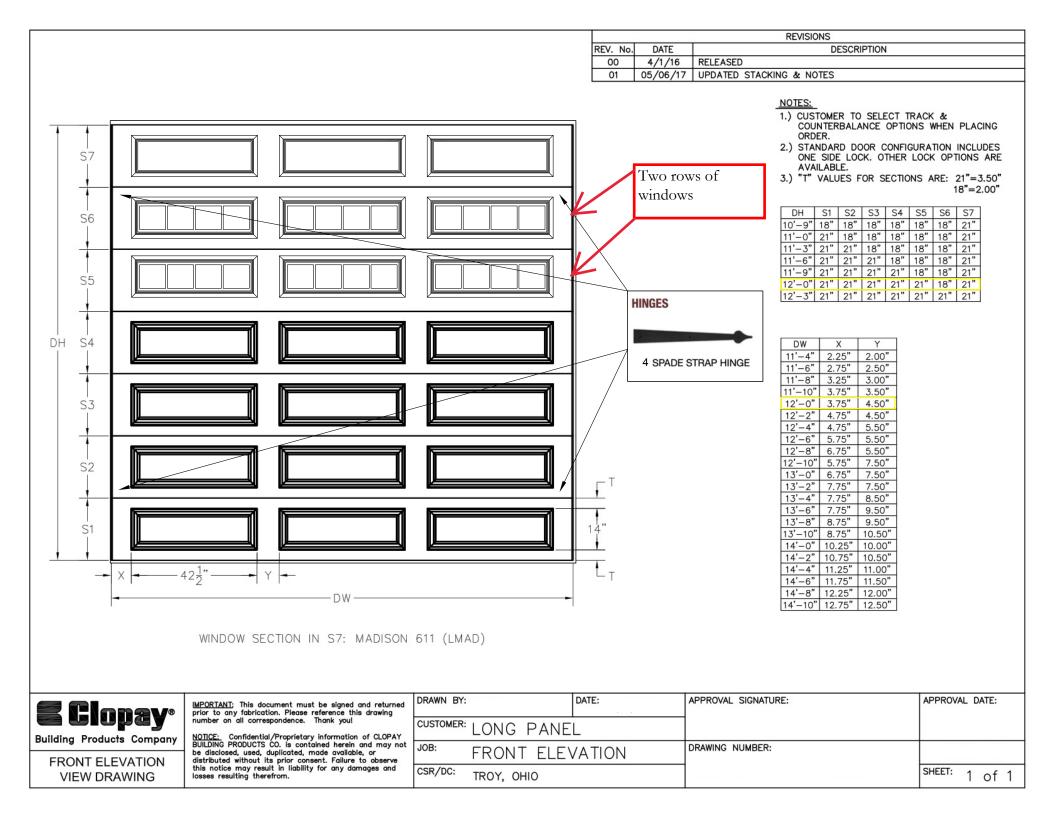
PROPOSED SHOP DOOR

4. The applicant has provided specifications on the proposed 12'x12' door which will be a metal faux wood grain insulated door with two rows of windows toward the top of the door.
