STAFF REPORT

AGENDA ITEM TITLE: Sherman Hotel Major Certificate of Approval – 121 G Street

REQUEST: The request is to receive a Certificate of Approval on the following external work that is being proposed for the Sherman Hotel.

THE FLAT @ THE
NEW SHERMAN

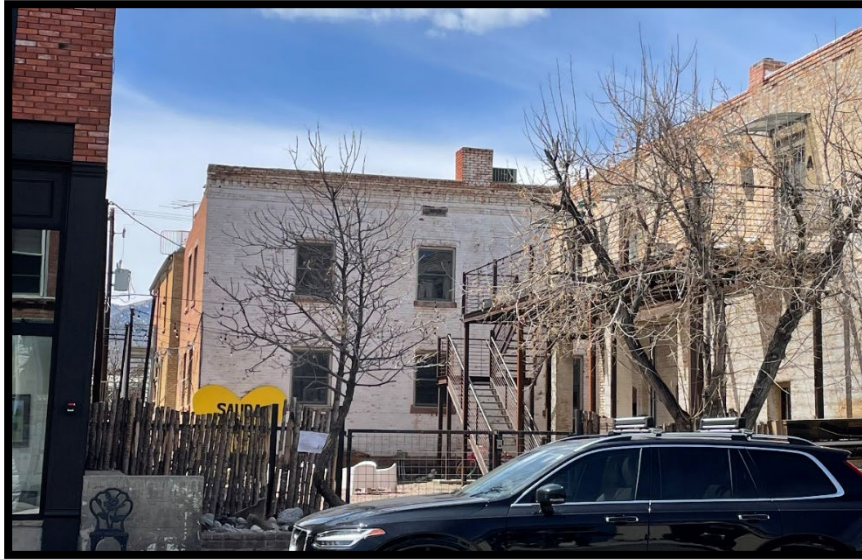
View of Subject Building from across First Street.

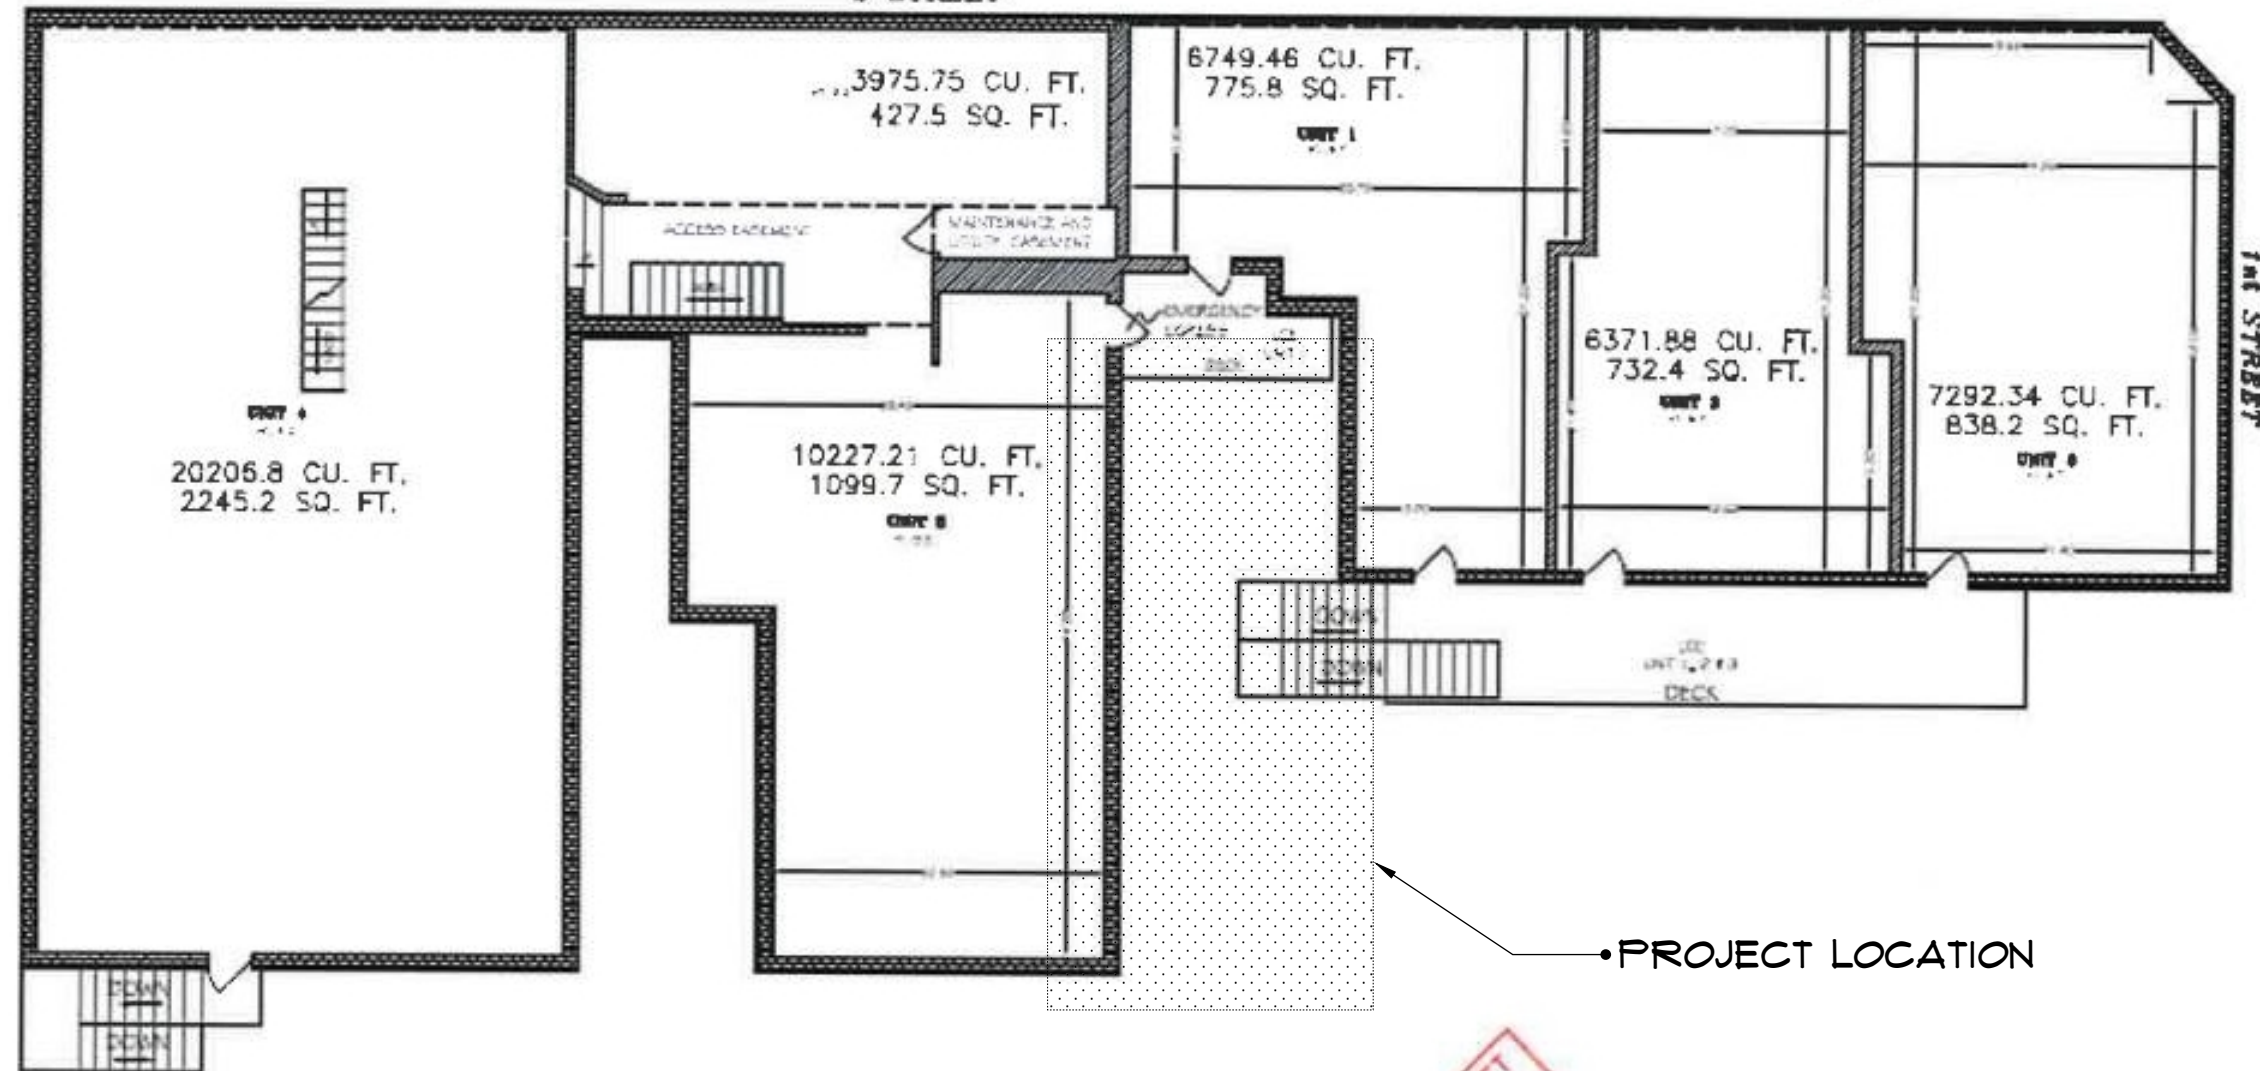
SITE PLAN

LOCATED WITHIN LOTS 11, 12 AND 13, BLOCK 21
OF THE CITY OF SALIDA,
CHAFFEE COUNTY, COLORADO

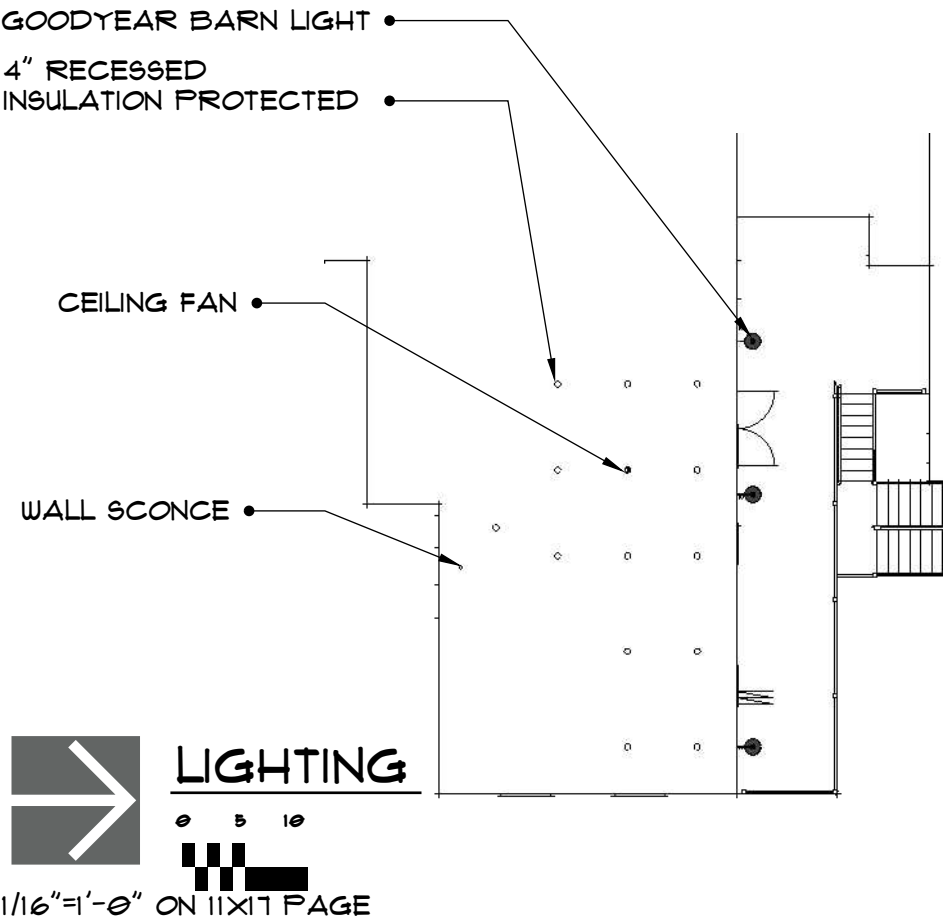
PROJECT SCOPE

THE PROJECT CONSISTS OF 3 PARTS
 PART 1. REMOVAL OF INTERIOR WALLS AND MATERIALS TO BE REPLACED TO CREATE A THREE BEDROOM PRIVATE CONDOMINIUM WITH 1 BATH KITCHEN AND LIVING ROOM.
 PART 2. ADD A STEEL DECK AND STAIR TO ACCESS THE NEW SPACE . THIS IS TO MATCH THE EXITRING APPROVED CONSTRUCTION RECENTLY COMPLETED(2017)
 PART 3. EXPAND EXISTING NORTH FACING OPENINGS TO ALLOW THE PLACEMENT OF STEEL FRAMED WINDOWS AND DOORS THAT ARE TO BE THE STANDATRD FOR FUTURE PROJECT ON THIS PROPERTY

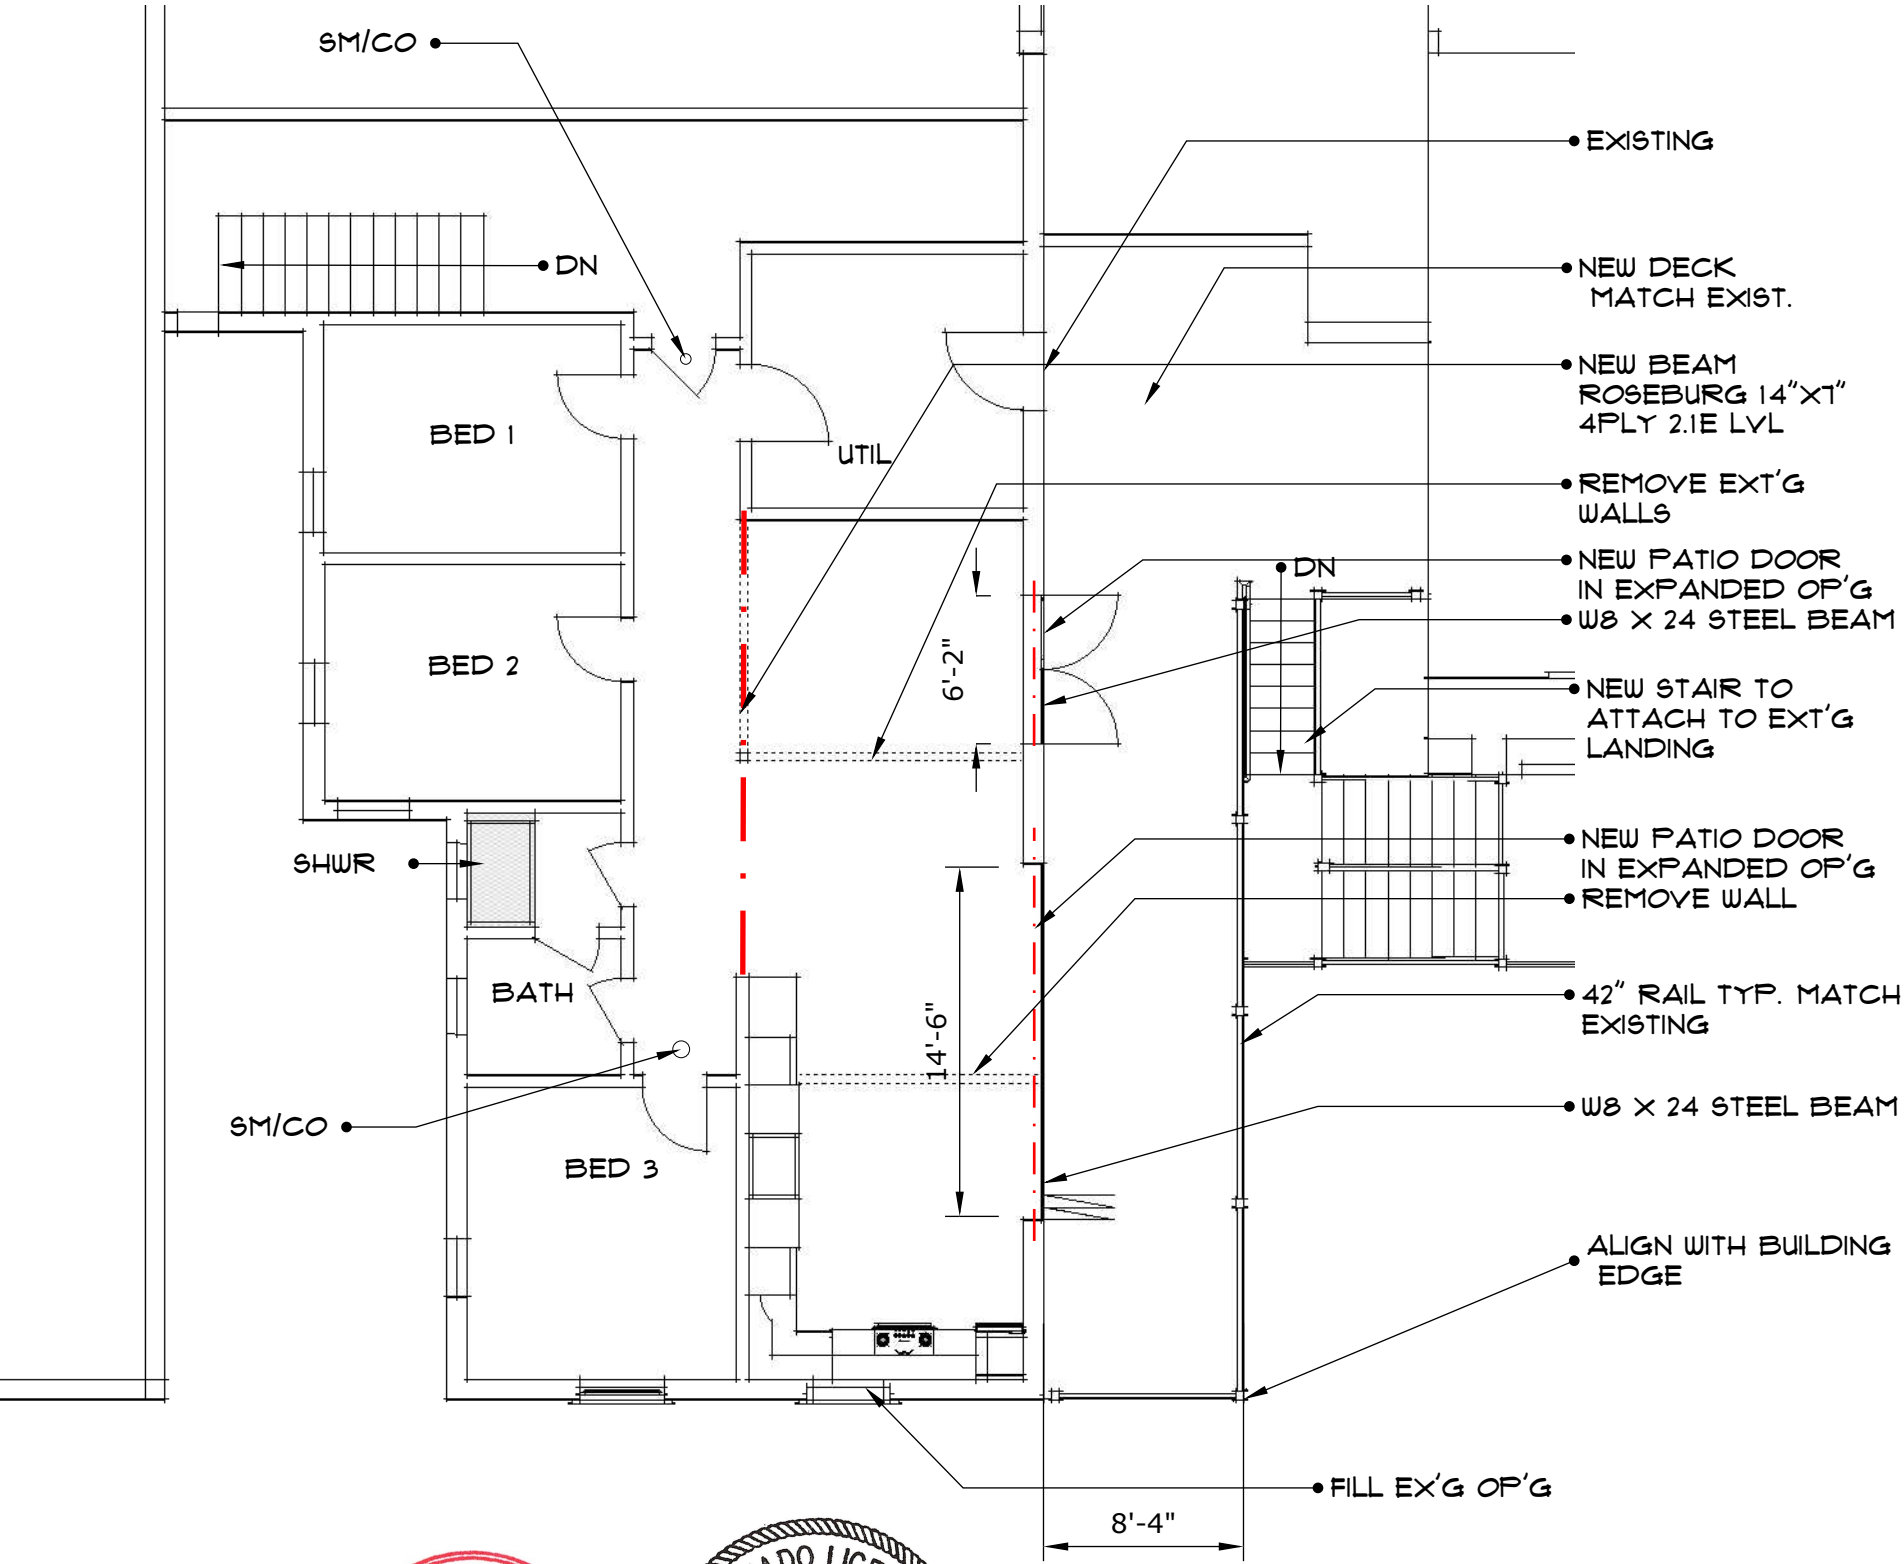
• FILL OP'G W/ ORIGINAL BRICK FROM BUILDING(ON SITE) •

ALL WINDOWS AND DOORS TO BE "HOPE'S OLD WORLD
SUITE" THERMAL BROKEN STEEL IN DARK BRONZE •

3. On the east side of the structure the applicant is proposing to remove one window and fill in the opening with brick. The applicant is proposing to keep the window header and window sill in place.

4. On the north side of the building the applicant is proposing to add a balcony and to remove three windows. One window opening is proposed to be enlarged in both height and width to accommodate a set of double patio doors, and two window openings will be enlarged so that a set of sliding glass accordion-style patio doors can span the current windows and wall area.

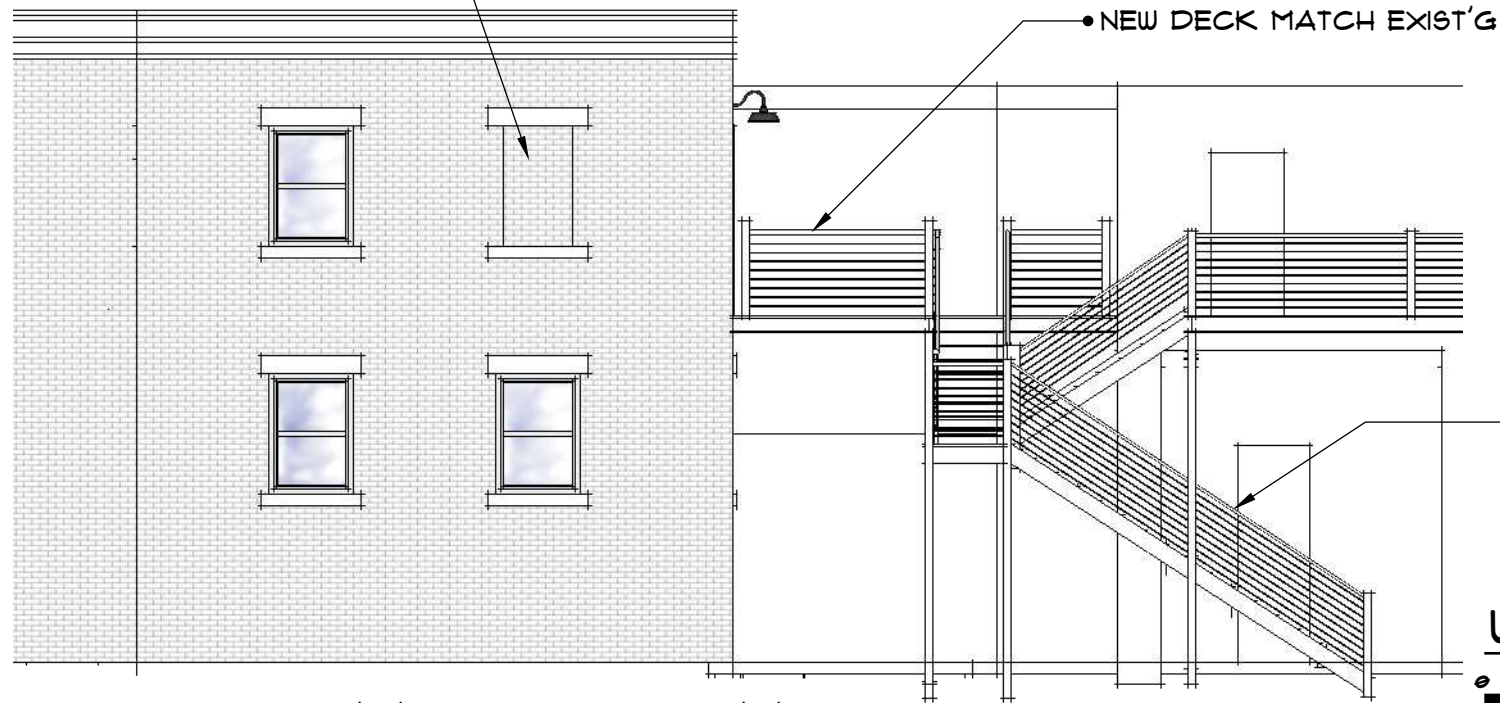
WEST

• NEW DECK MATCH EXIST'G

• EXISTING STAIR

MATCH EXISTING RAILING AND DECK DETAILS
AREA OF REMODEL

ITEM C: The applicant is proposing to add a balcony the length of the north façade, tying into an existing balcony (not visible) and into the stairwell of the balcony approved in October 2014 for the adjacent 149-151 W. First Street building (visible). This proposal, because it matches an existing, recently approved balcony addition, will not detract from the appearance of historic features.

ITEM C: The balcony materials will match the existing balcony. The existing balcony is not original, however it received a Certificate of Approval in October 2014.

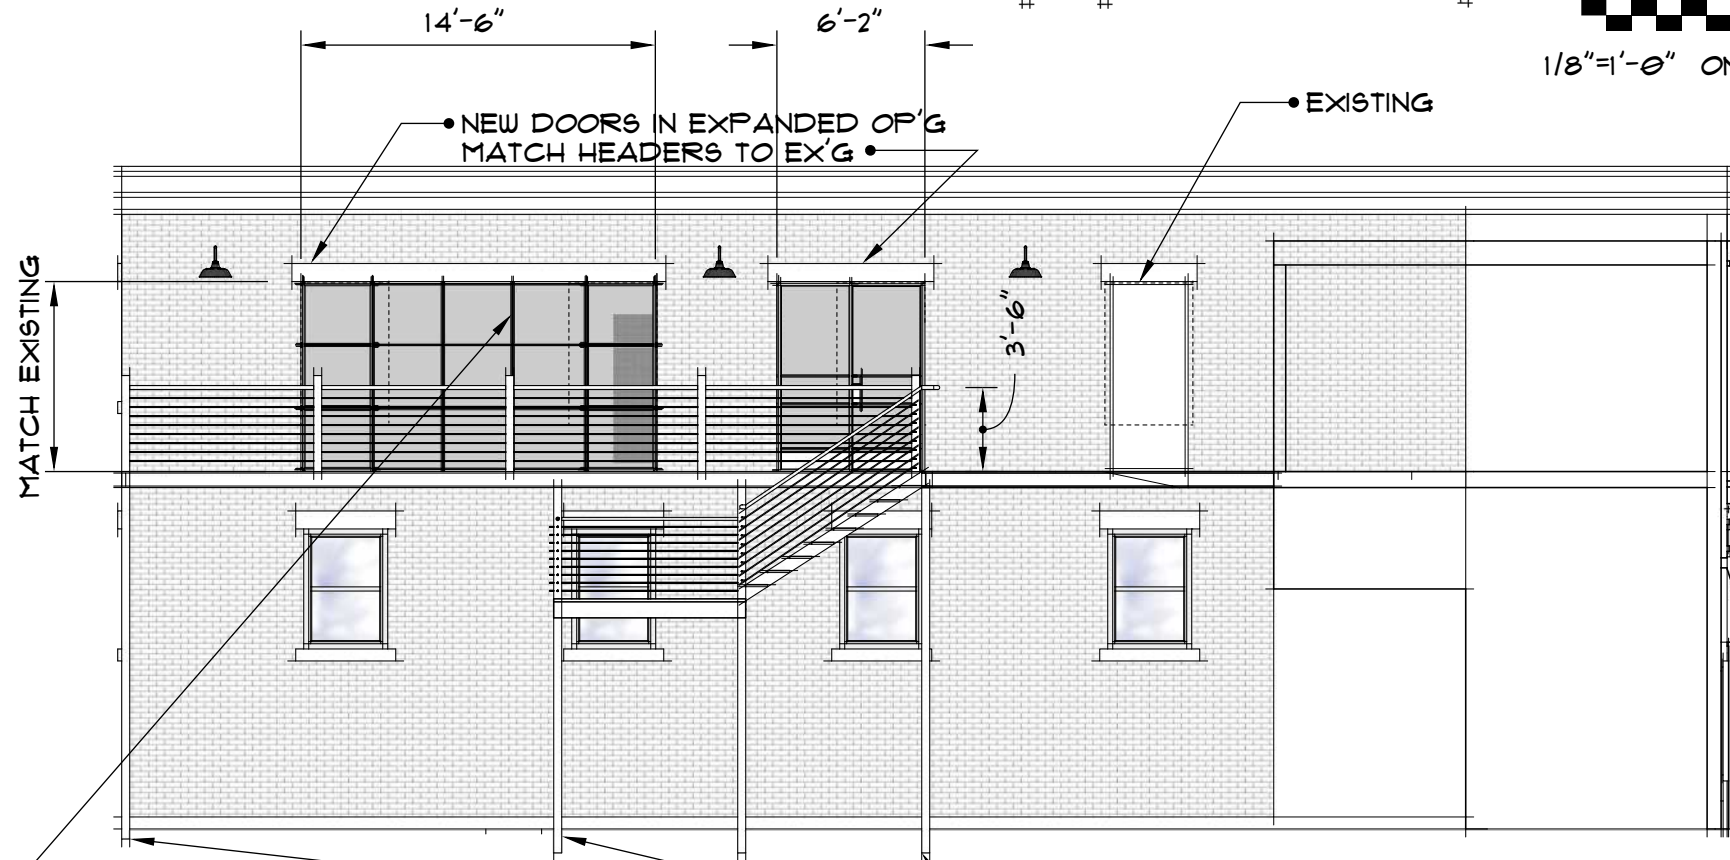
NORTH

• NEW DOORS IN EXPANDED OP'G
MATCH HEADERS TO EX'G •

• EXISTING

MATCH EXISTING

• NEW STEEL COLUMNS ON
12" CONC, PIERS 36" DEEP ON
BEARING SOILS

ITEM B: The removal of two windows and creation of a 14' 6" opening on a prominently visible façade – one that faces highly-trafficked First Street with a courtyard between the façade and First Street – will detract from the historic design. In the Salida Design Guidelines, Part 3. Rehabilitation Guidelines, Section C. Windows , Paragraph # 3 states: ***Preserve the position, number and arrangement of historic windows in a building wall.*** The removal of these two windows is in

ITEM D: The applicant is proposing to remove a window and replace it with a taller and wider opening (6' 2" wide) to accommodate glass, double doors onto the proposed balcony. The existing window is not visible. The proposed expanded opening will be only slightly visible. It will be less visible than the previously approved single door openings in the adjacent 149-151 W. 1st Street Sherman Hotel building, and any portion that may be visible, will not exceed the width of a single-door opening.

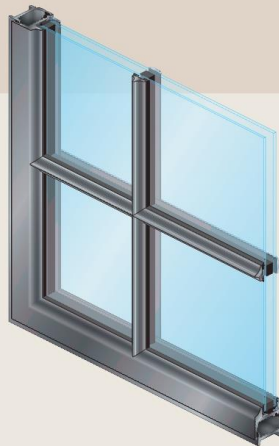
Old World Suite steel windows and doors offer extremely narrow sightlines with the ability to accept monolithic or insulated glass for energy efficiency. The historically accurate profiles and sightlines are ideal for new buildings as well as replacement projects and for both interior and exterior applications.

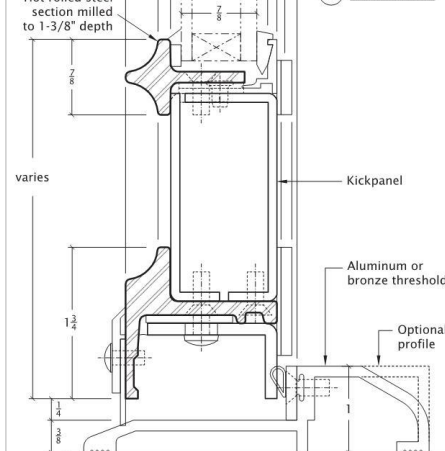
18 THRESHOLD

Details are full scale and shown with 7/8" thick glass. See page 15 for additional glass thickness and glazing bead options.
All Hope's products are custom manufactured to your specific project requirements.

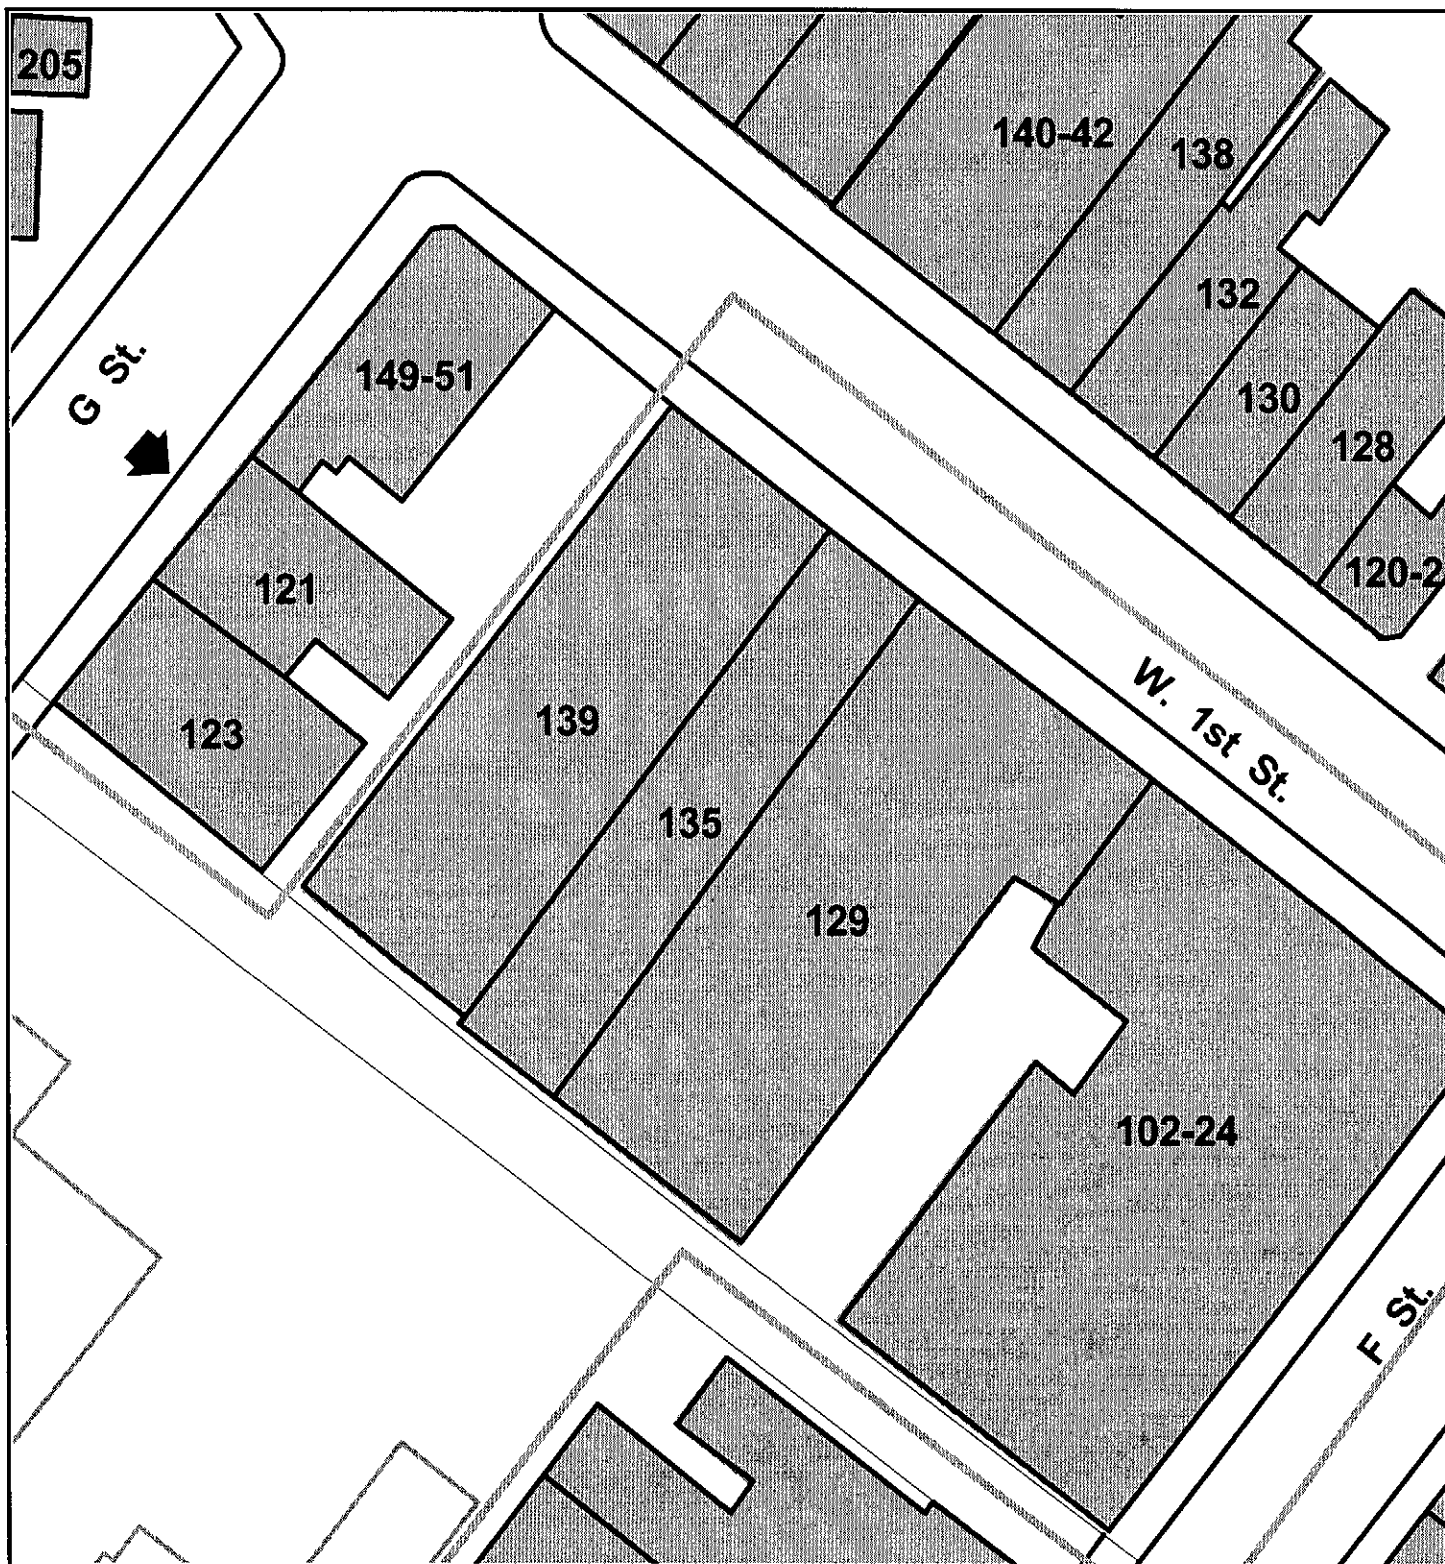
Downtown Salida Historic Buildings Survey, 2001-02
Sketch Map

121 G Street, 5CF406.119
