STORMWATER MANAGEMENT PLAN

**WI049/55985 William F. Fale USARC
2913 Erie Avenue
Sheboygan, Wisconsin 53081-3655**

August 2014

**Prepared by:
PARSONS**

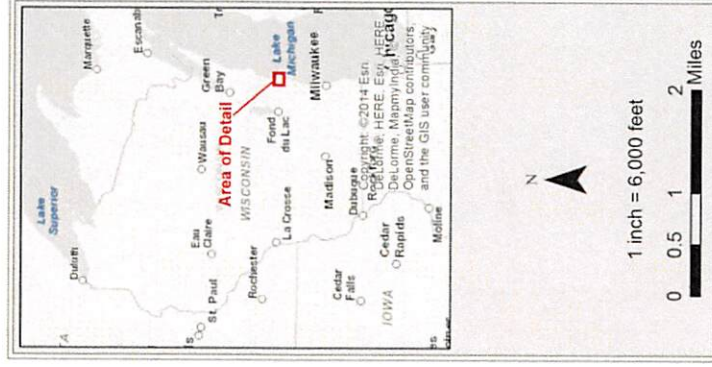
Figure 2
Site Layout and Land Use Map

The facility is located at 2913 Erie Avenue, Sheboygan in Sheboygan County, Wisconsin (Figure 1). The William F. Fale USARC facility includes approximately 3.8 acres of land and consists of a USARC building, a two-bay OMS building, one military equipment parking (MEP) area, and one privately owned vehicle (POV) parking area (Figure 2).

maintenance of vehicles and equipment. A site layout and land use map (Figure 2) shows the overall configuration of the site.

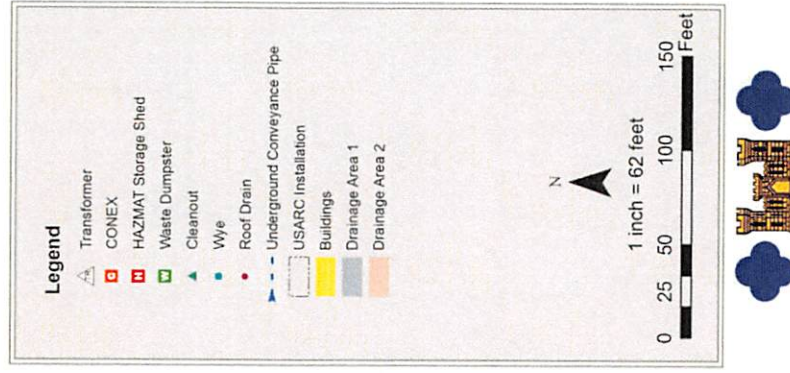
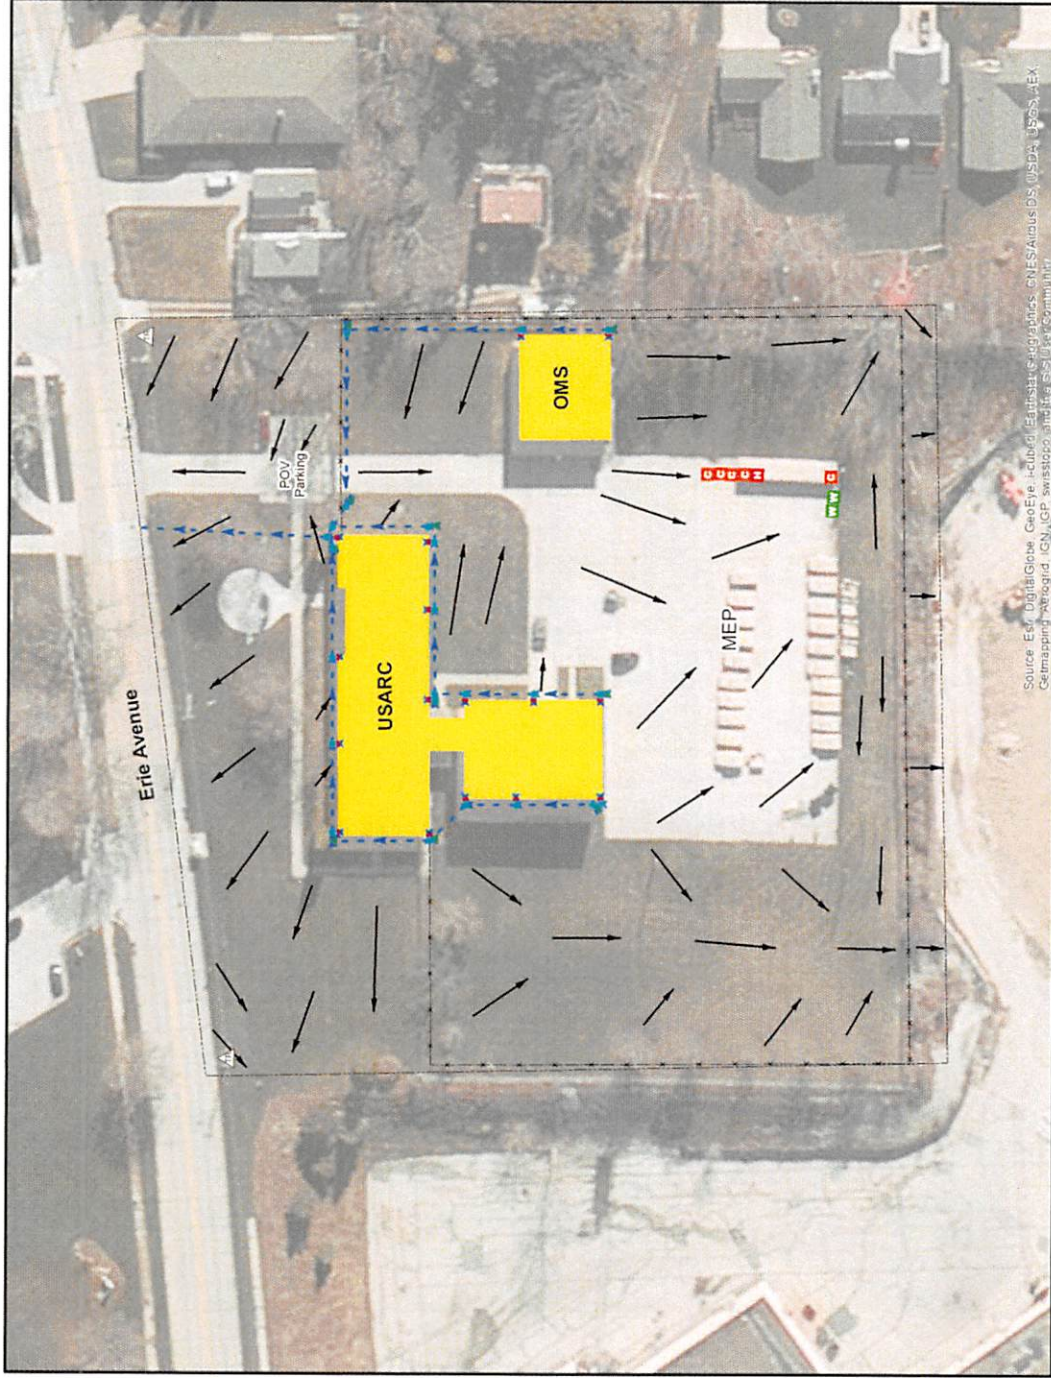
- Five CONEXs,
- One hazardous materials (HAZMAT) storage shed,
- Two waste dumpsters,
- Three pole-mounted transformers (two on one pole in northeast corner of property and one on one pole in northwest corner of property),
- Wood pallets, and
- Military vehicles and equipment.

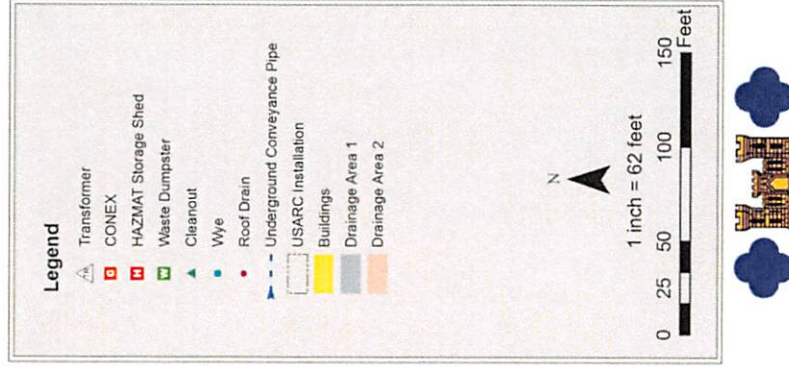
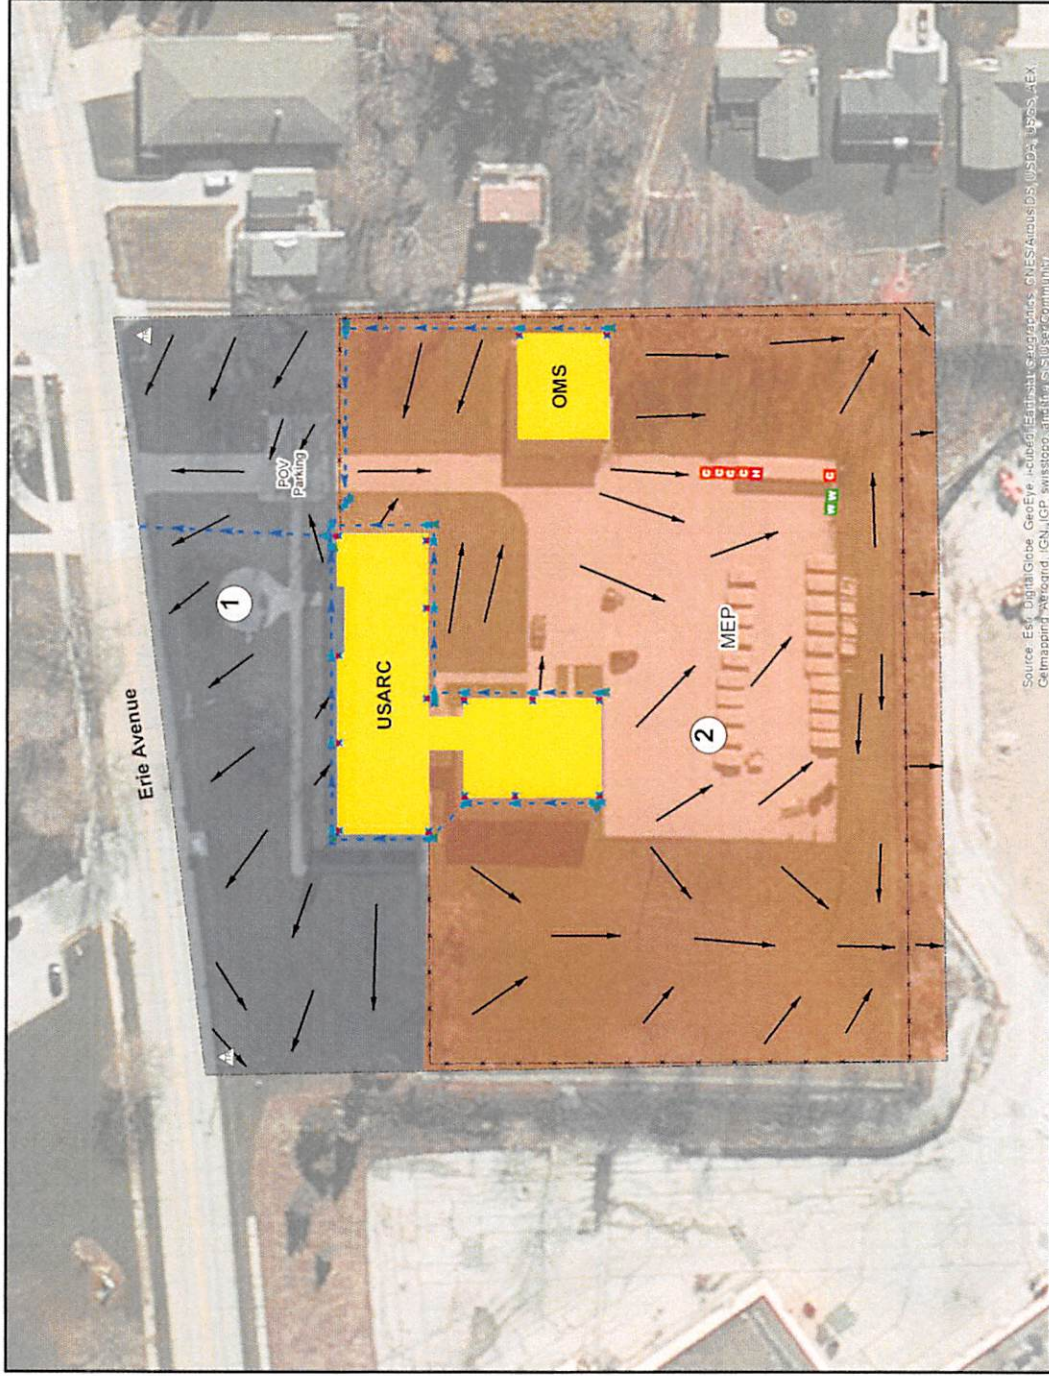
Figure 3 Site Drainage Map

Based on observations made by PGS during the SAV, the William F. Fale USARC can be divided into two distinct drainage areas (Drainage Areas 1 and 2). Figure 3 shows the drainage areas observed at the site, the general stormwater runoff drainage patterns, and the conveyances that accept stormwater runoff from each area.

The topography of Drainage Area 1 slopes down to the north. Stormwater within the grassy area primarily infiltrates into the ground or evaporates. In the event of heavy precipitation stormwater within the grassy area flows overland to the north and onto Erie Avenue. Stormwater within the POV parking area and entrance drive also flows overland to the north and onto Erie Avenue.

The topography of Drainage Area 2 has a slight downward slope to the south. Stormwater within the grassy areas primarily infiltrates into the ground or evaporates. Within the MEP area and in the event of heavy precipitation within the grassy areas, stormwater flows overland towards the property's southern boundary. Stormwater that reaches the property's southern boundary primarily drains off the property near the property's southwest and southeast corners.
