Re: Engineering Design Report – Red River Drive Stormwater Passage

Project No. WR24-04-050

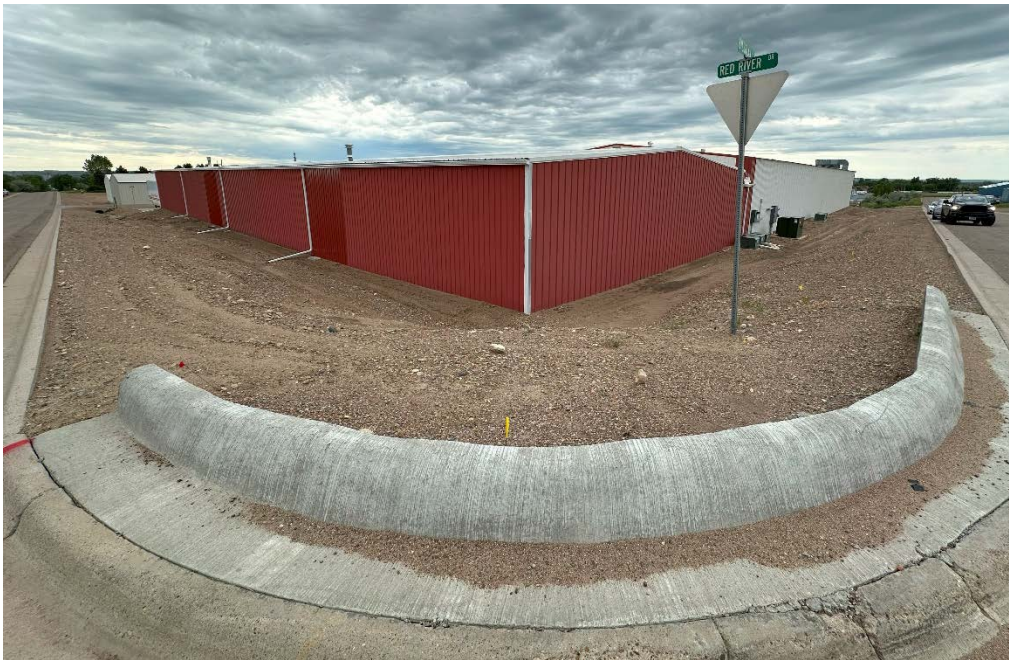
Currently, several inches of sediment deposition exist above the concrete foundation wall of the SMC shop, localized to the northwest building corner. Also, rilling and pronounced flow-line erosion are evident along the road shoulder ditches leaving the intersection in both directions along the building. Acute erosion is evident at the downspouts along the north side of the SMC building as well.

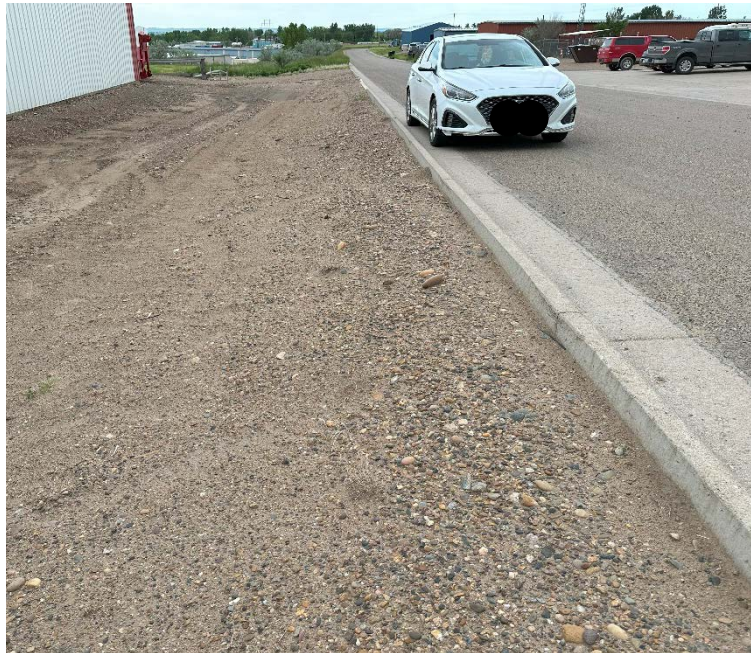
The road shoulders separating the SMC building foundation from the roadway along this corridor are relatively steep - being as steep as 2:1 (H:V). Little to no vegetation exists on these gravel embankments. These factors lead to the road shoulders being prone to erosion. As can be observed in site pictures included herein, several inches of vertical separation exist between the top-back-of-curb and the top-of-gravel against the backside of those concrete curbs along both curb lines. It can be inferred that, over the years since construction of the paved roadway, gravel along those slopes has been washed downslope during rain events and deposited against the sheet metal exterior of the SMC building. In doing so, differential deposition has compromised the uniformity of the ditch flow lines surrounding the intersection. Some evidence of ponding was observed in both the eastward- and southward-flowing ditches (mainly the southward-flowing ditch).

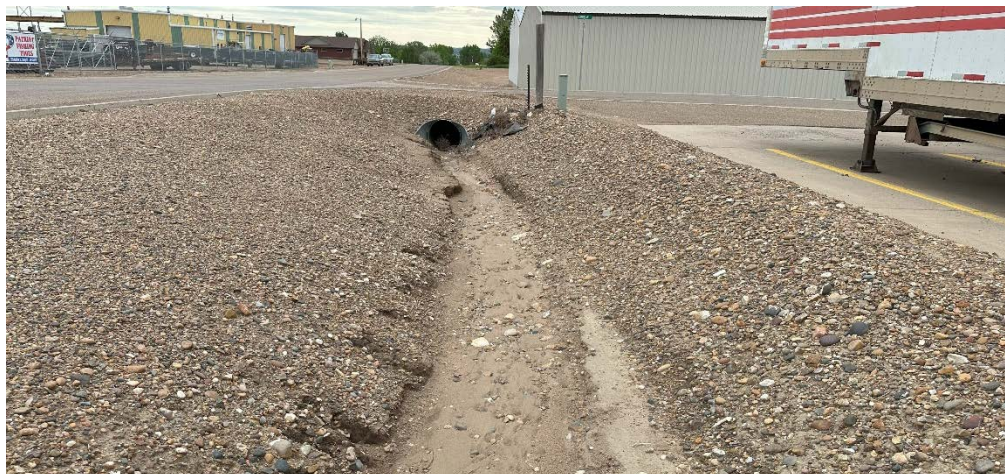
Turf Reinforcement Mat (ECP-3) is proposed at the inlet side of the existing Cambrian Lane CMP culvert. This culvert should first be cleaned of sediment and the inlet side re-graded for uniformity, with the existing flared end section exposed without constriction. The inlet side, as shown on the attached exhibit set, should then be outfitted with a single 8-ft width of ECP-3 TRM extending approximately 15-ft in length upstream of the culvert opening. The TRM should be installed on the upslope along the sides of the culvert to be at least even with the existing top-of-pipe. A 6"x6" key-in trench should be utilized on the upstream end of the TRM length, with a 0.7 staples/yd anchoring scheme generally followed. Two (2) polypropylene-netting excelsior wattles, spaced as shown on the attached exhibit, are also recommended upstream of the existing culvert. This configuration is proposed to halt further siltation within the CMP culvert. The proposed TRM will halt further localized erosion upstream of the culvert while the excelsior wattles will act to decelerate ditch flows and catch silt flowing from further up-ditch prior to it entering the culvert. With this approach, silt may be excavated as needed by hand (upstream of the culvert) rather than requiring a water jet to wash silt from the culvert barrel.
