DATE: August 11, 2025

TO: Design Review Committee

FROM: Erin Ventura, Contract Planner

RE: 40 Gold Dust Trail - Design Clearance for the remodel of an existing church  
(APN: awaiting new APN)  
Zoning: R-E  
Design Standard District: Historic District  
Applicant: JWCS Design

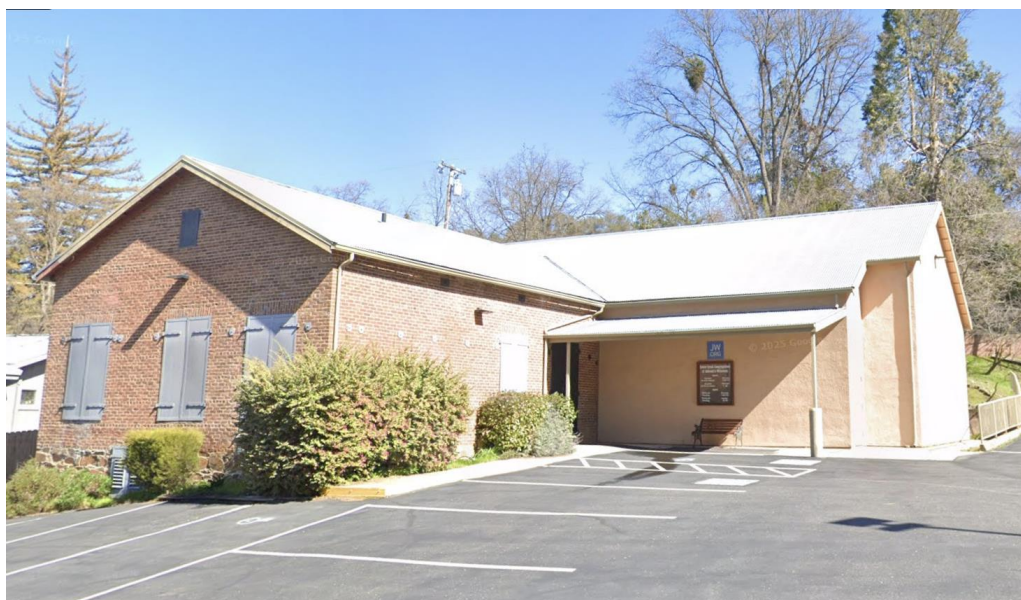
The historic building, originally built in the 1870s and once used by the Central Eureka Mining Company, is part of a historic mining site in Sutter Creek, CA. It has been renovated multiple times (notably in 1991, 1998, 1999, 2001, 2009, and 2019) and is currently owned by the Jehovah's Witnesses. (See application materials for a more detailed report on the history of the building.)

The existing structure reflects a simple National Style building that has undergone expansions over time, which has altered some of its original historical character. While the additions made do not fully align with traditional design criteria, the metal roof, masonry and shutters remain as notable features.
