# SPRING HILL MISSIONARY BAPTIST CHURCH

## STRUCTURAL STABILIZATION

### TUPELO, MISSISSIPPI

**Issue Date: May 6, 2026**  
**Project Number: 2319.1**  
**BID SET**

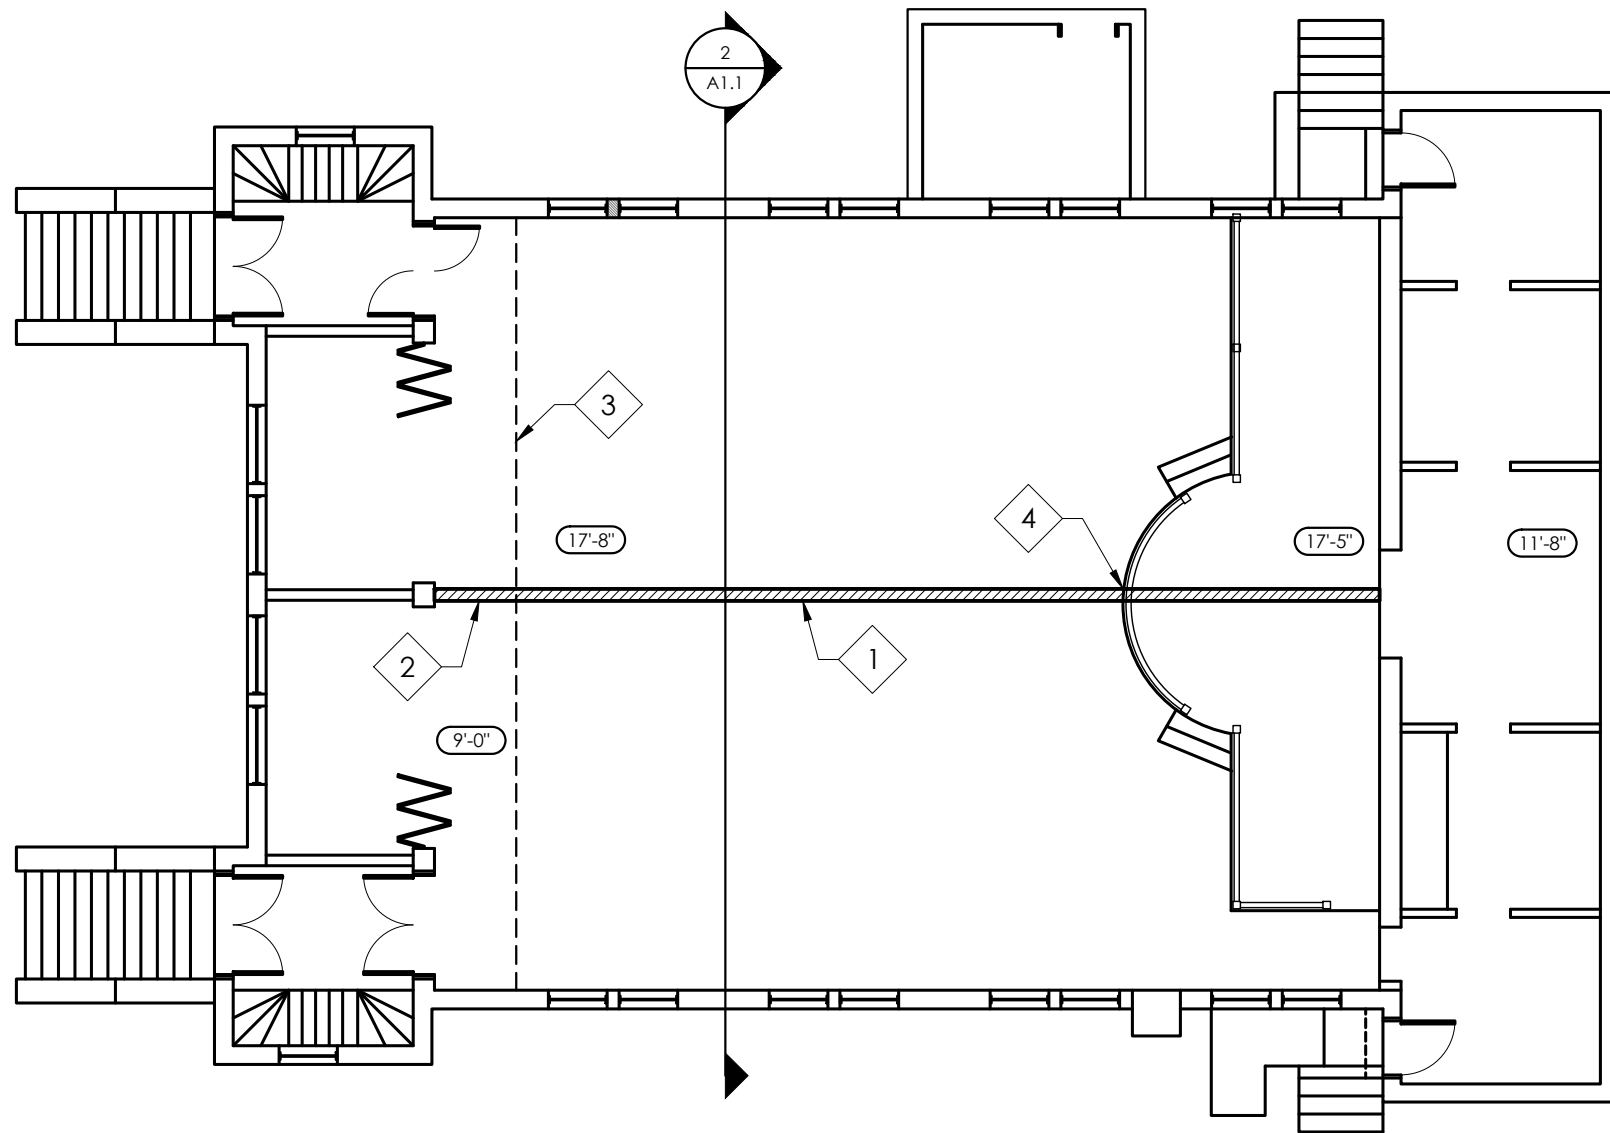
1  
A1.1

## FIRST FLOORPLAN

- OPTION #1:** INSTALL SINGLE SHORING WALL DOWN THE MIDDLE AS SHOWN. 2x6 WD STUDS @12" O.C. WITH CONTINUOUS SINGLE 2x6 SILL PLATE AND CONTINUOUS DOUBLE 2x6 TOP PLATE, TWO ROWS OF HORIZ. BLOCKING BETWEEN STUDS SPACED 6' APART, AND DIAGONAL 2x6 BRACING NEAR EACH END OF ONE SIDE OF WALL AT 45 DEGREE ANGLE. REMOVE HOLLOW BEAM PRIOR TO WALL INSTALLATION TO INSTALL NEW WALL DIRECTLY UNDER CEILING JOISTS. THEN, INSTALL TWO ROWS OF 2x6 DIAGONAL BRACING IN ATTIC AT EACH RAFTER & 45 DEGREE ANGLE, FROM EXIST. CEILING JOISTS NEAR NEW SHORING WALL UP TO RAFTERS, ONE ON EACH SIDE OF CENTERLINE.

**OPTION #2:** LEAVE HOLLOW BEAM IN PLACE AND INSTALL TWO SHORING WALLS, ONE ON EACH SIDE OF THE EXISTING BEAM, TIGHT TO THE UNDERSIDE OF THE EXISTING CEILING JOISTS (REMOVE ADHERED 12"x12" CEILING TILES AS NEEDED). WALL TO BE THE SAME AS OPTION #1 EXCEPT STUDS CAN BE SPACED @16" O.C.

- EXTEND SHORING WALL FROM FLOOR TO BALCONY ABOVE.
- LINE OF BALCONY ABOVE.
- LOCATE SHORING WALL STUDS TO AVOID EXISTING ALTER RAILING.

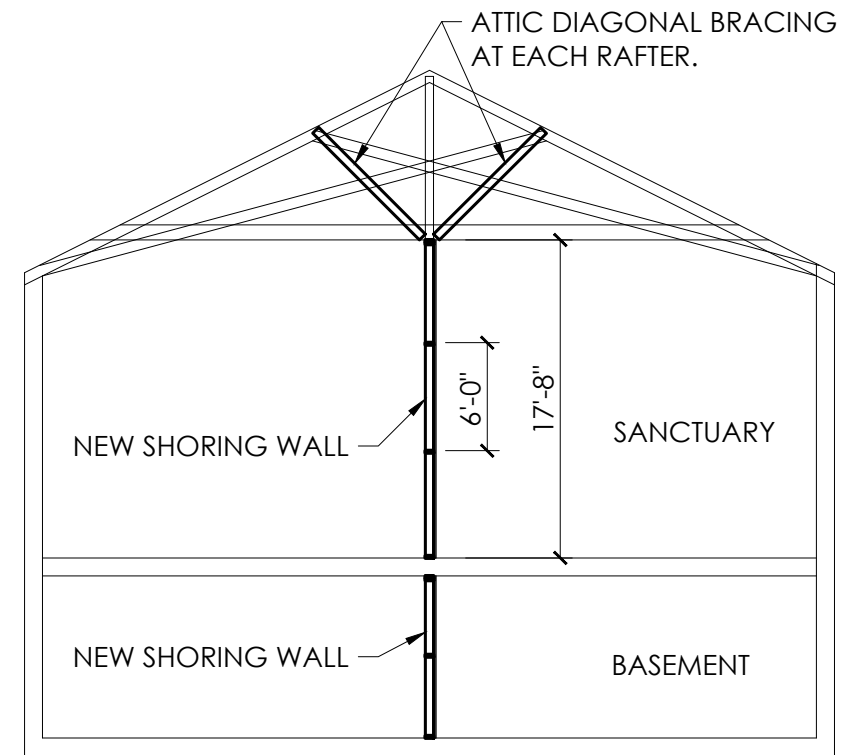
2  
A1.1

## BUILDING SECTION

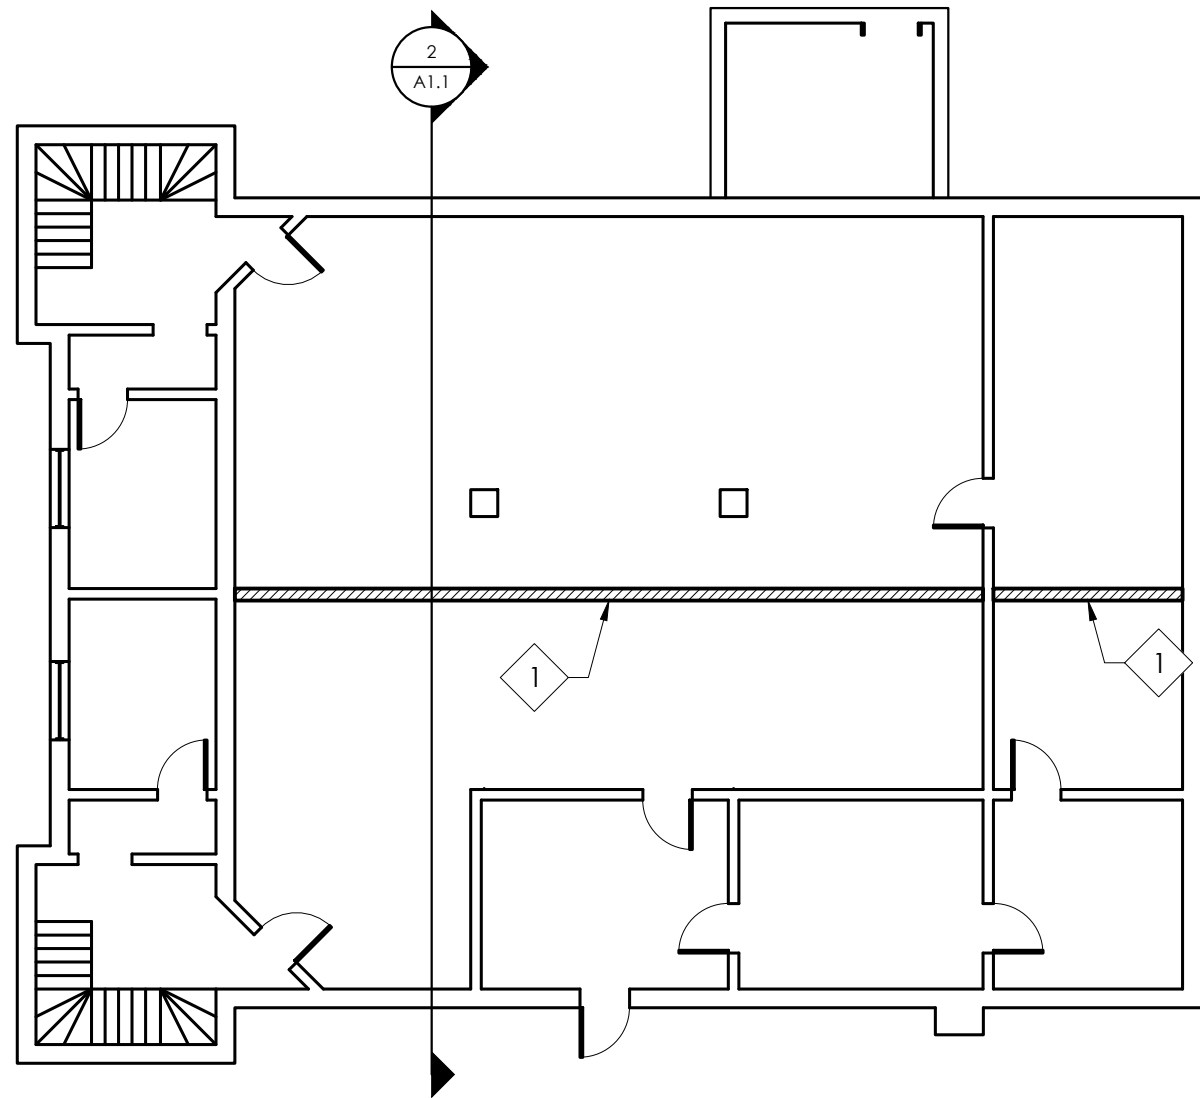
1  
A1.2

## BASEMENT FLOORPLAN

1. NEW STRUCTURAL SHORING WALL IN BASEMENT TO MATCH MAIN FLOOR SHORING WALL(S). CENTER DIRECTLY BELOW NEW SHORING WALL(S) ABOVE.

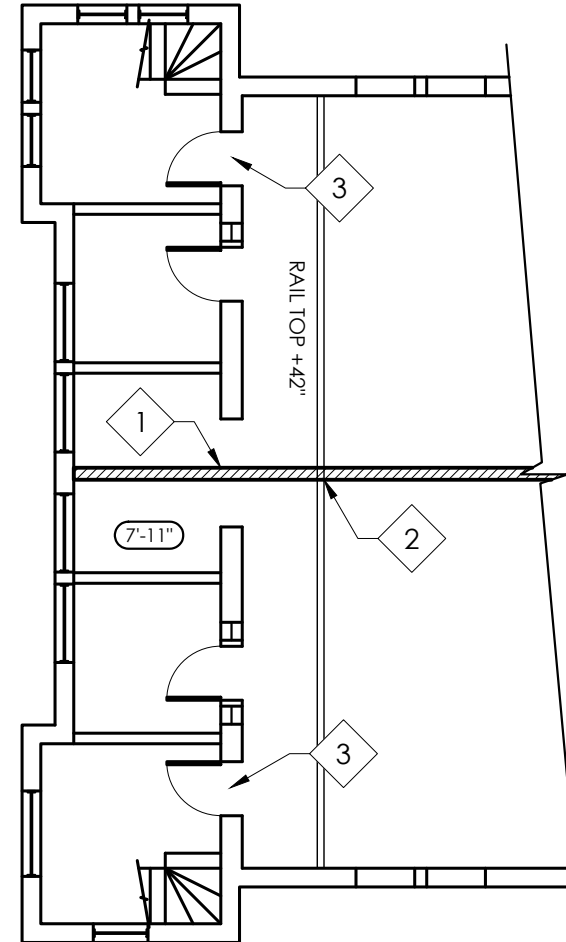
2  
A1.2

## BALCONY FLOORPLAN

1. NEW SHORING WALL(S) IN BALCONY TO CENTER DIRECTLY ABOVE NEW SHORING WALL(S) BELOW.
2. LOCATE SHORING WALL STUDS TO AVOID EXISTING BALCONY RAILING.
3. **ALTERNATE #1:** REMOVE EXISTING LOOSE BRICK VENEER FROM BACK OF BOTH TOWERS. ACCESS AND TEMPORARILY REPAIR WALL STUDS BEHIND REMOVED BRICK VENEER AND COVER WITH EXT. OSB PLYWOOD AND SELF-ADHERED WEATHER BARRIER TO SHED WATER. REMOVE AND REPLACE DETERIORATED AND COLLAPSED ROOF DECKING ALONG THIS AREA. REPLACE THE FIRST RAFTER OFF OF THE TOWER, WHICH HAS SEVERELY DETERIORATED AND PARTIALLY COLLAPSED. USE MATCHING SIZED FRAMING FOR RAFTERS AND WALL FRAMING.
