## **STAFF REPORT**

<b>Meeting Date:</b>	July 25, 2024
<b>Agenda Title:</b>	COA 24-49   28-32 Ashby Street
<b>Requested Action:</b>	Review request to replace the existing wood windows with wood, aluminum-clad Harvey windows on the façade.
<b>Department / Agency Lead:</b>	Community Development
<b>Staff Lead:</b>	Casey Squyres, Historic Preservation Planner

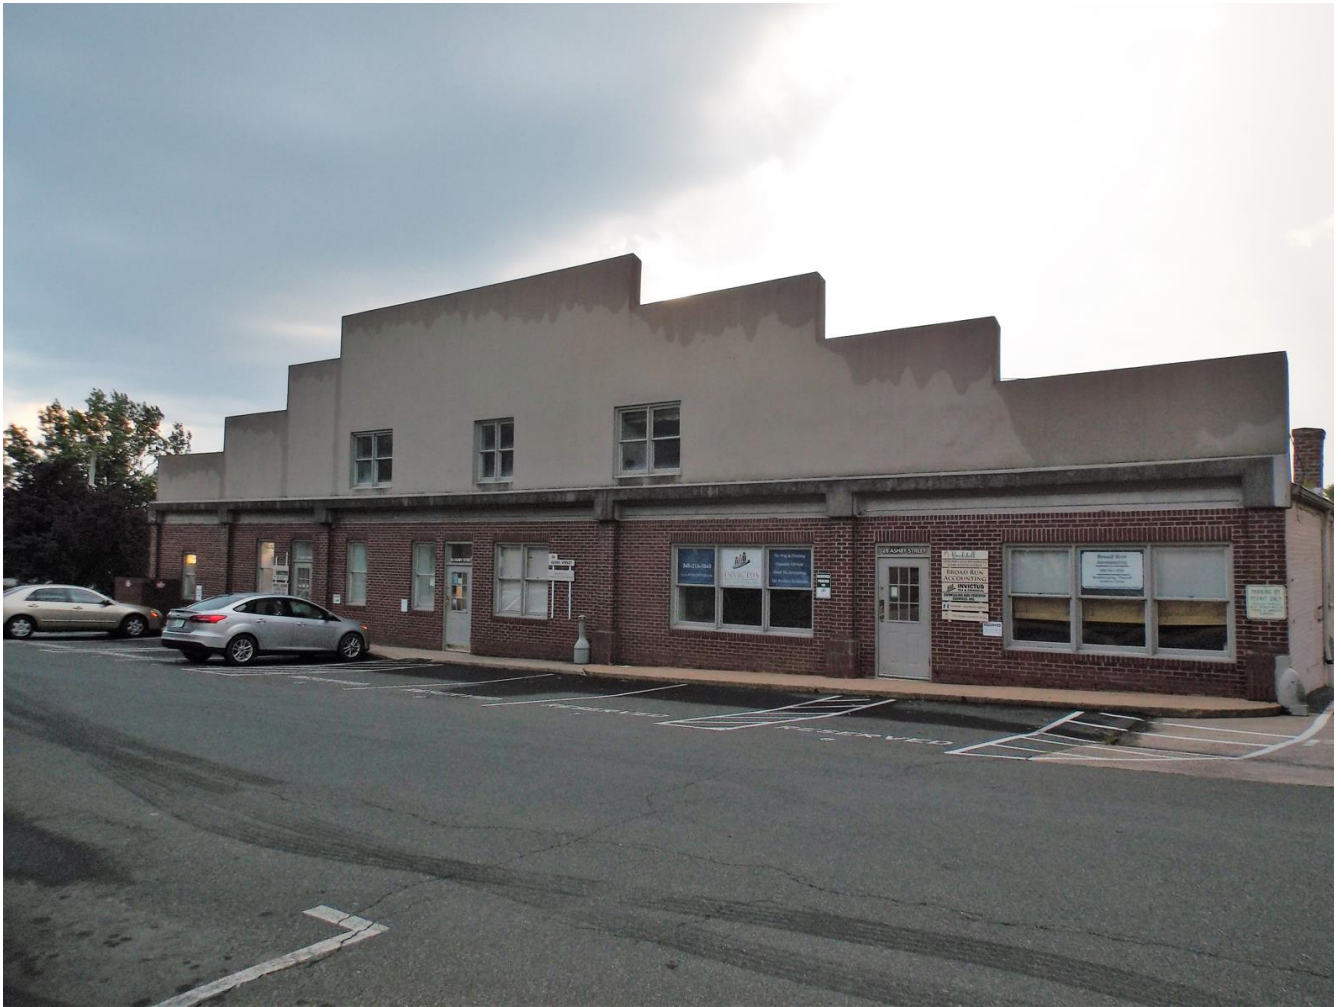
This building was constructed in c.1920 as a garage on the site of a former livery stable. It is in good condition. A new brick face was added to the building sometime prior to 1983, but the prominent stepped EIFS parapet that is visible today was added sometime after 1983. Although this resource is interesting in unique with its complex detailing and variety of materials, this building does not retain integrity. Due to the presence of the EIFS parapet that was added outside the period of significance, the historic appearance and design of this building is lost. Additionally, the EIFS is attached in a way that would harm the underlying material if removal was attempted. This building is a non-contributing resource within the district.

Staff recommends approval of the request to replace the existing wooden windows (which were installed sometime between 1980-early 2000s) due to inefficiency and water infiltration, and to replace with wooden, aluminum-clad Harvey windows, as well as the alteration of the existing tri-part windows with picture windows, as shown in the ca. 1970 image provided by the Applicant, provided the following conditions are met:

- 1) All necessary permits are acquired.
- 2) Retain fenestration patterning, size, shape, and operation. Owners of buildings with windows and doors that have been altered in the past are encouraged to restore these elements to their original appearance based on site evidence and appropriate historic research.
- 3) Design new windows, doors, and other elements to be compatible with the original building
- 4) Possible condition of approval to consider: All new windows shall be wood windows to match the existing, and not aluminum-clad wood windows, as proposed.

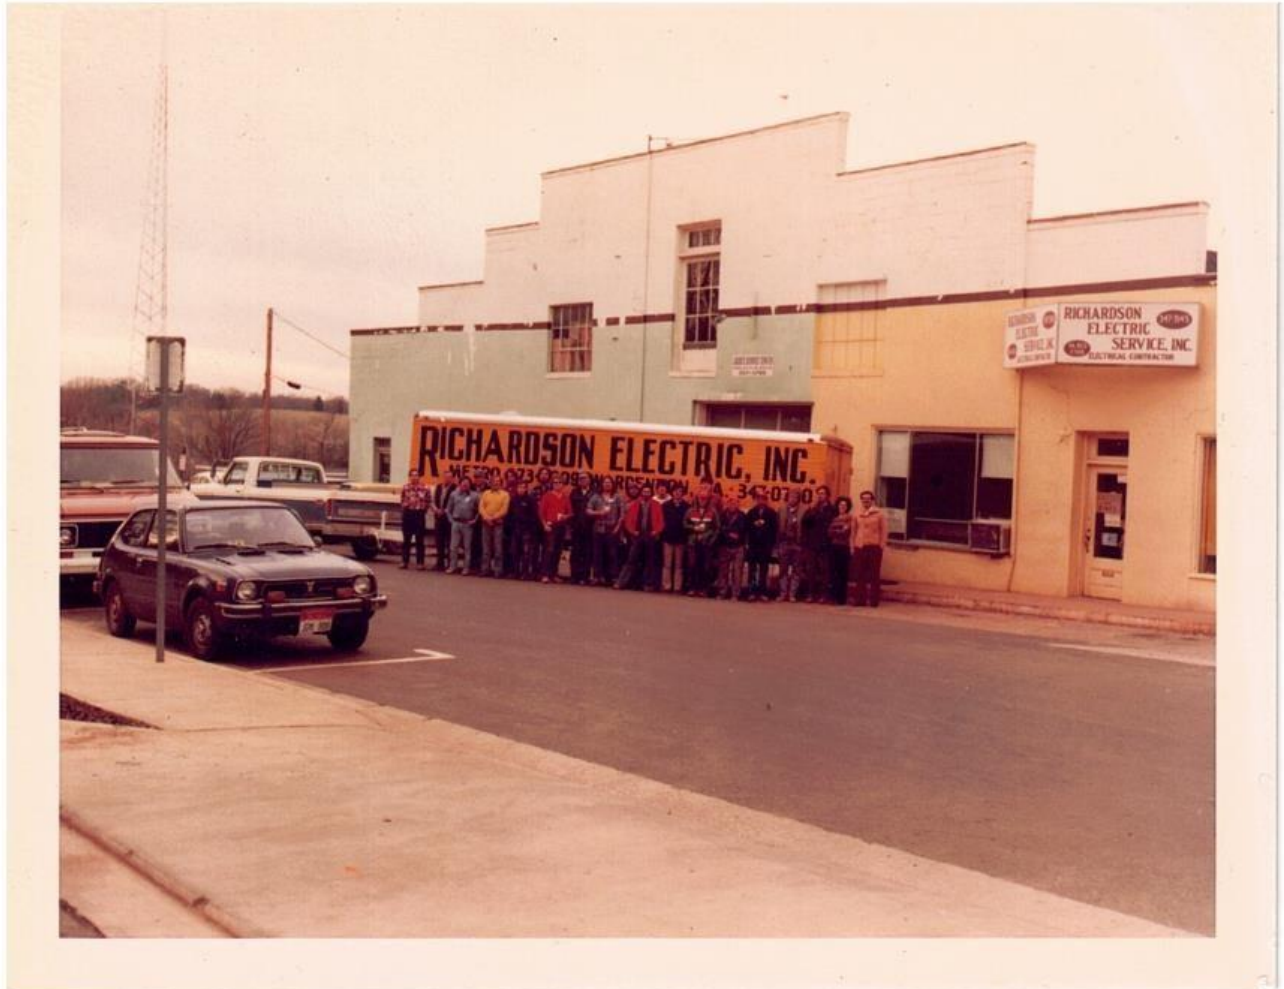
Circa 1970 image provided by Applicant:

The Applicant is requesting approval to replace the existing wooden windows (which were installed sometime between 1980-early 2000s) due to inefficiency and water infiltration. The Applicant is requesting to replace with wooden, aluminum-clad Harvey windows, to include the alteration of the existing tri-part windows with picture windows, as shown in the ca. 1970 image provided by the Applicant.
