## **STAFF REPORT**

| <b>Agenda Title:</b> | COA 26-47 |
| <b>Requested Action:</b> | Proposed exterior alterations, porch reconstruction, rear addition, and new garage outbuilding |

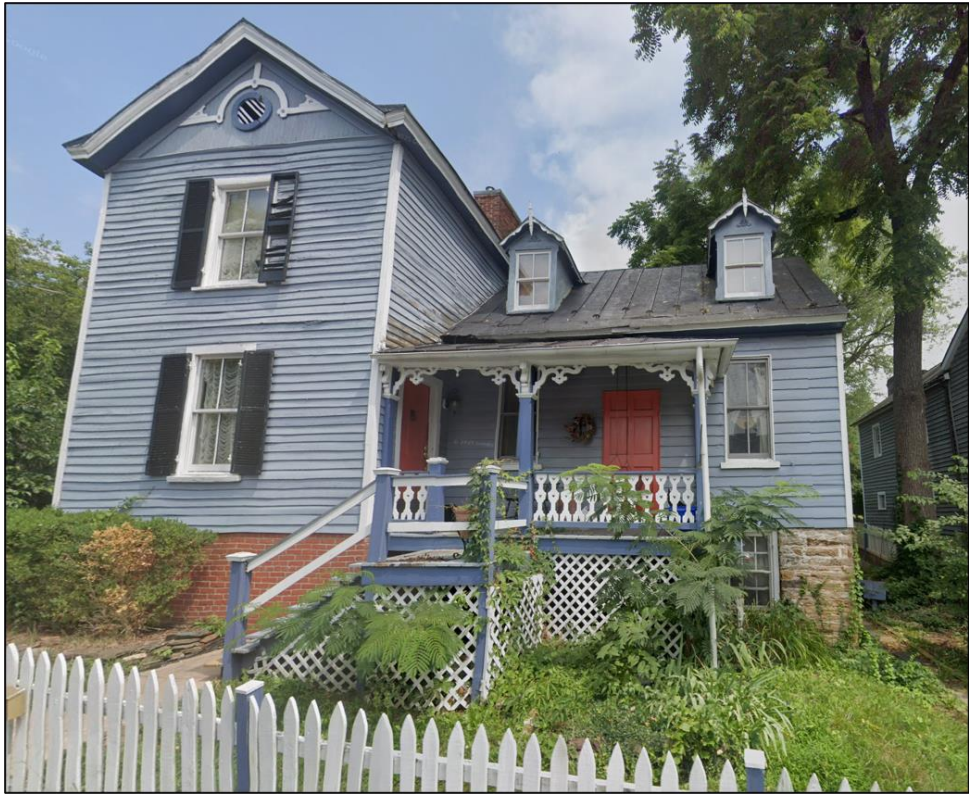
Existing

The one-and-a-half story, rectangular frame core of the dwelling on the stone foundation was constructed in the early 1880s. The dwelling later expanded with the two-story northern addition on a brick foundation between 1903 and 1908. The house has a Folk Victorian style with flat-sawn balusters, bargeboard, and gable trim. Mr. and Mrs. Ford G. Anderson purchased the property in 1918, soon after the large addition was constructed, and lived in the home for approximately five years. Mr. Anderson was a wealthy businessman, Free Mason, and member of the local Chamber of Commerce who made his fortune with a clothing and textile factory known as Anderson Clothing Co. Anderson purchased the Mosby-Spillman House on Main Street in 1923, which then became the family's primary residence. Ford died from a bout of illness in 1933 and left the North Sixth Street home and his other properties to his wife Ethel. Ethel maintained the property until her passing in the mid-1970s but likely leased the home to another while maintaining her residence at the old Mosby estate. Aerial photographs indicate two one-story additions were completed on the rear elevation in the 1950s, and the footprint remained consistent to present day.

Most of the façade's two-over-two sash windows were replaced with new wooden sashes circa 2003. Records of building and health code violations at the property reveal the house was subject to a long-term hoarding situation until recently, which resulted in the prior and existing poor conditions. A historic outbuilding sits in the rear yard behind the house

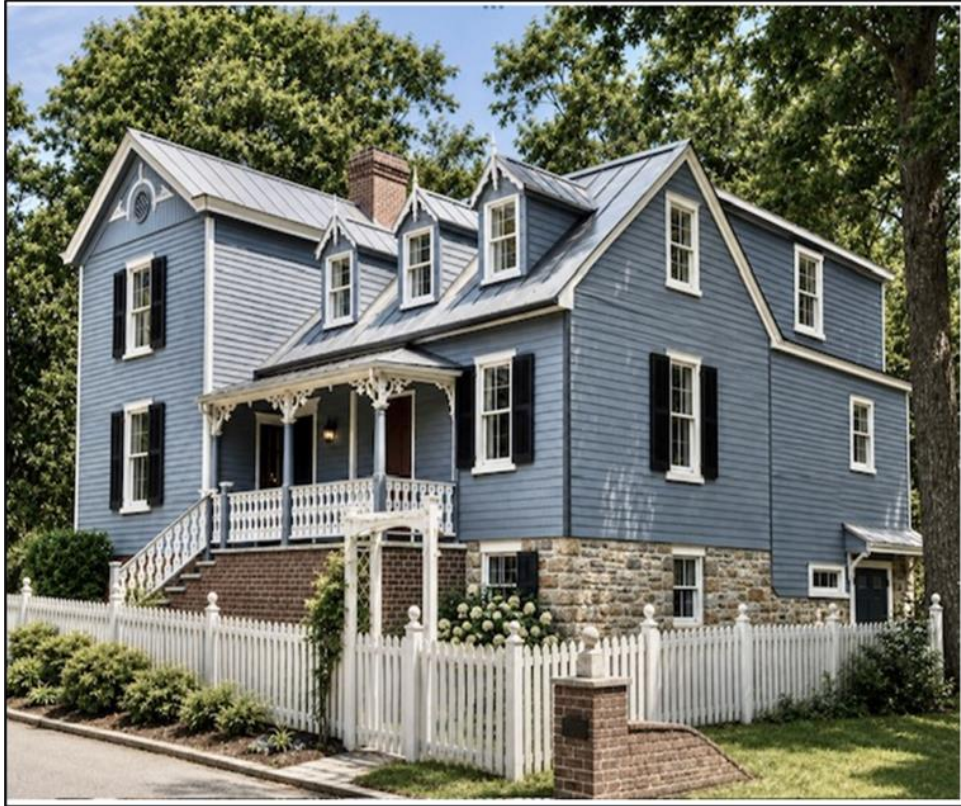
Proposed

The applicant purchased the deteriorated property with the intent to conduct historically sensitive renovation to the interior, conduct exterior repairs, and extend the living space with a new rear addition. All exterior siding will be replaced in-kind, the porch will be reconstructed with in-kind replacement jig sawn railings and a new stair with a brick foundation. The applicant proposes to add a third dormer to the 1.5-story roofline, and cut a new doorway where the faux-door (decorative) is now. The shutters and windows will be replaced in-kind as necessary. The rear second floor addition will extend from behind the 1.5 story roof ridgeline over the rear 1 story addition, as not to impact the street façade or overall footprint. The historic brick and stone foundations will not be impacted. Adding the dormer and possibly an extra doorway would constitute an impact on the historic fenestration, but not an adverse one. This would maintain the overall symmetry while increasing ease of internal circulation. The construction of a garage outbuilding to the north of the house in the side/rear yard will not be highly impactful, and the simple design should complement the existing house without implying historicism. A balance needs to be struck here between the historic guidelines and functionality for new tenants to bring this resource back into residential use.

The plan set has some errors and typos and design components that could use clarifications. The only matter to waffle over is the addition of the third dormer and the door/window across the original portion of the façade (1.5 story). It would not be an adverse effect and would complement the existing symmetry, but it will alter the fenestration pattern. If those items are not deal breakers for any ARB members, I recommend conditional approval with the following stipulations:

3. The new second-floor addition must extend southeast from the rear of the existing one-and-a-half story roofline as not to add vertical height to the façade or expand the building footprint; and
