## DEADWOOD HISTORIC PRESERVATION COMMISSION

DEADWOOD NOT-FOR-PROFIT GRANT PROGRAM FOR  
SITES NOT ELIGIBLE FOR STATE PROPERTY TAX MORATORIUM

RE: Summary Report  
Extent of Damage to Wood Girder Truss  
Insured: Masonic Center Association, 715 – 717 Main St., Deadwood, SD  
Claim Number: PHNP20121407260  
KMS Engineering File Number: 20-023

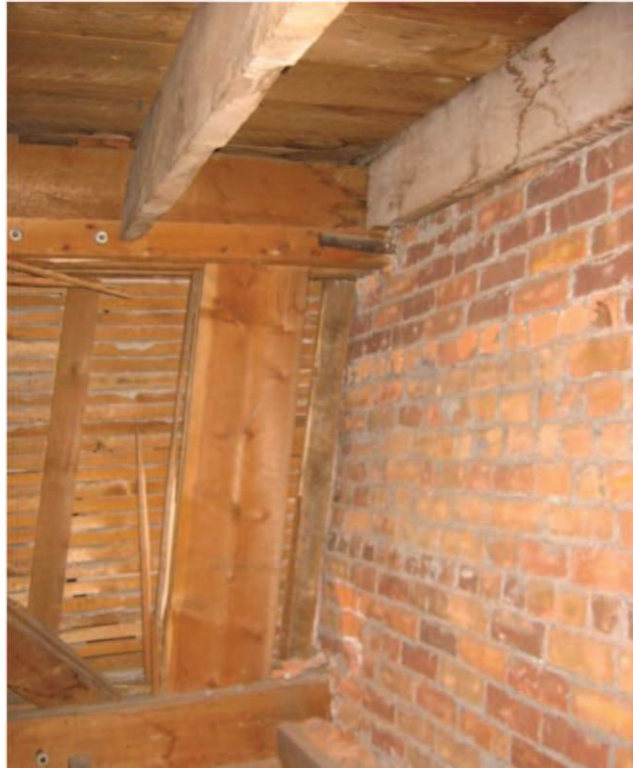
The top and bottom chords of the girder truss extended into the exterior brick wall at each end and were mortared in place. There was no other attachment between the girder truss and the walls observed. At the top and bottom chords on each side of the girder truss a 2x4 was placed for the full length and served as the bearing ledge for the ceiling and roof joists on each side.

Photo No. 13: North end of girder truss, bearing at brick wall.

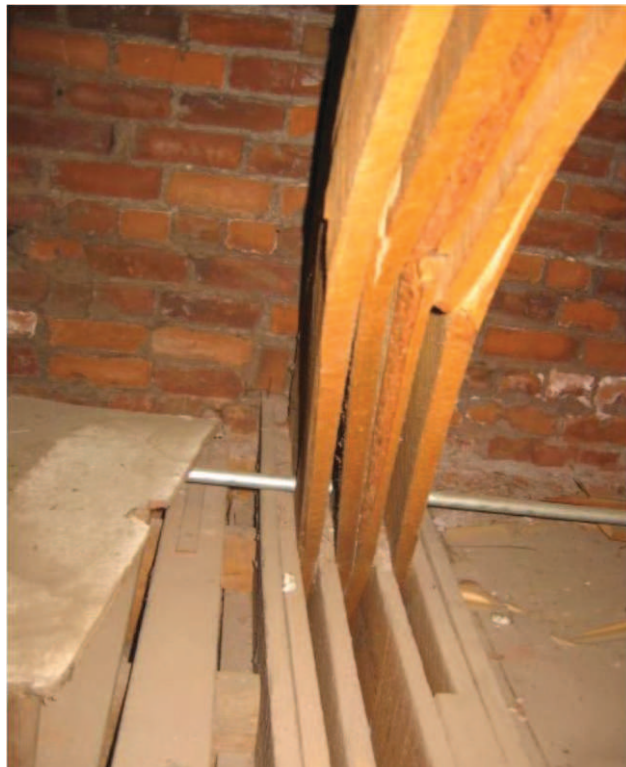
Photo No. 20: View of diagonal breakage at south end of girder truss.

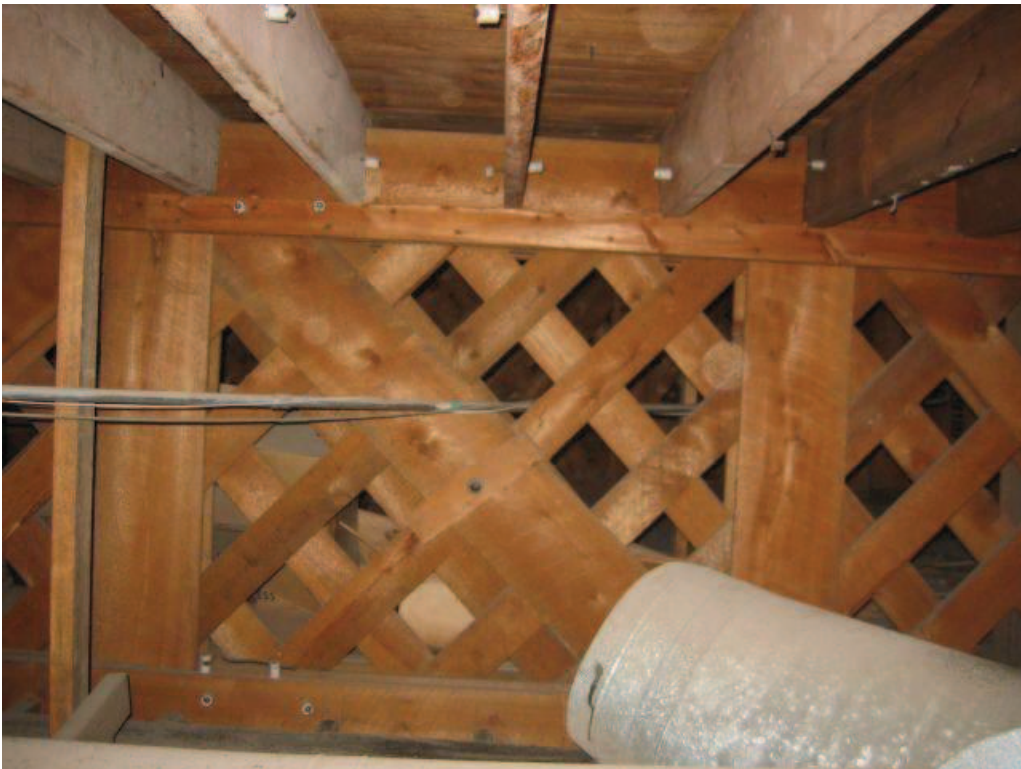
Photo No. 26: Interior panel of subject girder truss.

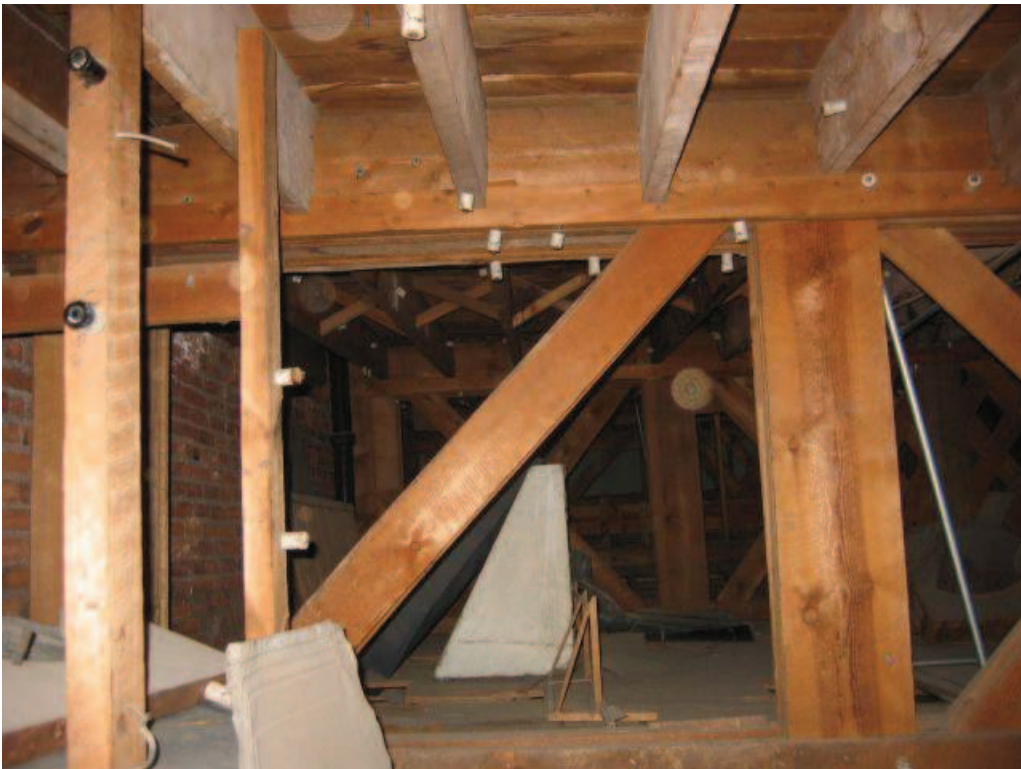
Photo No. 30: South end of subject girder truss.

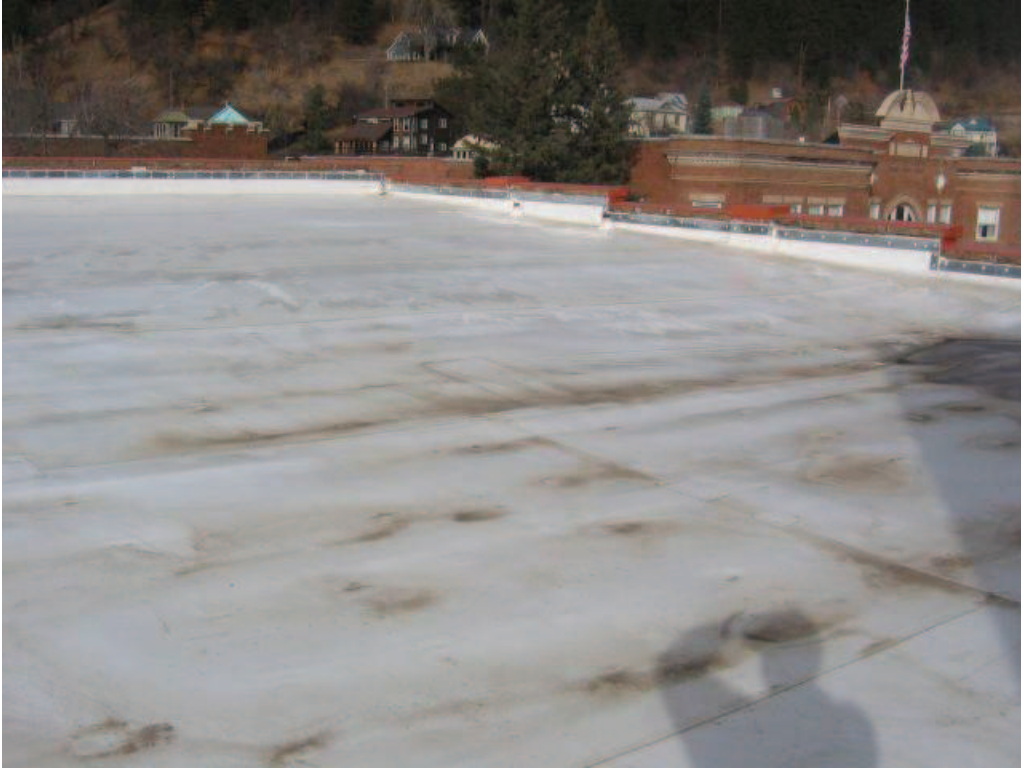
Photo No. 35: North parapet wall, west end.

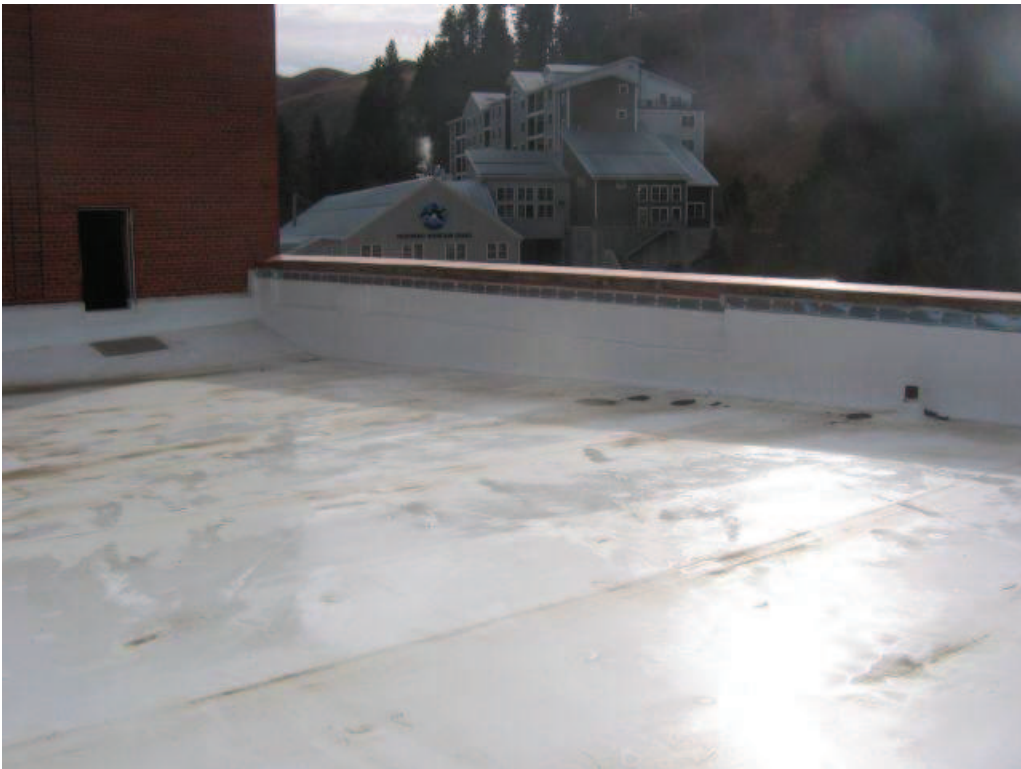
Photo No. 36: Southeast parapet wall, approximately 55-inches high.

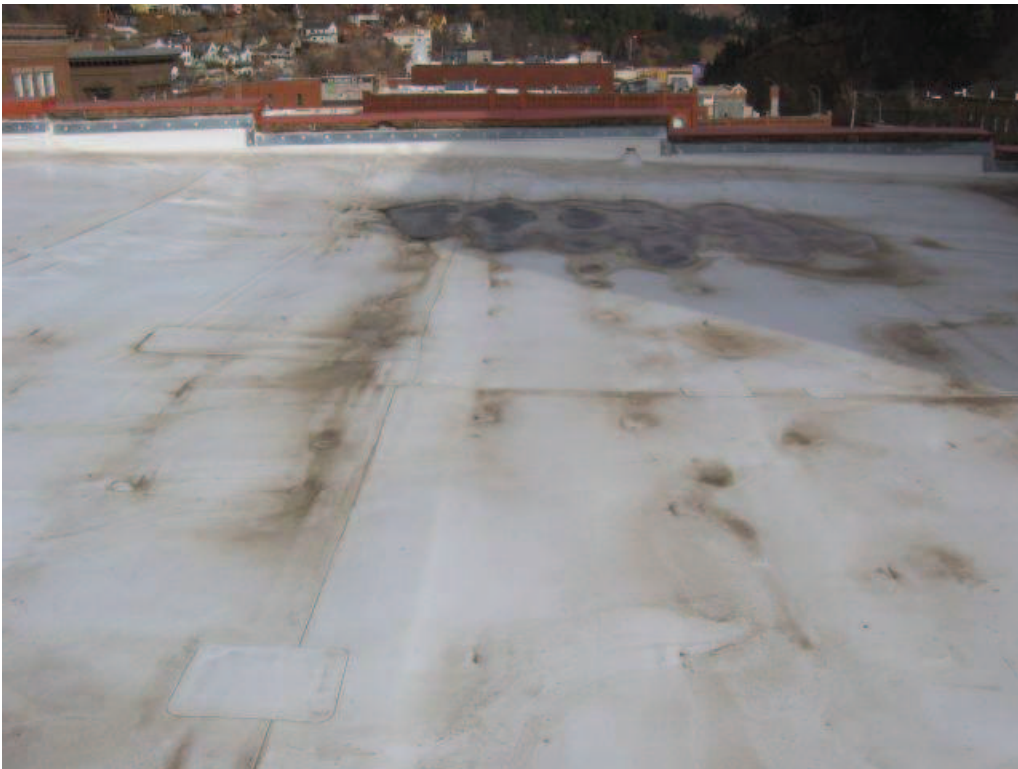
At the north end of the subject girder truss the roof was observed to have deflected downward approximately 12-inches. There was noticeable sediment markings on the roof membrane at this location indicating long term water ponding.

Photo No. 40: North end of truss deflected downward.
