Hilshire Village Municipal Utility District

Fire Hydrant Inspection & PM Report

May 2024

Hilshire Village
Fire Hydrant Survey Summary
May 2024

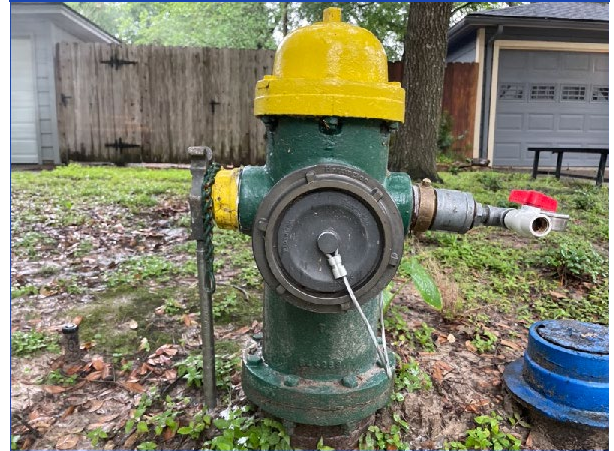
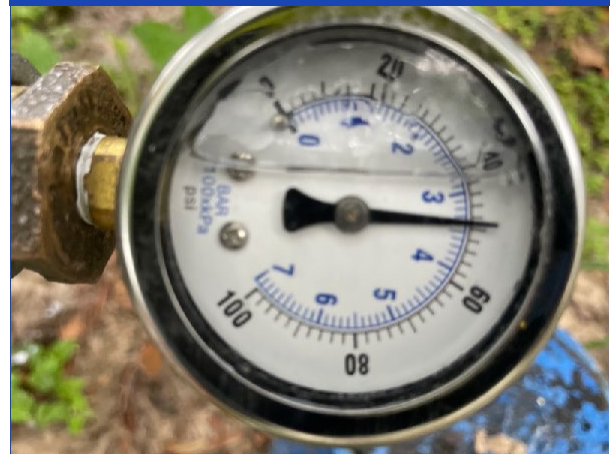
Photo #2

Ok

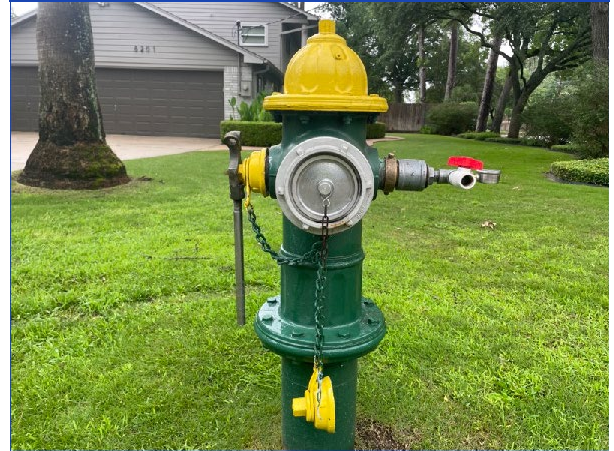
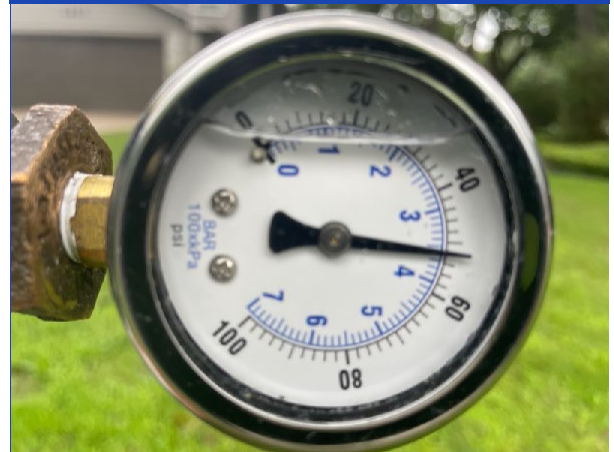
Photo #2

Ok

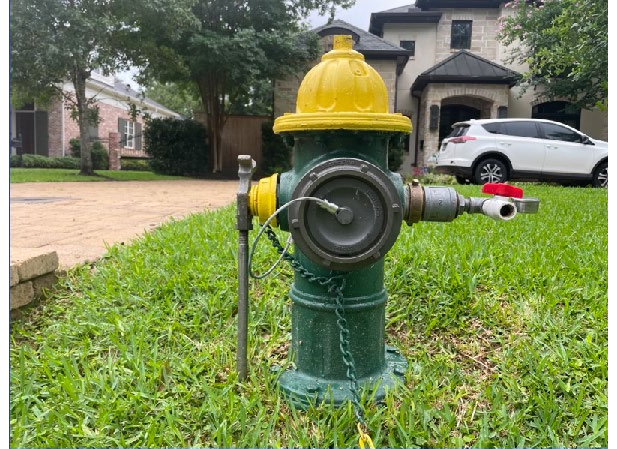
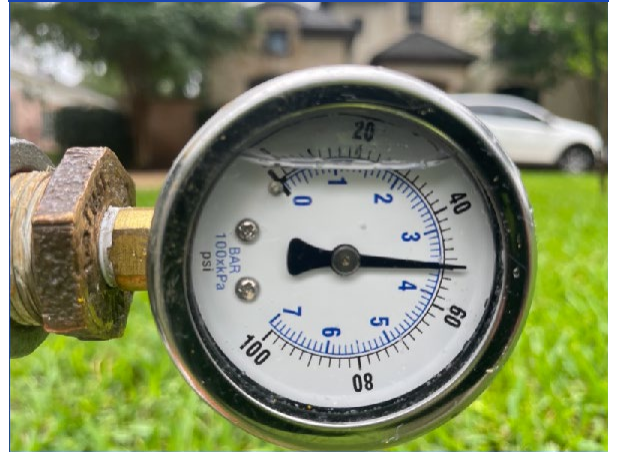
Photo #2

Ok

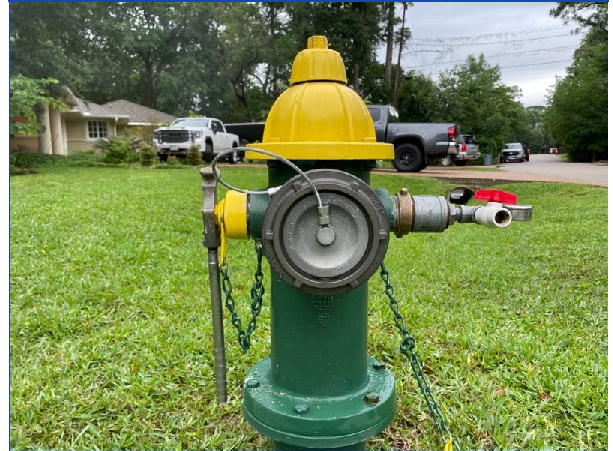
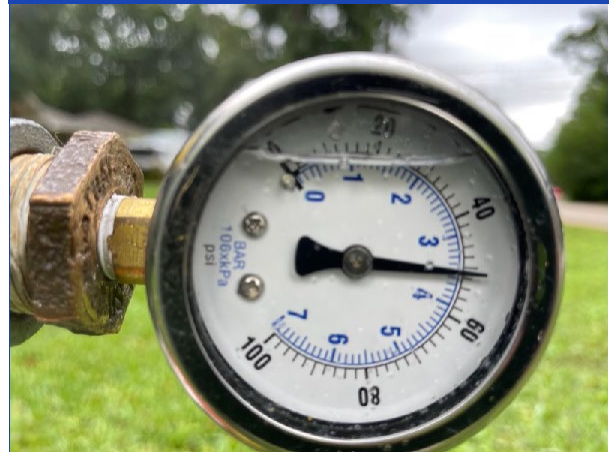
Photo #2

Ok

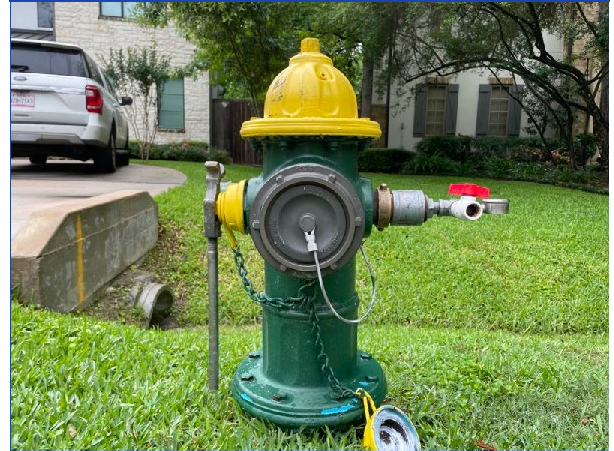
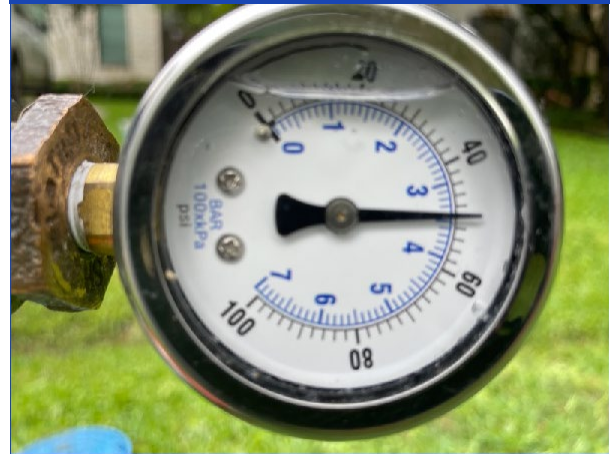
Photo #2

Ok

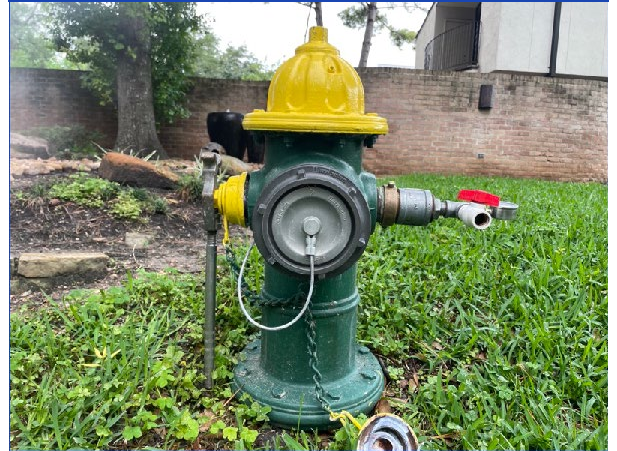
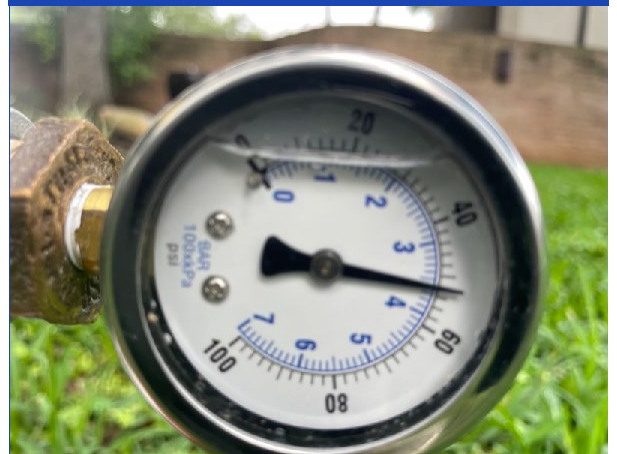
Photo #2

Ok

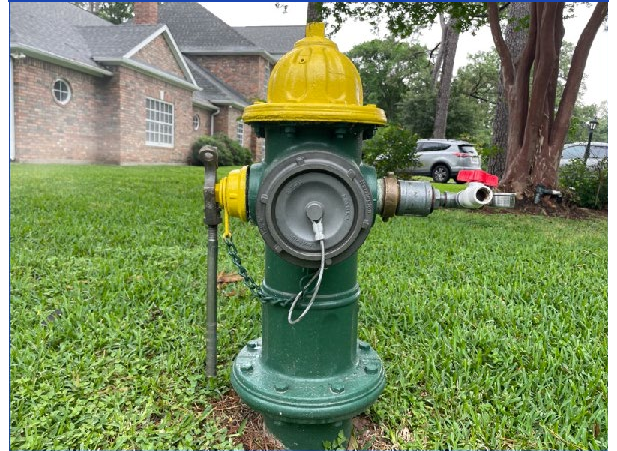
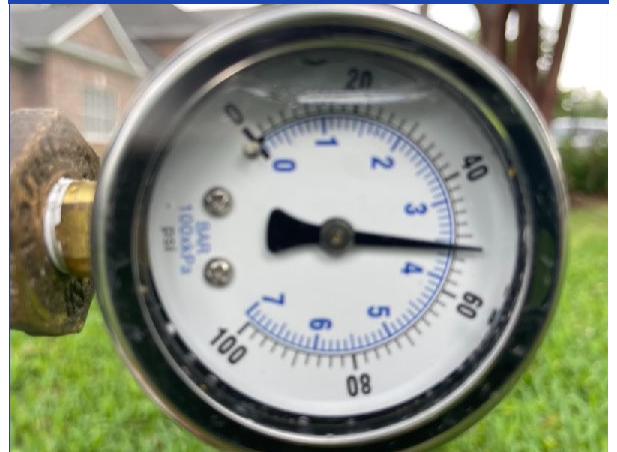
Photo #2

Ok

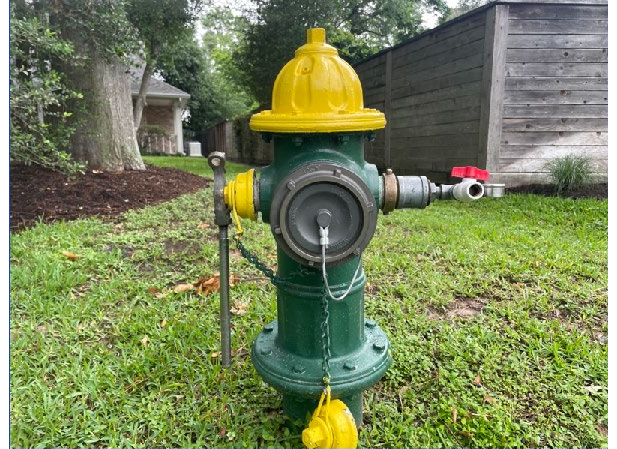
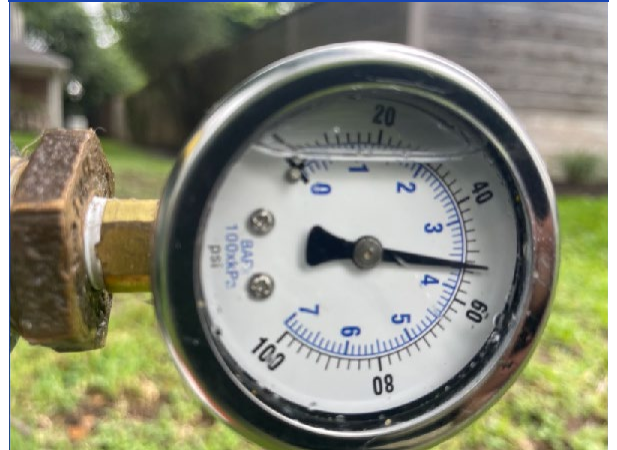
Photo #2

Ok

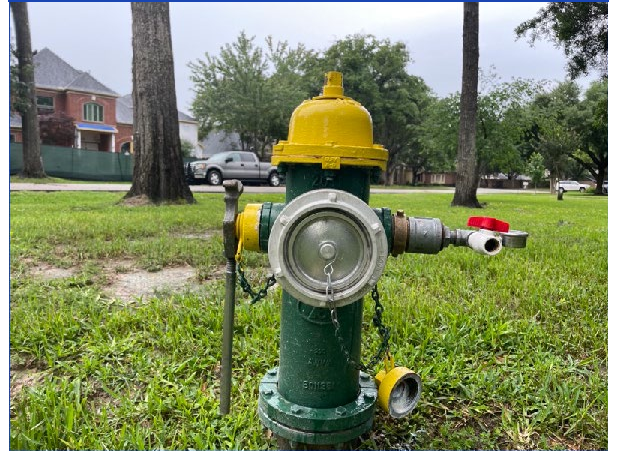
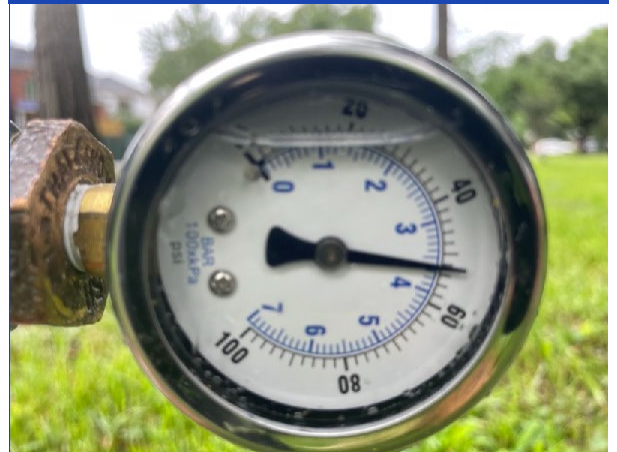
Photo #2

Ok

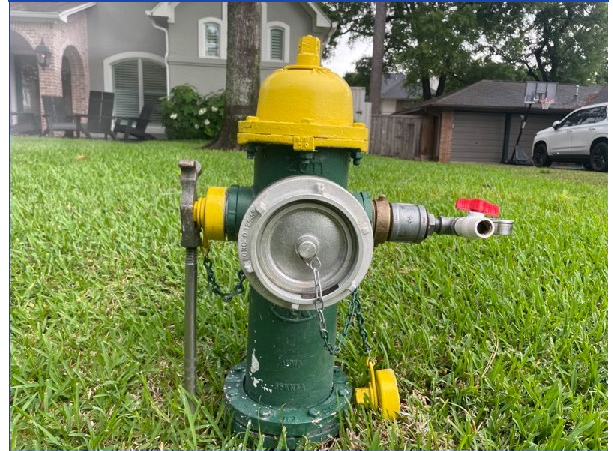
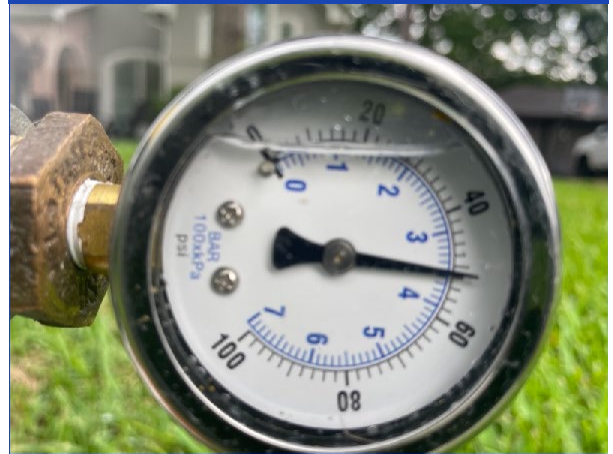
Photo #2

Ok

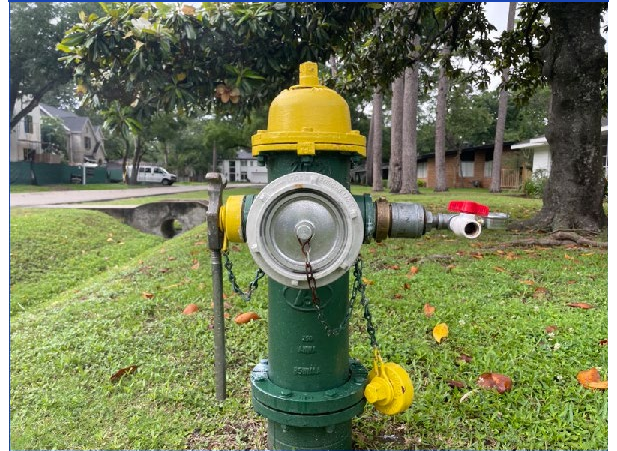
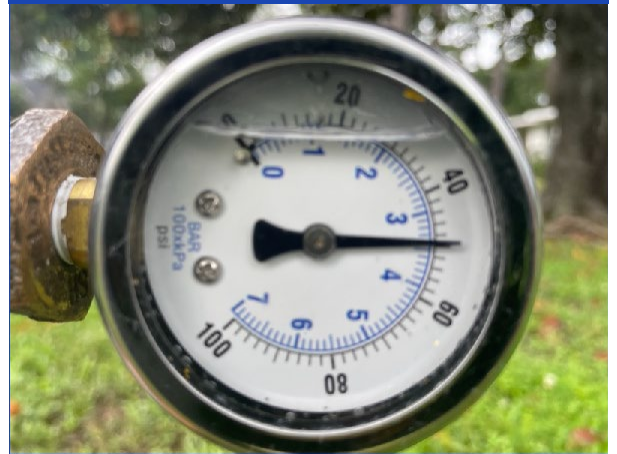
Photo #2

Ok

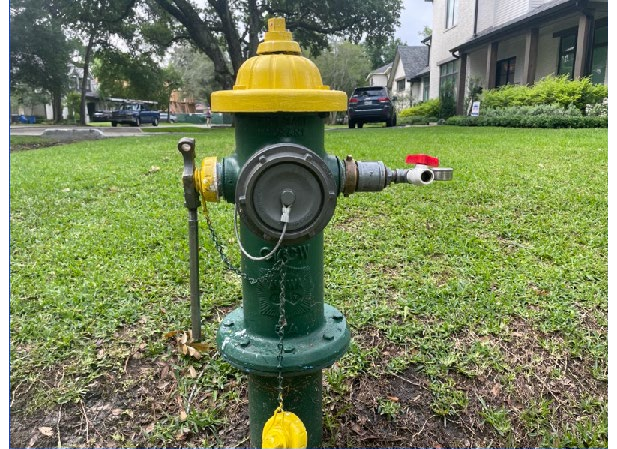
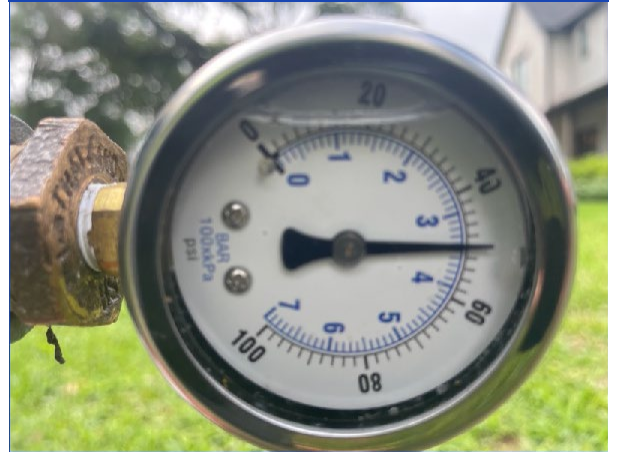
Photo #2

Ok

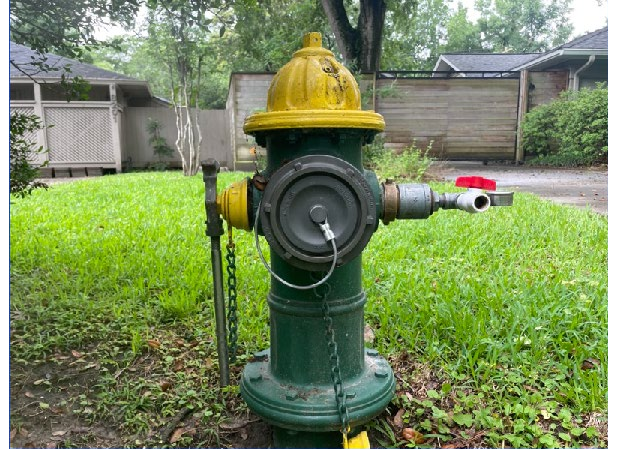
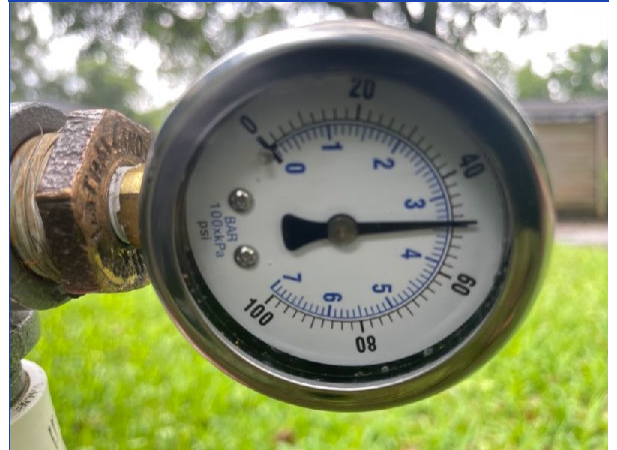
Photo #2

Ok

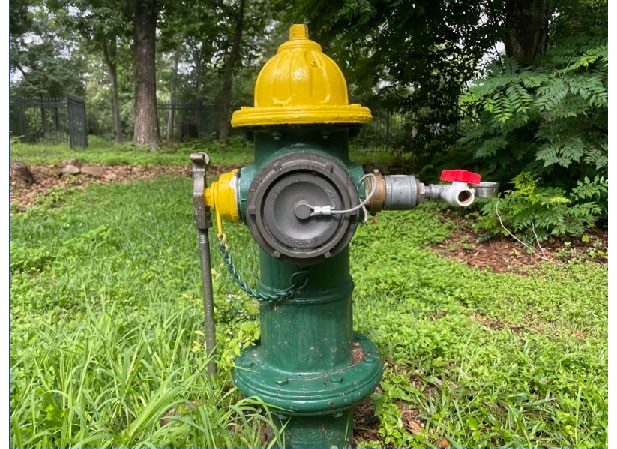
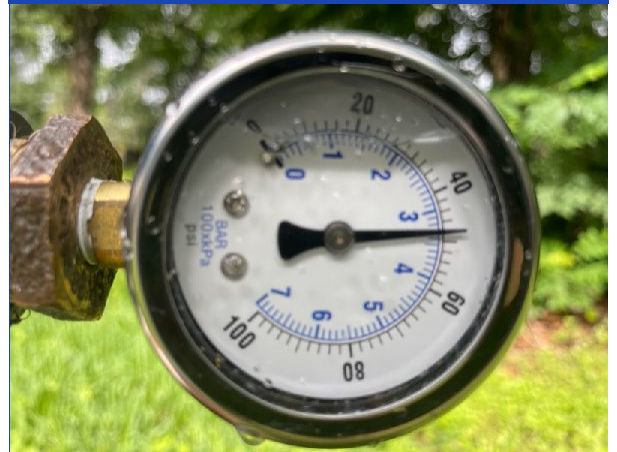
Photo #2

Ok

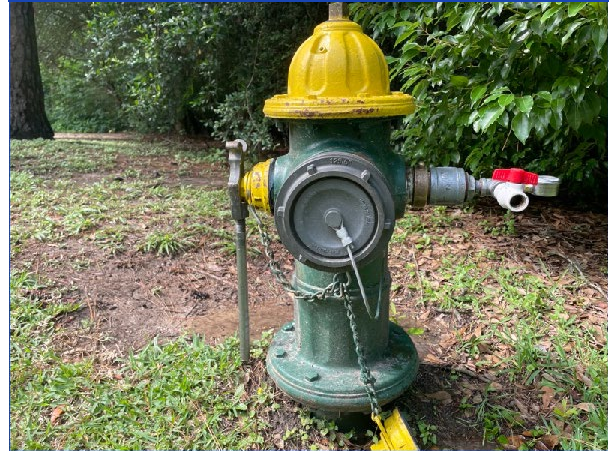
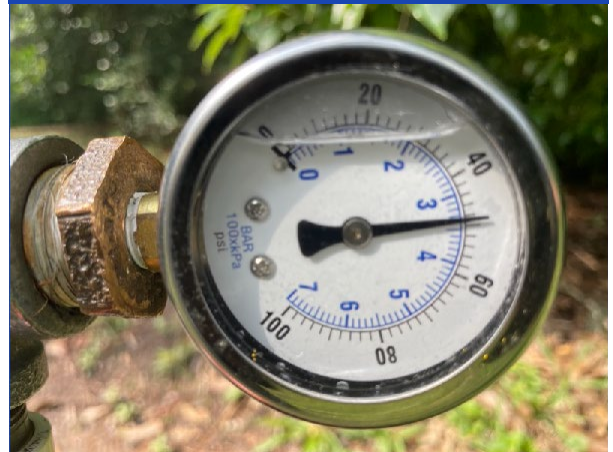
Photo #2

Ok

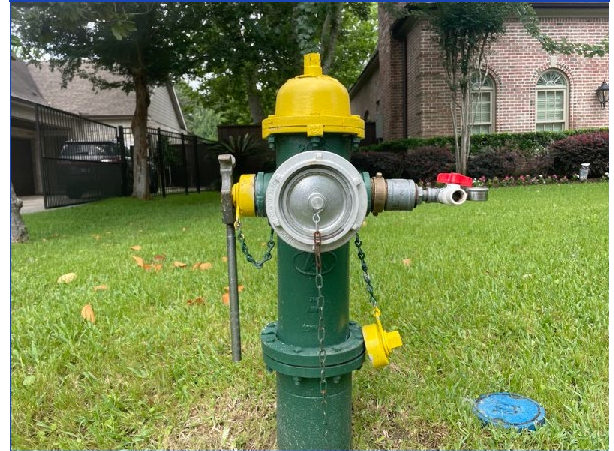
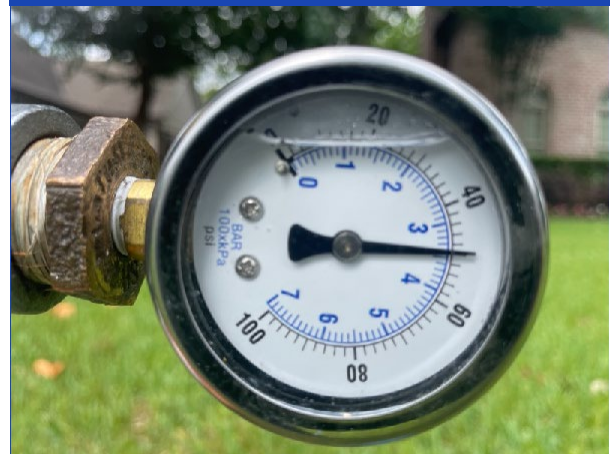
Photo #2

Ok

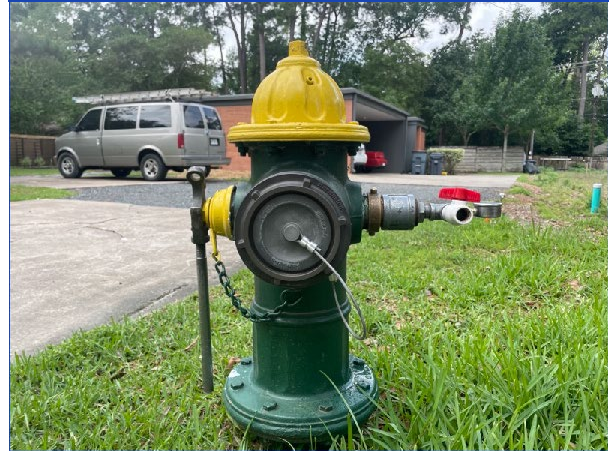
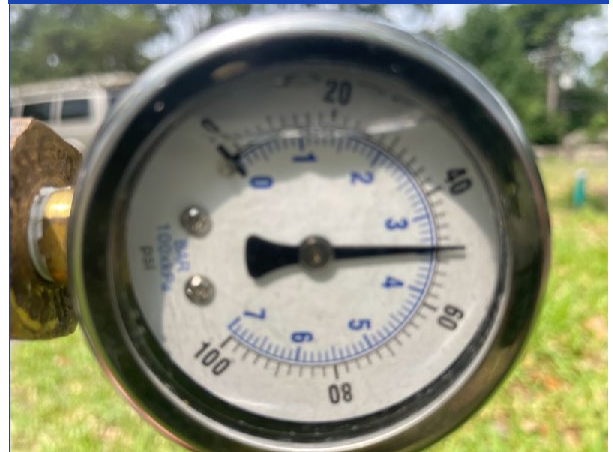
Photo #2

Ok

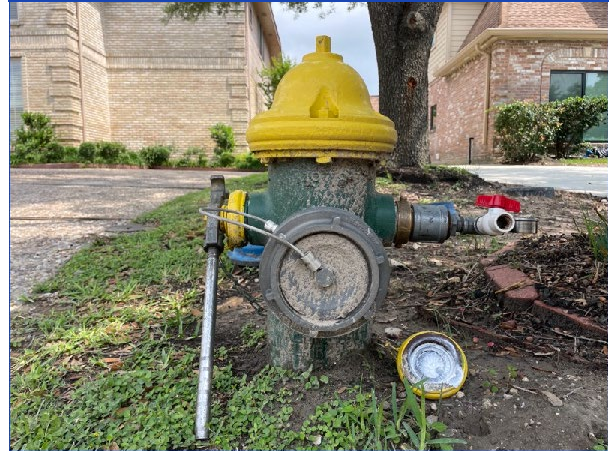
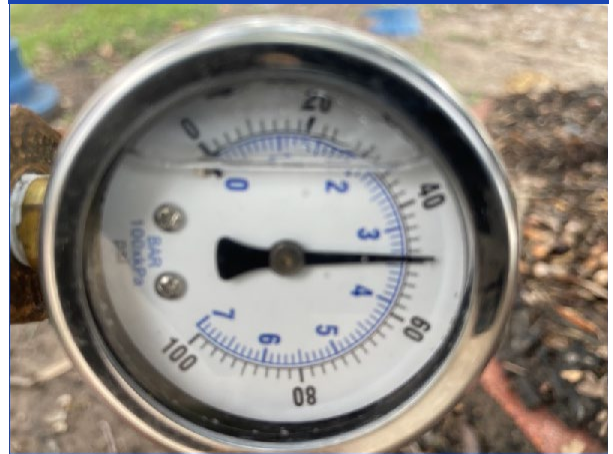
Photo #2

Hydrant wrench will not turn freely.

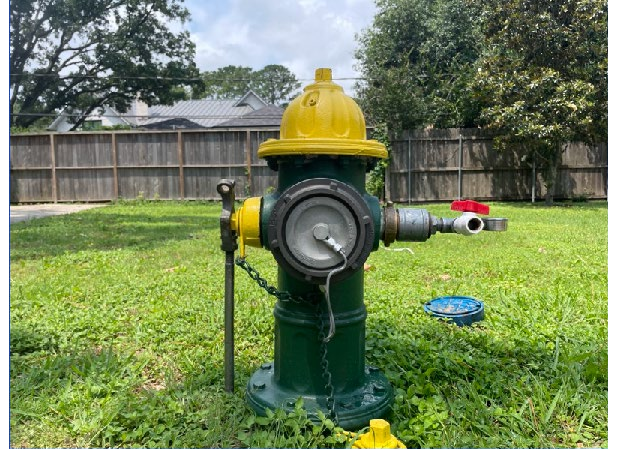
Photo #2

Ok

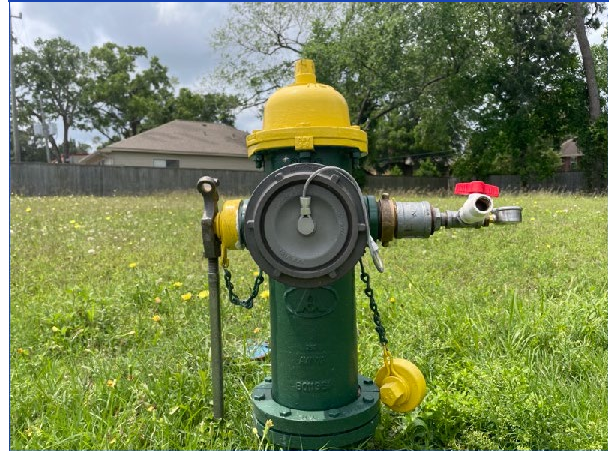
Photo #2

Ok

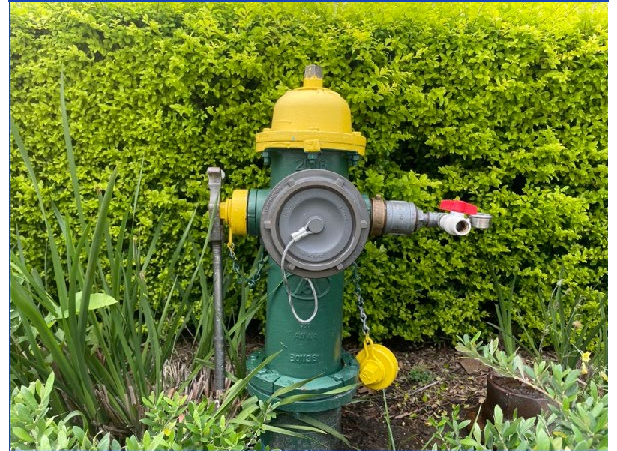
Photo #2

Ok

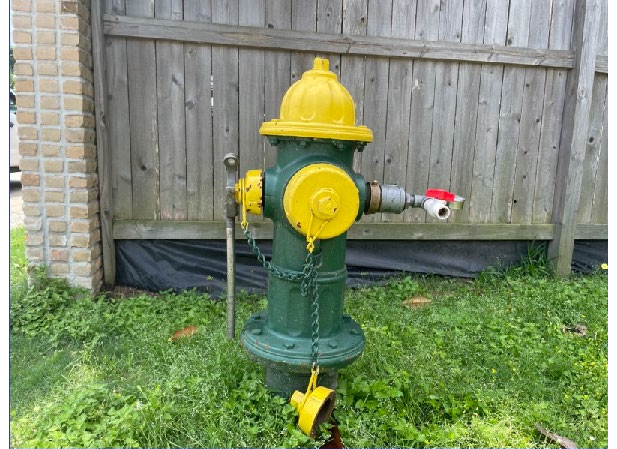
Photo #2

Ok

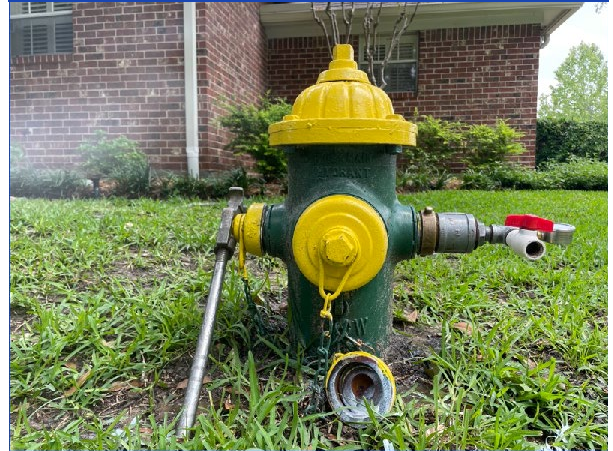
Photo #2

Hydrant wrench will not turn freely.

2 - Schedule repair

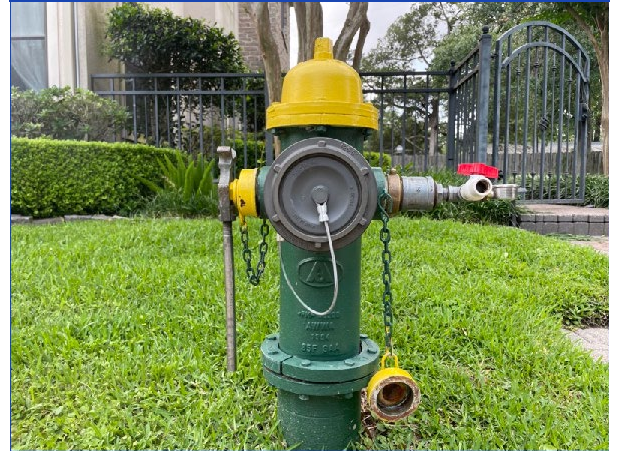
Photo #2

Ok
