PND 242085

Subject: Aurora Harbor Office Site Visit

CBJ Docks and Harbors – Aurora Harbor Office & Outbuilding/Garage Condition Assessment

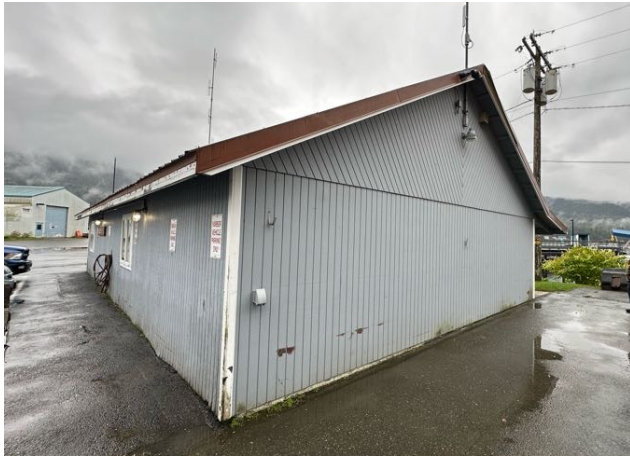
Photograph 1

View of the northwest corner of the office building with failing paint on the T-111 siding.

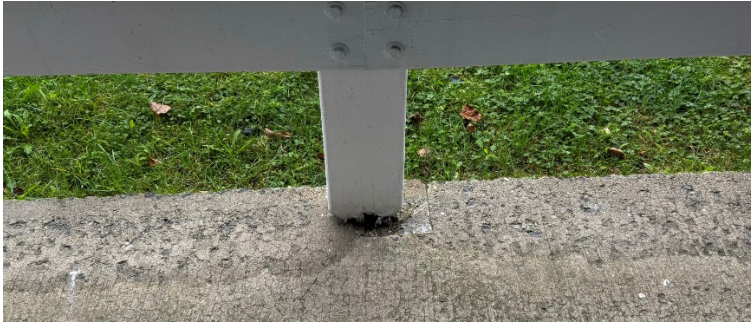
**Photograph 15****Description**

View of the rotted base of a timber post supporting the roof eave.

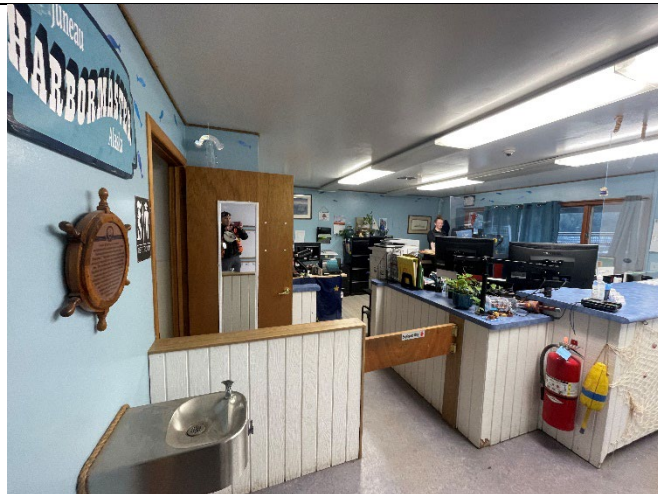
Aurora Harbor Office: Front main office area accessibility requirements should be evaluated further.

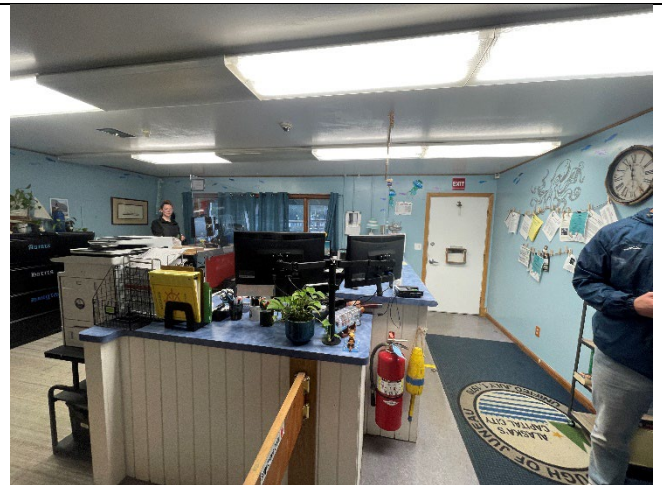
Aurora Harbor Office: Front main office area accessibility requirements should be evaluated further. Exit signage is not illuminated.
