**Re: 918 Park Avenue Historic Preservation Board Appeal**

# STRUCTURAL ASSESSMENT

918 Park Avenue

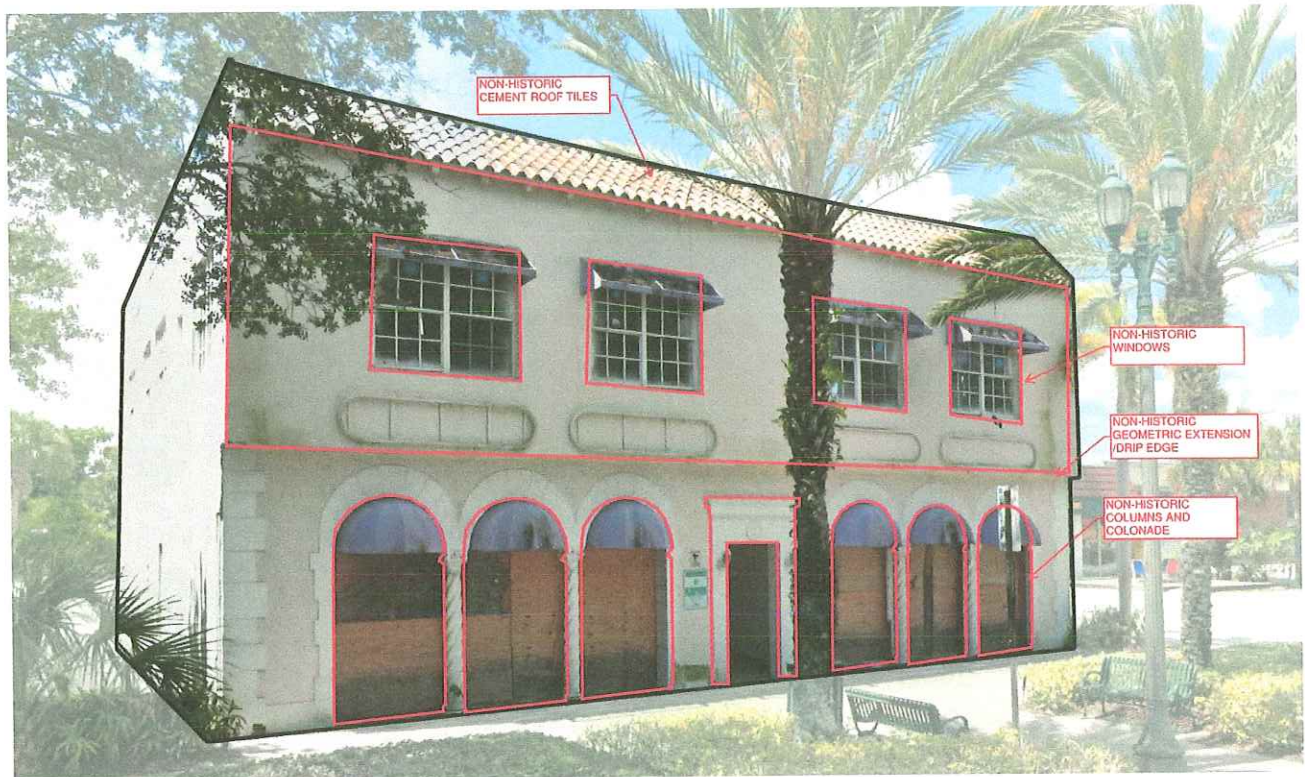
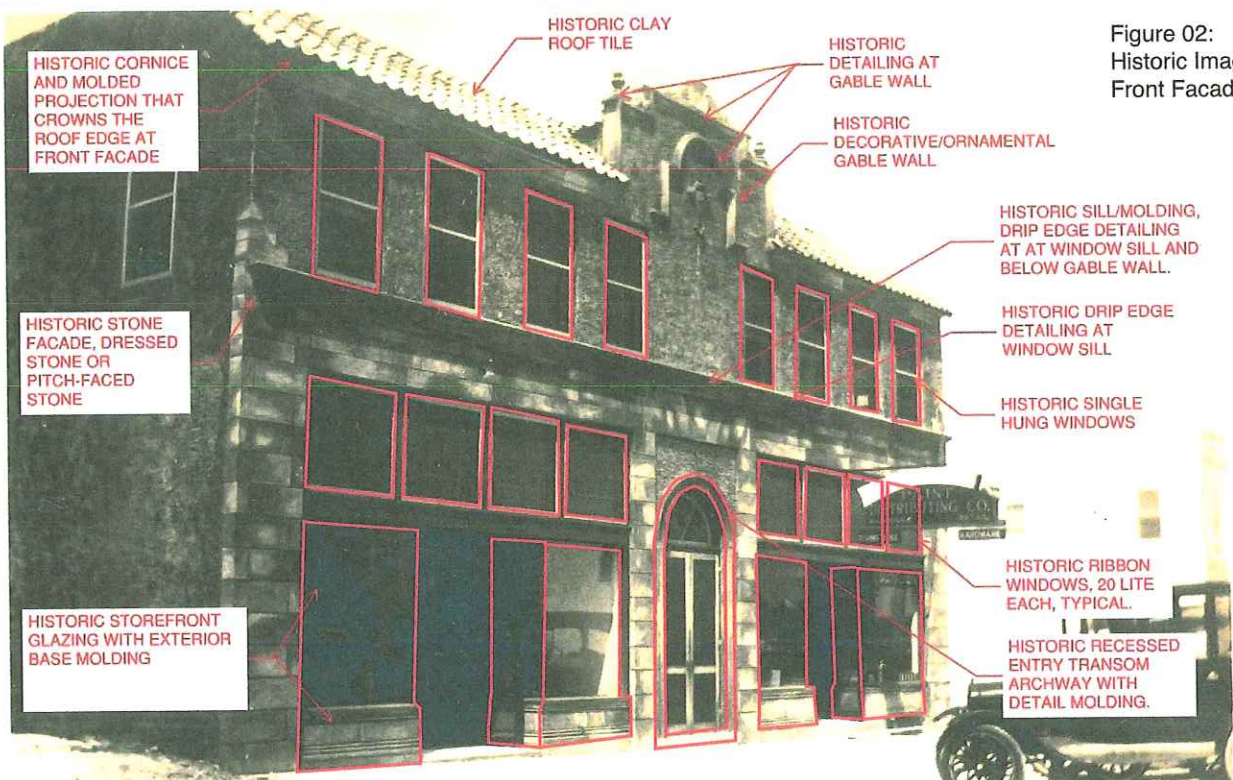
Figure 7: Existing - Front Facade

The majority of alterations and additions were built in the 1970's to facilitate the mix-use commercial aspect of the property. This includes the elimination and disturbance of the main street historic façade of the building (Refer to Figure 7) and a non-historic large addition at the rear (Refer to Figure 12).

For a street-side observer, the mix of historic and new materials on later additions to the structure makes it hard to discern which parts of the building are truly historic (Refer to Figure 7). The Standards also provide the following guidance, "New additions and adjacent or related new construction shall be undertaken in such a manner that if removed in the future, the essential form and integrity of the historic property and its environment would be unimpaired." The addition (rear) to the building has compromised the original structure and removal of significant architectural elements from the main north elevation, which includes altered and removal of historic fenestration, exterior stone, removal of storefronts, double hung windows, first floor transom windows, decorative gable end, quoining, and roofing materials (Refer to Figure 7 and Figure 8).

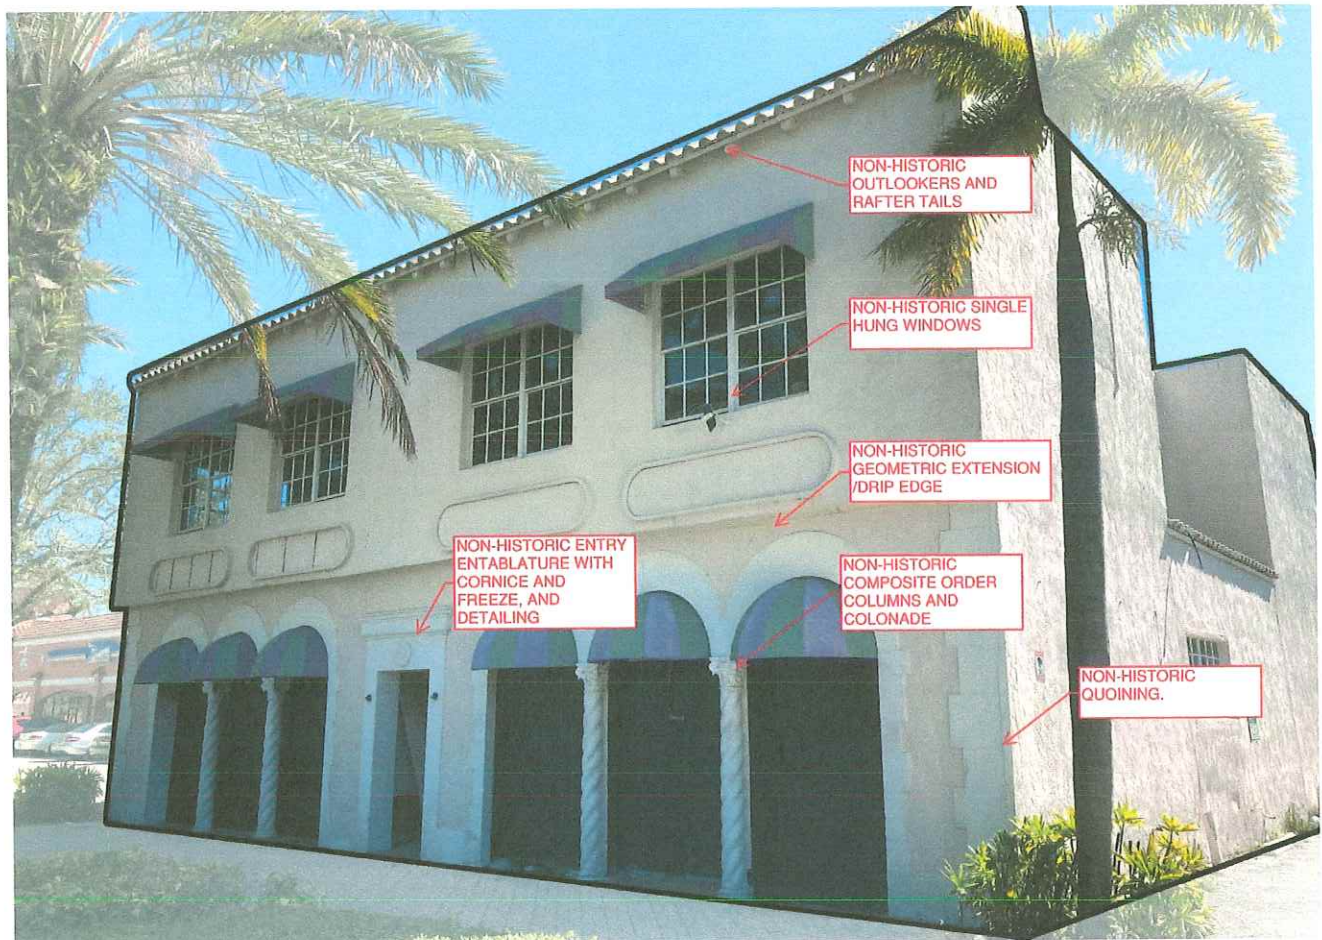
Figure 8: Historic Photo of Fenestration

"Front (North) façade has a sloped clay barrel tile roof with ornamental parapet wall ends, and all windows/storefront openings were altered from the original (Refer to Figure 8 and Figure 9). Many significant changes have occurred to the exterior. Items such as window/storefront replacements, stucco repair and re-coat, enclosure/infill of rear sleeping and eating porches, inappropriate and insensitive rear (South) alterations, infills and additions.

The rear (South) appears to have been sleeping and eating porches with stairway. Front (North) façade has a sloped clay barrel tile roof with ornamental parapet wall ends, and all windows/storefronts openings were altered from the original (Refer to Figure 8 and Figure 9). Many significant changes have occurred to the exterior. Items such as window/storefront replacements, stucco repair and re-coat, enclosure/ infill of rear sleeping and eating porches, inappropriate and insensitive rear (South) alterations, infills and additions.

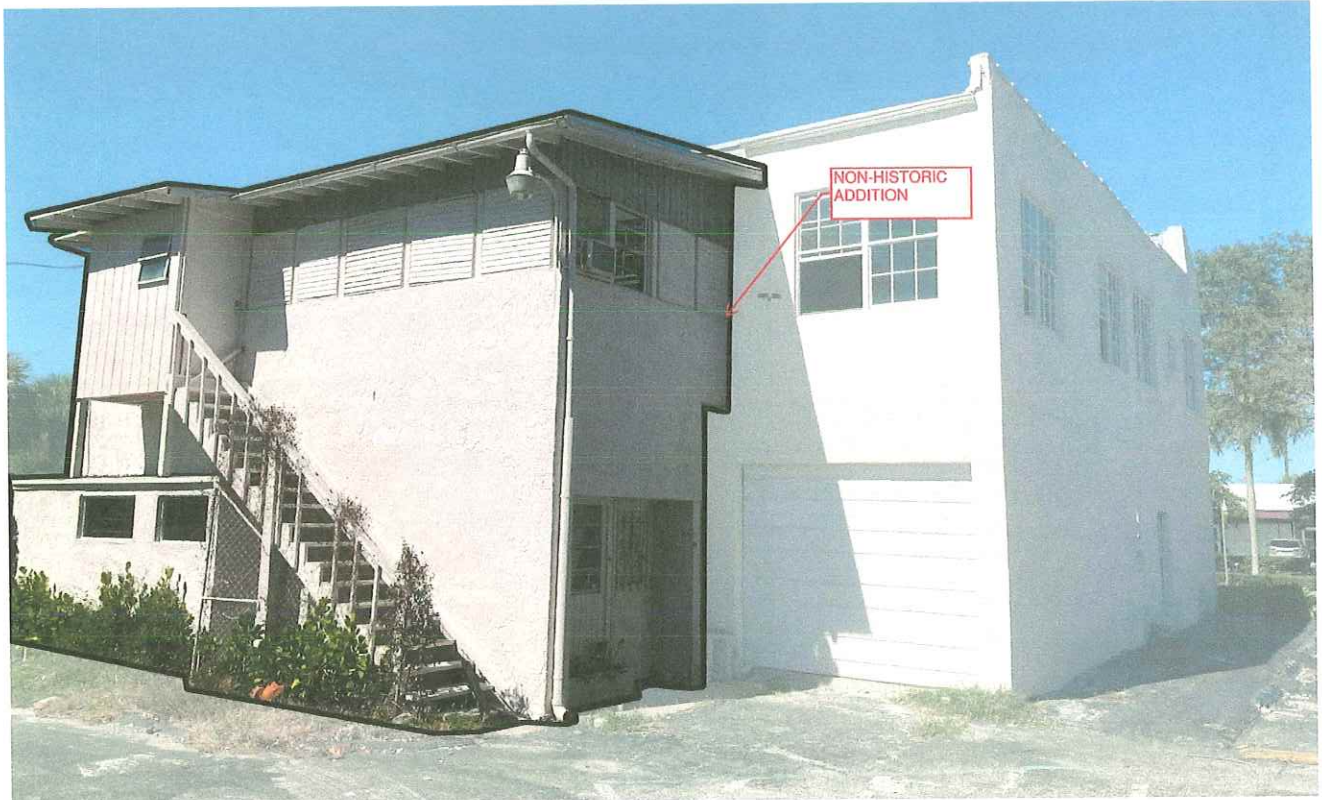
Figure 12: Existing Non-Historic Addition, south west elevation

The non-historic addition (rear) uses historic materials that have been salvaged or re-purposed from other buildings. The mix of historic and non-historic materials does not allow the additions to be distinguished as non-historic (Refer to Figure 12). Following the Standards, "To preserve a property's historic character, a new addition must be visually distinguishable from the historic building."

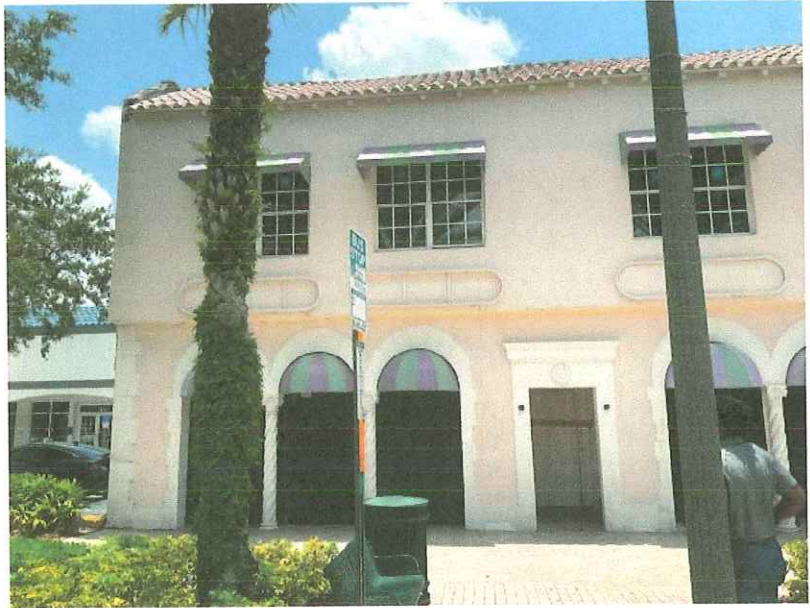
The exterior stucco is delaminating and spalling (see photos 002 and 009), loss of bonding to the structural frame, damage from water penetration, failed lath attachments, or damage to the wood framing from termites or dry rot. Significant exterior finish damage was observed by the entrance of the building, where pieces of stucco were severely damaged and cracked, or completely missing (see photos 005, 006 and 007). A significant indentation on the West side of the building was observed on the wall (see photo 010). This may have been caused by a vehicle crashing into the wall since parking stalls are noted perpendicular to the wall. The stucco finish at this location has been improperly patched and would require repair and further assessment of the existing wall framing.

Photo No. 002  
Date Taken: 07/10/2023  
File Name: 20230710\_173333447  
Description: Cracked stucco at top of Northeast corner of building  
Comments: Cracked stucco allows for water infiltration, allowing for structural water damage to wood framing members

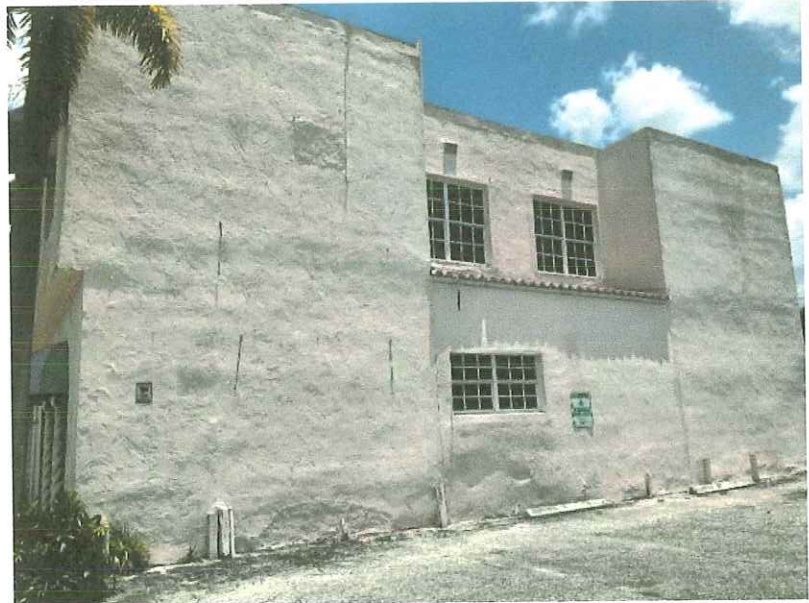
Photo No. 010  
Date Taken: 07/10/2023  
File Name: 20230710\_174453683  
Description: Large indentation on stucco finish

Comments: Presumed vehicle impact. Wall framing needs to be inspected for damage.

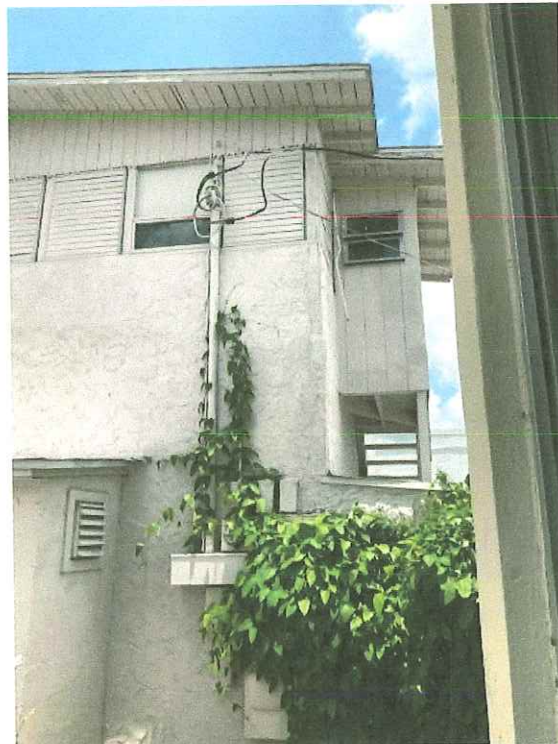
The windows seem to have been installed in recent times, but some are shattered (see photo 011) indicating that they are not impact resistant. Some exterior door frames show a large gap around the opening which allows for pest and water intrusion (see photos 013 and 024).

Photo No. 013  
Date Taken: 07/10/2023  
File Name: IMG\_7937  
Description: Broken screen door and exposed door frame at Southwest corner of building

Comments: Dangerous debris needs to be removed

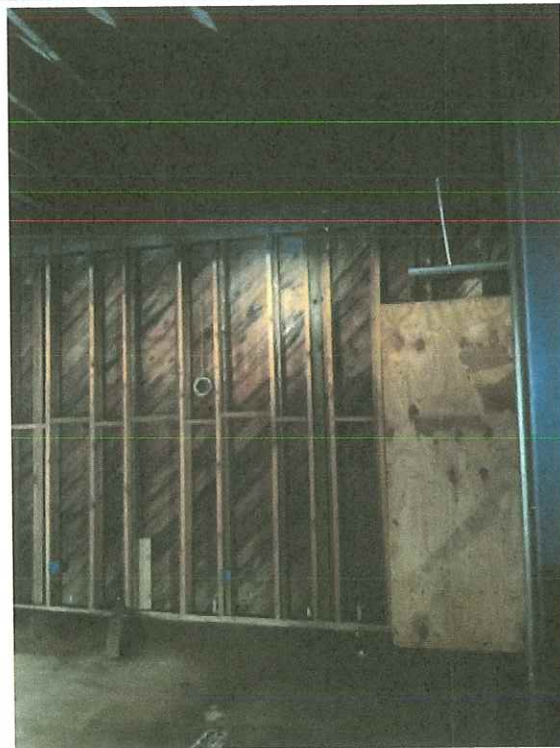
From the inside of the building, the exterior walls are noticed to be sheathed with diagonal or batten boards (see photos 005 and 028). Along the East/West direction of the building, the diagonal boards are seemed spaced at  $\pm 16"$  OC (see photo 029) and not directly abutting each other as were noted along the North/South direction exterior walls. This framing condition does not provide continuous lateral resistance to the exterior shear walls, making them inadequate to sustain the lateral forces produced by a major hurricane. Figure 1 shows the proper assembly for diagonal lumber shear wall sheathing, to be able to resist in-plane lateral forces.

Photo No. 029  
Date Taken: 07/10/2023  
File Name: IMG\_7974  
Description: Interior front wall at  
Northeast side of building

Comments: Missing sheathing, missing  
headers over arched  
openings

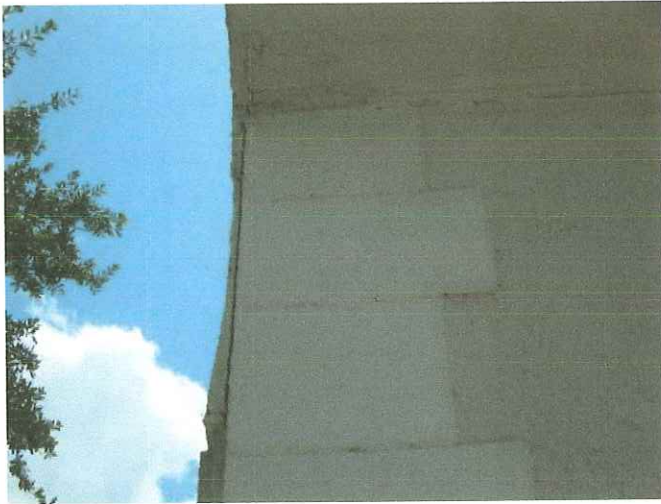
Finish separation  
PHOTO NO. IMG\_7919

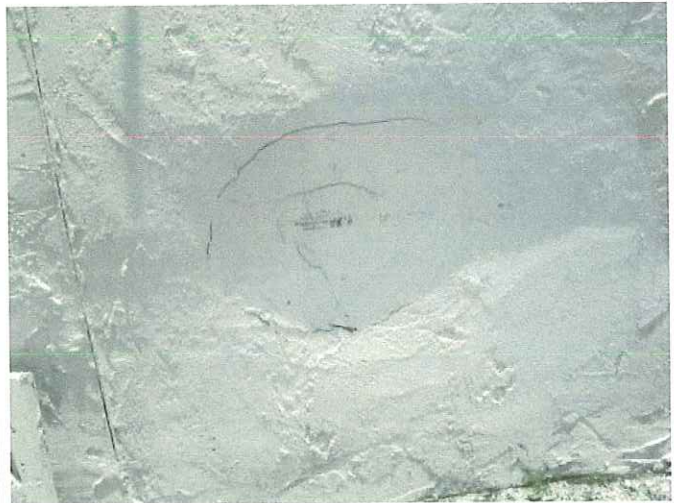
Stucco finish indentation  
PHOTO NO. IMG\_7931

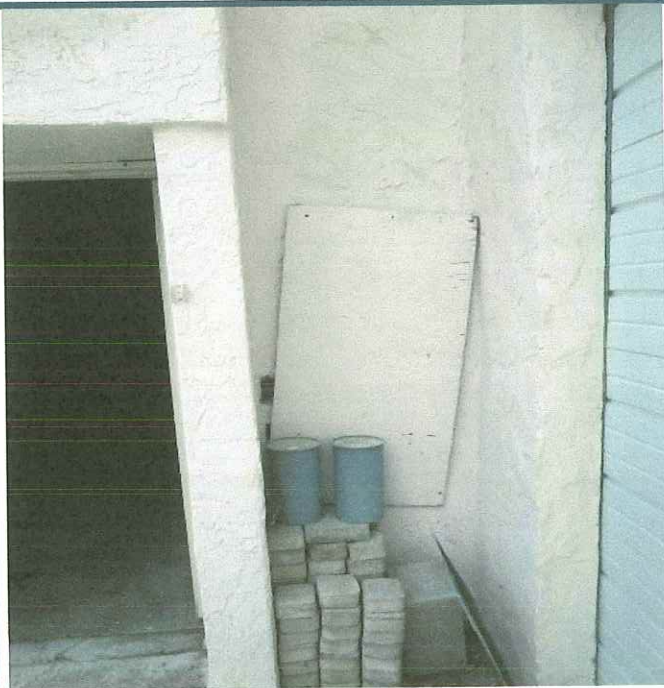
Unfastened board at wall opening  
PHOTO NO. IMG\_7946

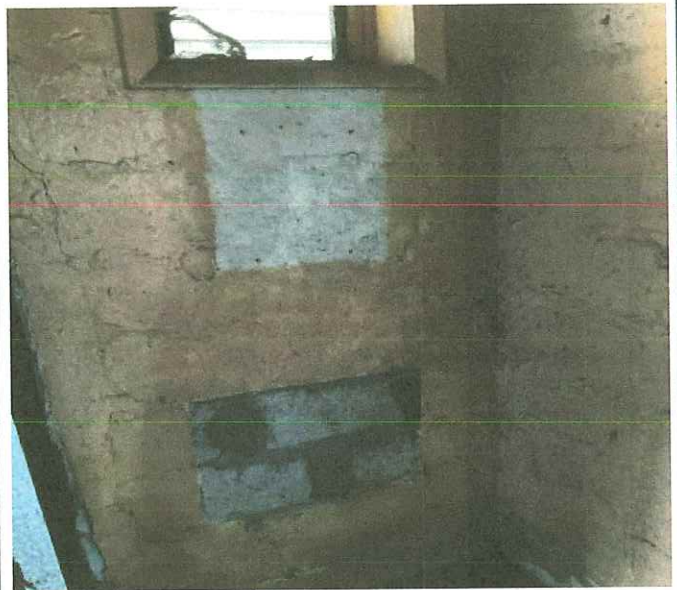
Rear expansion floor framing from underside  
PHOTO NO. 20230710\_175601186

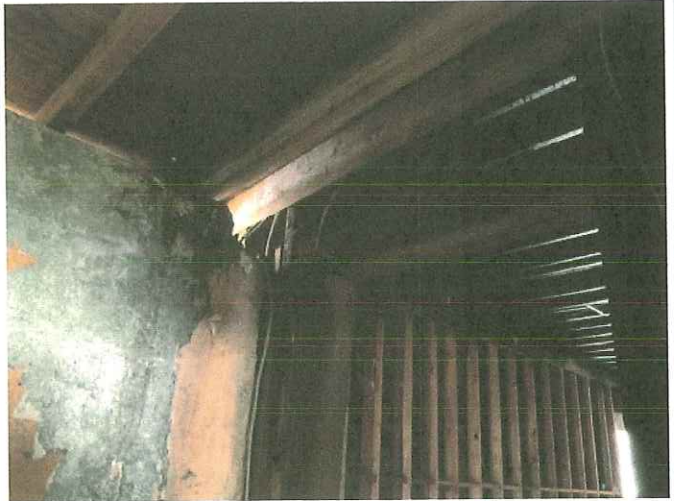
Rear expansion masonry wall  
PHOTO NO. 20230710\_180036624

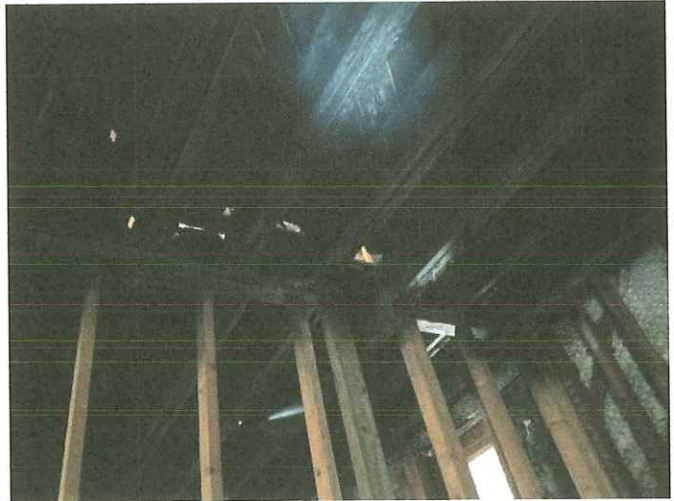
Underside of 2<sup>nd</sup> floor framing  
PHOTO NO. 20230710\_180258452

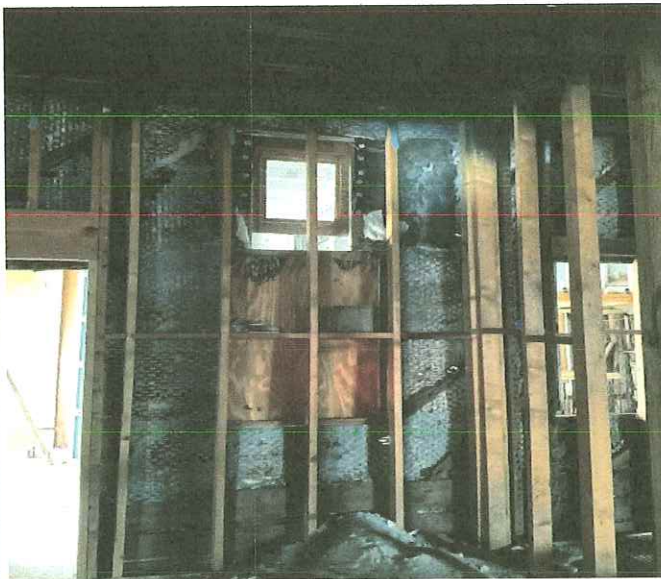
Underside of 2<sup>nd</sup> floor framing, discontinued top plate  
PHOTO NO. 20230710\_180448544

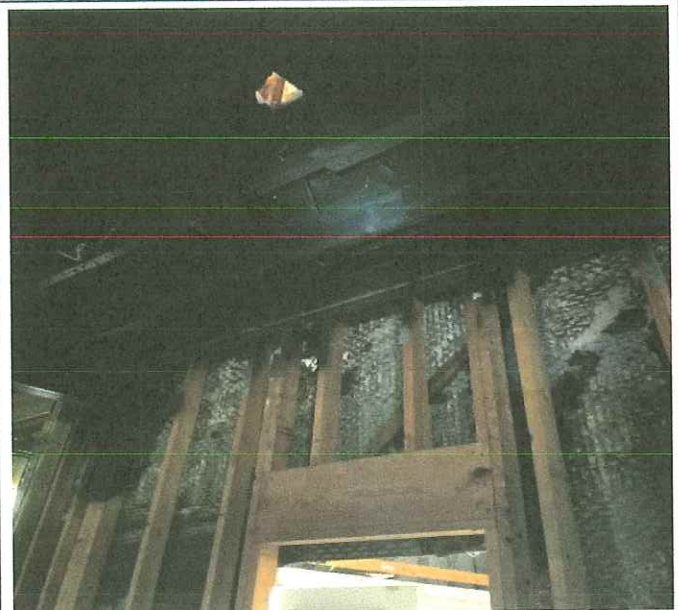
Original rear wall framing, exposed stucco lath, unfinished  
PHOTO NO. 20230710\_180812979

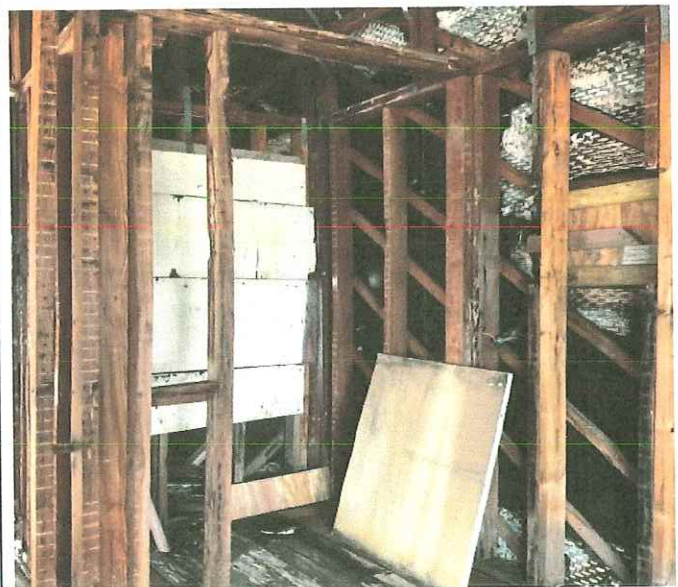
2<sup>nd</sup> Floor interior wall framing  
PHOTO NO. 20230710\_182257563

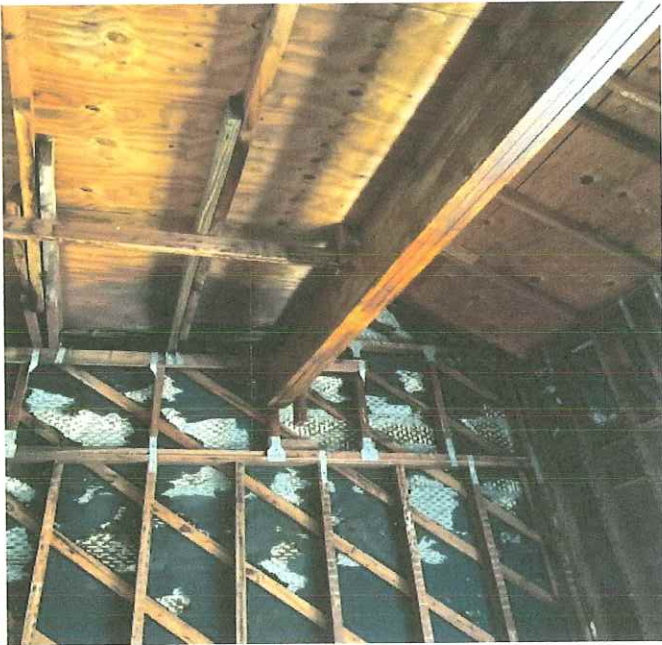
2<sup>nd</sup> Floor wall framing  
PHOTO NO. 20230710\_182322393

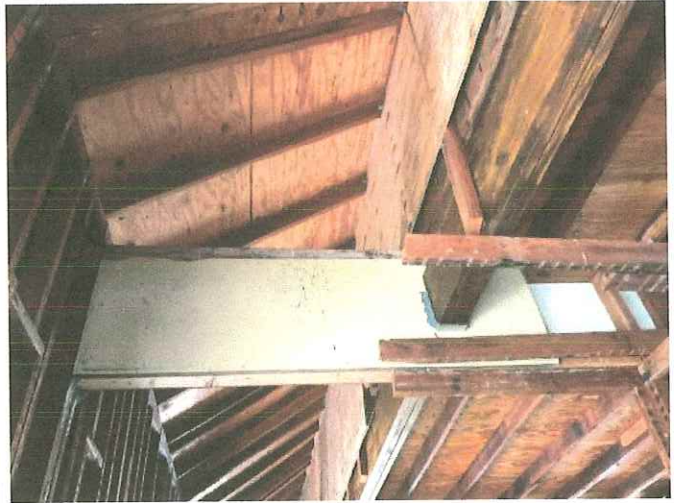
Unconventional top of wall framing  
PHOTO NO. 20230710\_182333863

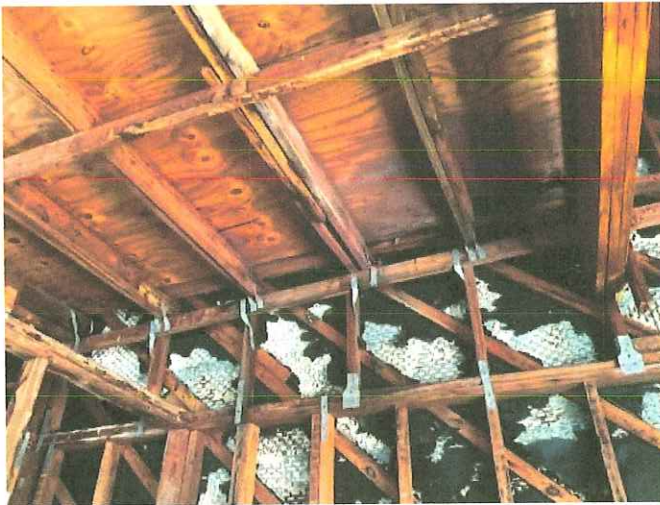
Unconventional roof framing by the North wall  
PHOTO NO. 20230710\_182644649

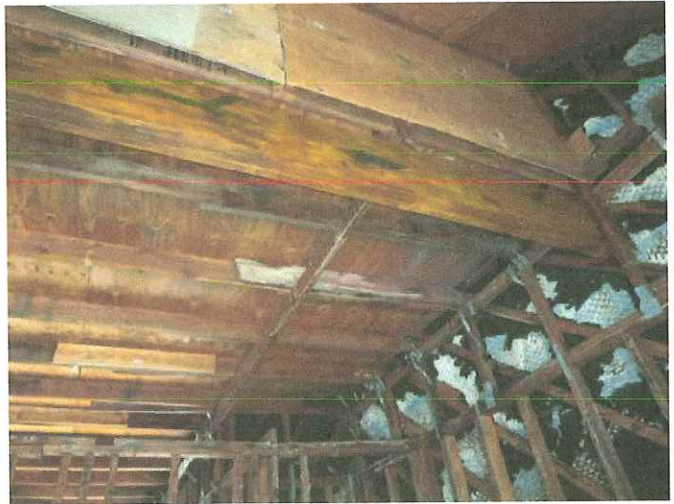
Spliced roof joist framing at bearing ends  
PHOTO NO. 20230710\_182352450

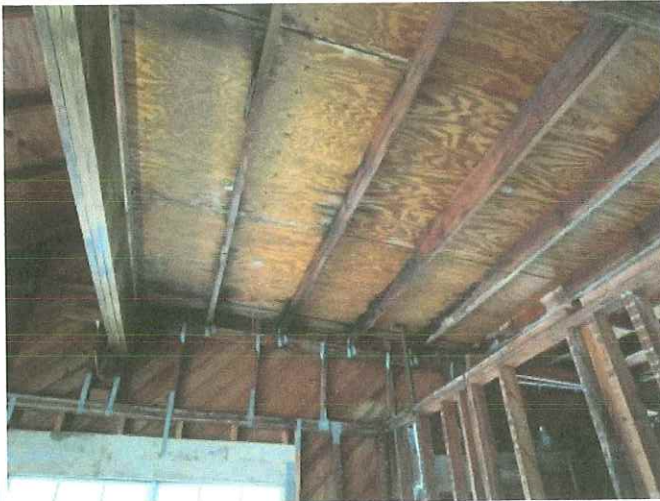
Unconventional roof framing  
PHOTO NO. IMG\_7993

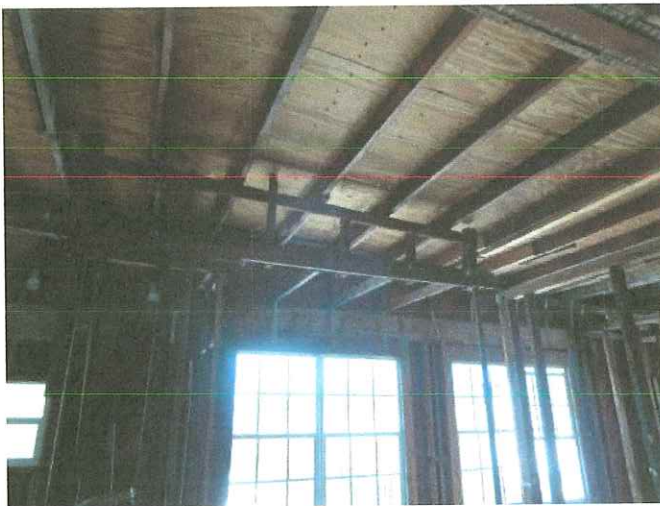
Discontinuous floor deck sheathing  
PHOTO NO. IMG\_8002

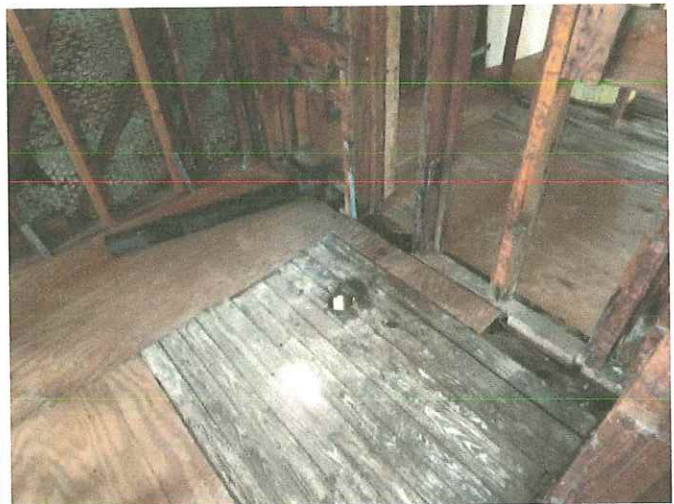
Interior wall framing at 2<sup>nd</sup> floor  
PHOTO NO. IMG\_8003

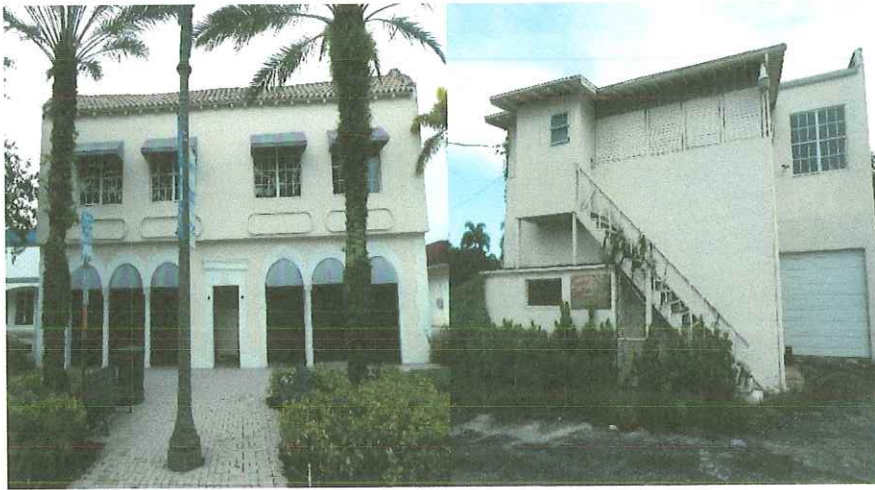
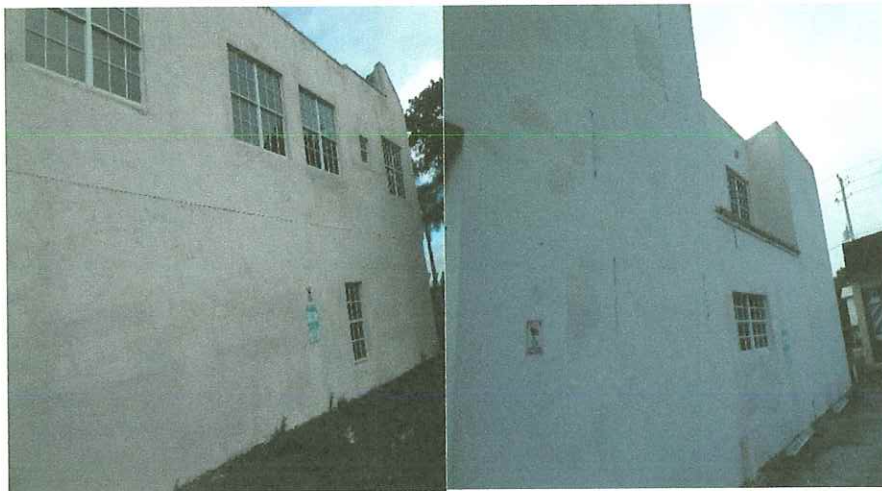
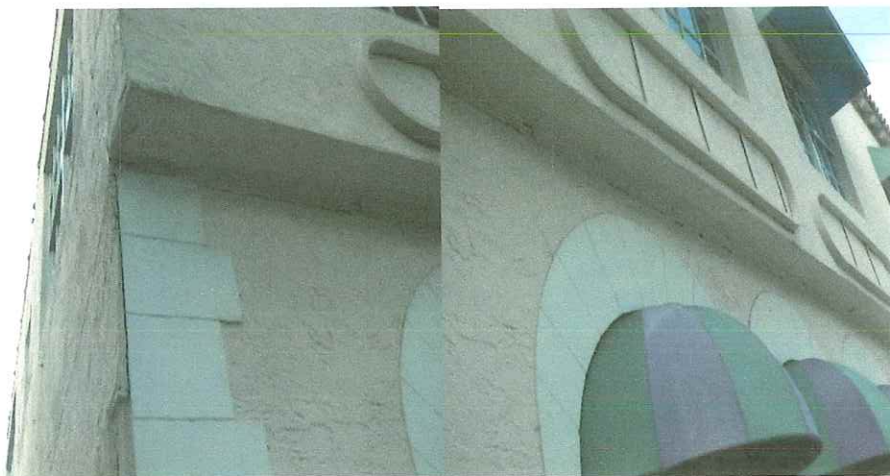
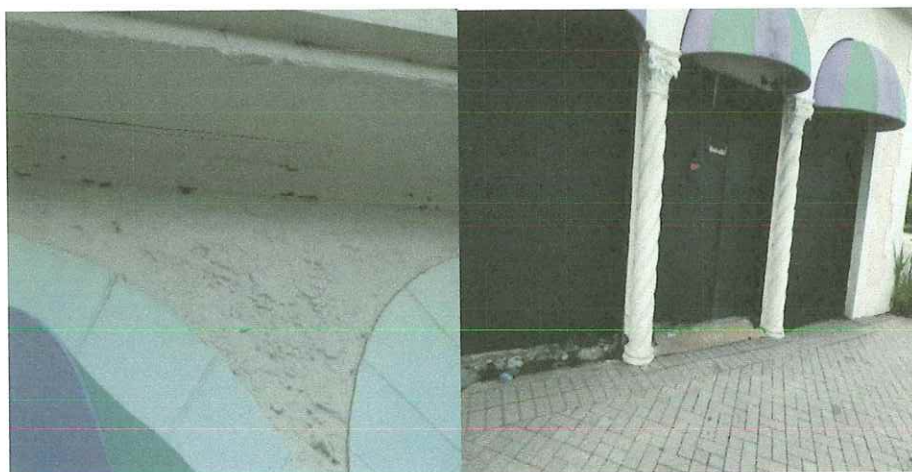
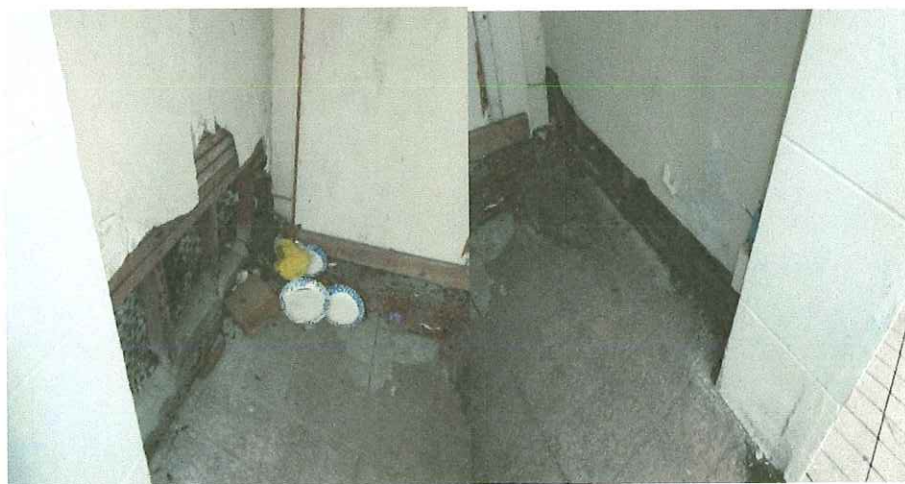
- 1) Heavy Drywood Termite damage, pellets and wings were noted to all north side interior 2x4s and wall.
- 2) Heavy Drywood Termite damage and pellets were noted to the west side of the interior 2x4s and wall.
- 3) Heavy Drywood Termite damage and pellets were noted to the south side interior 2x4s and wall.
- 4) Heavy Drywood Termite damage and pellets were noted to the east side interior 2x4s and walls.
- 5) Drywood Termites were noted to the interior south side walls.
- 6) Drywood Termites and damage were noted to the south side second floor walls

- 1) Subterranean Termites and damage were noted to the north side interior 2x4s and wall joists
- 2) Subterranean Termite Mud tubes were noted to the north side interior floor joists and header beams.
- 3) Subterranean Termite mud tubs and damage were noted to the interior front north walls.
- 4) Heavy Subterranean Termite mud tubes were noted to the exterior north wall.
- 5) Subterranean Termite damage was noted to the interior northeast, west, south and east side 2x4s, floor joists and walls.
- 6) Heavy Subterranean Termite mud tubs and damage were noted to the north front entrance and framing.

- 1) Fungus wood rot was noted to the interior downstairs south and east walls.
- 2) Fungus wood rot was noted to the interior east wall.
- 3) Heavy fungus wood rot was noted to the second-floor south wall (roof leaking)
- 4) Wood rot was noted to the exterior stairway.

**DUE TO THE EXTENSIVE DAMAGE AND CONDITION OF 2X4S, 2X6, WALLS, FLOOR JOIST AND HEADER BEAMS, WE RECOMMEND REMOVING AND OR RE-BUILD. THIS BUILDING IS UNSAFE.**

**IF NO CURRENT GAURRANTEEE, WE RECOMMEND TERMITE TREATMENT**
