PROPERTY CONDITION ASSESSMENT

1 North San Antonio Road
Los Altos, Santa Clara County, California 94022

RSB Project No. 2403055

Report Date: May 3, 2024

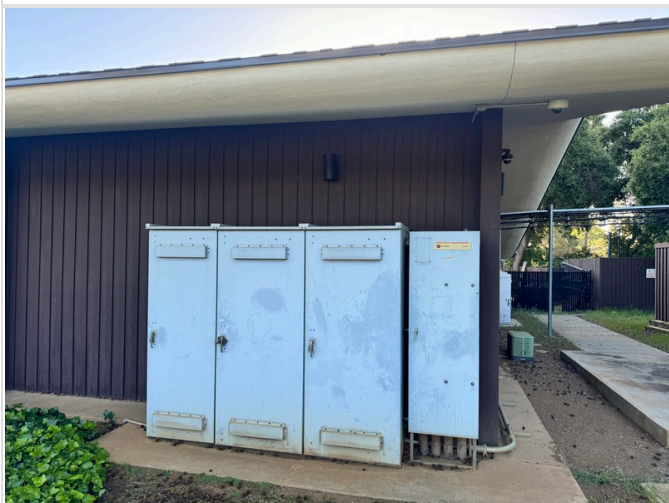
39. Transformer

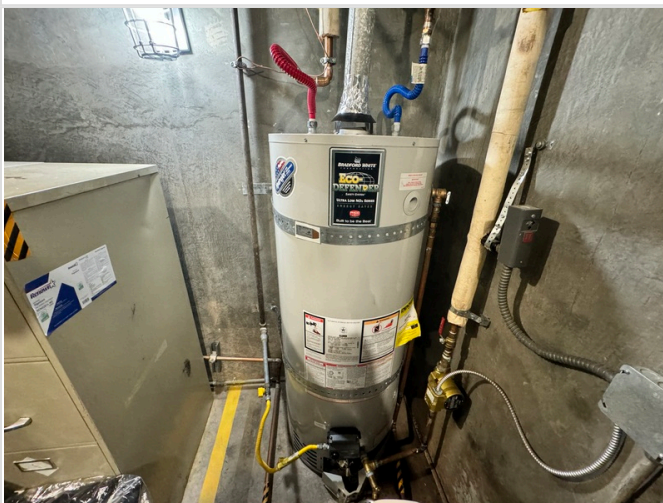
40. Water heater

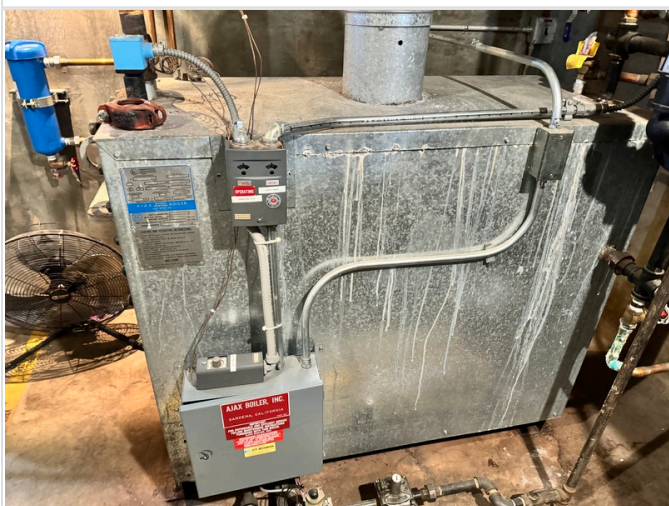
41. Gas-fired boiler

- + D Services: Replace Domestic Hot Water Boiler - Gas at an estimated cost of \$14,846 in year 2016
- + D Services: Replace AHU - Constant Volume #1 at an estimated cost of \$95,248 in year 2016

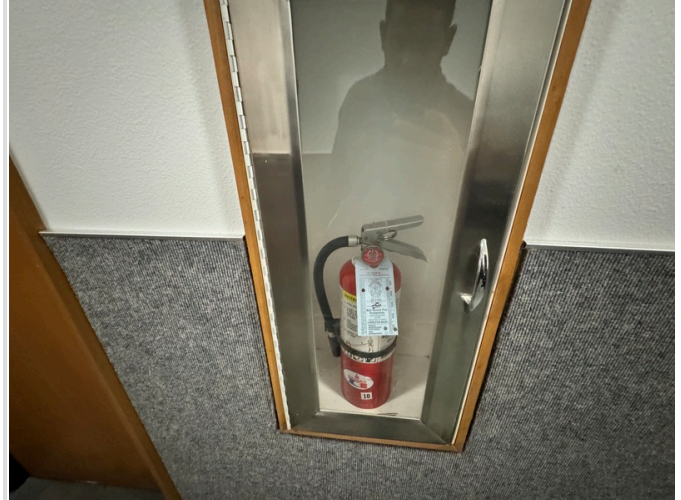
44. Fire extinguisher

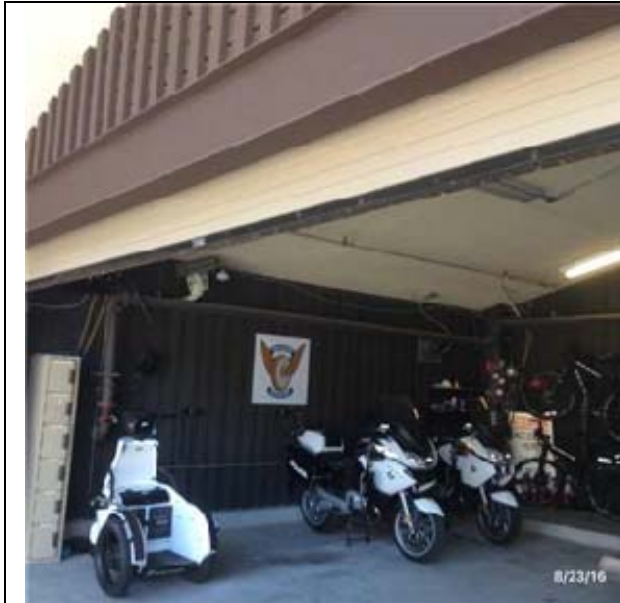
B1031 Steel Frame Structure:- View of Steel Frame Structure

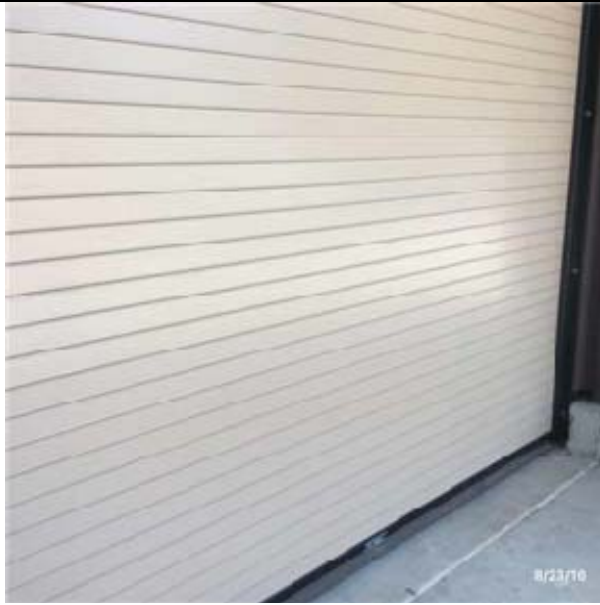
B2034 Overhead Doors:- View of Rolling Overhead Doors, Electric

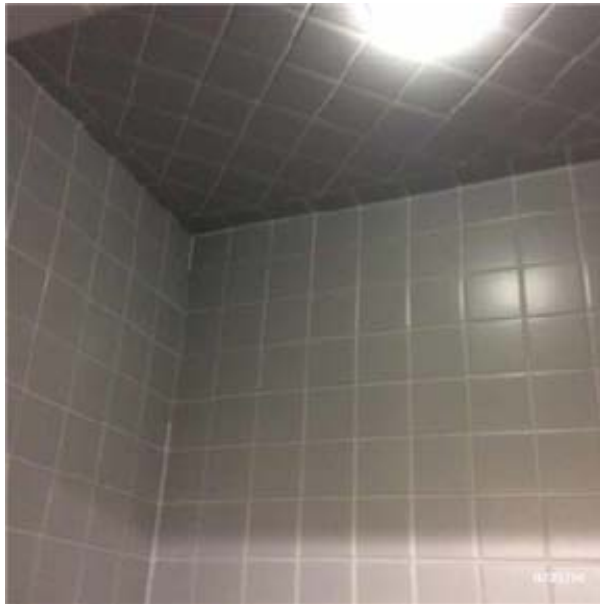
C3012 Wall Finishes to Interior Walls:- View of Ceramic Wall Tiles

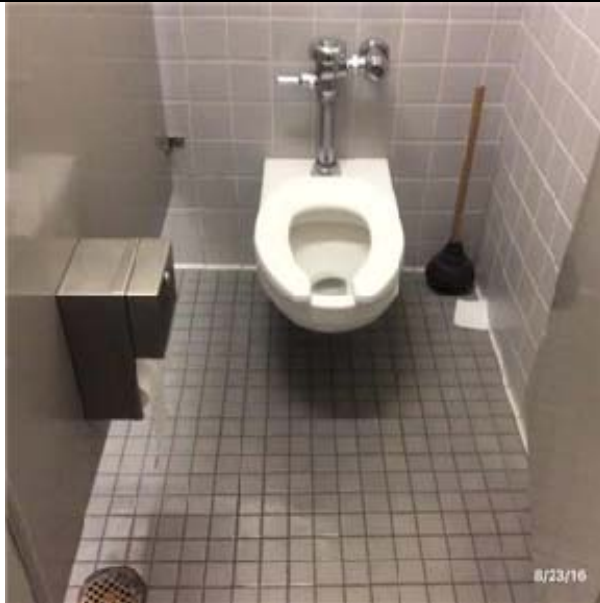
D2011 Water Closets:- View of Wall Mounted Water Closets

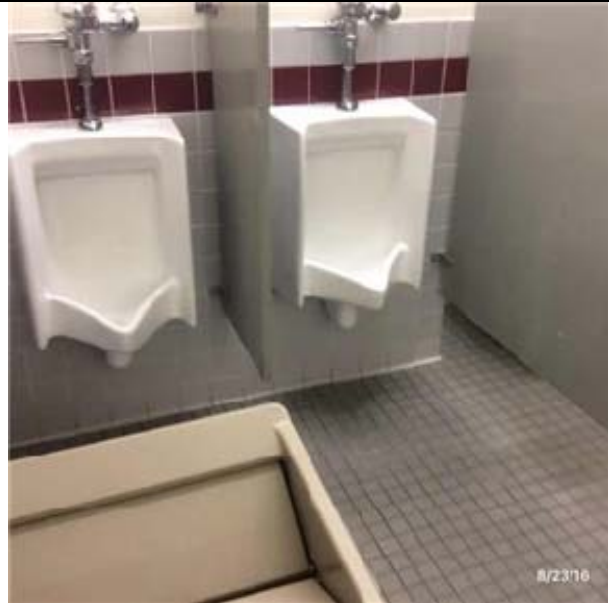
D2012 Urinals:- View of Wall Hung Urinals

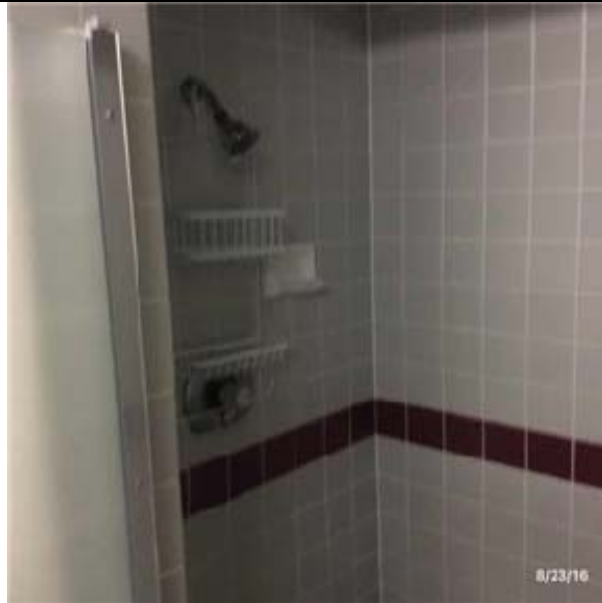
D2017 Showers:- View of Shower - Three Wall Ceramic Tile

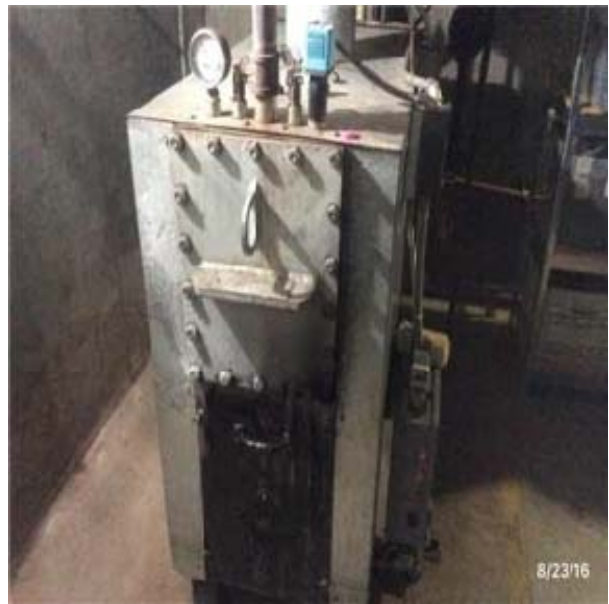
D2022 Hot Water Service:- View of Domestic Hot Water Heater - Gas

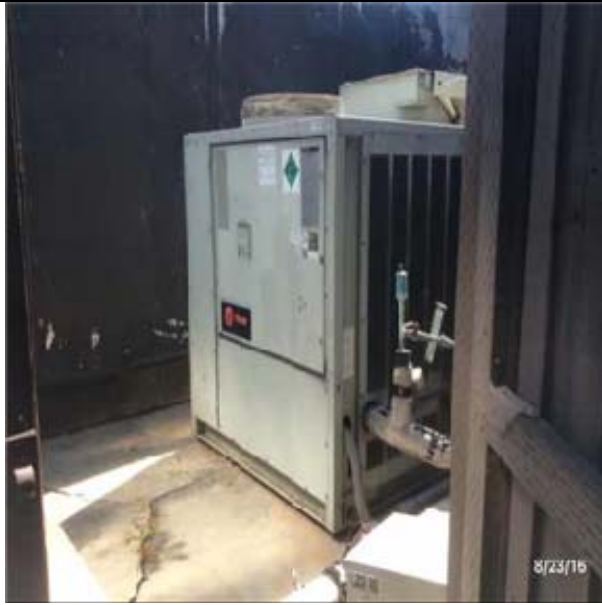
D3021 Boilers:- View of Domestic Hot Water Boiler – Gas

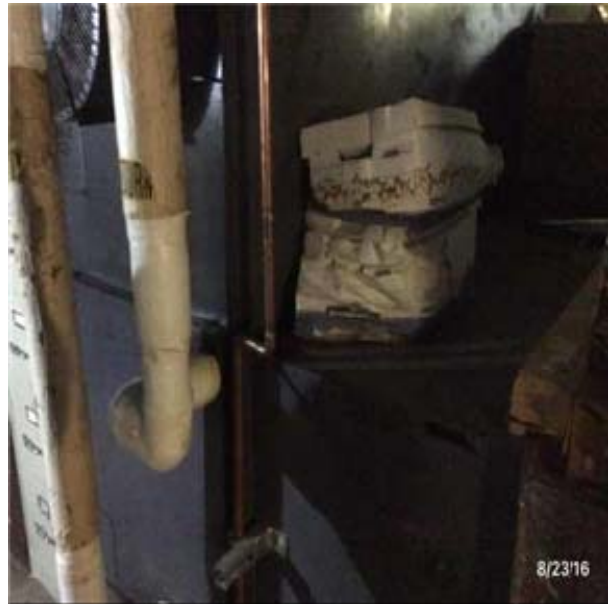
D3041 Air Distribution Systems:- View of AHU - Constant Volume #1

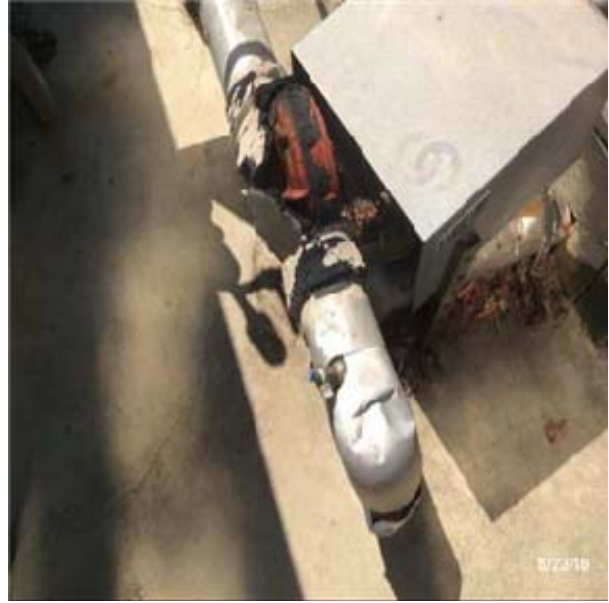
D3044 Hot Water Distribution:- View of HW Circulation Pump/Motor 1-2 HP

149951	D3040	Deferred Maintenance	Replace HW Circulation Pump/Motor 1-2 HP	1	EACH	\$2,924.18	\$2,924		\$2,924
		149952	D3040	Deferred Maintenance	Replace CW Circulation Pump/Motor 1-2 HP	1	EACH	\$2,924.18	\$2,924		\$2,924
		149954	D3040	Deferred Maintenance	Replace AHU - Constant Volume #1	8850	CFM	\$10.76	\$95,248		\$95,248
		149955	D3040	Deferred Maintenance	Replace AHU - Constant Volume #2	7536	CFM	\$10.76	\$81,106		\$81,106
		2019	\$30,864	149943	C3020	Deferred Maintenance	Replace Carpet Tiles - Standard	370.56	SY	\$83.29	\$30,864

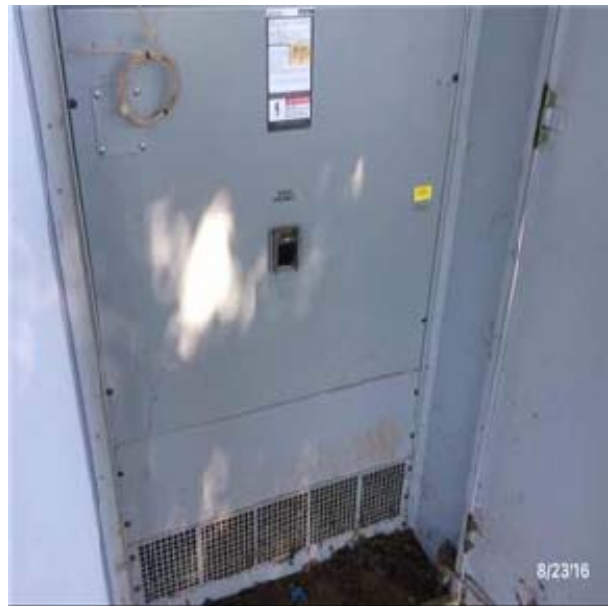
D5012 Low Tension Service & Dist:- View of Emergency Transfer Switch

149959	D5010	Capital Renewal	Replace Emergency Transfer Switch	1	EACH	\$8,610.00	\$8,610	\$8,610
		149960	G4090	Capital Renewal	Replace Generator Sets, Diesel Engine - 100 to 200 kW	100	KW	\$473.01	\$47,301	\$47,301
2022	\$27,321	149945	C3030	Routine Maintenance	Repaint Ceilings	9935	SF	\$2.75	\$27,321	\$27,321
Total									Total:	\$832,246

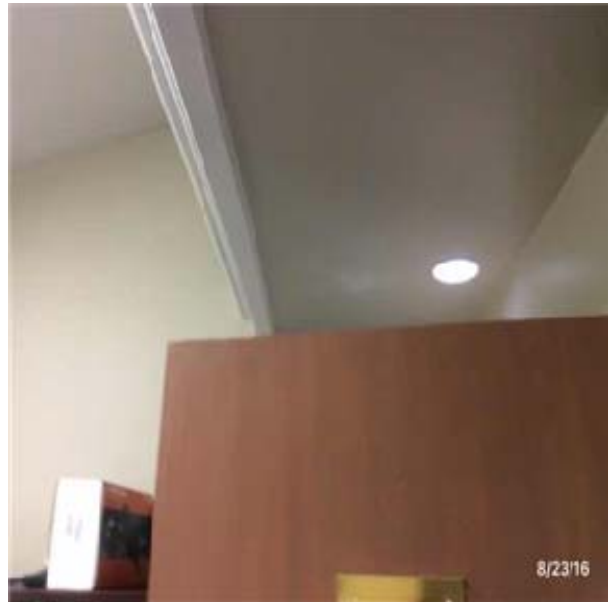
D5022 Lighting Equipment:- View of Interior Fluorescent Light Fixtures

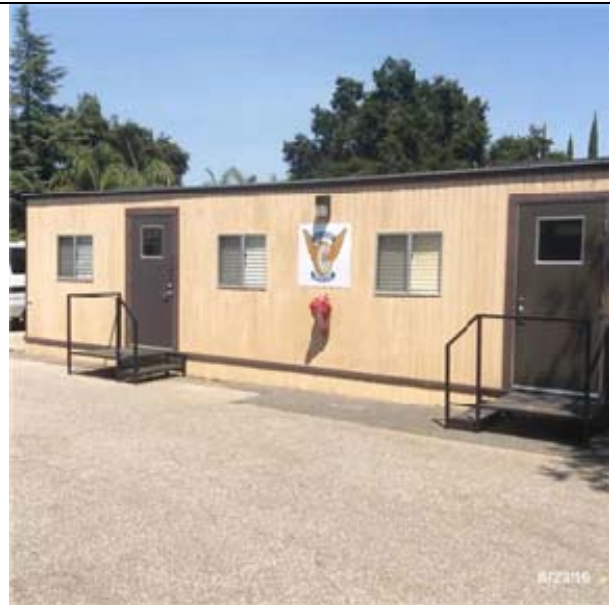
D5037 Fire Alarm Systems:- View of Fire Alarm System (Full System Inc. Panel)

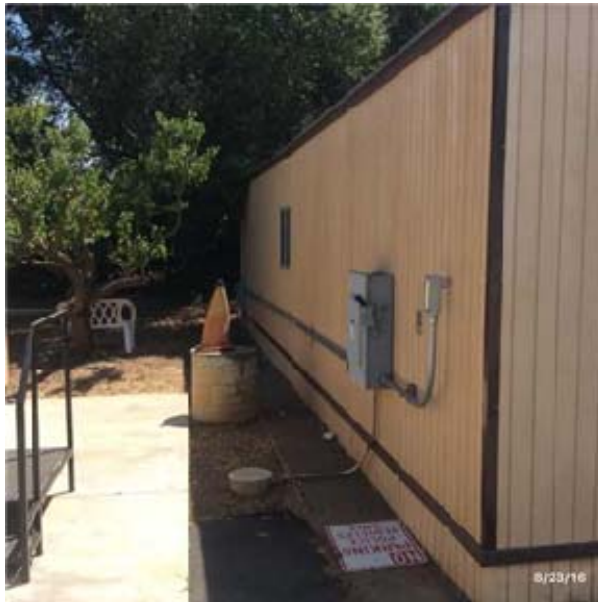
F1012 Pre-engineered Structures:- View of PreFab Modular Building #1
