PROPERTY CONDITION ASSESSMENT

765 Fremont Avenue
Los Altos, Santa Clara County, California 94022

RSB Project No. 2403055

Report Date: May 3, 2024

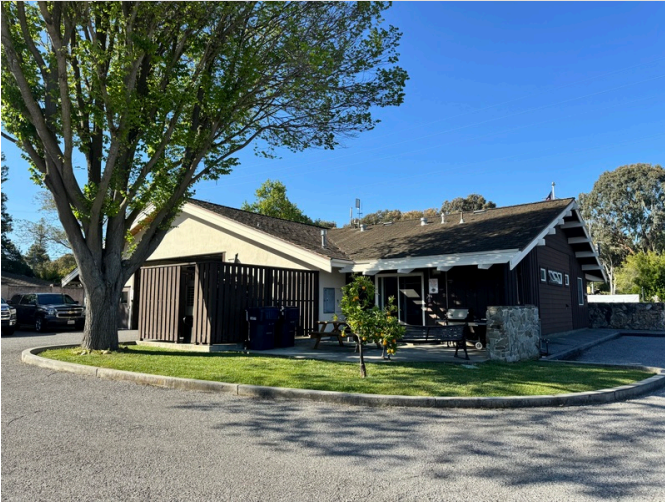
1. View of subject property

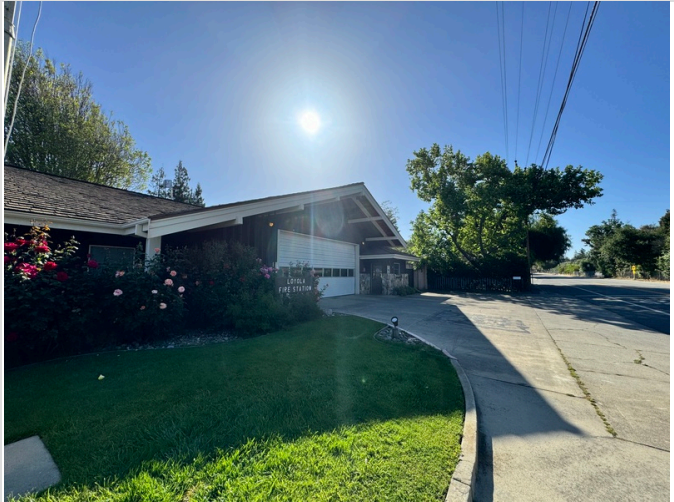
2. View of subject property

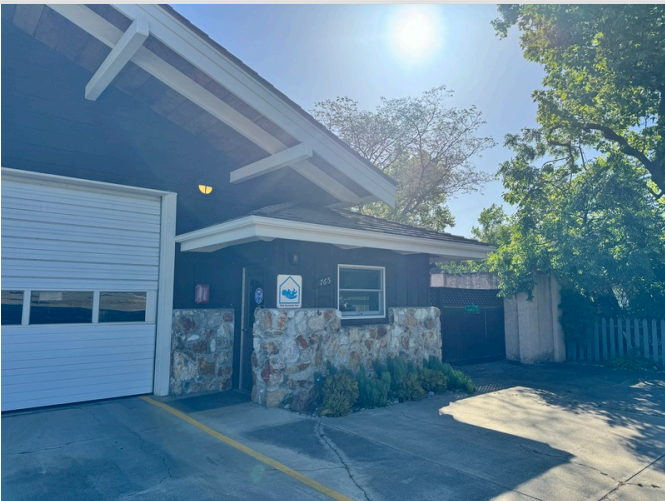
3. View of subject property

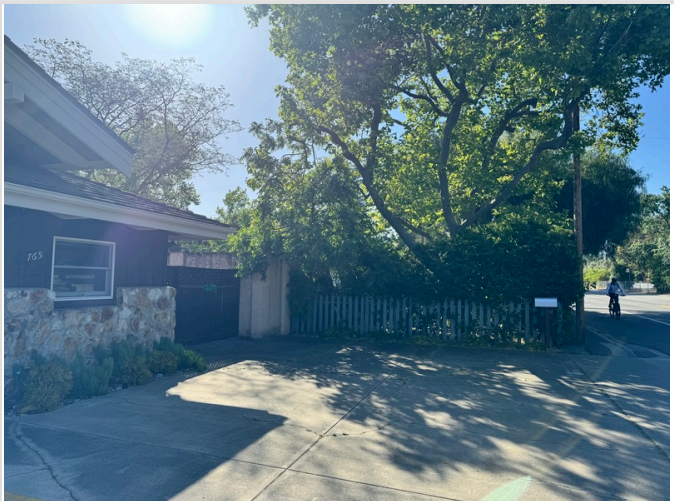
4. View of subject property

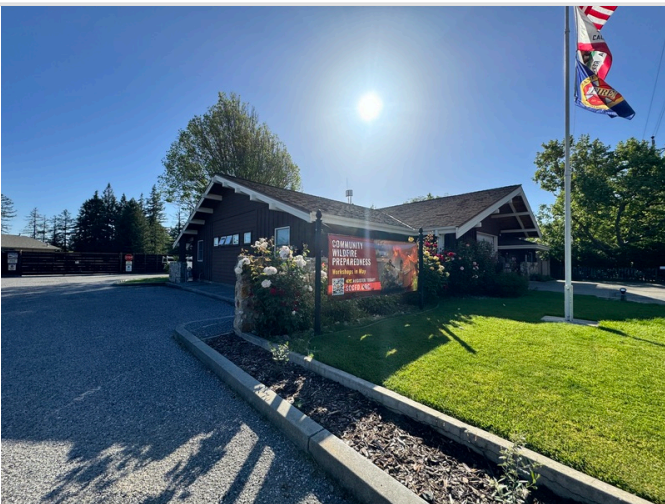
5. View of subject property

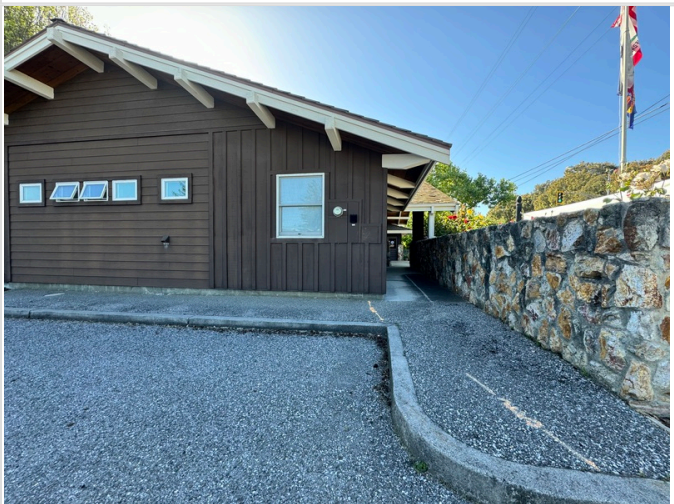
6. Building exterior

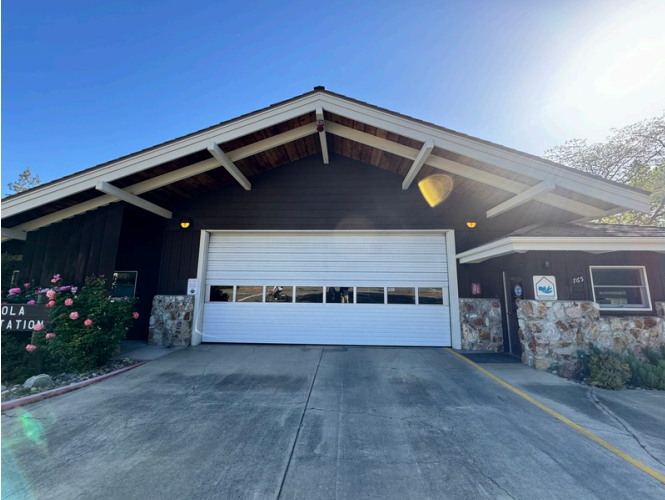
7. Garage entrance

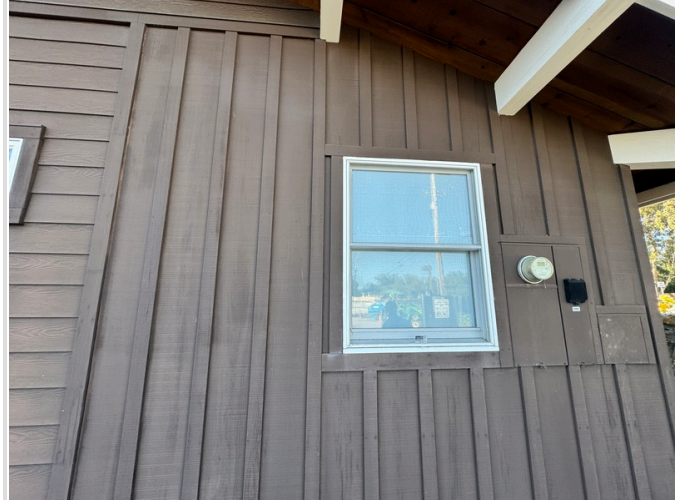
8. Building exterior

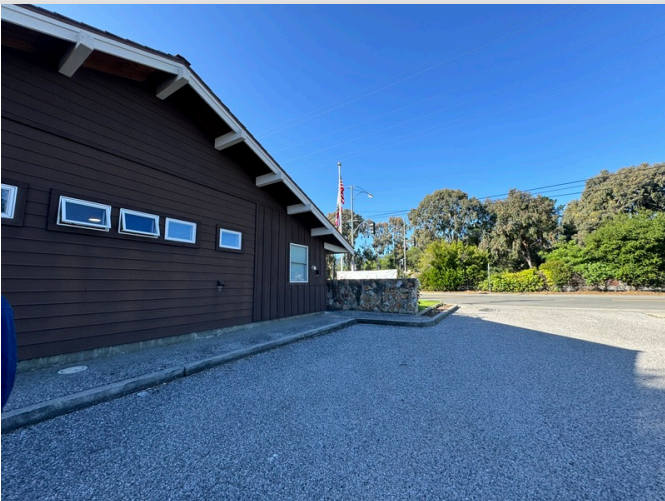
9. Building exterior

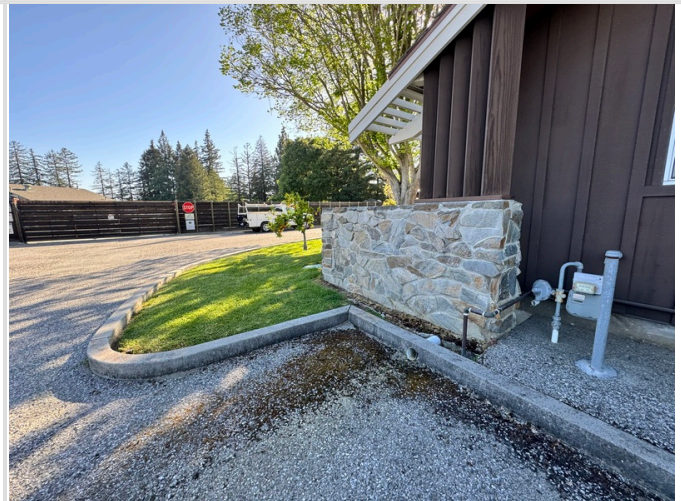
10. Building exterior

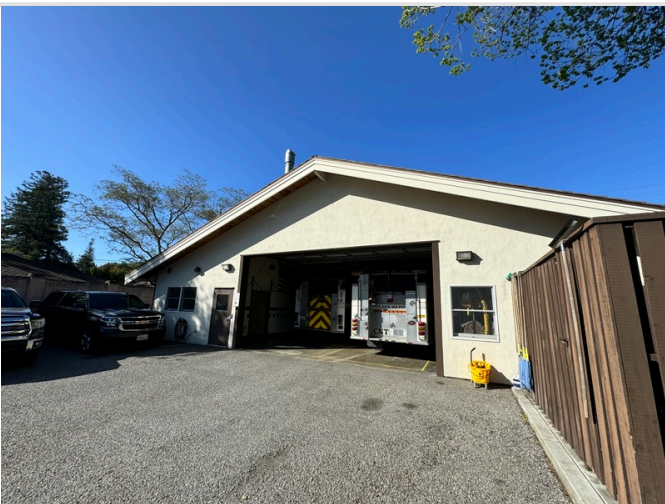
11. Building exterior

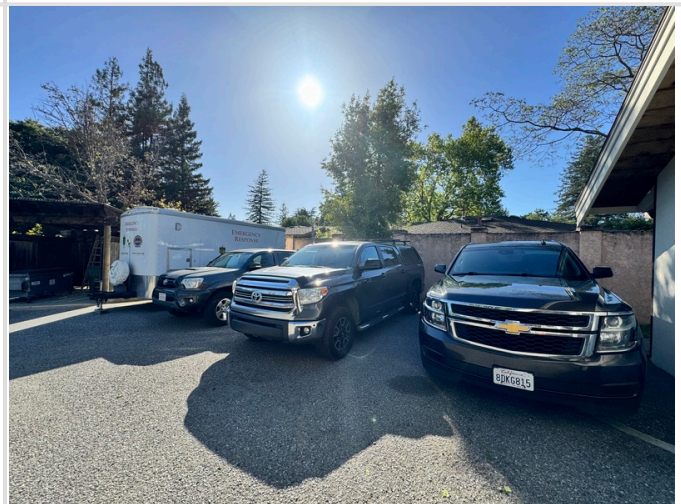
12. Parking

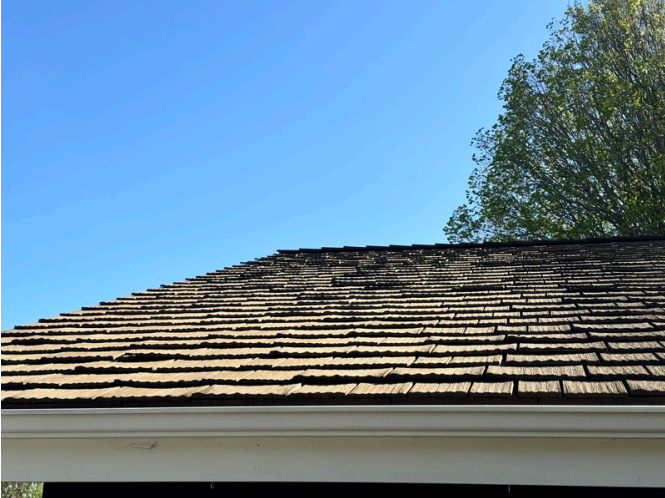
13. Roof

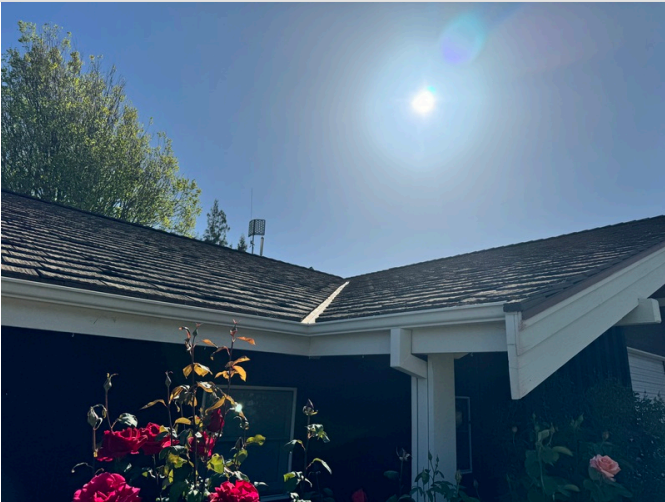
15. Roof

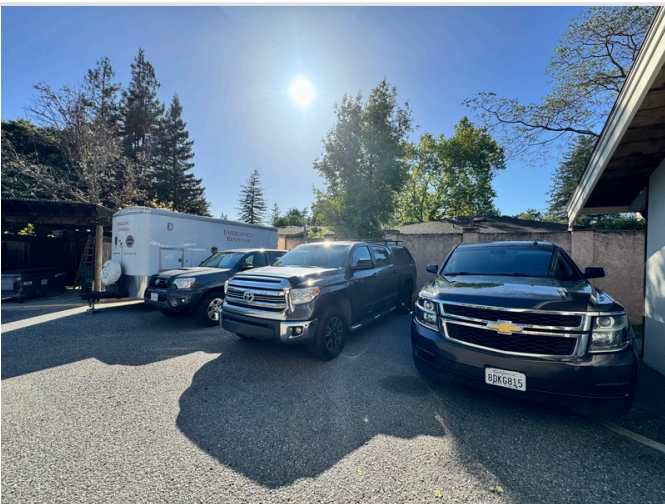
Item	Quantity	Unit	Unit Cost	Replacement Percent	Immediate Total	Comments
4.1.4 Paving, Curbing and Parking						
Patching, crack sealing, seal coating and striping	1,053	SF	\$0.20	100%	\$211	The parking area sealant and striping is in poor condition, with indications of heavy wear
4.2.1 Substructure						
Inspection and report by foundation engineer	1	Allow	\$6,000.00	100%	\$6,000	Severe cracks were observed in foundation components and appear to be the result of possible substructure degradation
Total Repair Cost					\$6,211.00

17. Parking pavement

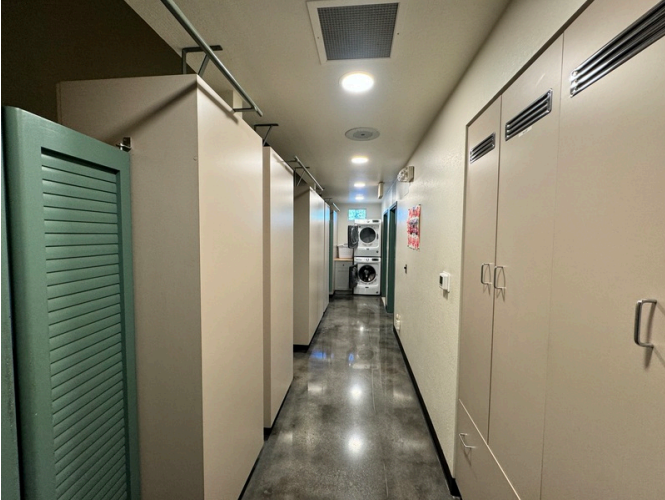
19. Hallway

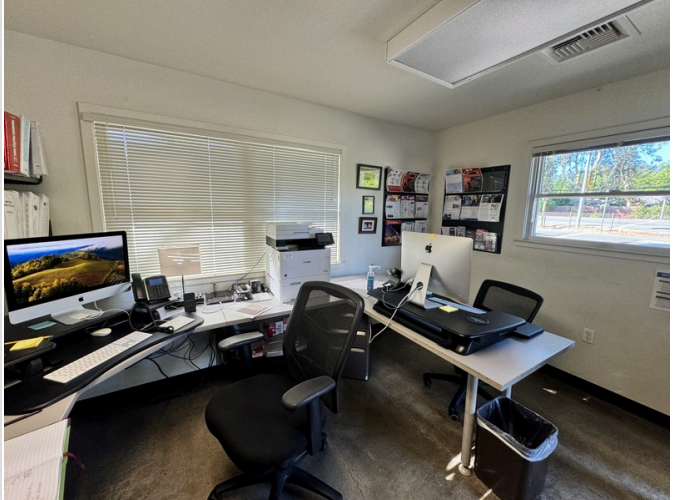
20. Office interior

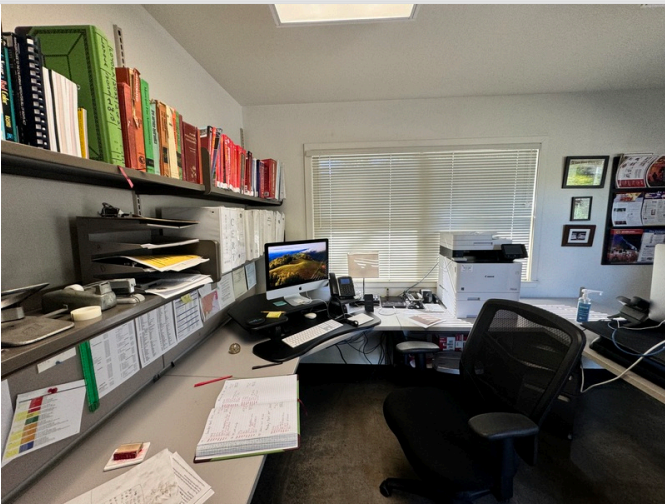
21. Office interior

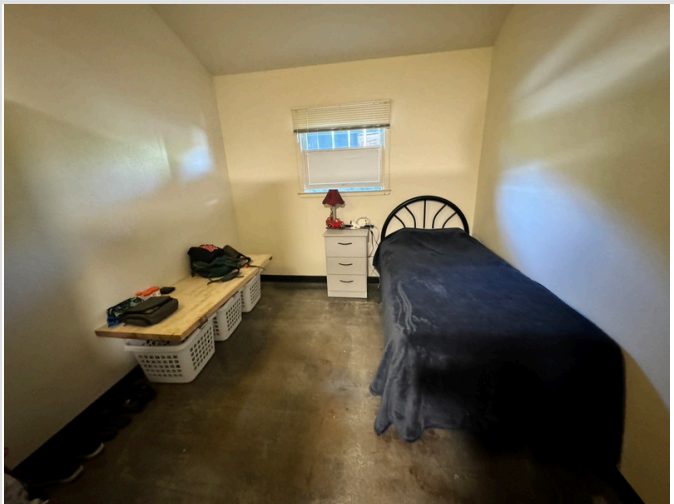
22. Dorm room interior

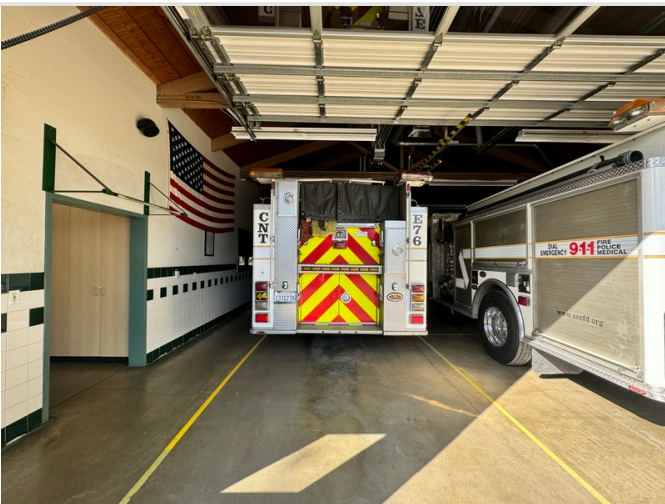
23. Garage interior

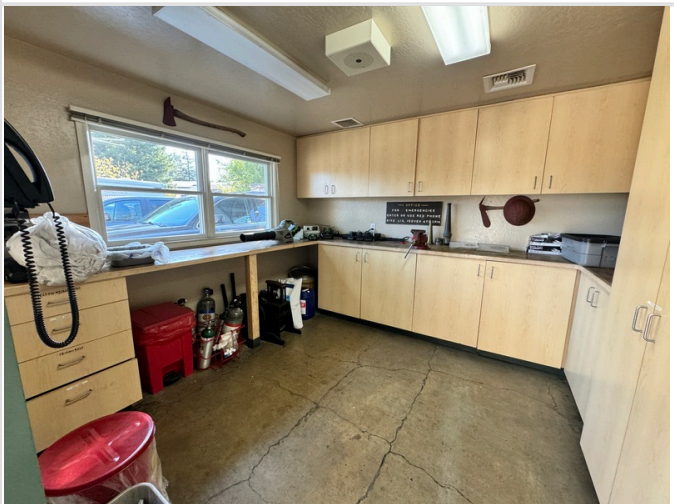
24. Building interior

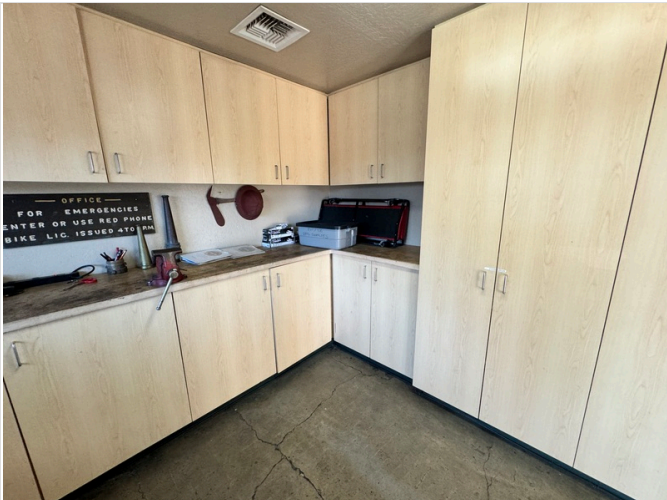
25. Break room interior

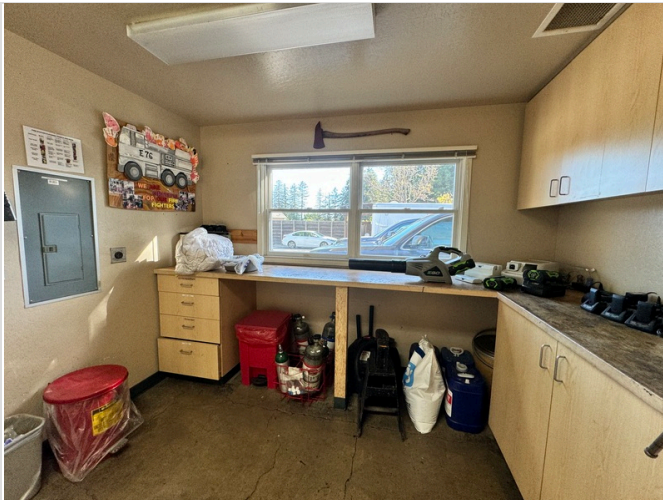
26. Building interior

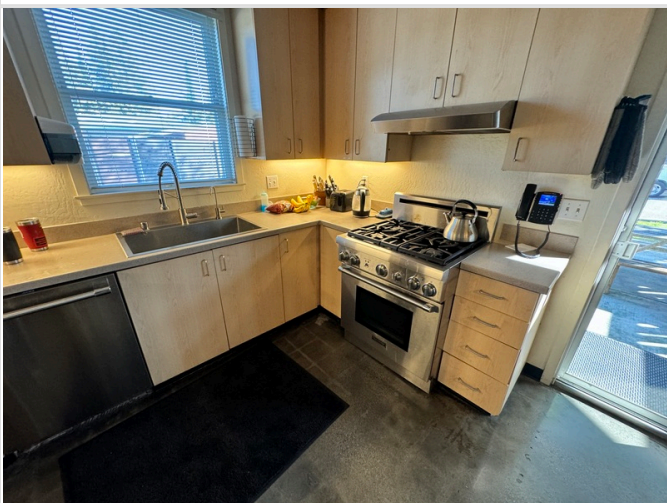
27. Kitchen interior

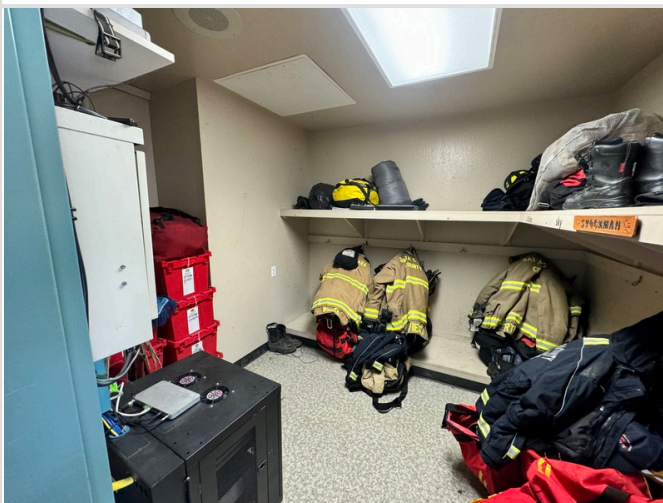
28. Storage interior

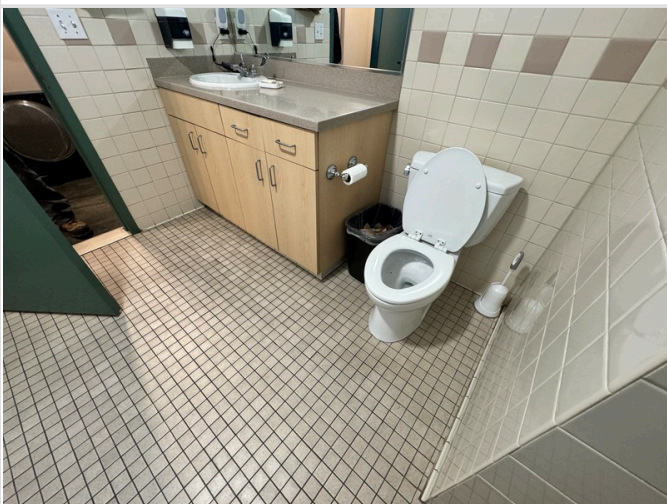
29. Restroom

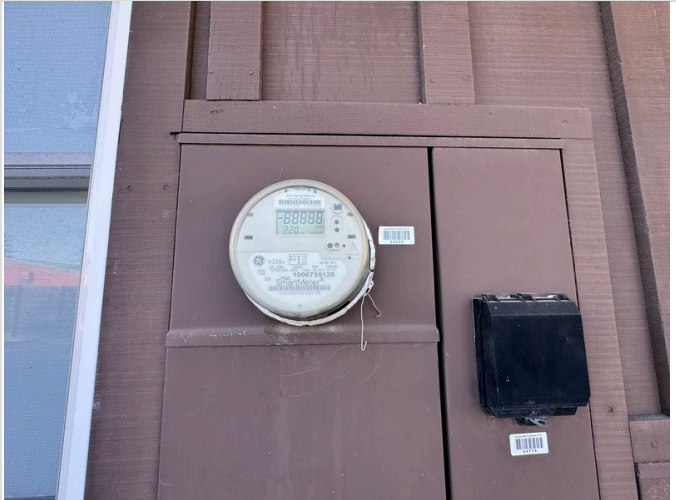
32. Electric meter

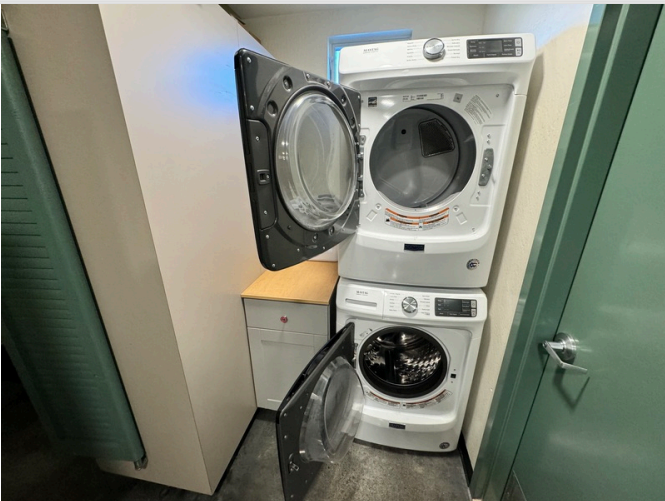
33. Washer, dryer

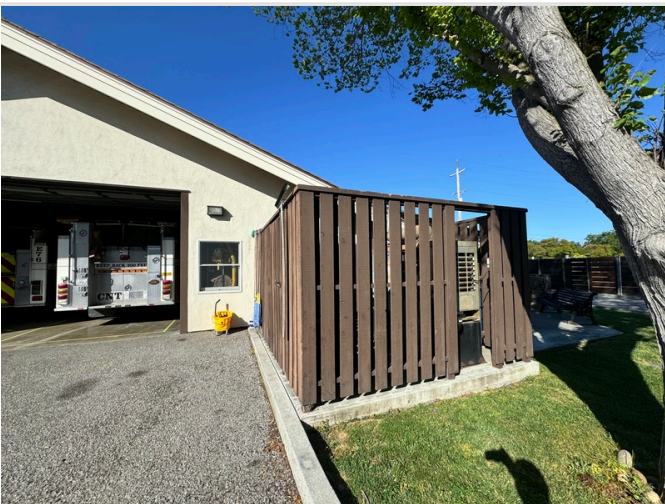
35. Emergency-power generator

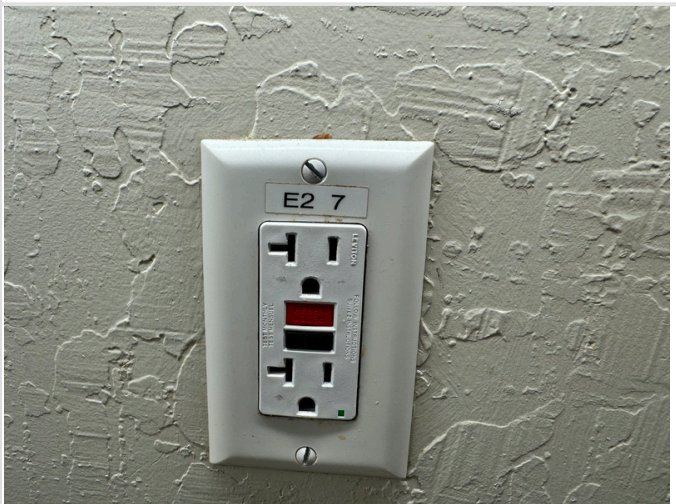
36. GFCI outlet

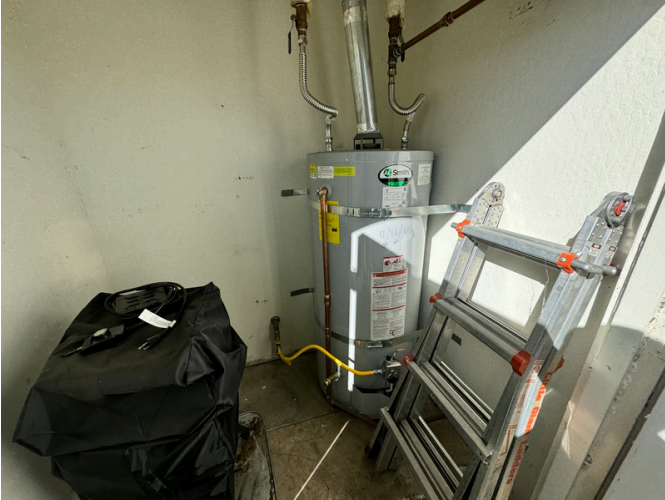
37. Water heater

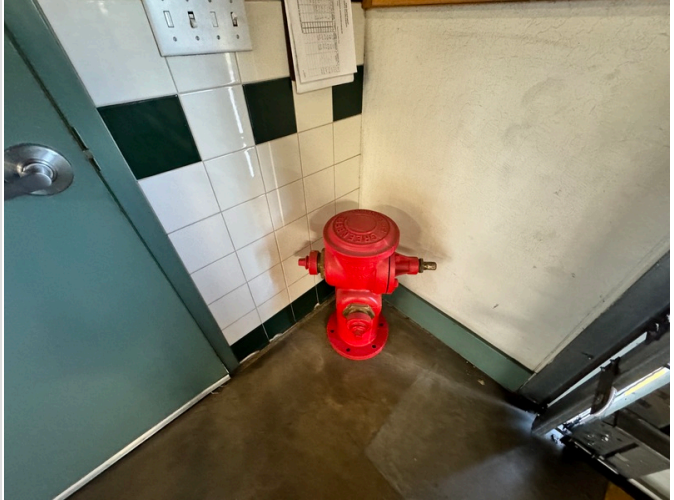
38. Fire hydrant

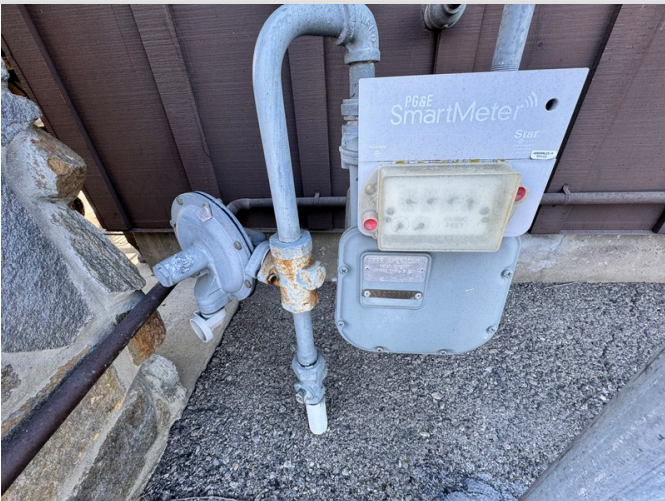
39. Gas meter

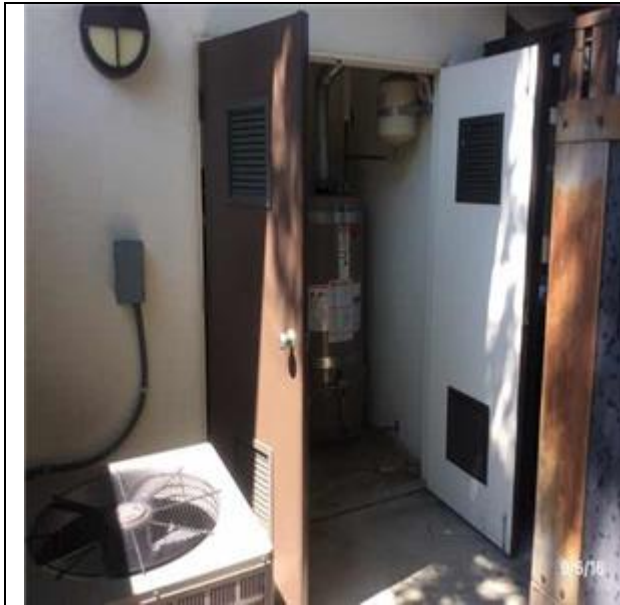
B2032 Solid Exterior Doors:- View of Double Solid Core Wood Doors

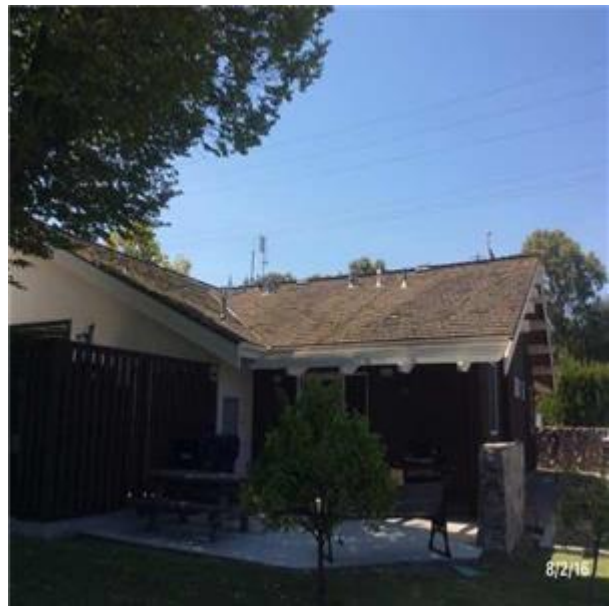
B3011 Roof Finishes:- View of Wood Shake Roof

- + B Shell: Modifications to Exterior Door at an estimated cost of \$6,250 in year 2016
- + B Shell: Replace Wood Shake Roof at an estimated cost of \$47,937 in year 2020
- + C Interiors: Replace Broadloom Standard without Padding at an estimated cost of \$8,760 in year 2018
- + C Interiors: Replace Seal Floor Coating at an estimated cost of \$7,815 in year 2018
- + C Interiors: Replace Painted Finish - Standard at an estimated cost of \$11,136 in year 2020
- + D Services: Replace Emergency Generator Transfer Switch at an estimated cost of \$8,610 in year 2018
- + E Equipment & Furnishing: ADA - Provide Accessible Public Counter at an estimated cost of \$5,600 in year 2016
- + G Building Sitework: Replace Generator Sets, Diesel Engine - 50 kW at an estimated cost of \$58,130 in year 2018

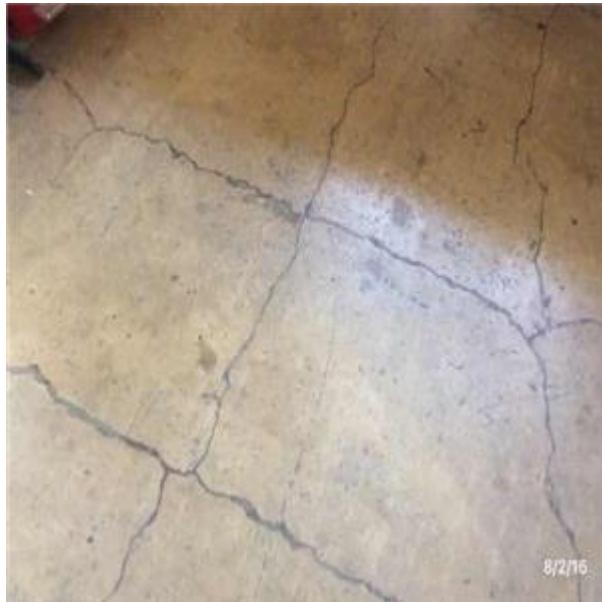
C3023 Hardeners and Sealers:- View of Seal Floor Coating

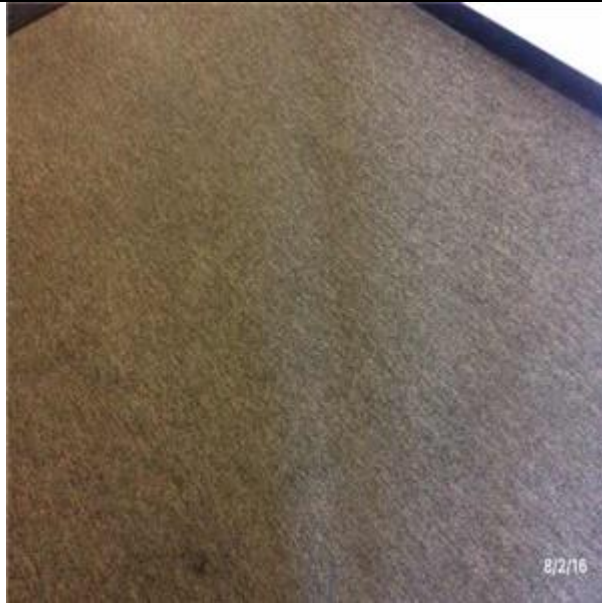
C3025 Carpeting:- View of Broadloom Standard without Padding

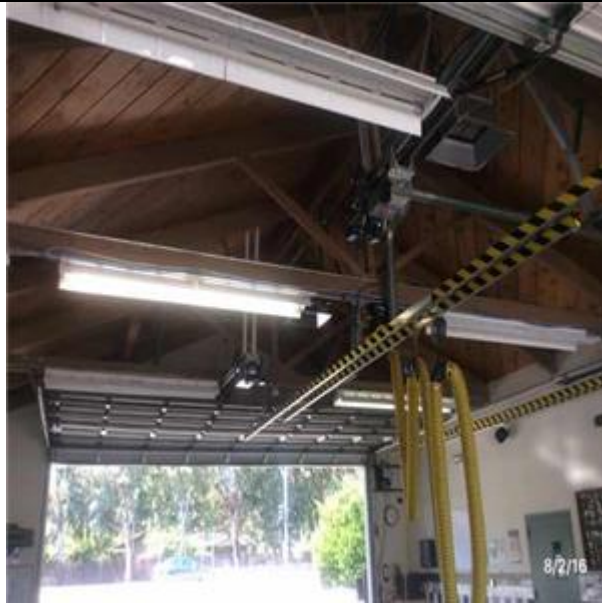
D5022 Lighting Equipment:- View of Interior Light Fixtures -
Fluorescent

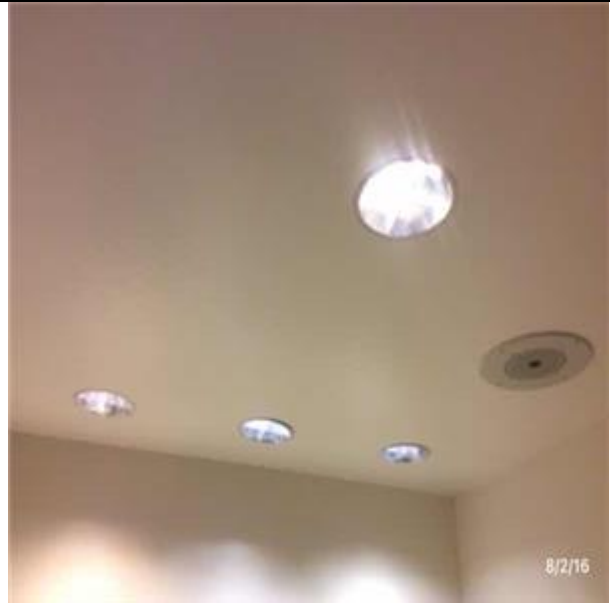
D5022 Lighting Equipment:- View of Recessed Can Light
Fixtures

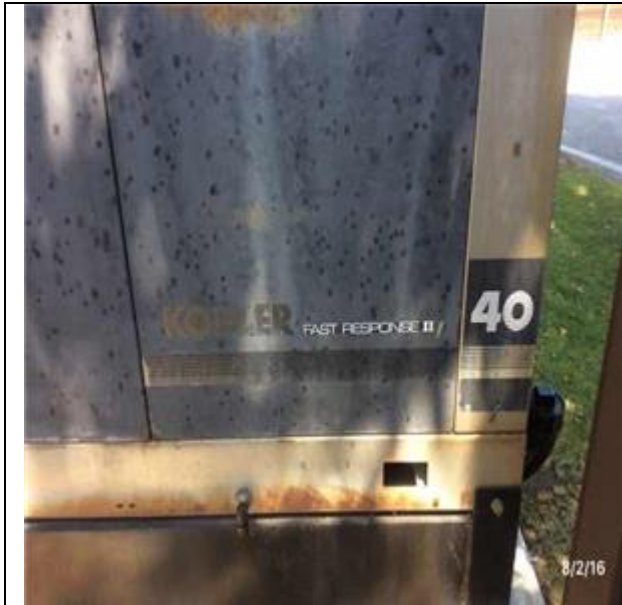
G4092 Site Emergency Power Generation:- View of Generator
Sets, Diesel Engine - 50 kW
