PROPERTY CONDITION ASSESSMENT

10 Almond Avenue
Los Altos, Santa Clara County, California 94022

RSB Project No. 2403055

Executive Summary	
Project Name:	Los Altos Fire Station
Property Address:	10 Almond Avenue, Los Altos, Santa Clara County, California 94022
Property ID (APN):	170-43-005
Property Owner (per tax records):	City of Los Altos
Property Type:	General Public Use (Los Altos Fire Station)
Site Acreage:	Approximately 0.90 - acres
Number of Buildings:	One (1)
Total Building Square Footage:	Approximately 9,442 (Calculated) - SF
Year Built:	1968 (Historic Aerials)
Number of Floors:	One (1)
Number of Units:	One (1)
Substructure (Foundation):	Slabs-on-grade
Superstructure (Building Frame):	Concrete and steel
Facades (Exterior Walls):	Stucco, brick veneer and wood siding
Roof:	Pitched, asphalt shingle roof and low-slope, modified, bituminous asphalt membrane roof
HVAC:	Grade-mounted HVAC units, PTAC units and gas furnace
Elevators:	Not applicable
Fire and Life Safety:	Fire extinguishers
Seismic Zone:	4
Flood Zone:	Flood zone X Unshaded

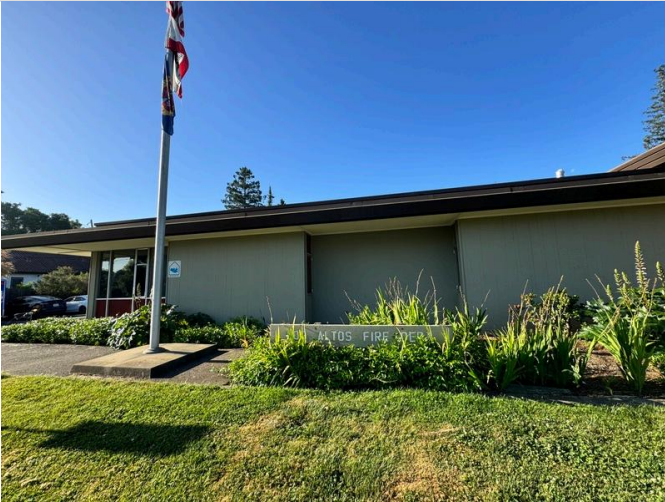
1. Property signage

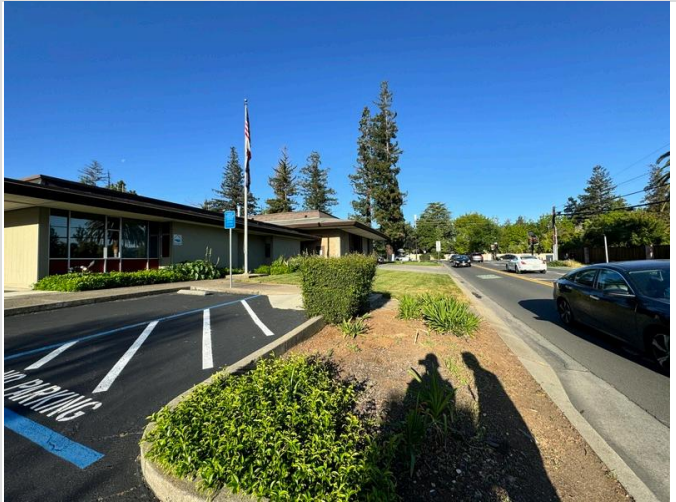
2. View of subject property

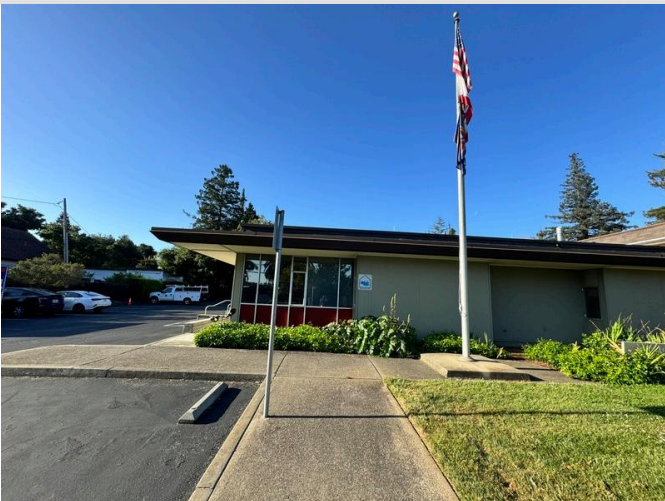
3. View of subject property

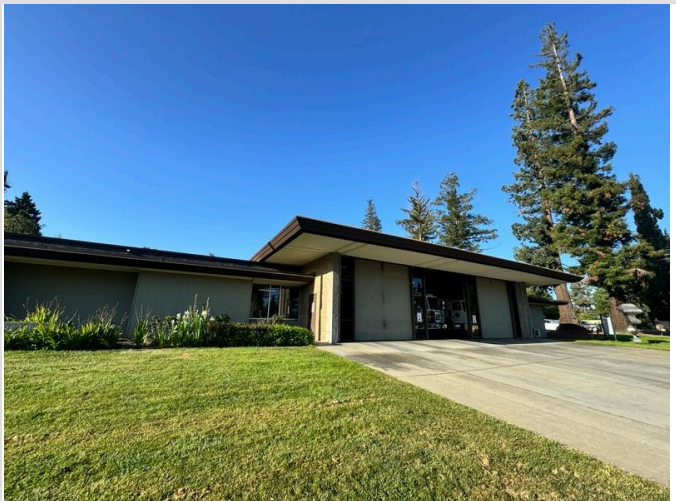
4. View of subject property

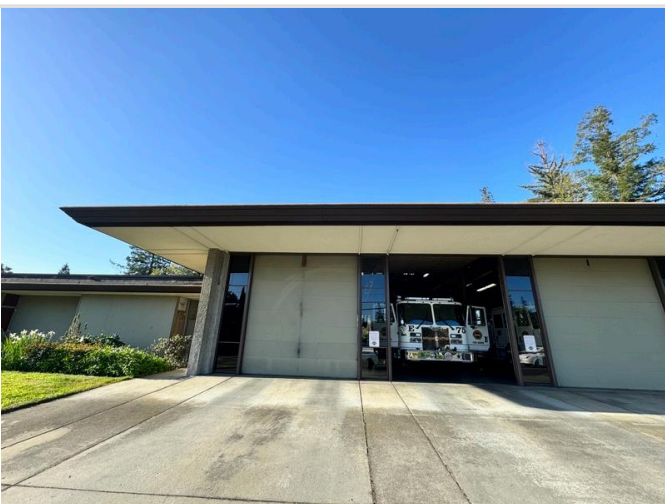
5. View of subject property

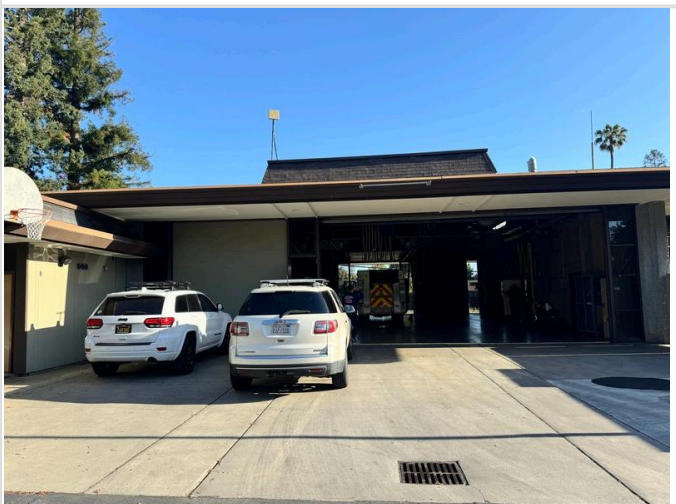
6. View of subject property

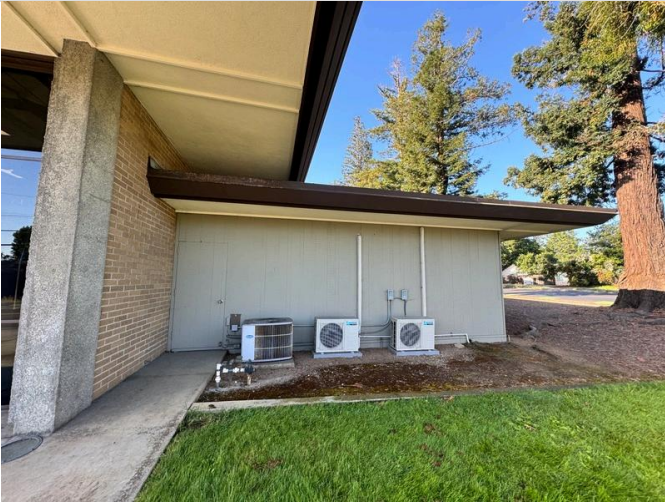
7. Building exterior

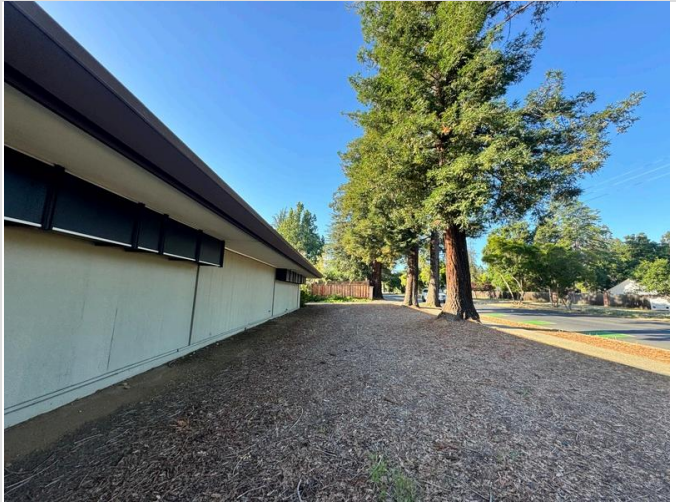
8. Building exterior

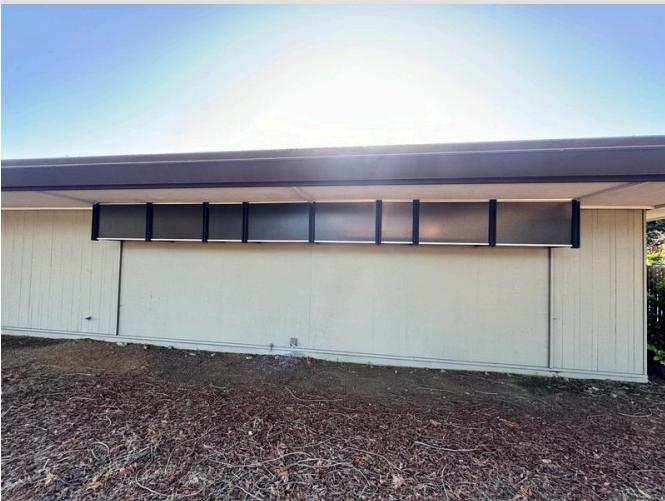
9. Building exterior

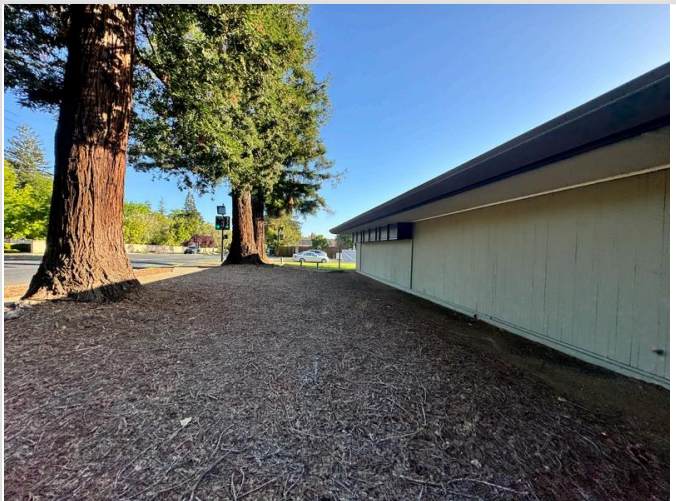
10. Building exterior

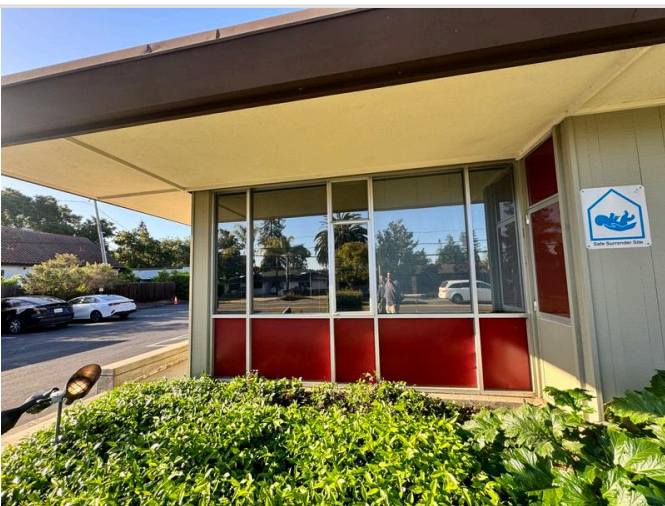
11. Building exterior

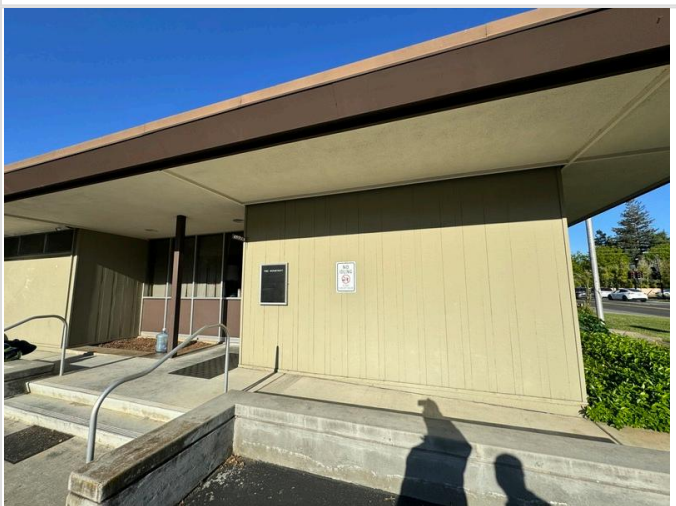
12. Building exterior

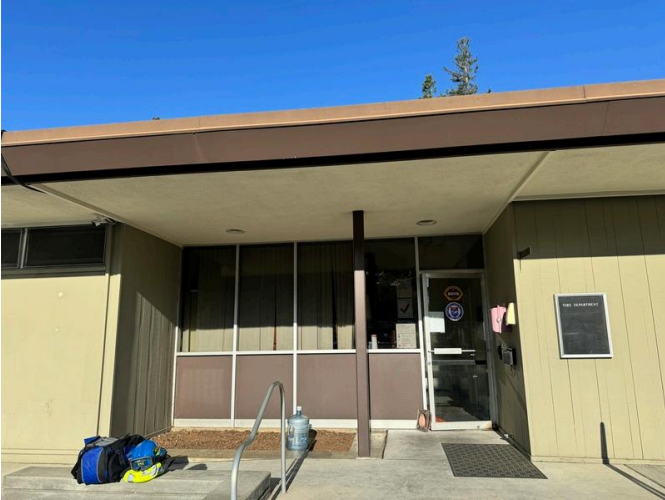
13. Building exterior

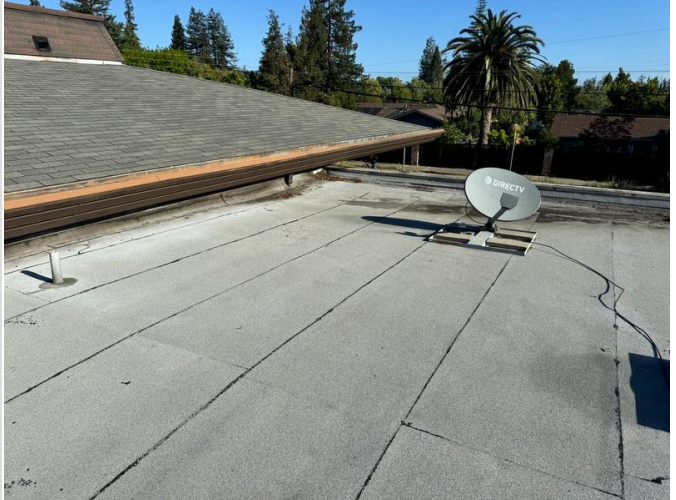
14. Roof

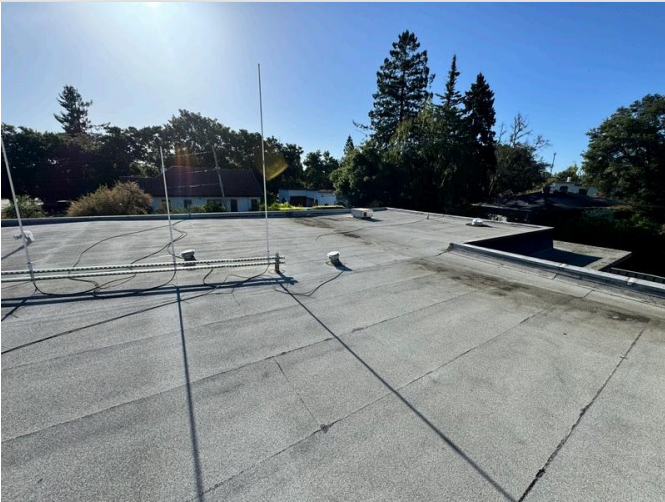
15. Roof

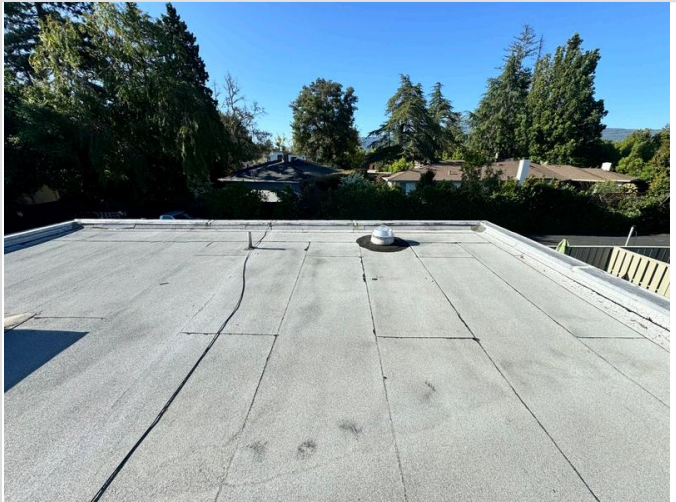
16. Roof

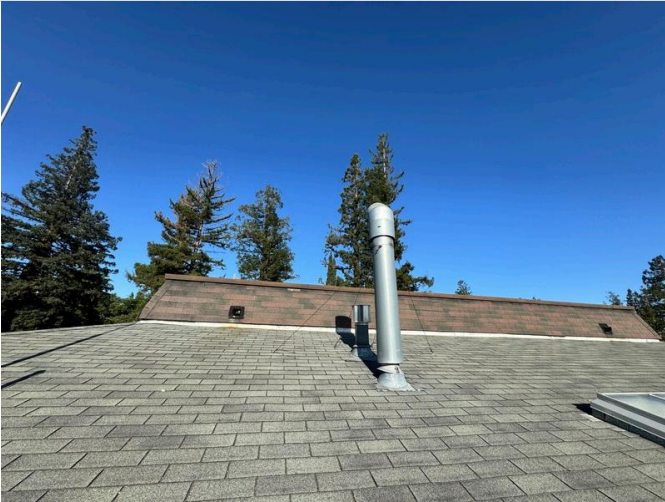
19. Roof

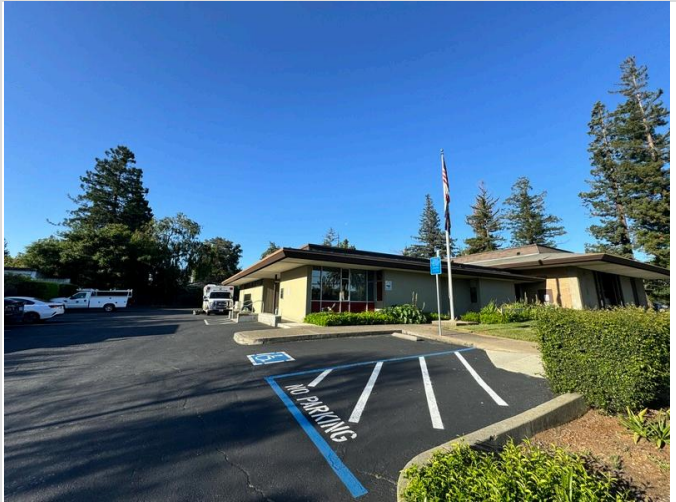
20. Parking , ADA parking

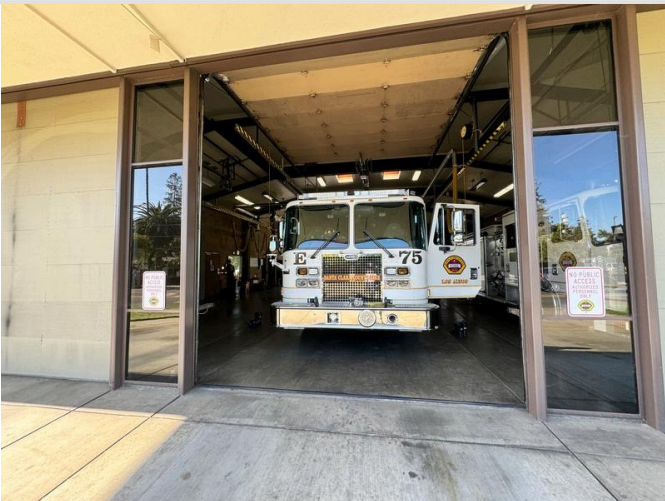
21. Grage entrance

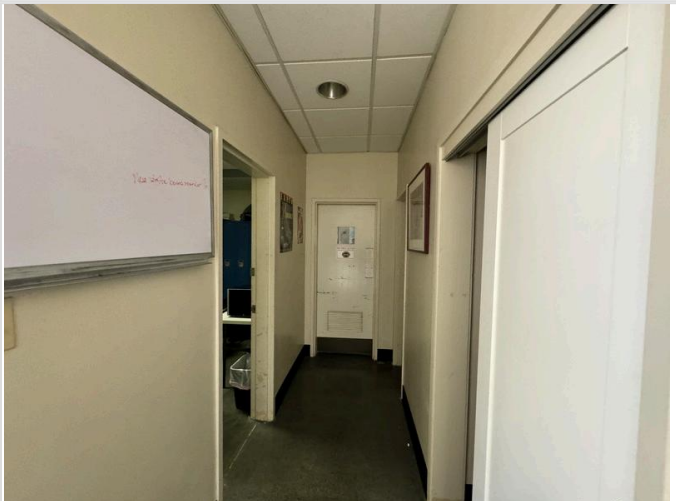
22. Hallway

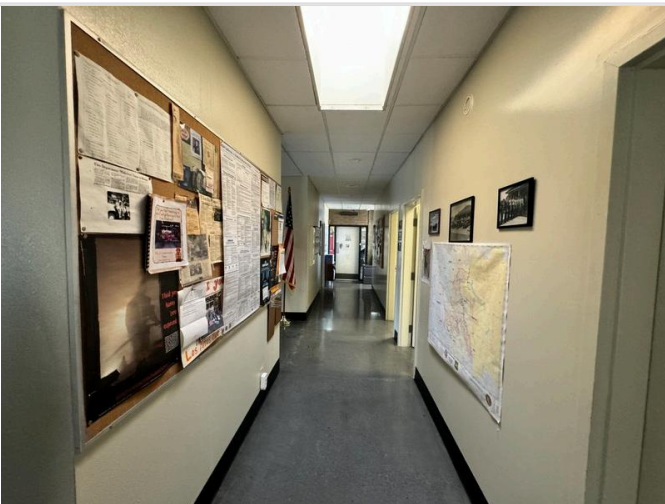
23. Hallway

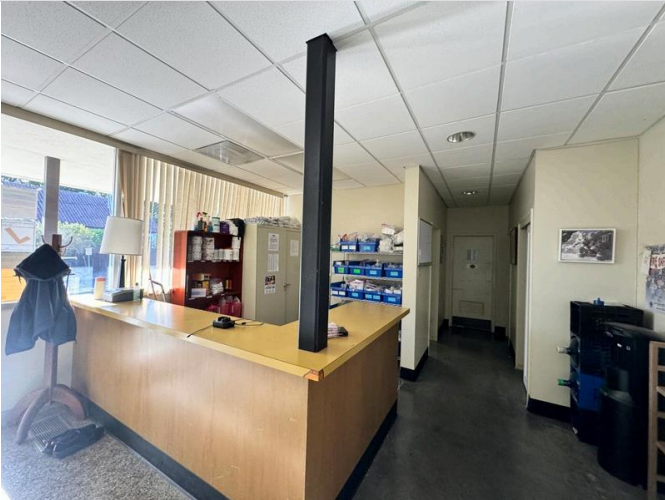
25. Reception desk

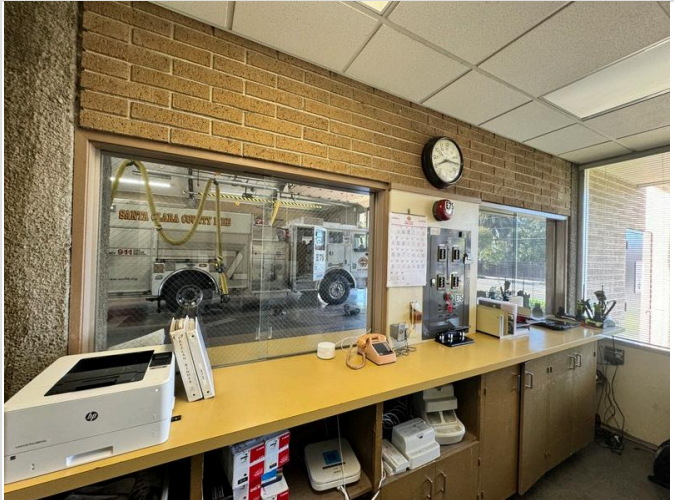
26. Building interior

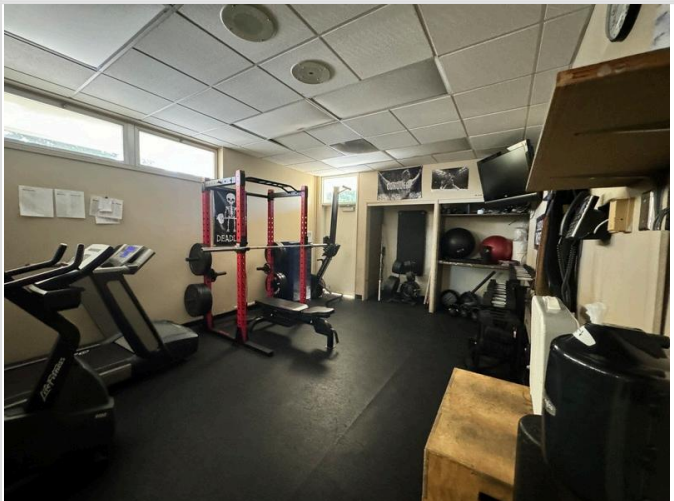
28. Fitness center interior

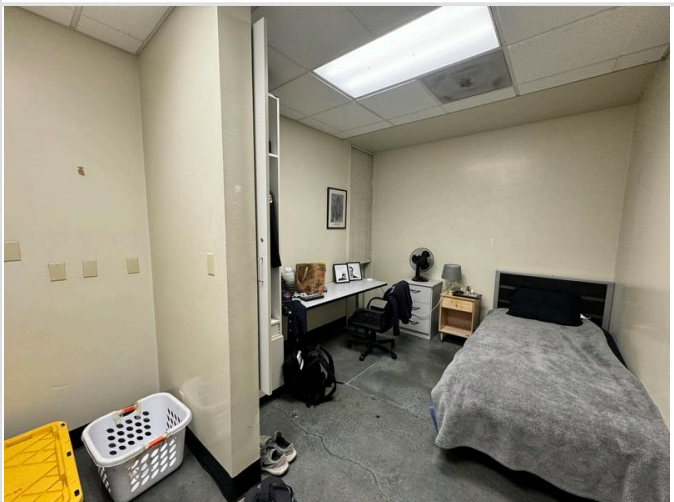
30. Dorm room interior

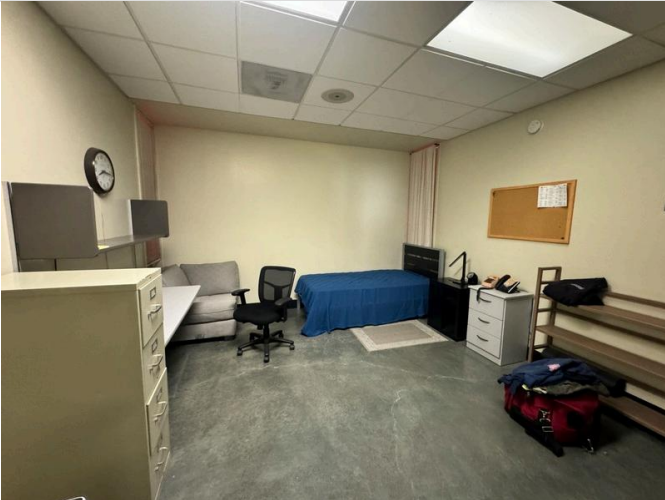
31. Dorm room interior

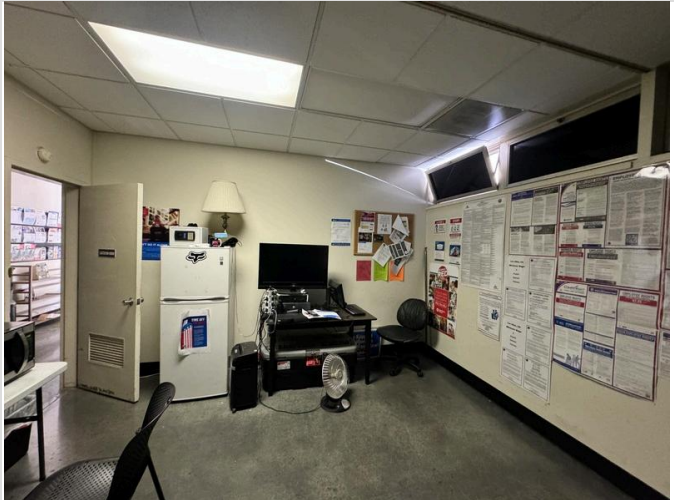
32. Office interior

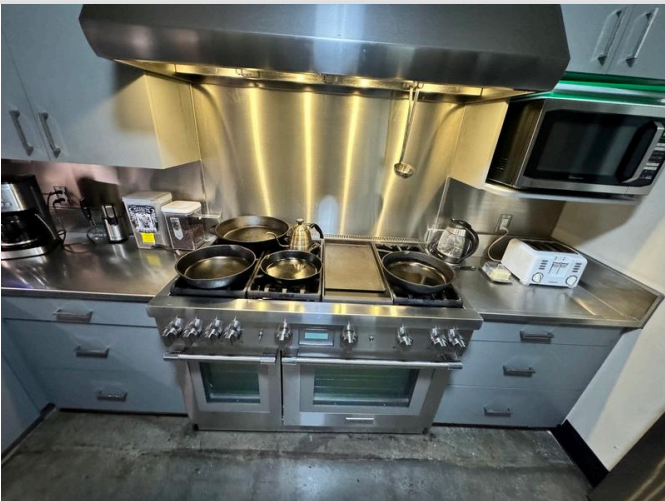
33. Kitchen interior

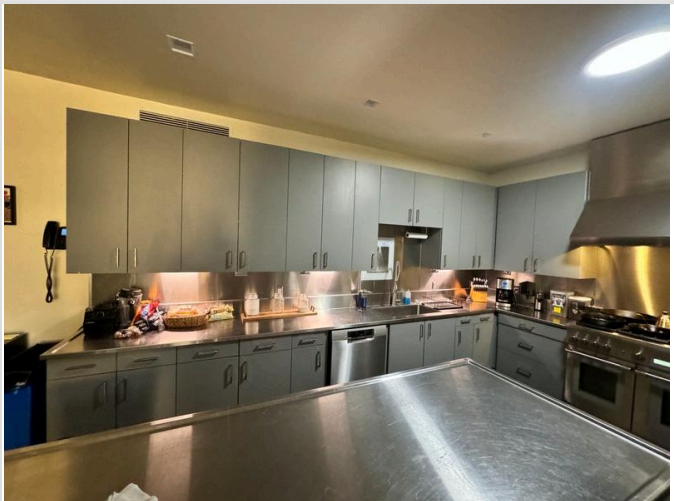
34. Kitchen interior

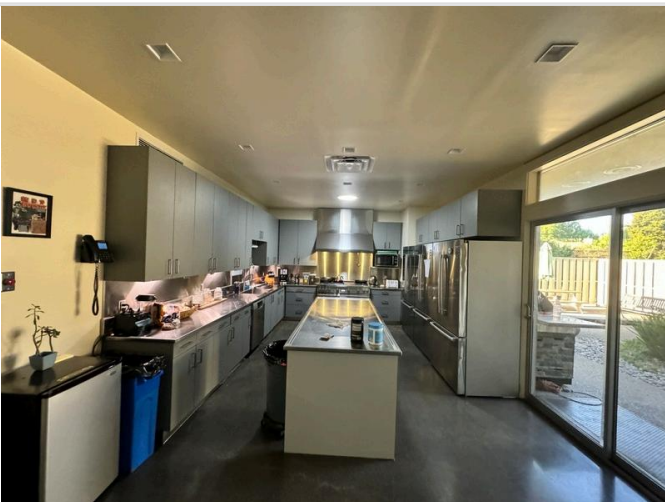
35. Breakroom interior

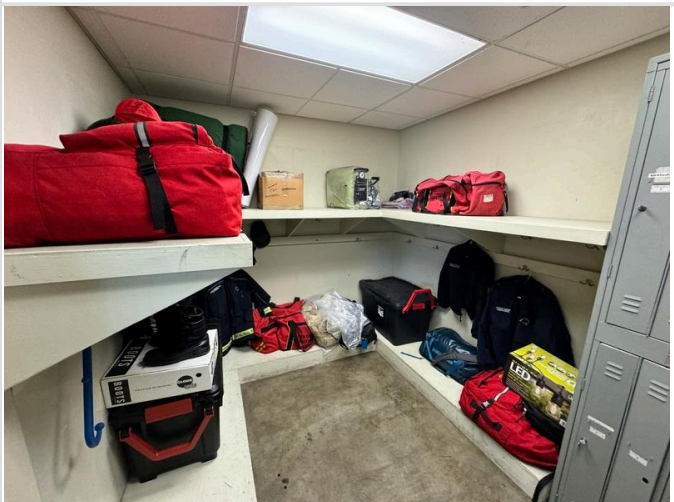
36. Storage interior

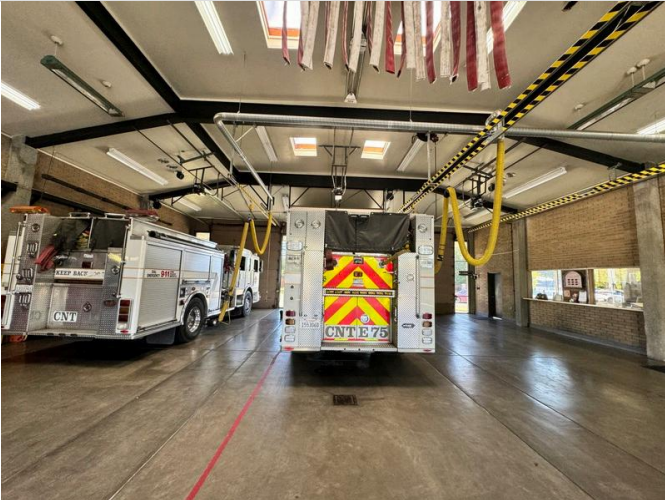
37. Garage interior

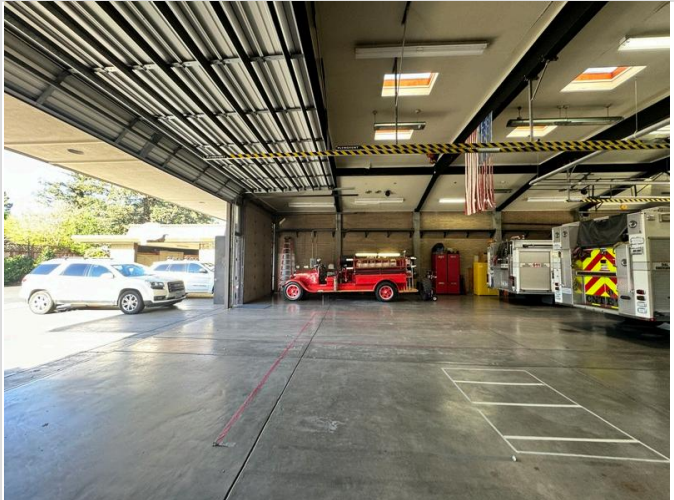
38. Garage interior

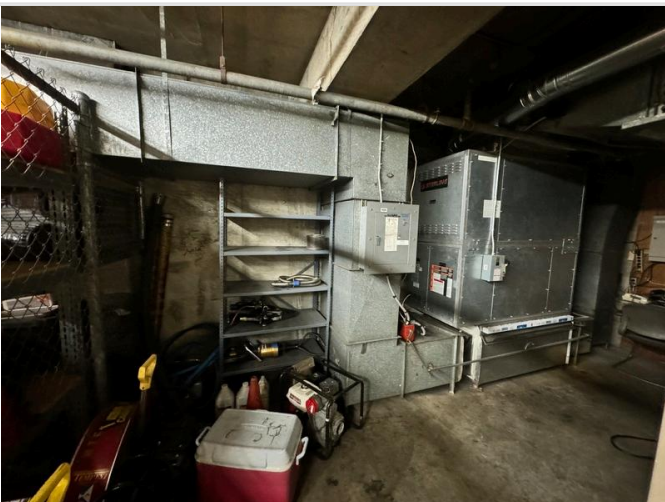
41. Basement interior

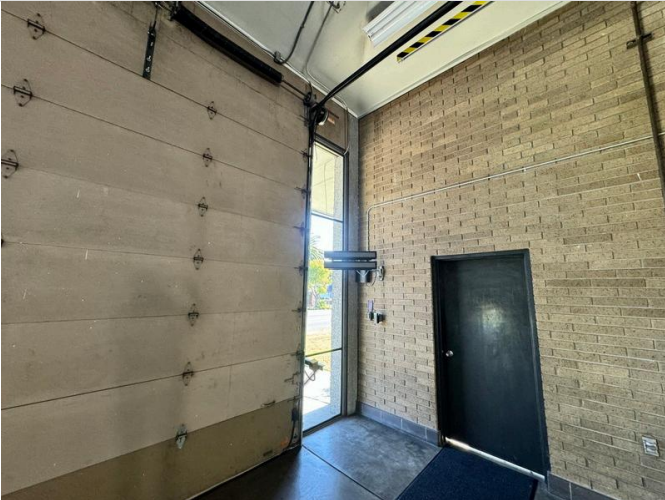
43. Building interior

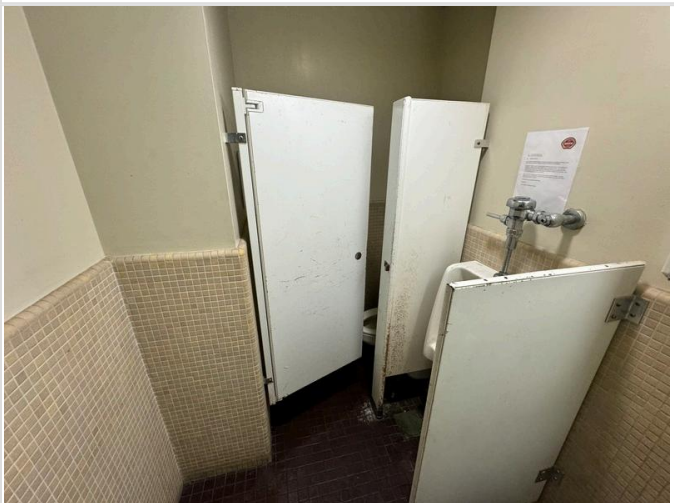
46. Restroom

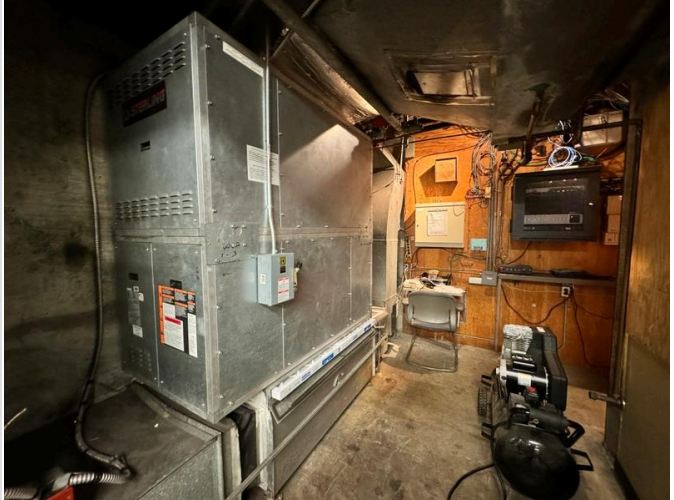
50. Gas furnace

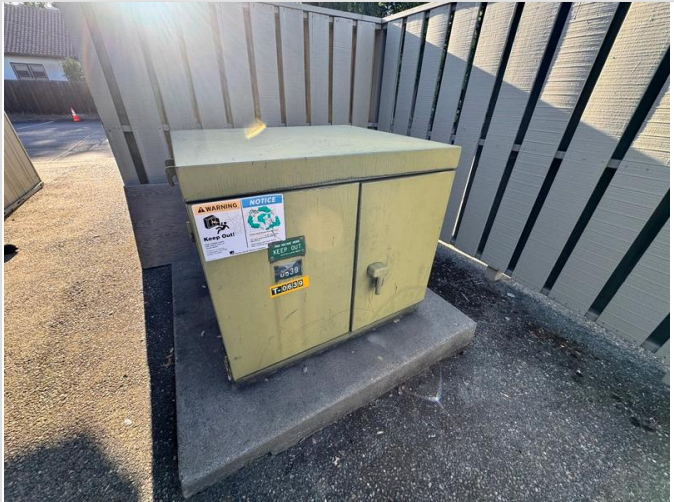
52. Pad-mounted transformer

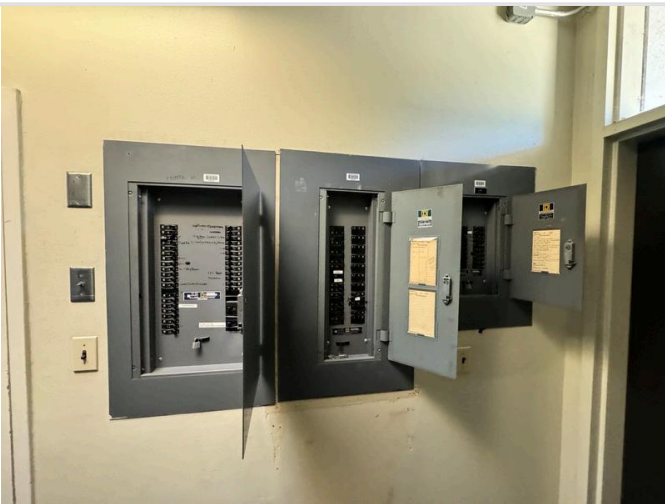
53. Electric panel

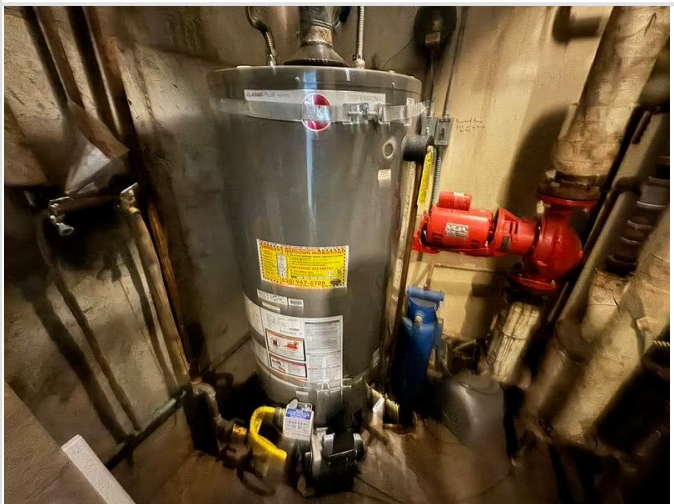
54. Water heater

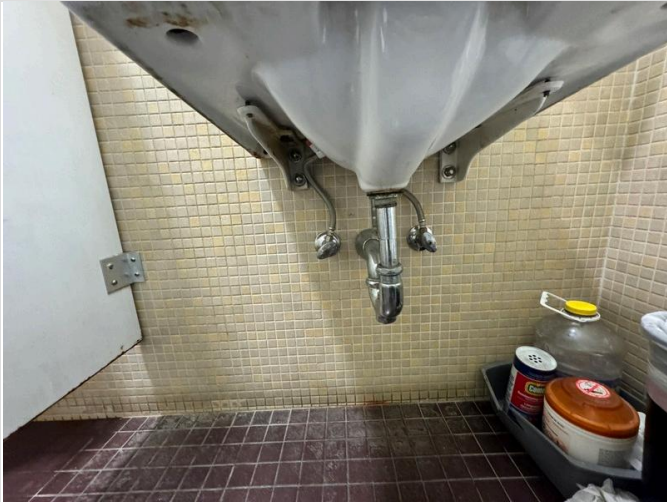
55. Observed plumbing

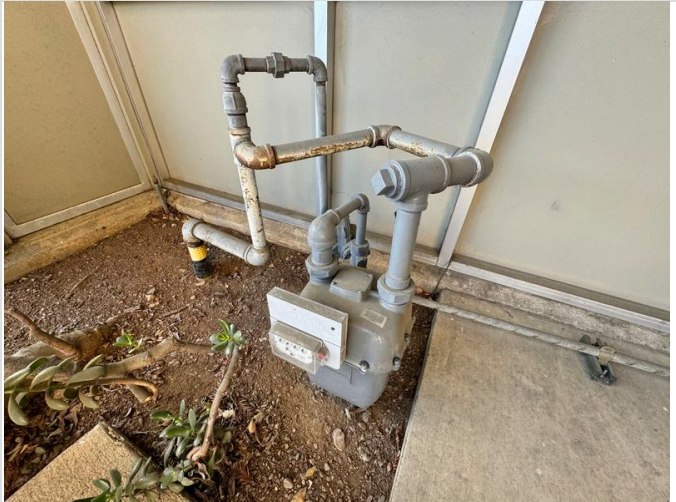
56. Gas meter

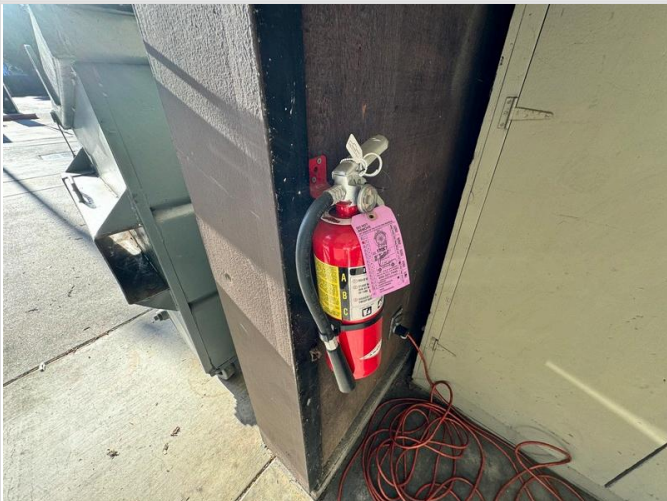
57. Fire extinguisher

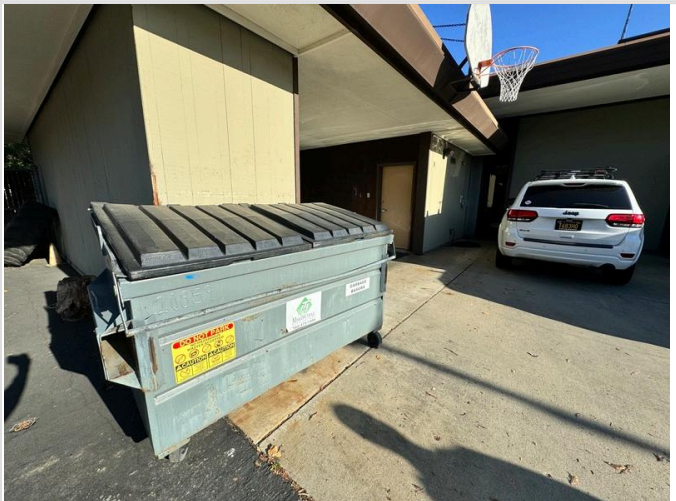
58. Trash dumpster

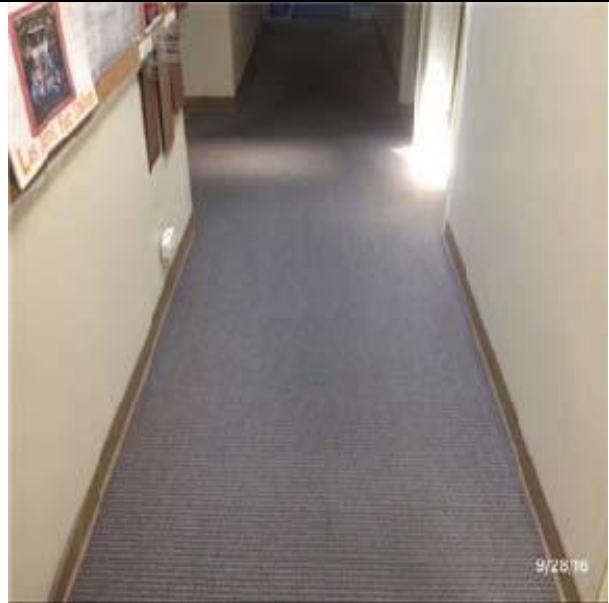
C3024 Flooring:- View of Vinyl Composite Tile (VCT)

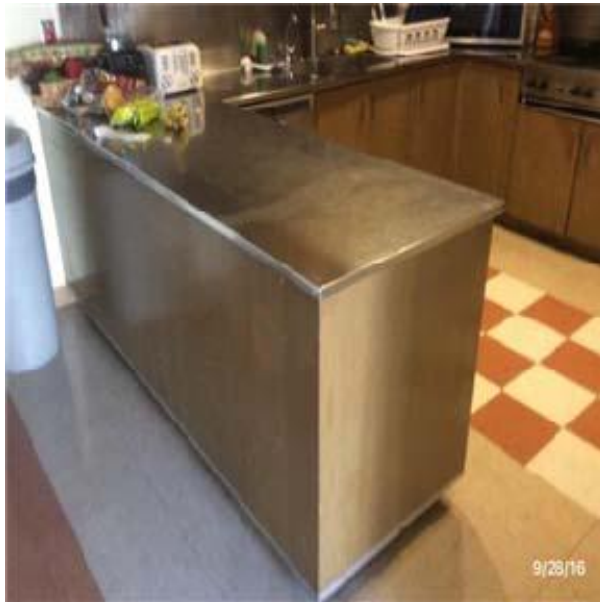
The building contains upper and lower cabinets with stainless steel countertops and integral sinks in the kitchen area.

We have assumed the cabinets and countertop to be part of the refurbishment in 1999, therefore, based on a EUL of twenty years, we recommend replacing during in the study period.

E1095 Unit Kitchens:- View of Floor Mounted Base Cabinets - Standard

ID	Type	Recommendation	Priority	Year	Expenditures
151841	E1090	Replace Unit Kitchens - Wall Mounted Cabinets - Standard	Priority 3	2019	\$13,496
151842	E1090	Replace Unit Kitchens - Counter Top - Stainless Steel	Priority 3	2019	\$6,478
151843	E1090	Replace Floor Mounted Base Cabinets - Standard	Priority 3	2019	\$32,391
151844	E1090	ADA - Provide Accessible Public Counter	Priority 1	2016	\$5,600
