03/06/2024

Arborist Report

Client: Live Oak Associates - Attention: Katrina Krakow

Site: 50 Los Gatos-Saratoga Rd, Los Gatos CA

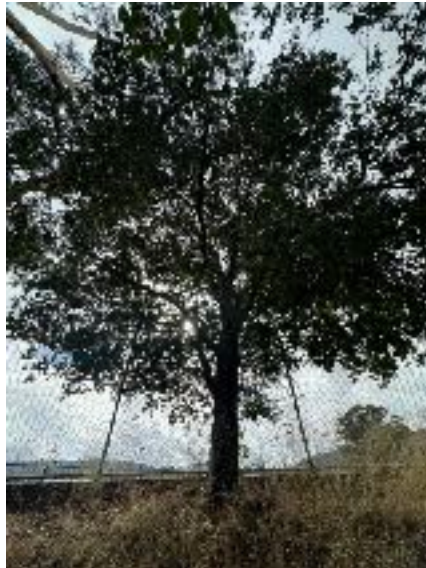
Tag 4801: Tree is located on a grade at the property line.

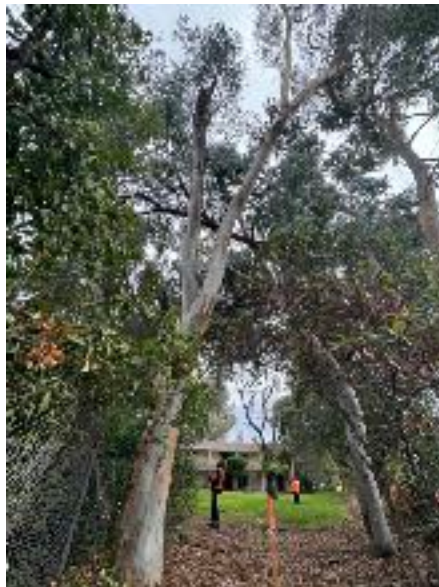
Tag 4802: Substantial rot in first main crotch
Significant lean - potential to upright failure

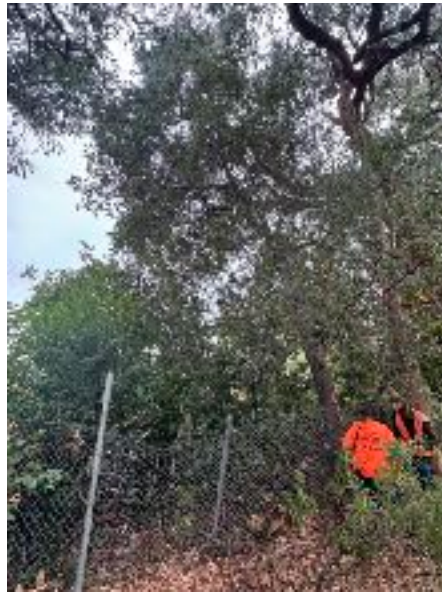
Tag 4803: Located on property line
Girdling around base due to chain link fence

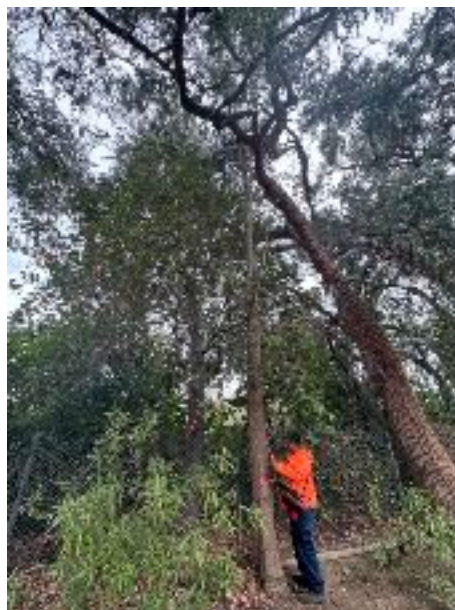
Tag 4804: No foliage until upper canopy due to growing amongst live oak and eucalyptus. Significant vertical growth to obtain light over neighboring trees

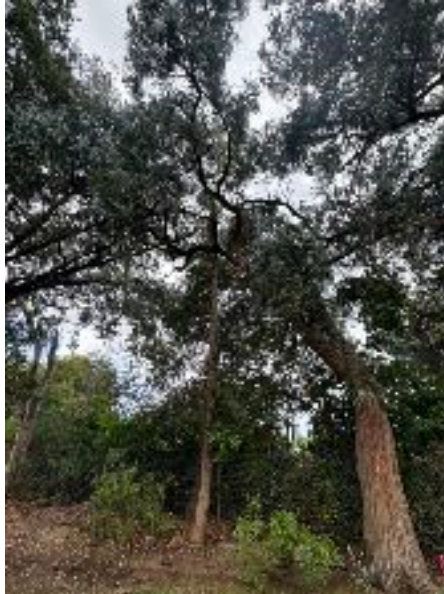
Tag 4805: Canopy leaning north west due to competition for light.
Located on fenceline.
Crossing limbs and merging canopies with neighboring trees.

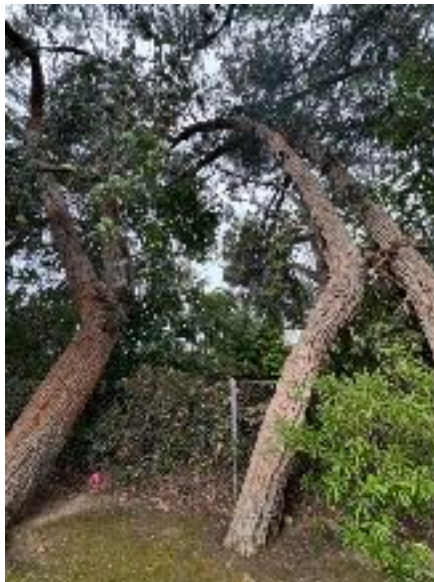
Tag 4806: Canopy leaning north west due to competition for light.
Located on fenceline.
Crossing limbs and merging canopies with neighboring trees.

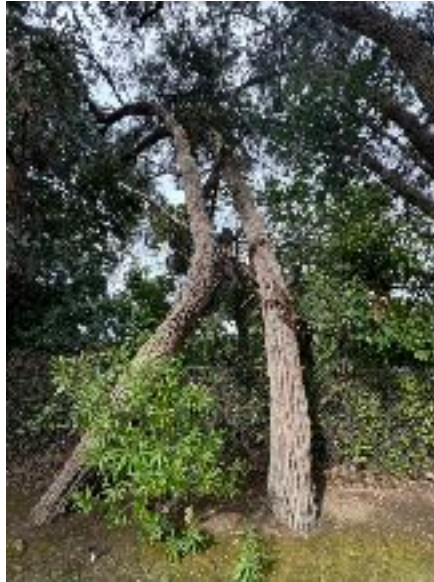
Tag 4807: Canopy leaning north west due to competition for light.
Crossing limbs and merging canopies with neighboring trees.

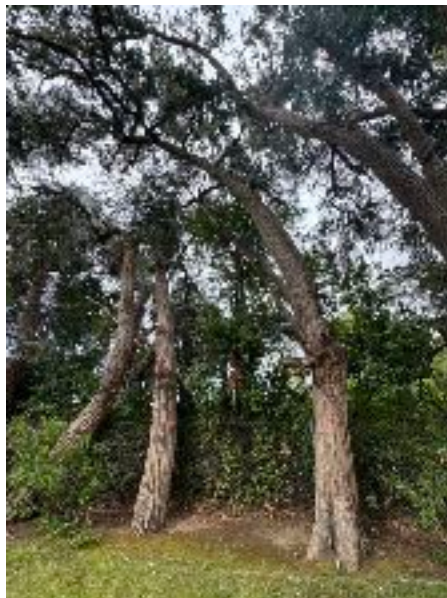
Tag 4808: Canopy leaning north west due to competition for light.
Crossing limbs and merging canopies with neighboring trees.

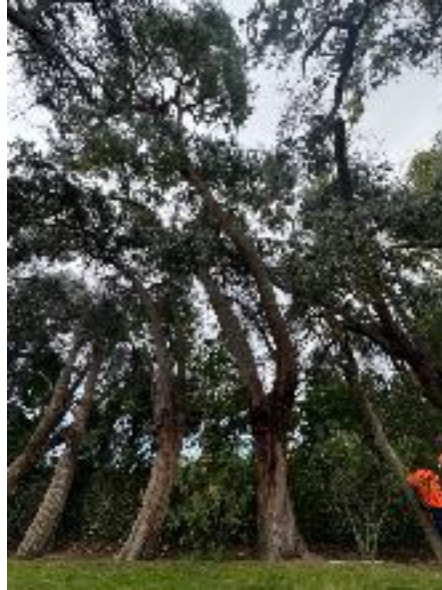
Tag 4809: Bad attachments at first main crotch of codominant uprights. Crossing limbs and merging canopies with neighboring trees.

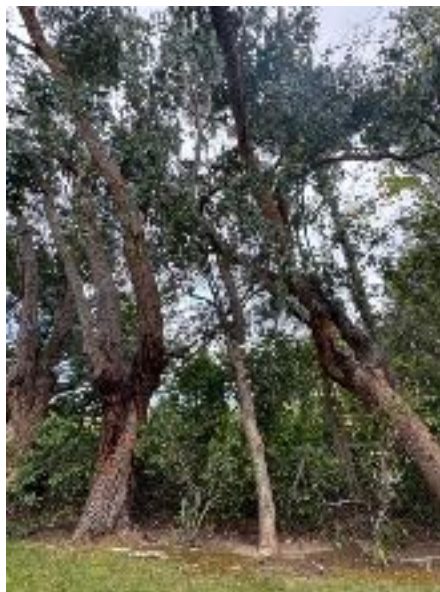
Tag 4810: Crossing limbs and merging canopies with neighboring trees. Located on fenceline.

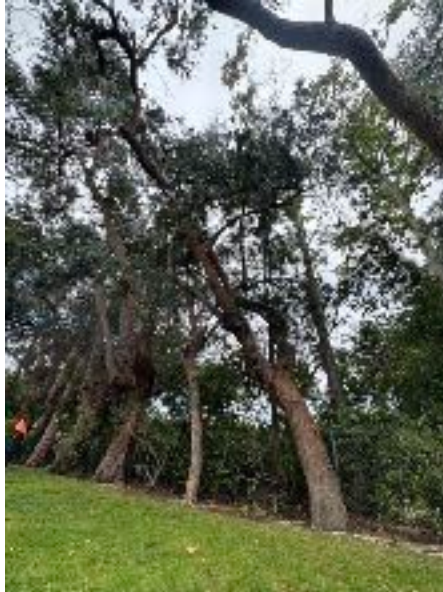
Tag 4811: Canopy growing to the northwest.
Decay noted in wounds from cuts of large removed limbs.
Located on the fenceline.

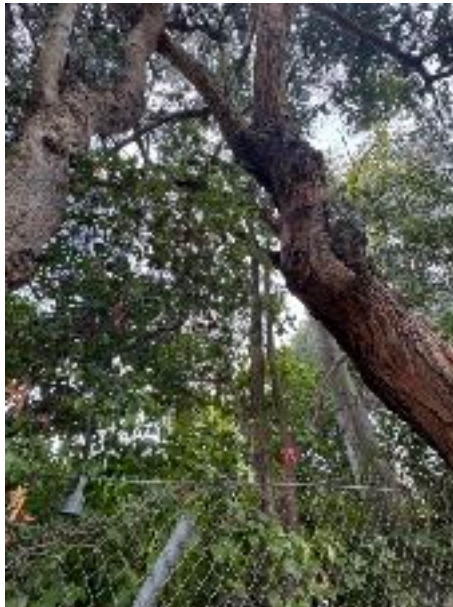
Tag 4812: Located on adjacent lot with drip line over property.
This tree is not suitable for landscape tree.

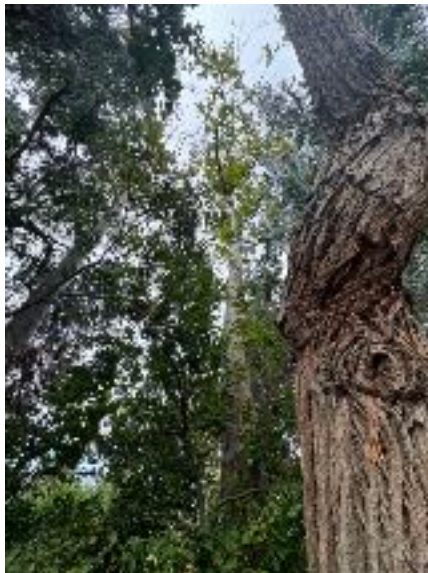
Tag 4814: Located 3ft from fenceline.
On adjacent lot with drip line over property.
Deadwood noted in upper canopy.

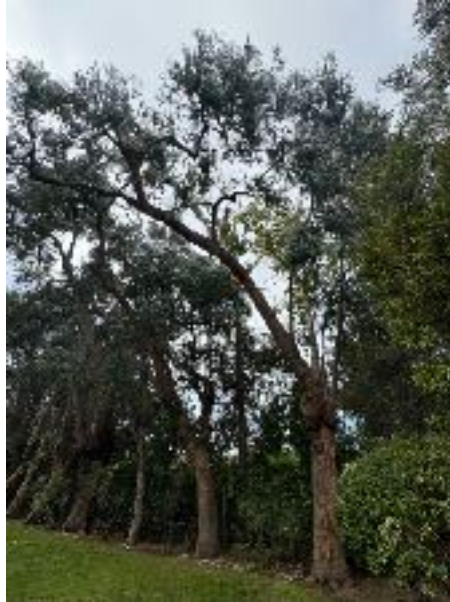
Tag 4815: Rot noted in main stem and in dominant upright.
Poorly attached epicormic growth.
Located on property at fenceline.

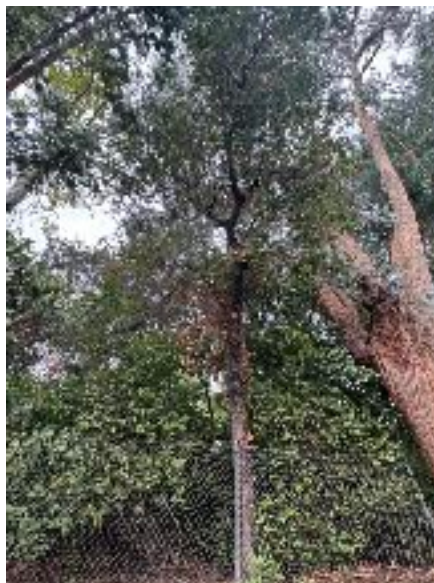
Tag 4816: Thick dead vine observed on main stem.
Needs to be removed - dead tissue of vine can lead to fungal and pest infection.

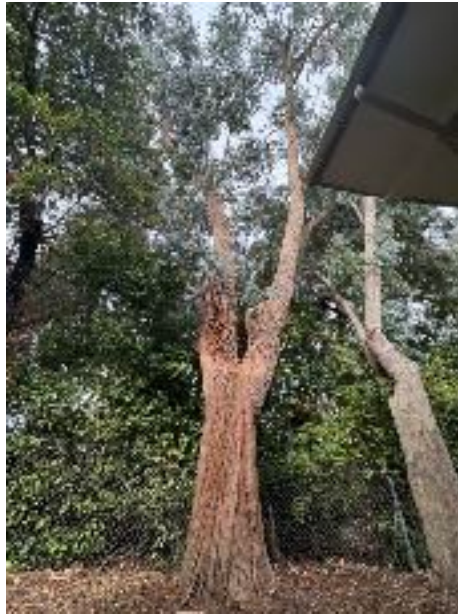
Tag 4817: Located on property at fenceline.
Heavy limbs of upper canopy extend over roofline.

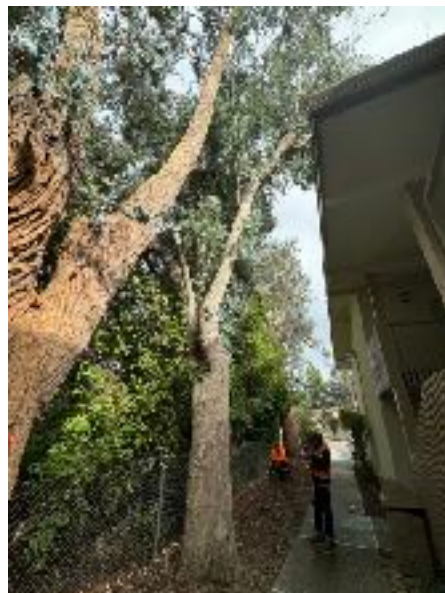
Tag 4818: Upper canopy colliding with neighboring upright Located 3ft from fence-line.
Co-dominant upright extending over roof with fused limbs.

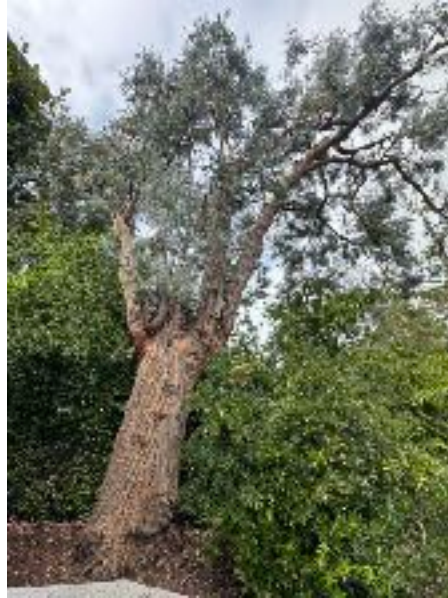
Tag 4819: Lower canopy has significant epicormic growth.
Decay noted in main stem.

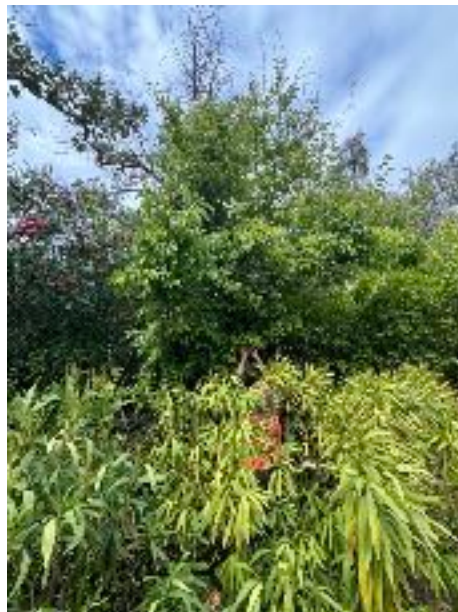
Tag 4820: Significant deadwood upper canopy.
Located 3ft from fenceline on the adjacent lot with drip line over property.

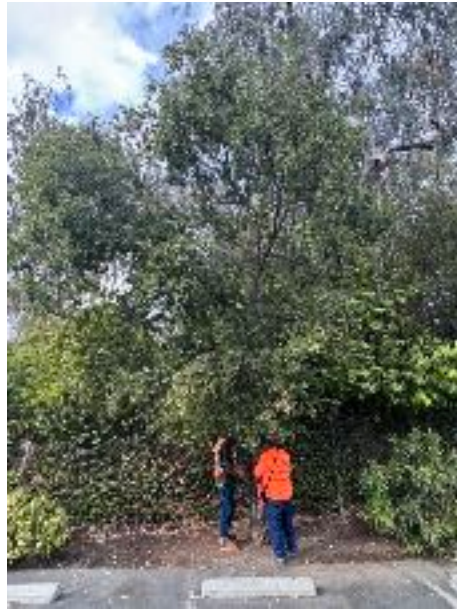
Tag 4821: Old wound noted at base of main stem.
Moderate decay and fruiting fungal bodies observed at base of trunk.

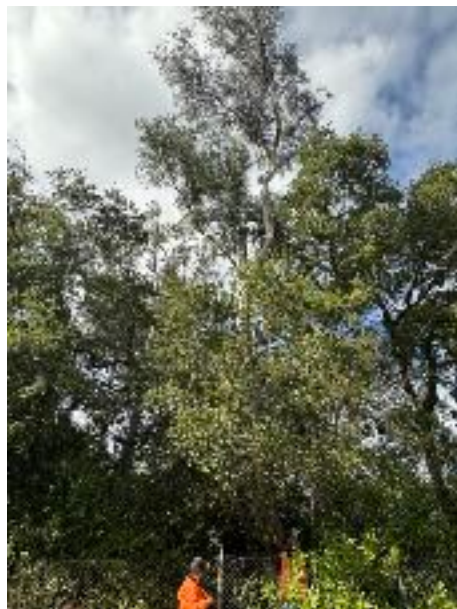
Tag 4822: Located on adjacent lot 3 feet from fence line with drip line extending over property.
Decay noted on codominant upright.

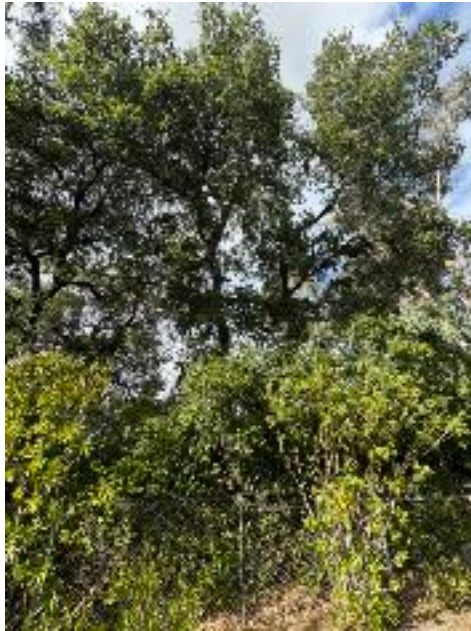
Tag 4823: Large decaying wound at base of root flare.
Located on adjacent lot 3 feet from property line with drip line extending
over property.

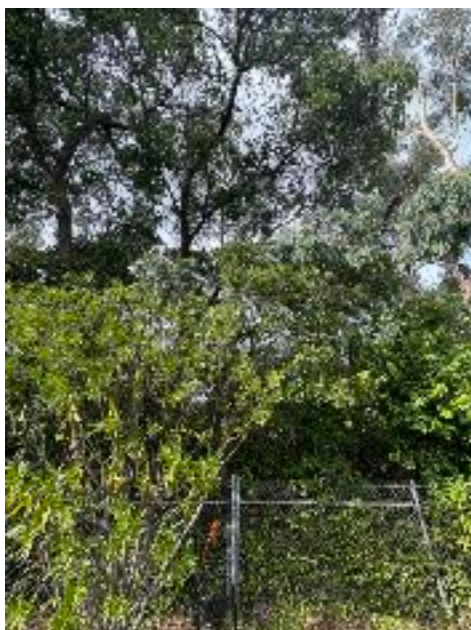
Tag 4824: Competing for sunlight with neighboring trees.
Limited foliage on trunk until upper canopy.

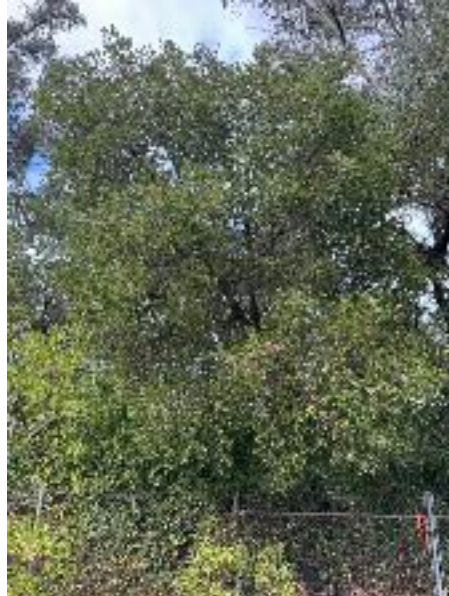
Tag 4825: Dense lower canopy.
Dead foliage from neighboring trees throughout canopy.

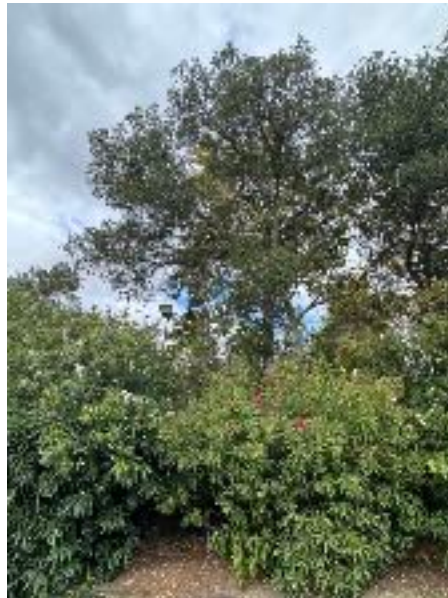
Tag 4826: Girdling at the base due to chain link fence.
Trunk has fused to chain link fence.
Located on neighboring property.

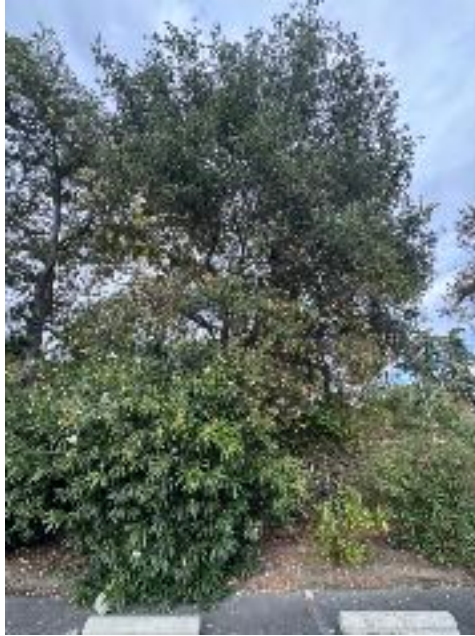
Tag 4827: Lower canopy has minor foliage dieback. Located 2ft from fenceline on neighboring property.

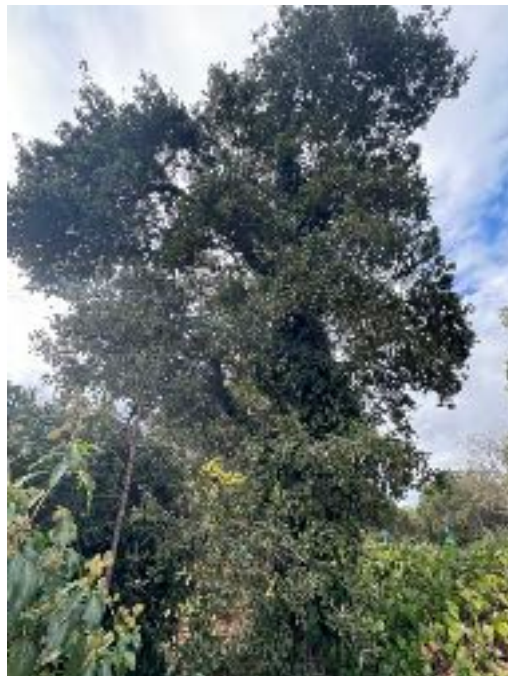
Tag 4828: Entire trunk of the tree is covered in ivy that should be removed. Located 4ft from fenceline on neighboring property. Future growth of canopy will cover parking lot light.

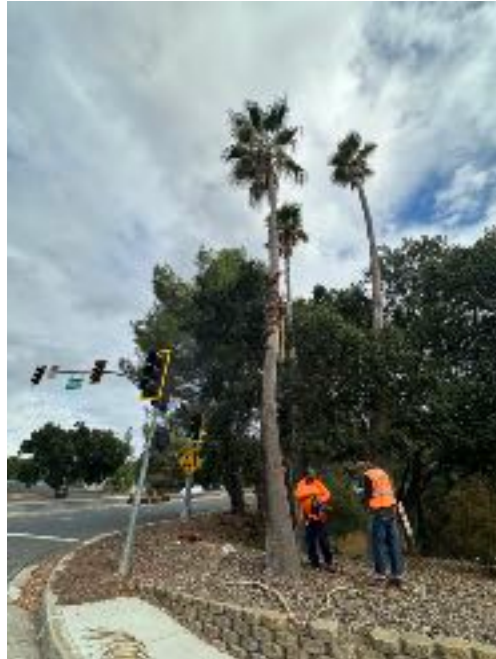
Tag 4829: Slight mechanical damage at base of trunk.
No action necessary.

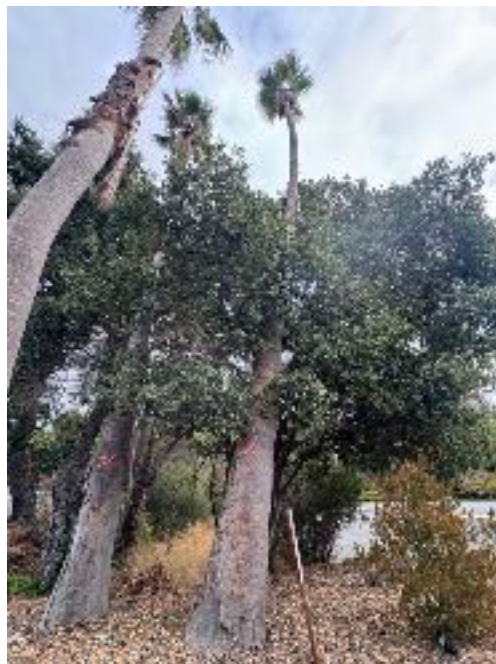
Tag 4830: Slight mechanical damage at base of trunk
No action necessary

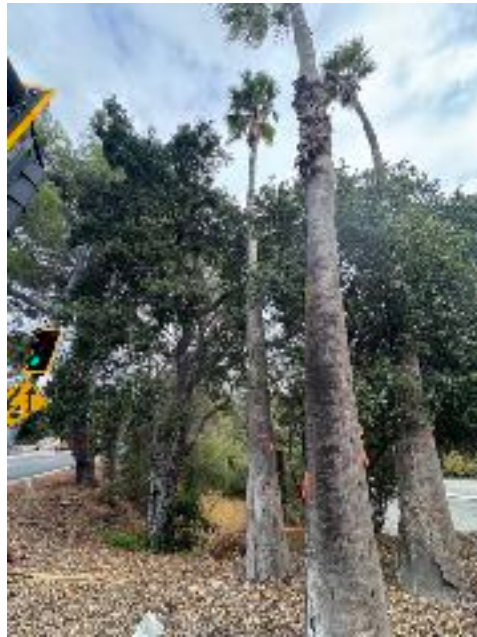
Tag 4831: Slight mechanical damage at base of trunk
No action necessary

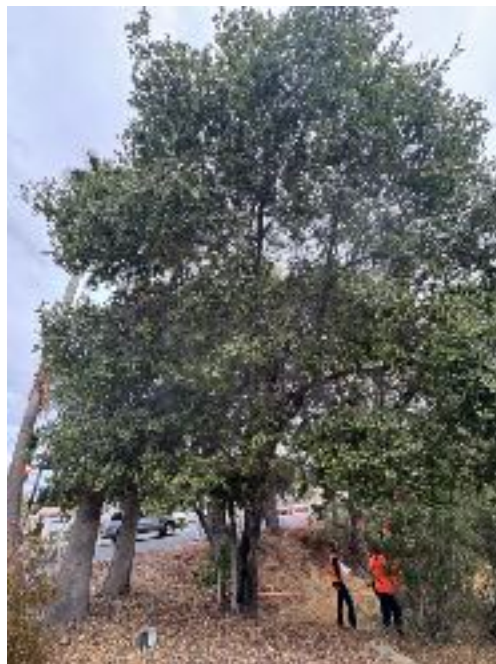
Tag 4832: Multiple stems from secondary growth.
Dense canopy.

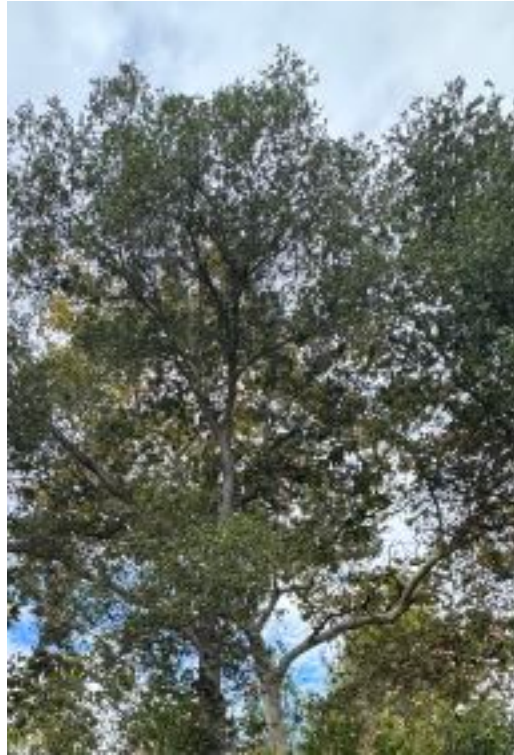
Tag 4833: Minor dieback and deadwood in upper canopy.

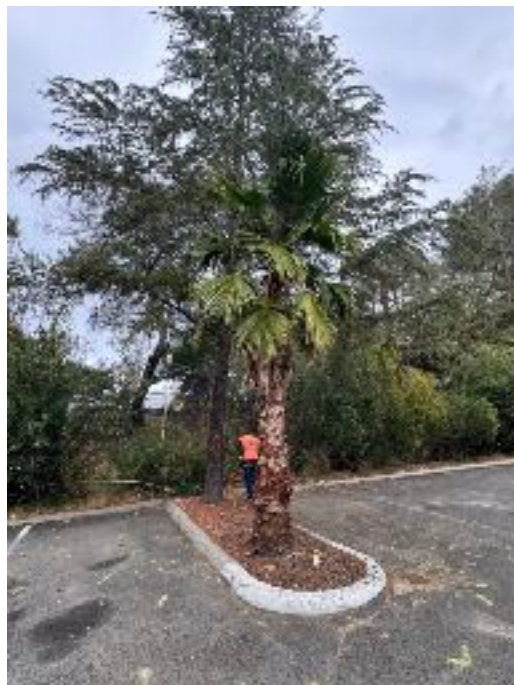
Tag 4834: Competing for sunlight with neighboring cedar tree.

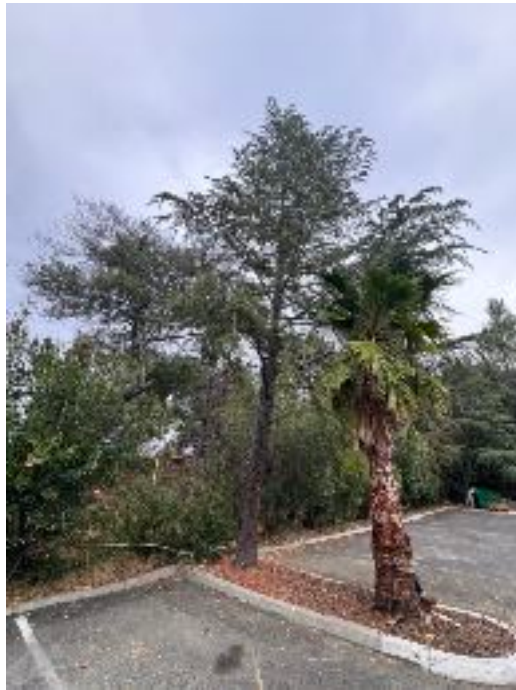
Tag 4835: Canopy interfering with growth of neighboring palm tree.

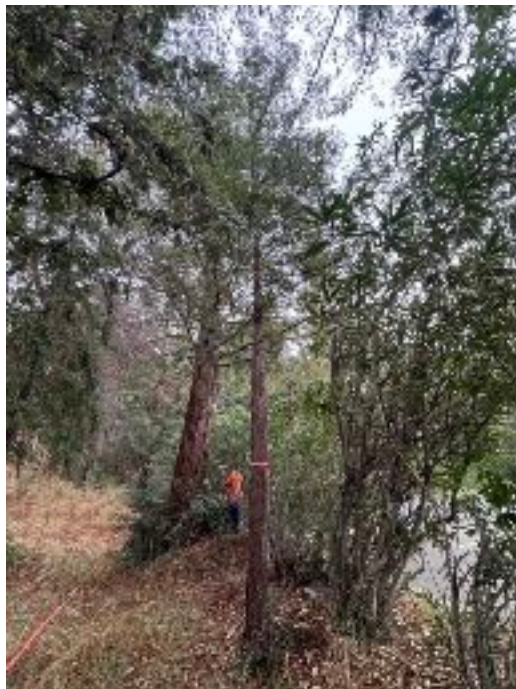
Tag 4838: Competing for sunlight between neighboring redwood trees.

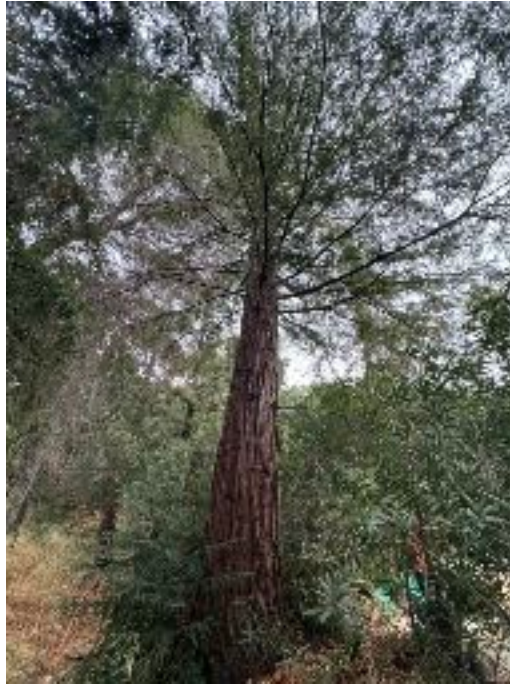
Tag 4839: Sparse and thin foliage due to long term drought stress.

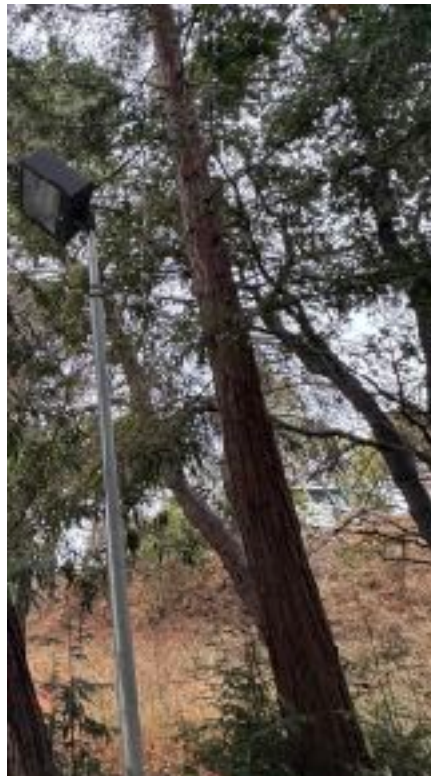
Tag 4842: Significant secondary growth at root flare.
Evidence of minor drought stress.

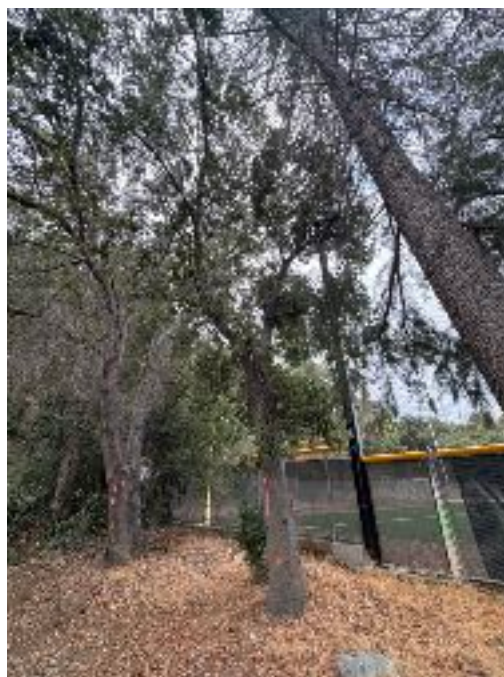
Tag 4848: Upright growing towards neighboring property is close to contact with sports fencing.

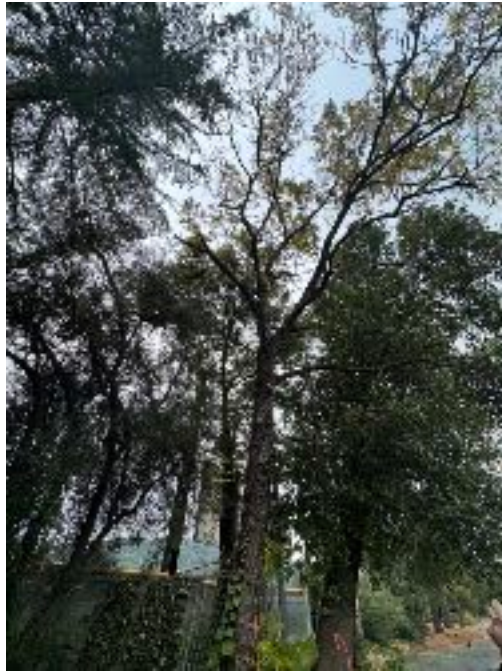
Tag 4851: Ivy growing around base of the tree and up main stem. Dieback evident in the canopy

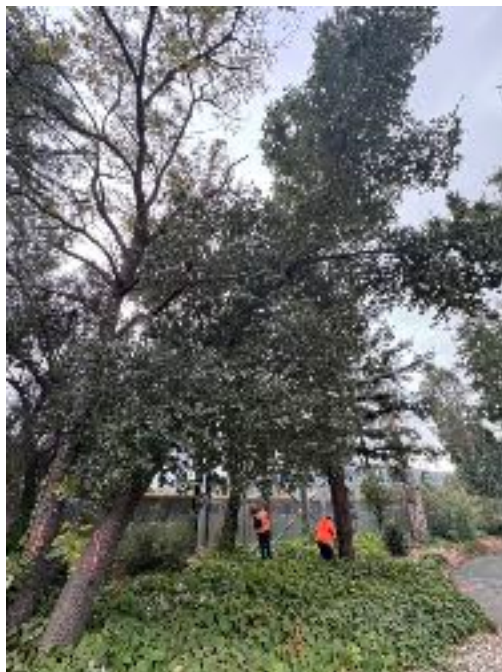
Tag 4852: Significant lean to the north due to competition for light with the walnut tree. Ivy growing at the base of the tree.

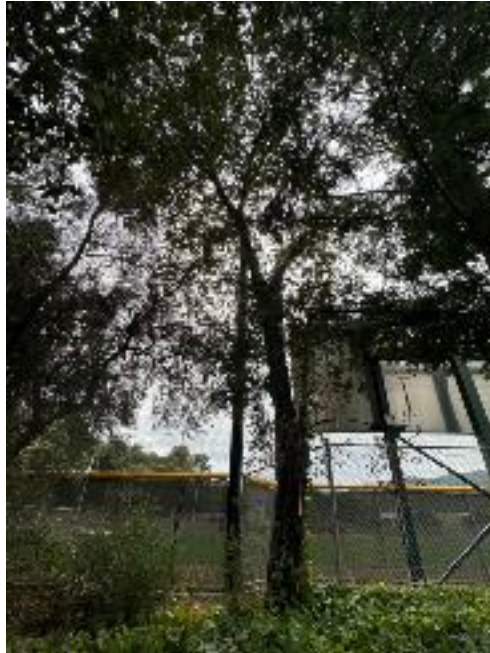
Tag 4853: Ivy growing around the base of the tree and up the main stem. Minor bark damage from bark beetle.

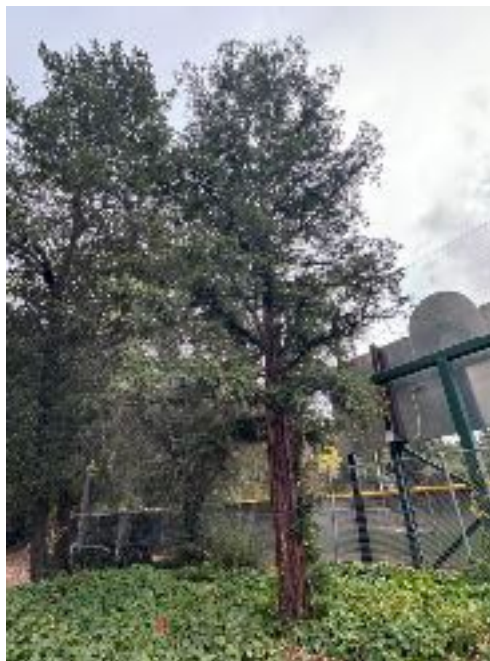
Tag 4854: Ivy growing around the base and beginning to climb trunk.

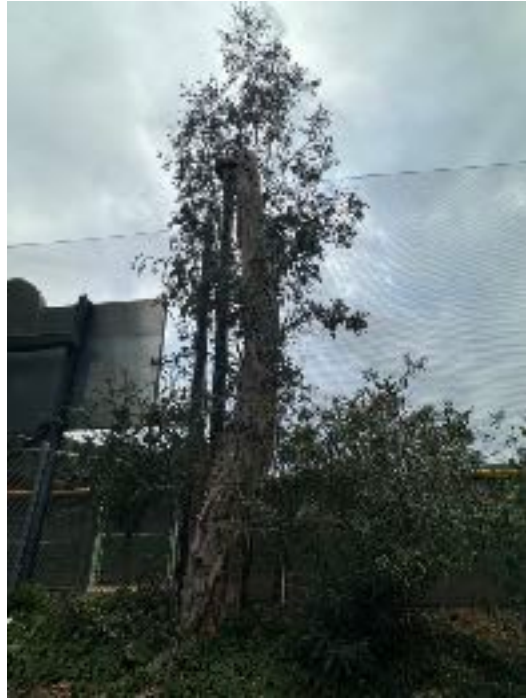
Tag 4855: Tree has been pollarded.
Ivy growing around the base and starting to climb the trunk.

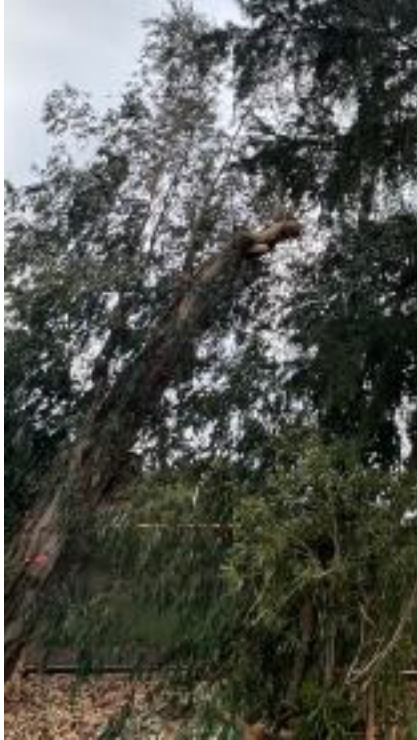
Tag 4857: Damage to trunk flare noted.

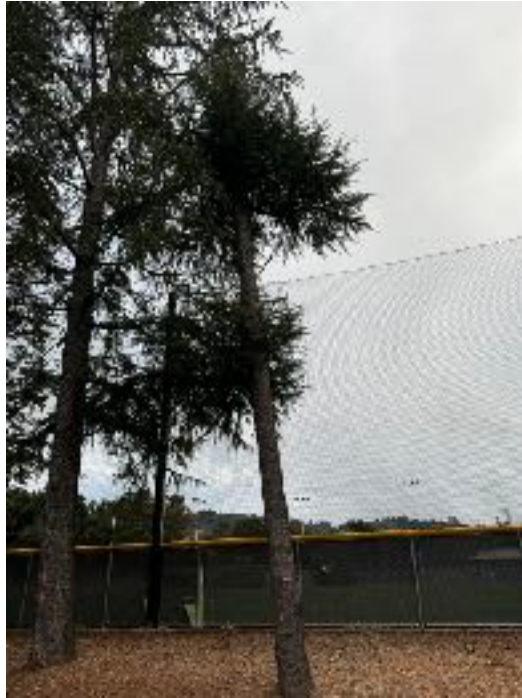
Tag 4861: Tree has been topped.
Canopy is comprised of secondary growth.

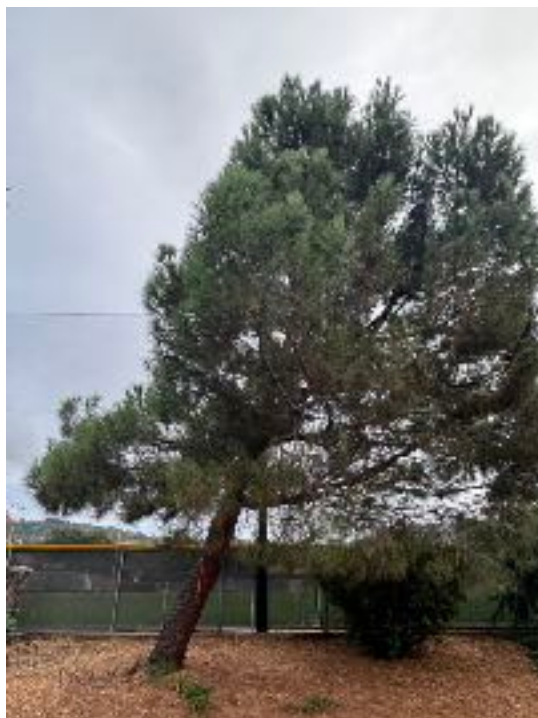
Tag 4862: Tree has a moderate lean to the north.

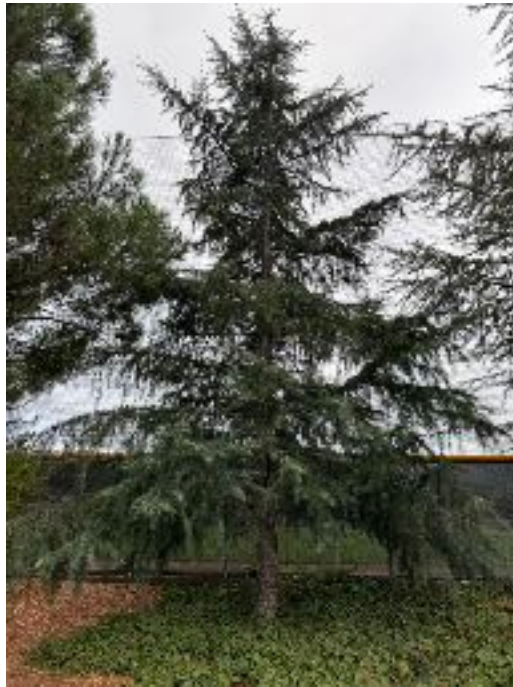
Tag 4863: Ivy growing around base of tree.

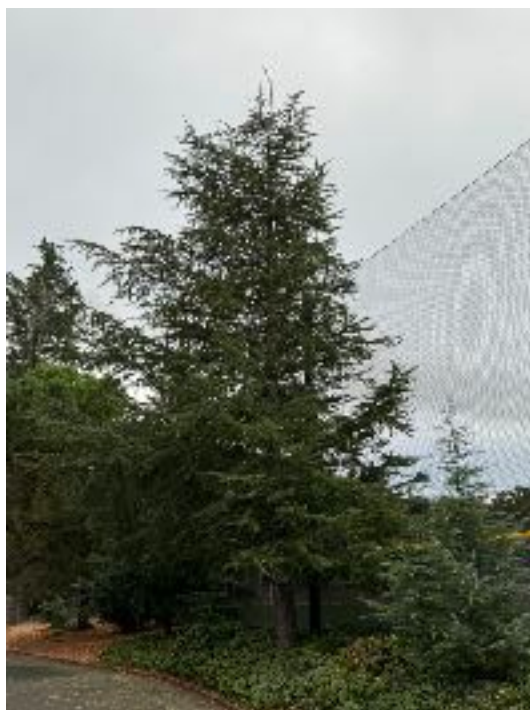
Tag 4864: Ivy growing around base of tree.

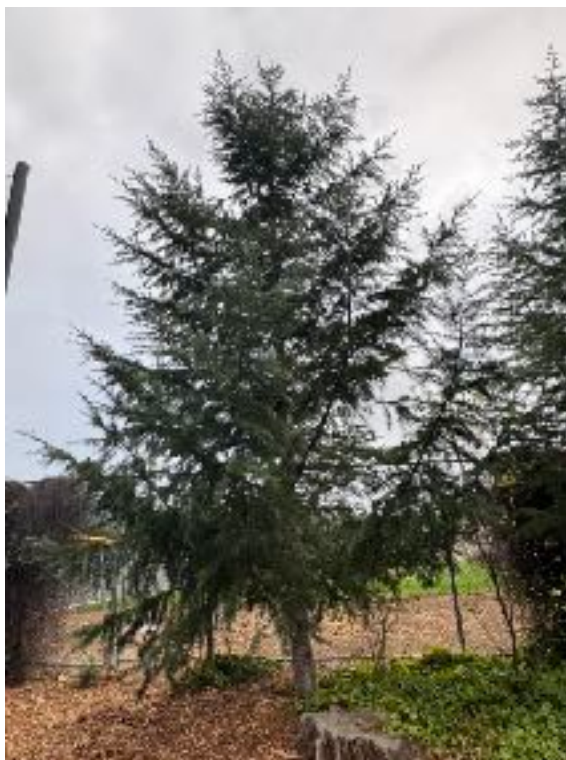
Tag 4866: Ivy growing at the base of the tree.

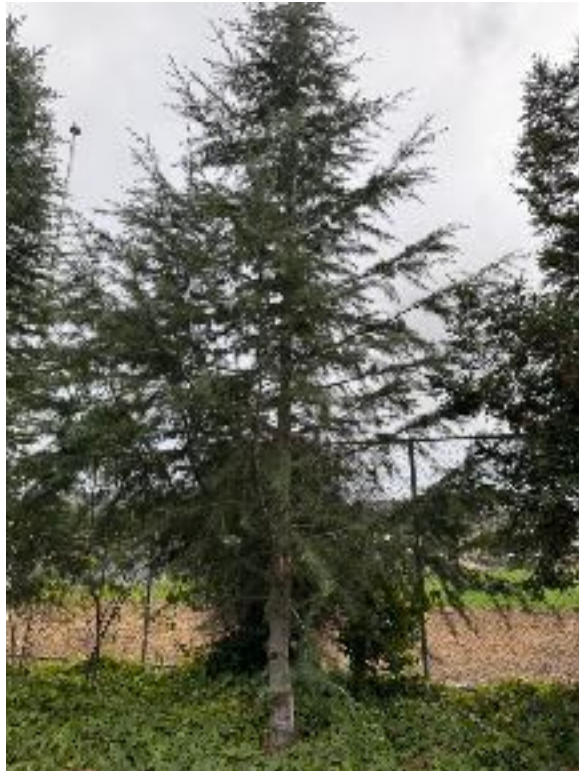
Tag 4867: Ivy growing around the base of tree

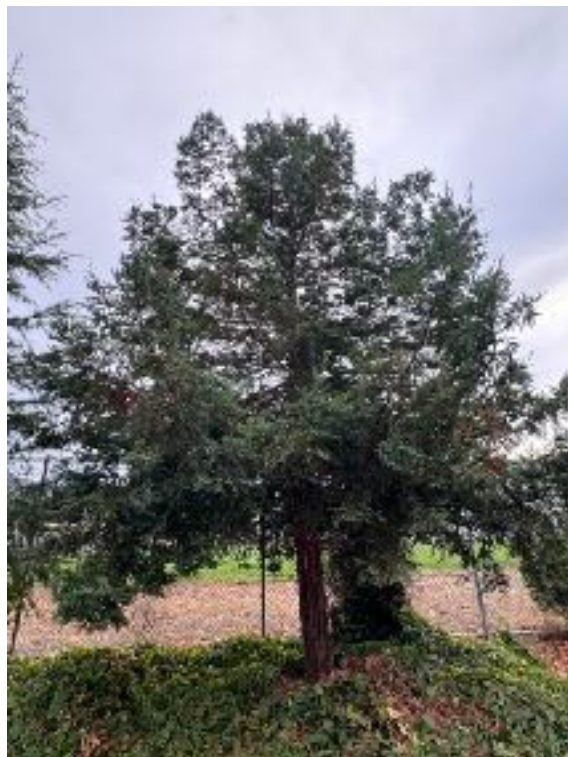
Tag 4868: Ivy growing around the base of tree.

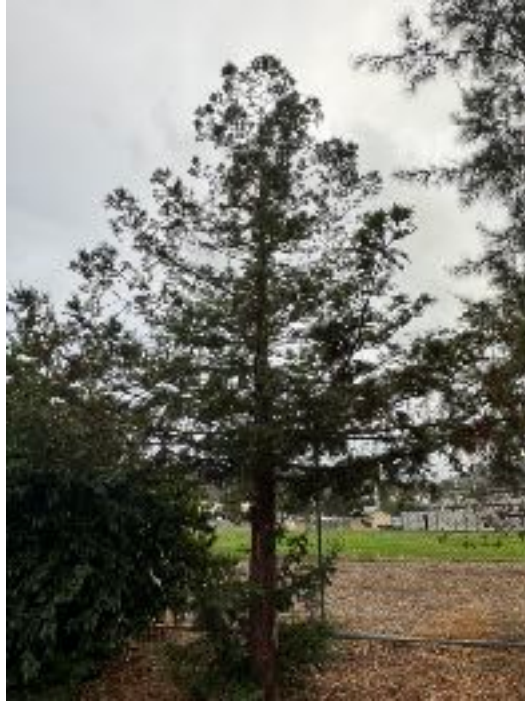
Tag 4869: Moderate secondary growth growing out of the base of the tree.
Minor stress due to drought.

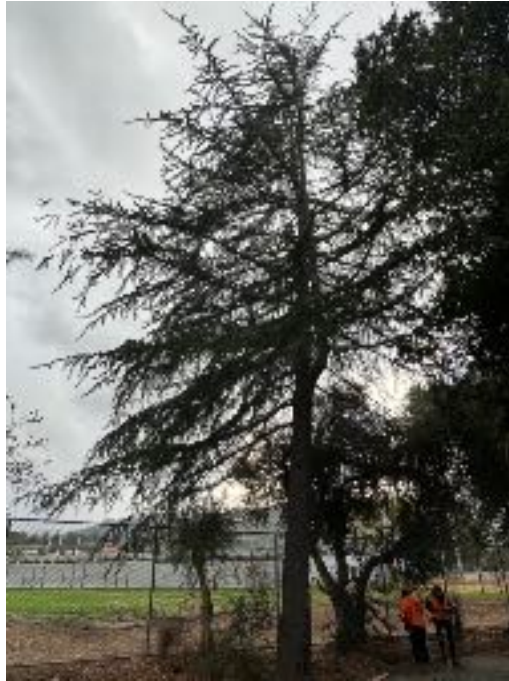
Tag 4871: Minor physical damage at base of the trunk.
Tree splits into two codominant uprights at about 18 feet above ground.

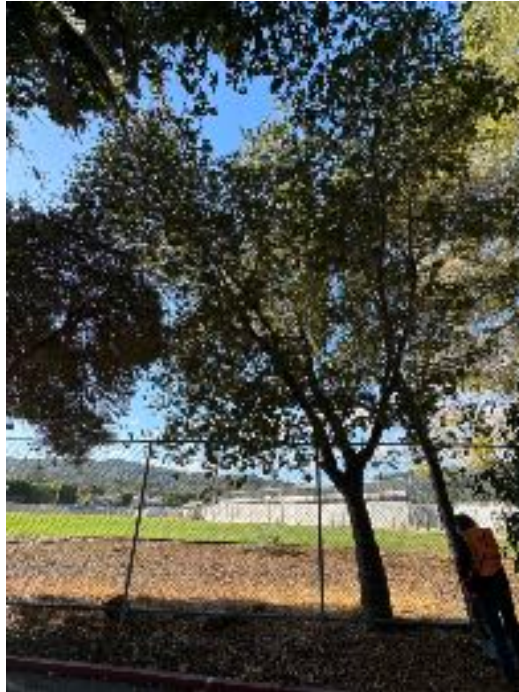
Tag 4873: Leaning against the property fence.
Located on the adjacent lot approximately 3 inches from property line.

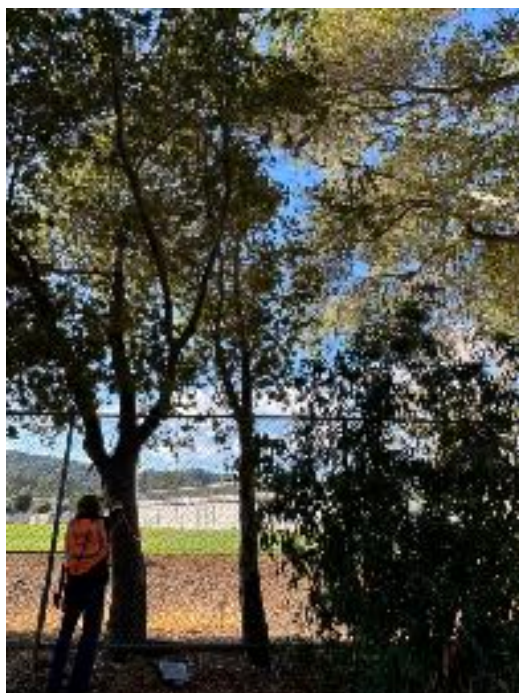
Tag 4874: Leaning against the property fence.
Located on the adjacent lot.

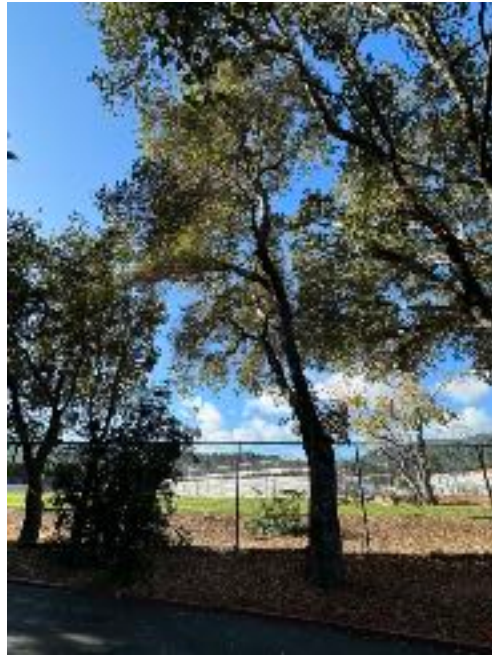
Tag 4875: Canopy is growing towards the south due to old pruning and competing for light with neighboring trees.

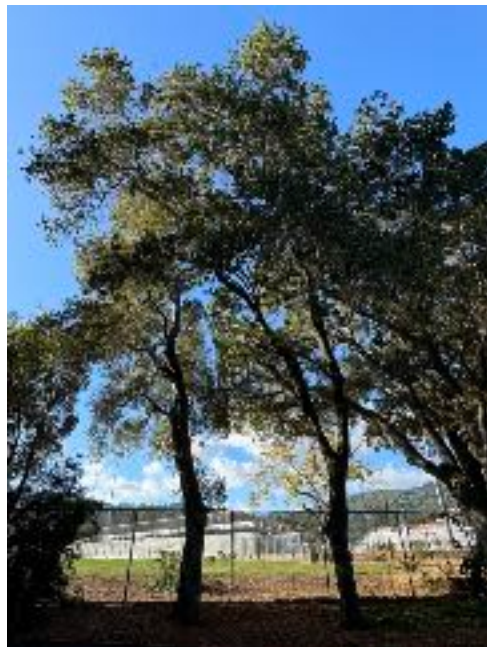
Tag 4876: Canopy is growing towards the north east due to competing for light with neighboring trees. Foliage and upper canopy is sparse.

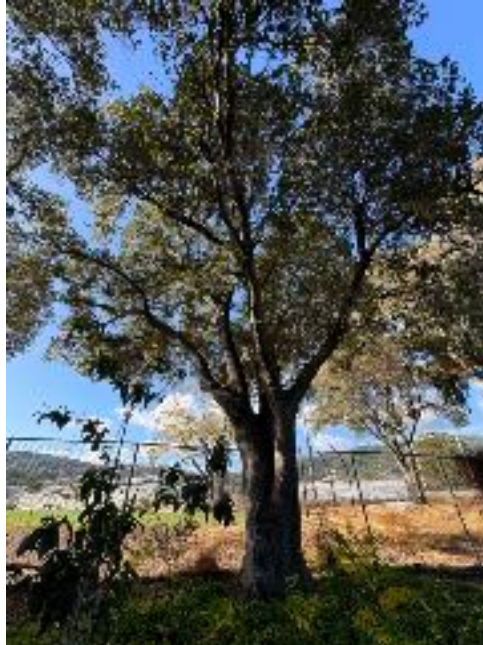
Tag 4877: Pushing up against the chain link fence.
Poor connection with the codominant main stem.

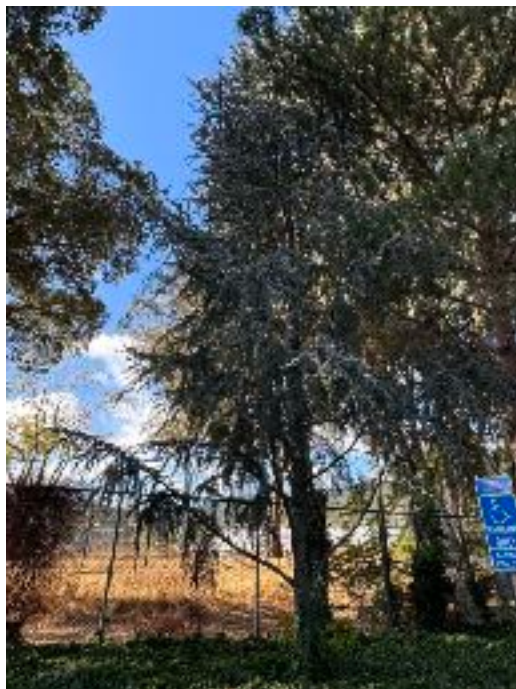
Tag 4878: Ivy growing around the base of the tree and up the trunk.

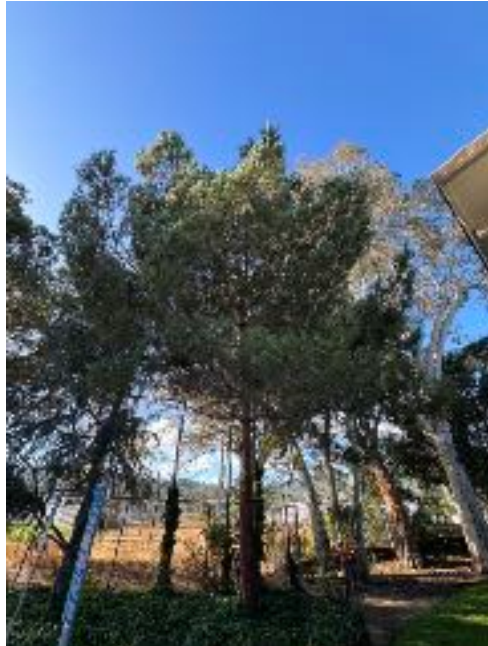
Tag 4879: Ivy growing around the base and up the main trunk of the tree. Tree has a slight lean and the canopy is growing towards the adjacent property structure.

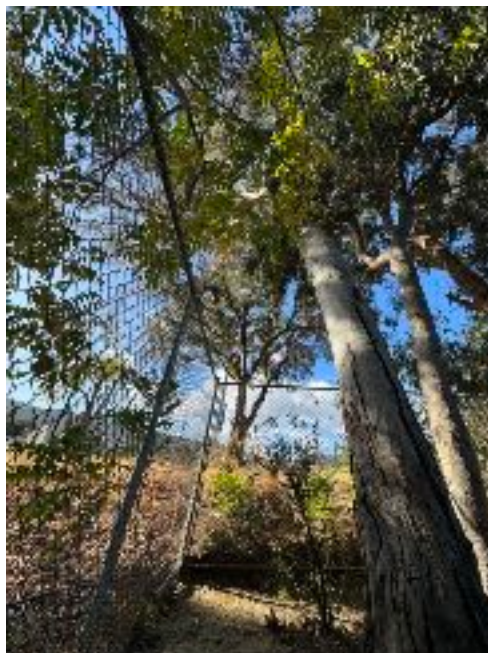
Tag 4880: Significant lean to the southeast due to competition with neighboring trees.

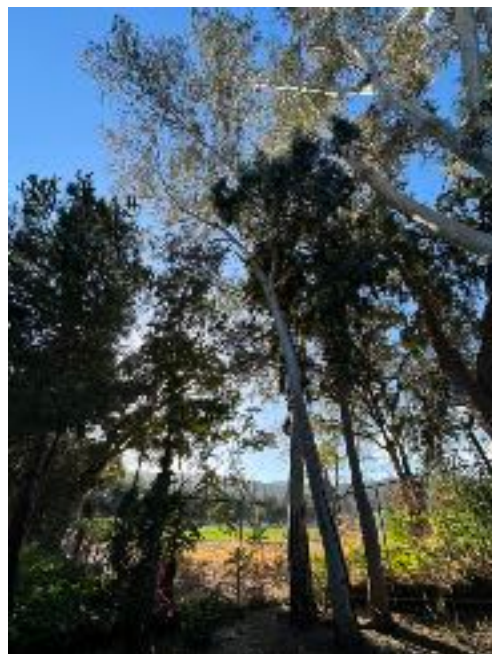
Tag 4882: Canopy is converging with neighboring trees.
Moderate dead wood noted in canopy.
Canopy is growing towards the south east due to competition for light with neighboring trees.

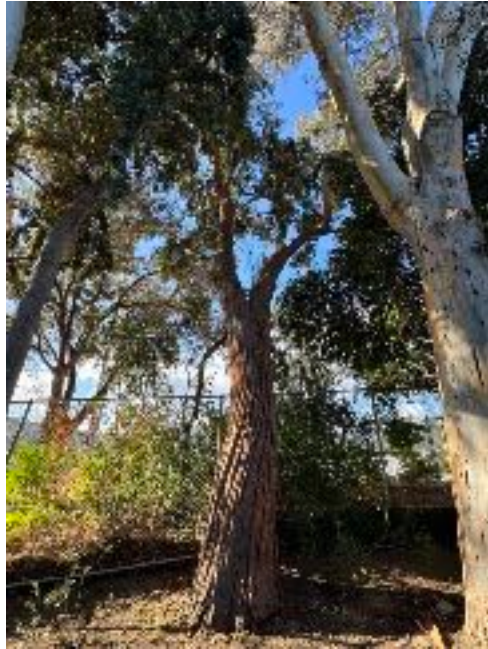
Tag 4883: Canopy is growing towards the southwest, with a significant lean due to competition with the trees for light.

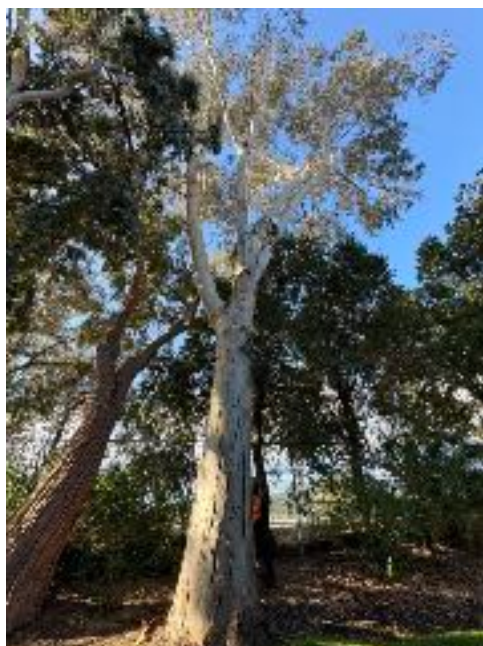
Tag 4884: Proximity to property structure and size of limbs in the upper canopy could result in major damage if a failure occurs due to wind or rain.

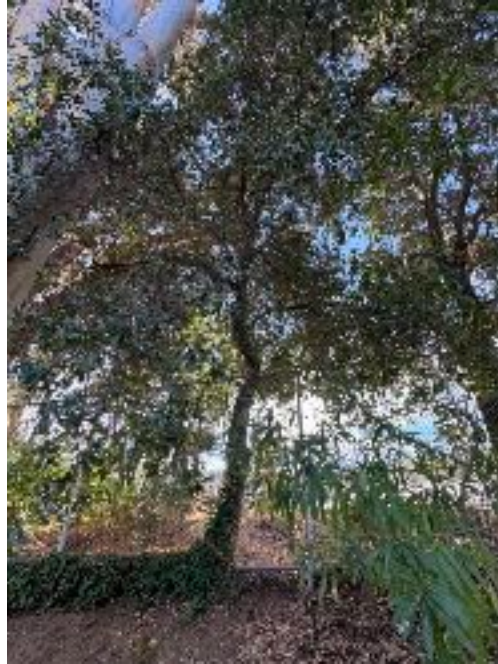
Tag 4885: Root flare is overly exposed and has poor anchorage.
Ivy is growing around the base of the tree.
Tree is pushing up against the chain link fence.

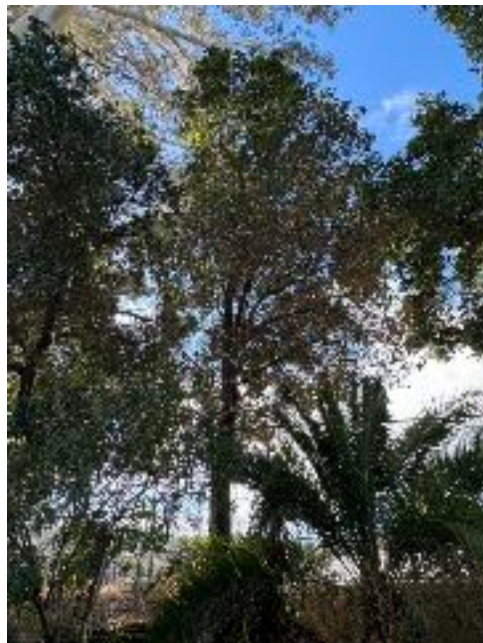
Tag 4886: Roots of the tree are partially constricted by cement and retaining wall.
Tree is pushing up against the chain link fence.

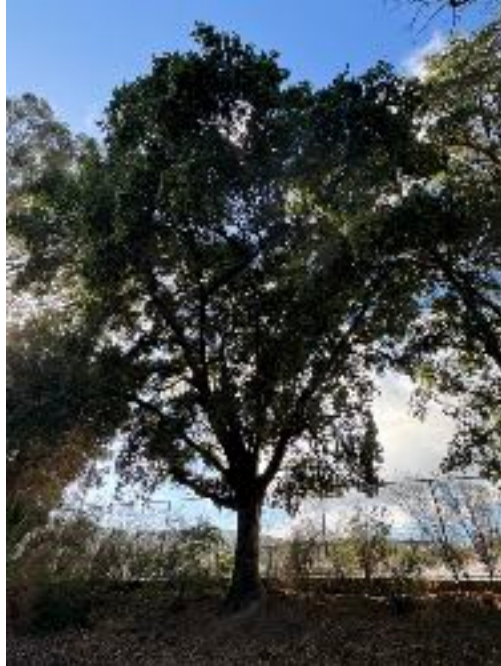
Tag 4887: Base of the trunk is pushing against the retaining wall and chain link fence.
Large limb is crushing the fence.
