03/06/2024

Arborist Report

Client: Live Oak Associates - Attention: Katrina Krakow

Site: 50 Los Gatos-Saratoga Rd, Los Gatos CA

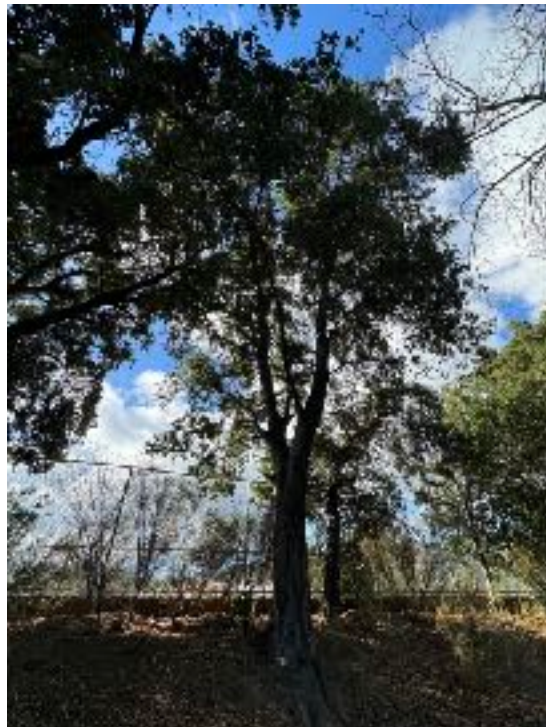
Tag 4888: Canopy is converging with neighboring oak tree.

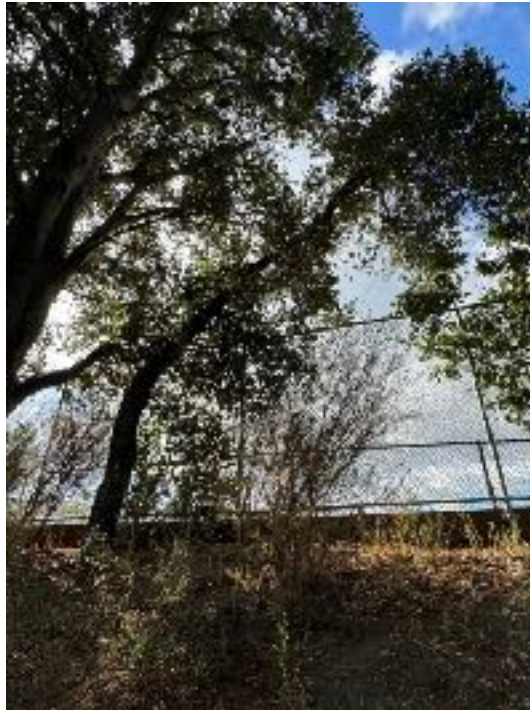
Tag 4889: Canopy has a significant lean to the southwest to due to competition for light with the neighboring oak tree.

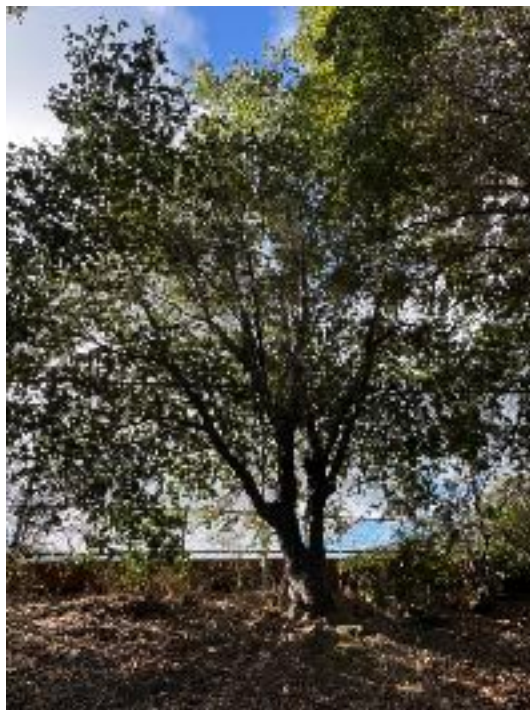
Tag 4890: Main uprights are growing into the chainlink fence.

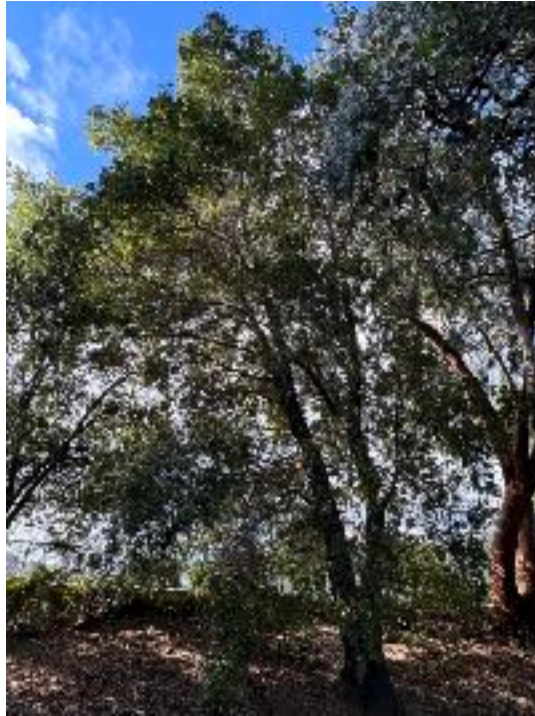
Tag 4891: Poor connection at base of first main crotch with included bark.

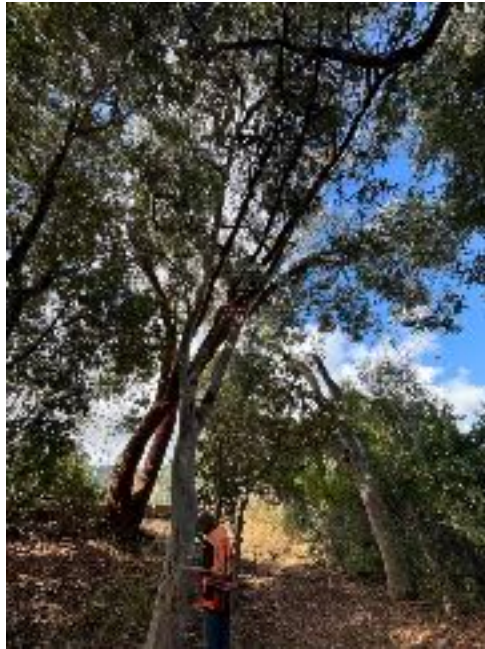
Tag 4893: Canopy is largely impeded by large neighboring eucalyptus
Decay noted in main stem.

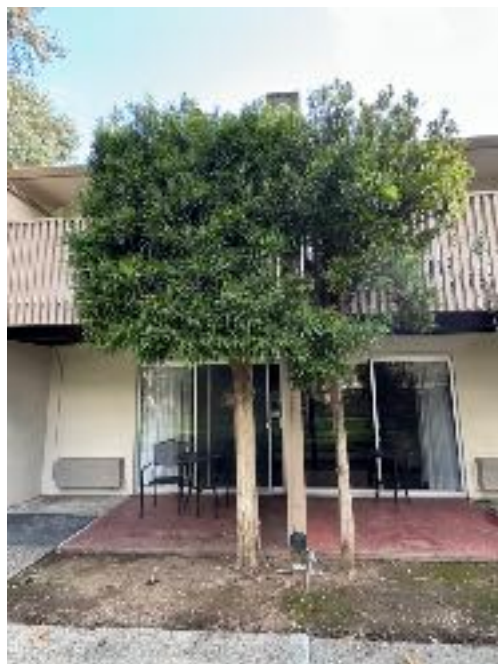
Tag 4895: Canopy is growing in contact with second floor deck railing.

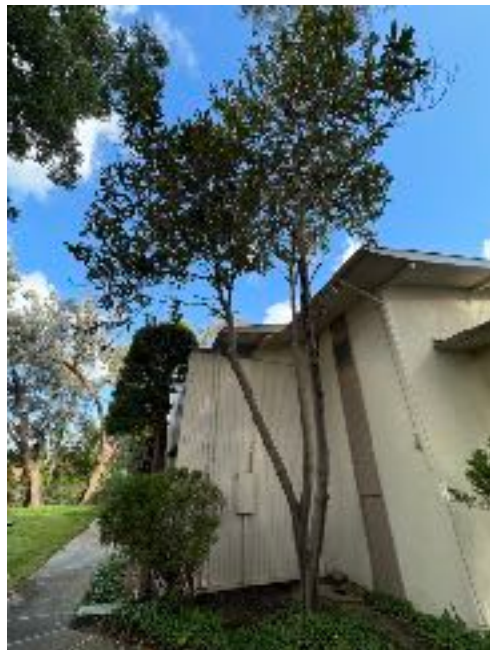
Tag 4897: Canopy is growing over the roof of property. Moderate deadwood noted in canopy.

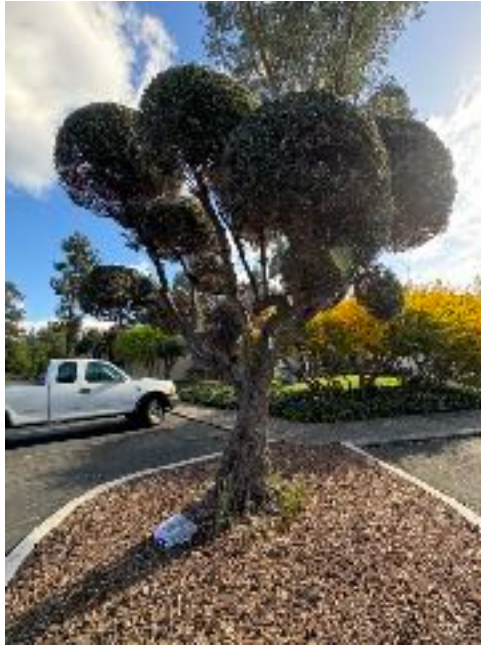
Tag 4904: Moderate decay evident in main uprights.

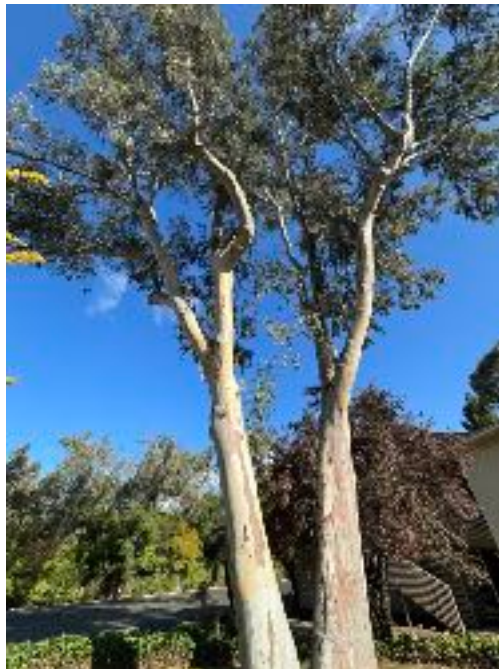
Tag 4905: Large amount of end weight in the upper canopy.

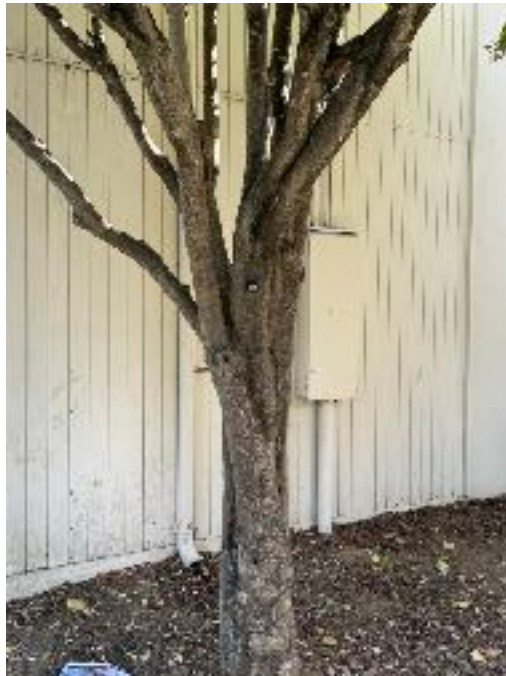
Tag 4908: Branches are growing into contact with property structure. Fused aerial crotch.

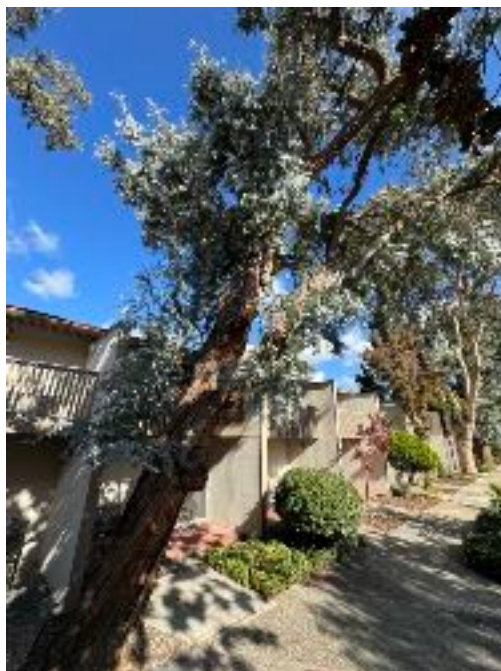
Tag 4911: Tree has a significant lean to the north east, and is growing over the property structure. This tree could pose a threat to property of persons if a failure was to occur.

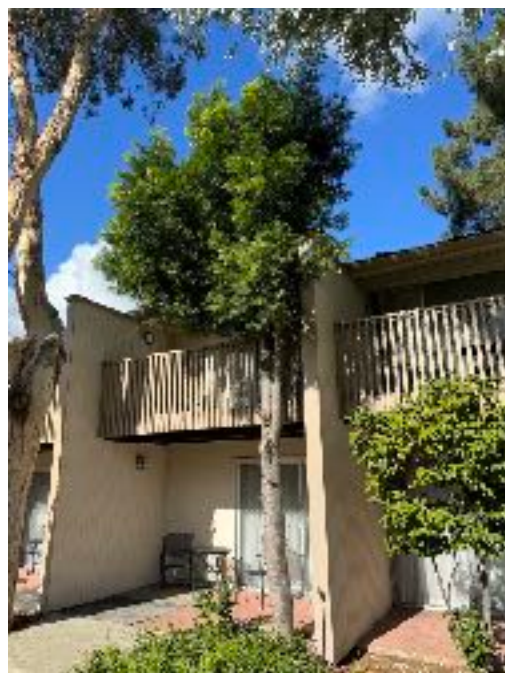
Tag 4913: Tree is growing against balcony railing of property, and over roof.

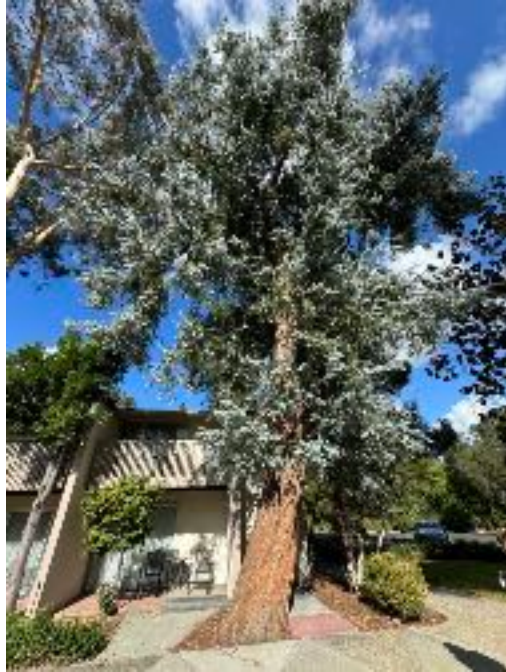
Tag 4914: Tree is leaning to the northeast.
Canopy foliage is very dense.

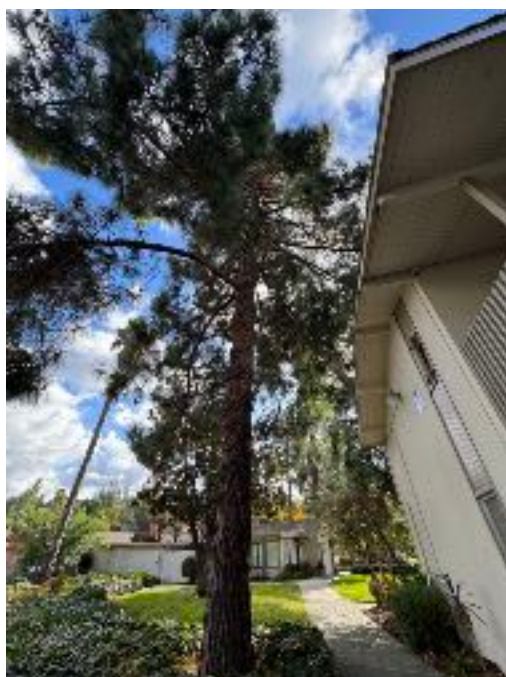
Tag 4915: Branches in the upper canopy are growing over the roof of the property structure.
Significant weight on branches in the upper canopy.

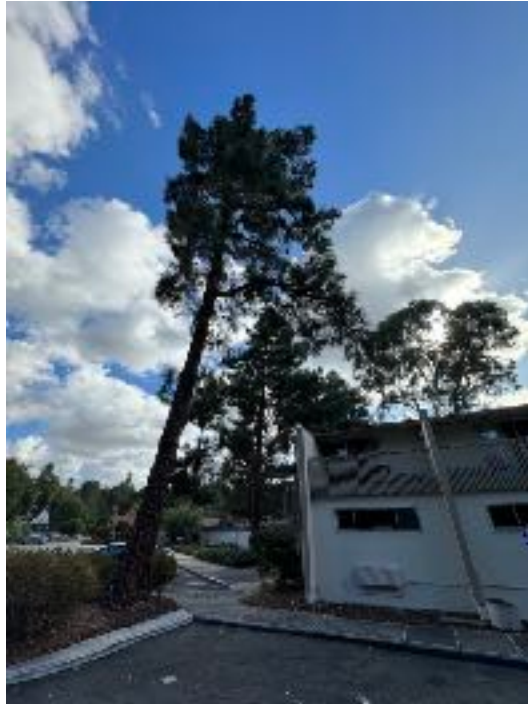
Tag 4916: Branches are extending towards the south over the property structure, and significant end weight on south west side of the tree.

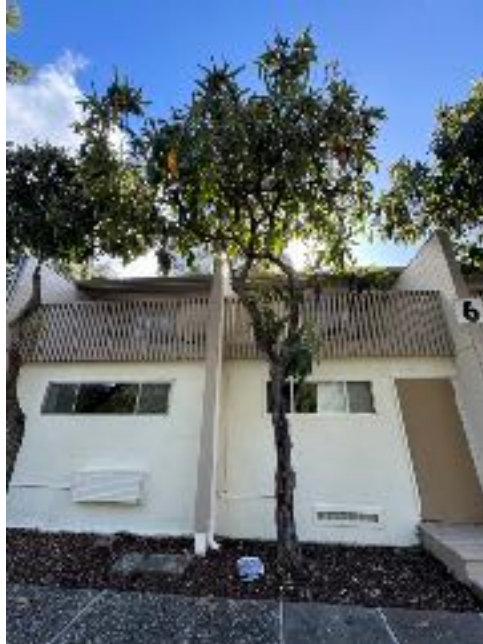
Tag 4918: Mechanical damage is noted on the bark of the main stem
Small amounts of die back noted upper canopy.

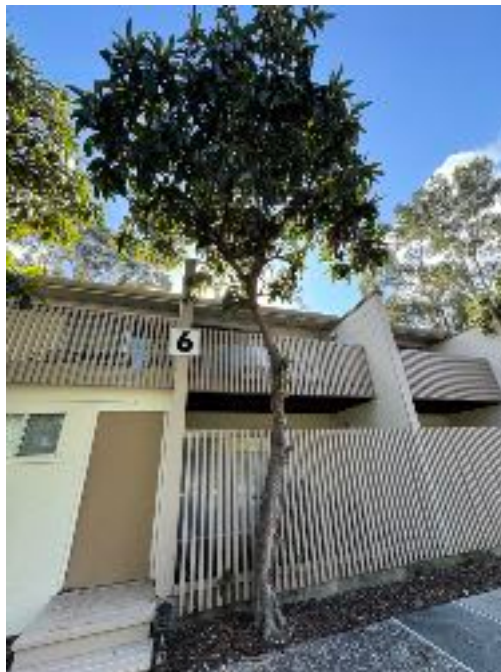
Tag 4919: Mechanical damage is noted on the bark of the main stem
Small amounts of decay noted on Main stem.

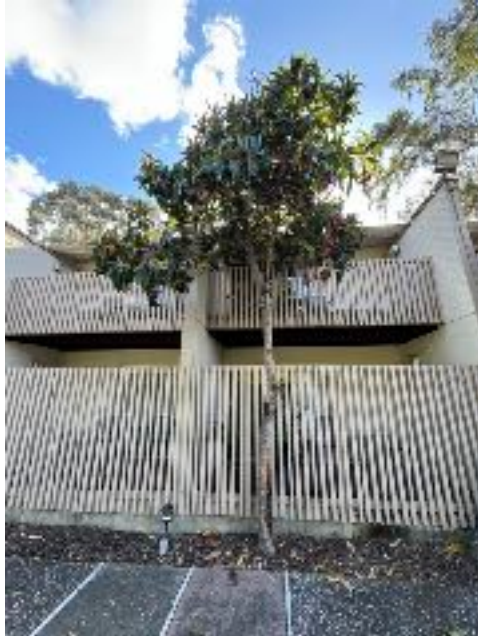
Tag 4920: Discoloring in the bark due to cankering on main stem, small fungal infection noted.

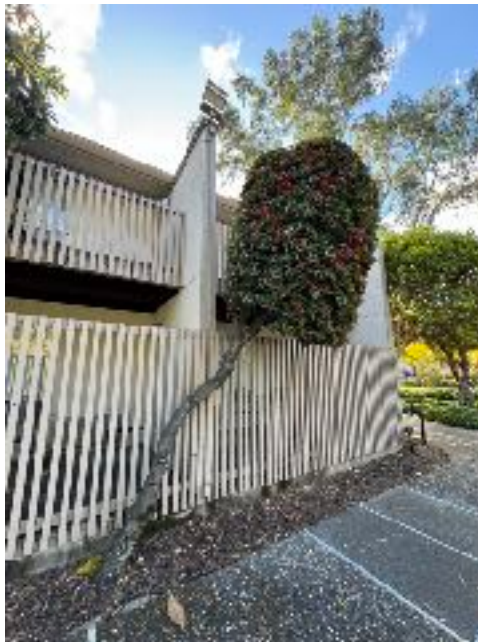
Tag 4921: Significant lean to the southwest. Main stem is pushing against the structure.

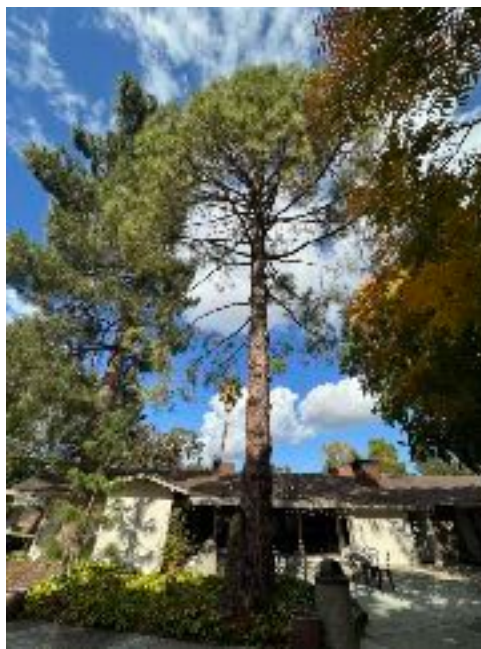
Tag 4926: Sparse foliage in upper canopy.
Evidence of moderate decay on root flare.
Ivy growing around the base.

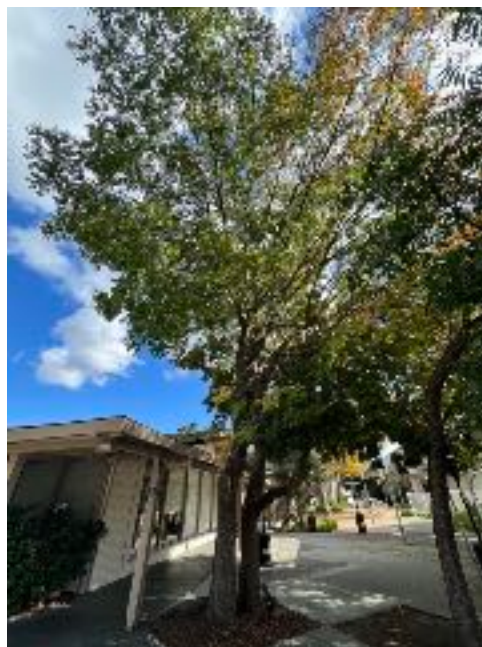
Tag 4927: Canopies among neighboring Chinese pistache trees have become uniform, minor decay noted in main stem, resulting from old wound.
Branches growing over roof of property structure.

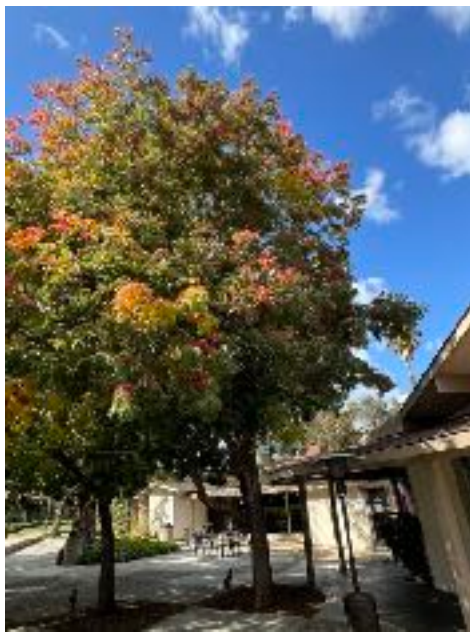
Tag 4928: Canopies among neighboring Chinese pistache trees have become uniform.
Branches growing over roof of property structure.

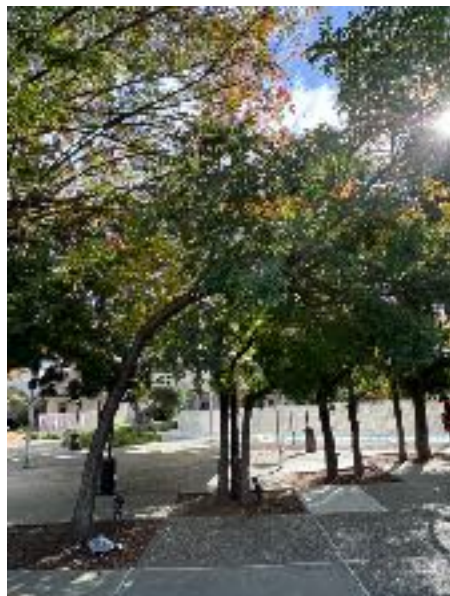
Tag 4929: Canopies among neighboring Chinese pistache trees have become uniform.
significant lean to the south due to competition for light with neighboring trees.

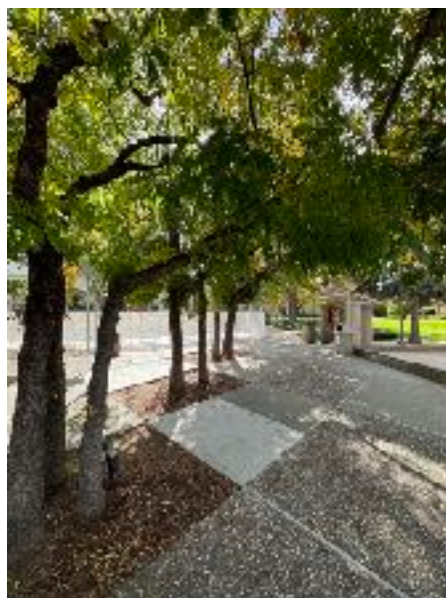
Tag 4931: Canopies among neighboring Chinese pistache trees have become uniform.
Significant lean to the southwest, due to competition with neighboring Chinese pistache trees.

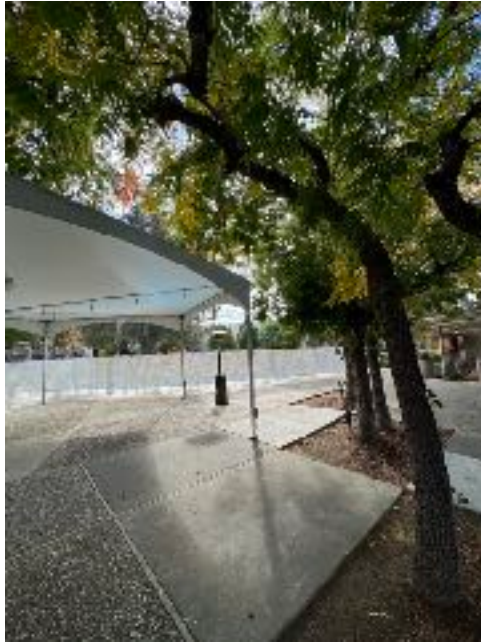
Tag 4932: Canopies among neighboring Chinese pistache trees have become uniform.

Significant lean to the southeast, due to competition with neighboring Chinese pistache trees.

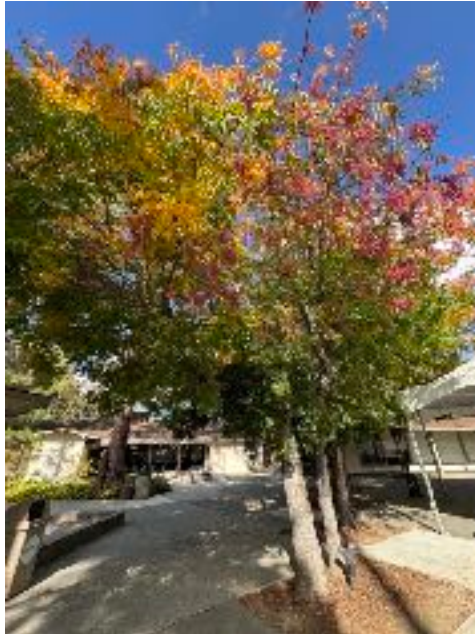
Tag 4936: Canopies among neighboring Chinese pistache trees have become uniform.
Dense secondary growth at main crotch.

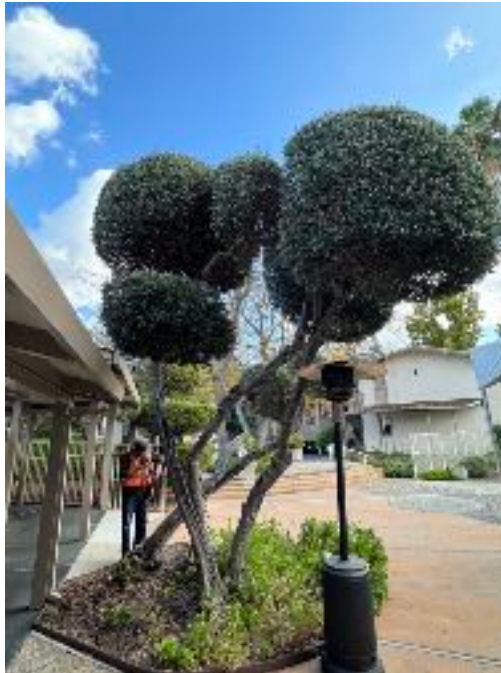
Tag 4940: Significant decay noted on main stem and main uprights.

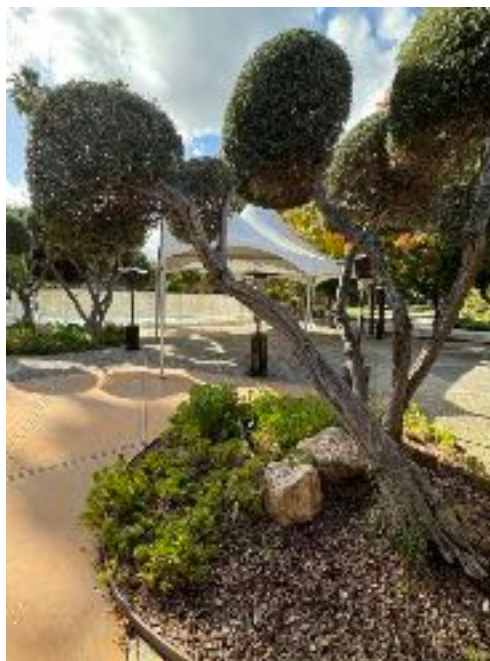
Tag 4941: Significant decay noted on main stem and main uprights.
Very poor attachment at root flare.
Significant lean to the south.
Significant potential for failure.

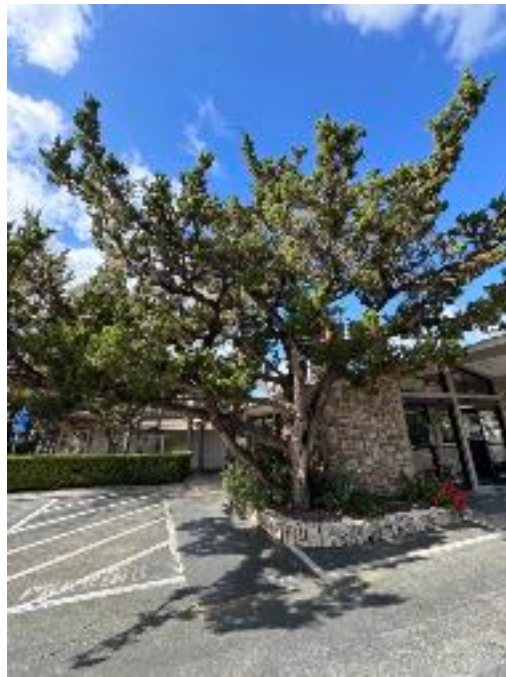
Tag 4944: Mechanical wound noted on entry to complex, multiple broken limbs visible.

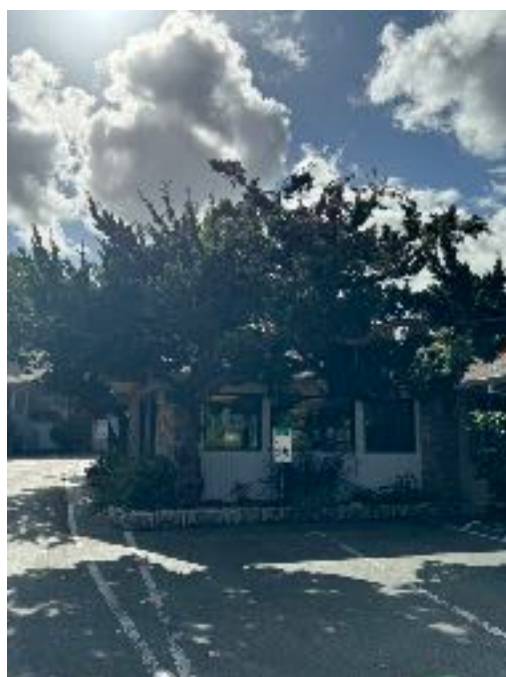
Tag 4945: Mechanical wounds from vehicle noted on limb, extending over parking area.
wound evident from major upright, splitting from main stem.

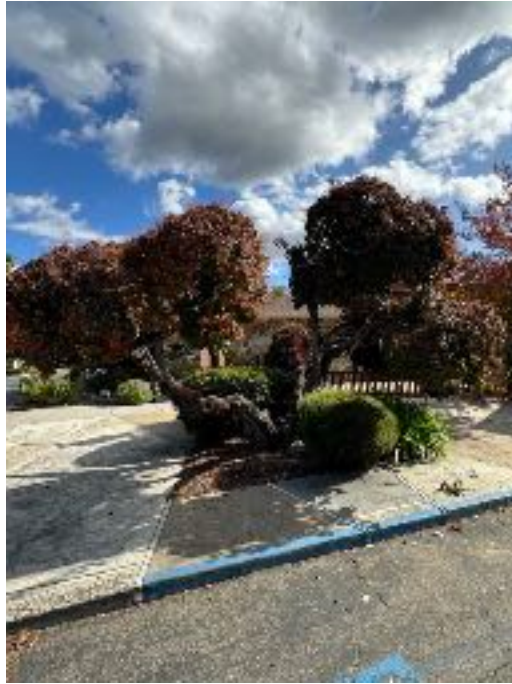
Tag 4946: Moderate decay noted on main stem and lateral branches.

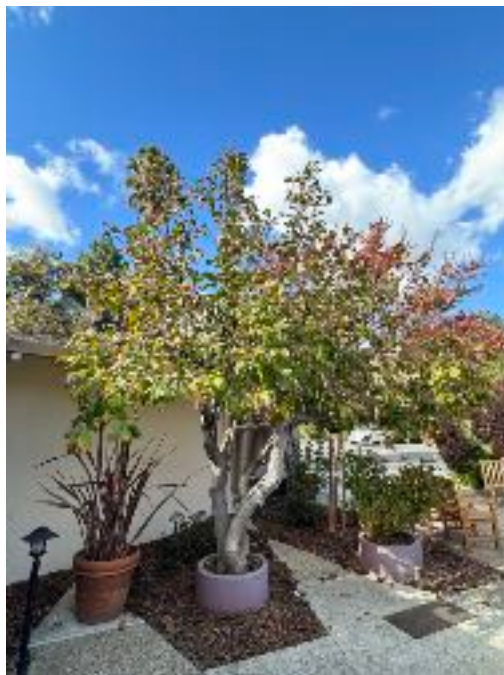
Tag 4947: Moderate decay noted on main stem and main uprights.

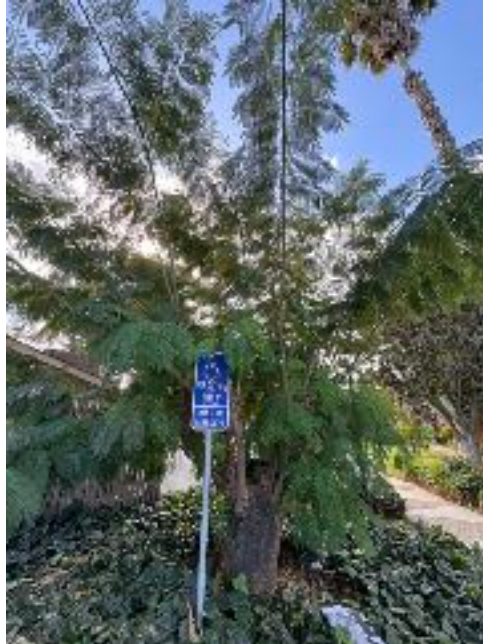
Tag 4948: Substantial amount of decay in trunk where tree was removed at 3ft
Canopy consists of secondary growth.

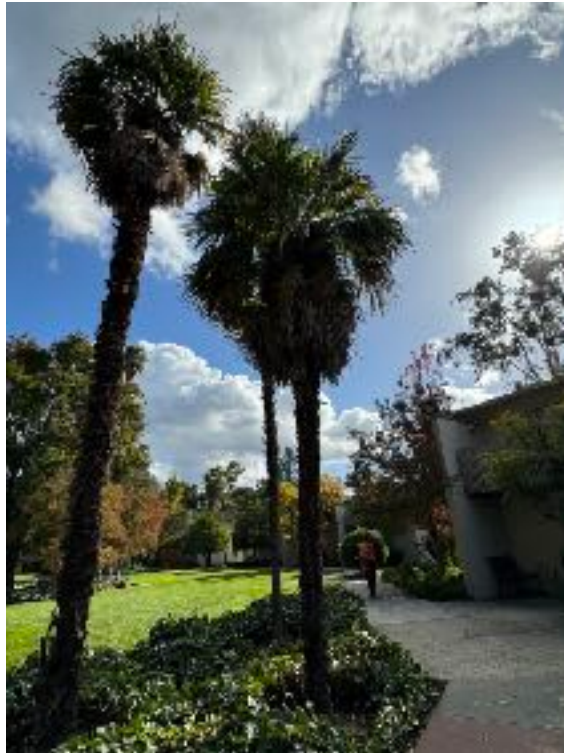
Tag 4950: No notable observations.

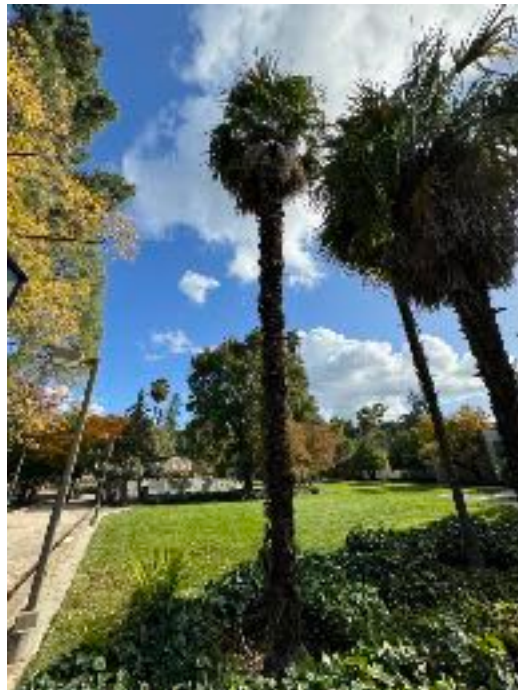
Tag 4951: No notable observations.

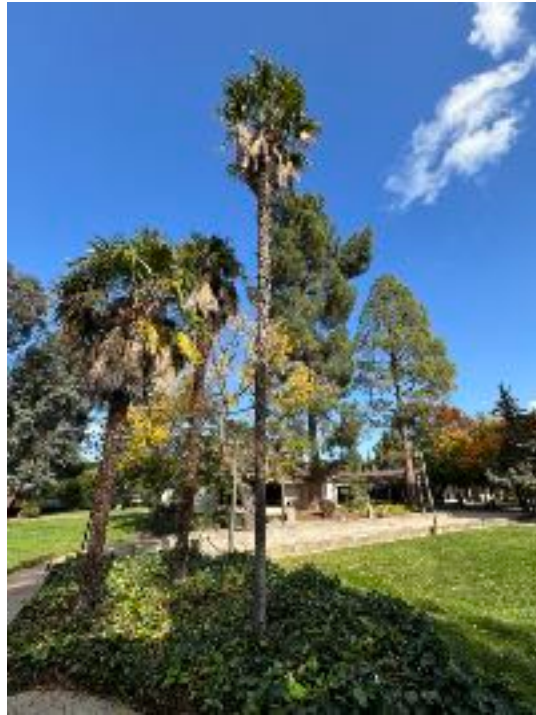
Tag 4952: No notable observations.

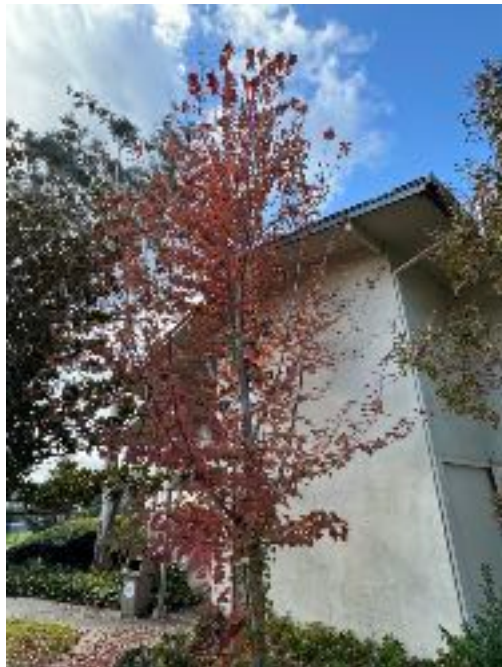
Tag 4953: Canopy branches are coming into contact with roof of adjacent property structure.

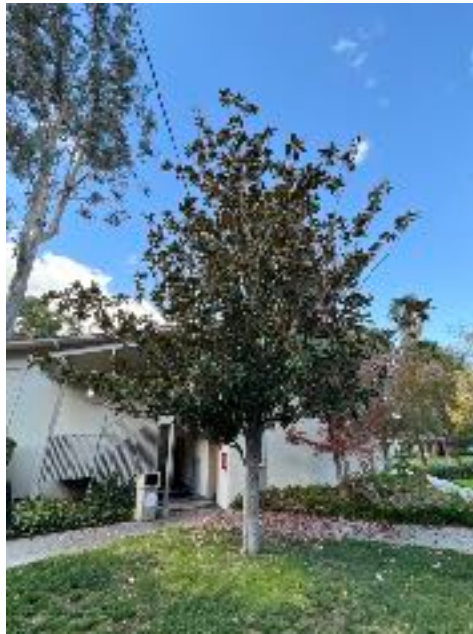
Tag 4954: Canopy branches are coming into contact with telephone wire, extending between two property structures.

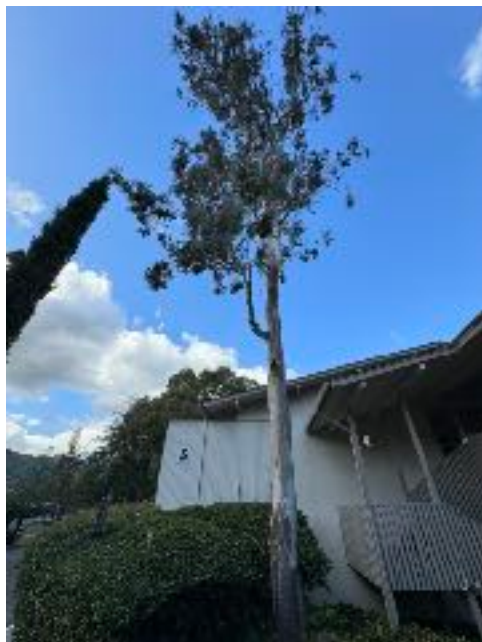
Tag 4955: Heavy end weight noted an upper canopy failure of a major upright can result in property damage due to proximity to structure.

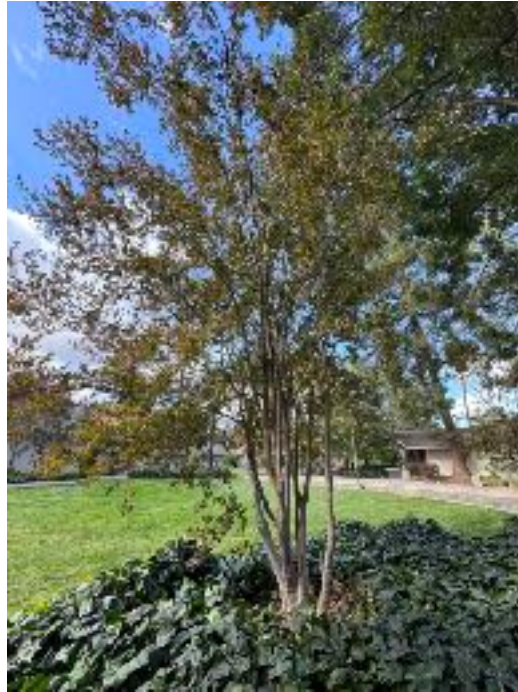
Tag 4958: No notable observations.

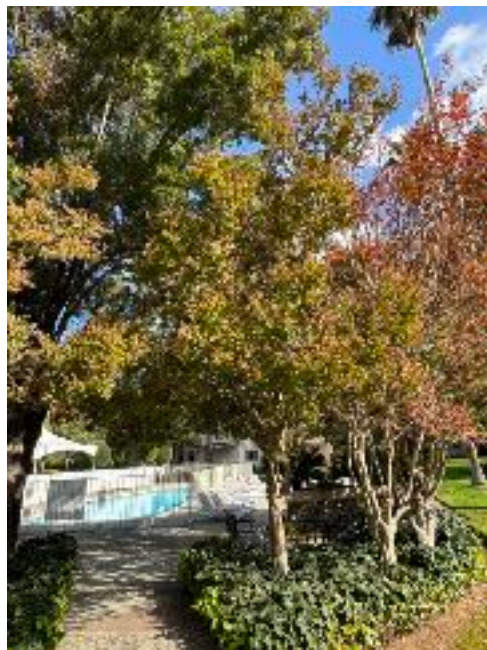
Tag 4959: Canopy has merged with neighboring crape myrtle trees.

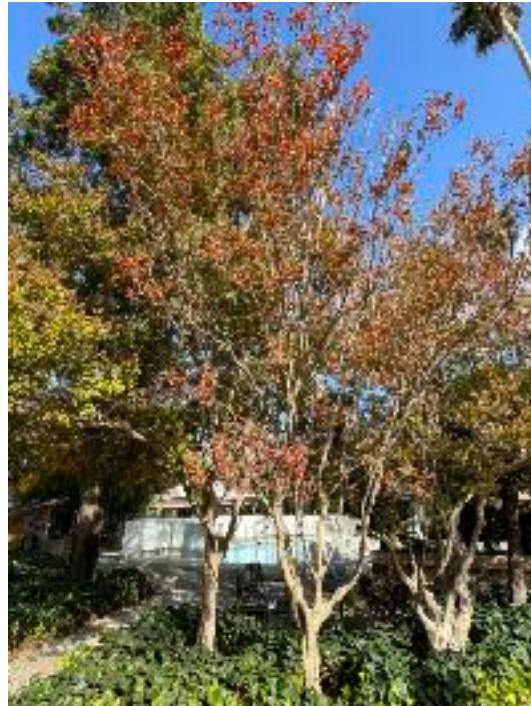
Tag 4960: Canopy has merged with neighboring crape myrtle trees.

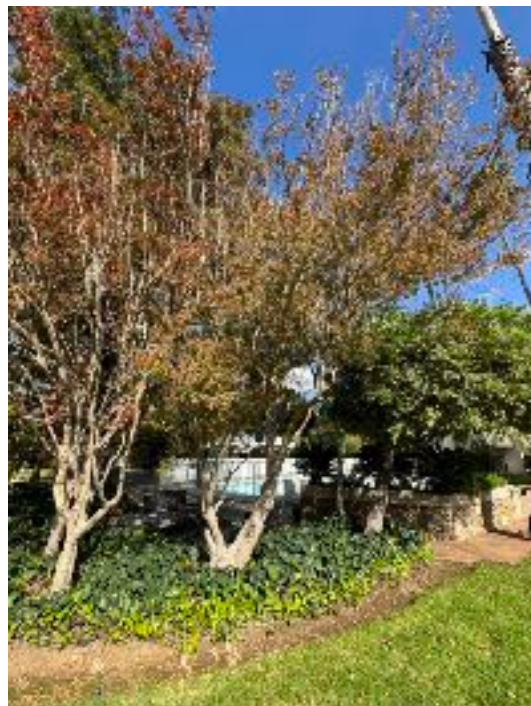
Tag 4961: Canopy has merged with neighboring crape myrtle trees.

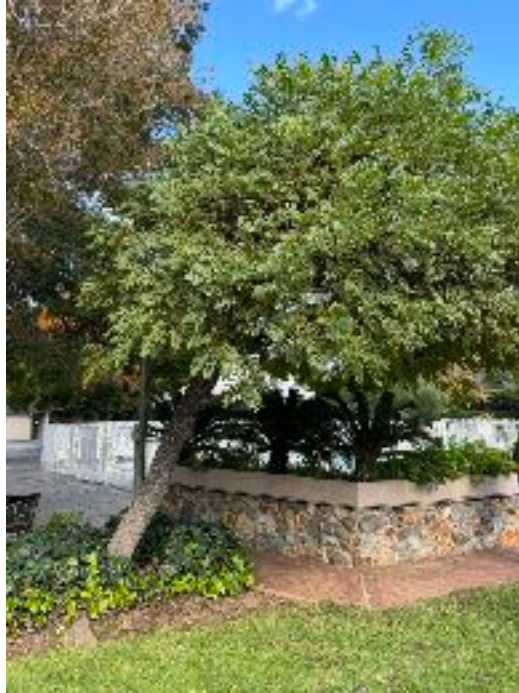
Tag 4962: Canopy of the tree has a significant lean to the east due to competition with neighboring trees.

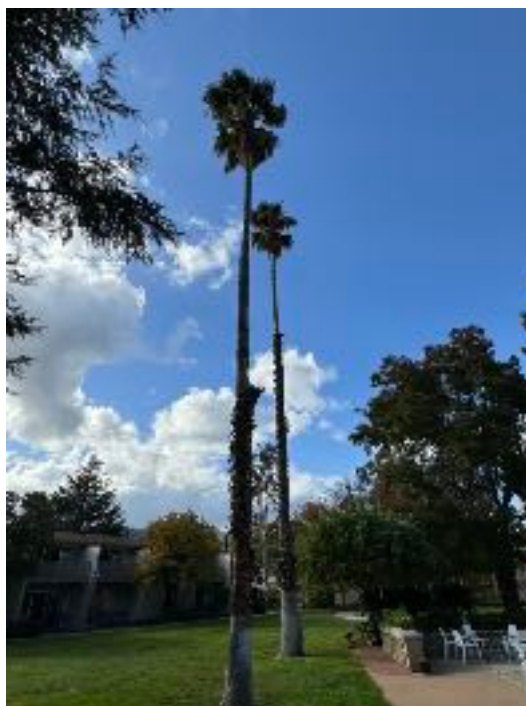
Tag 4963: No notable observations.

Tag 4964: No notable observations.

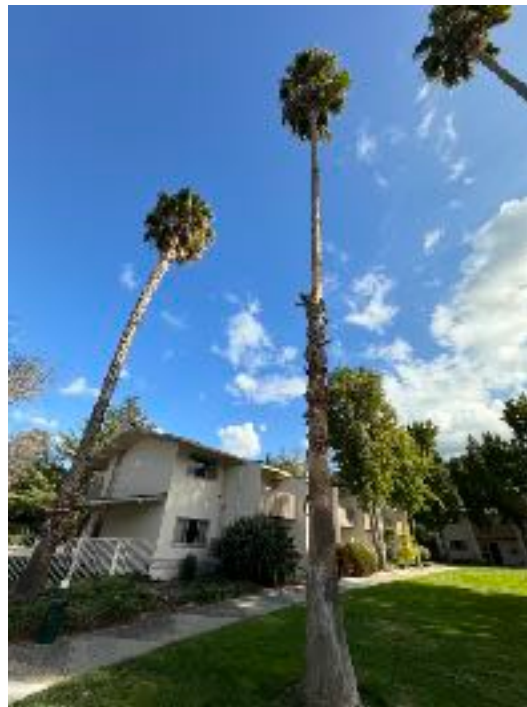
Tag 4965: No notable observations.

Tag 4966: No notable observations.

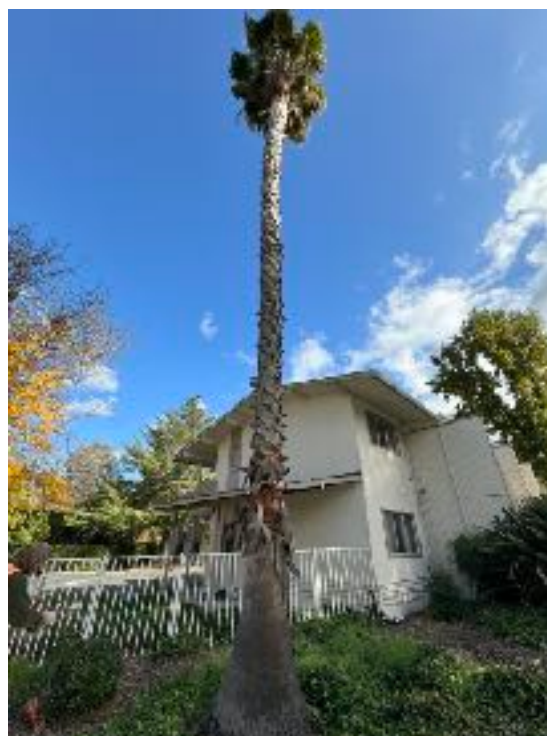
Tag 4967: No notable observations.

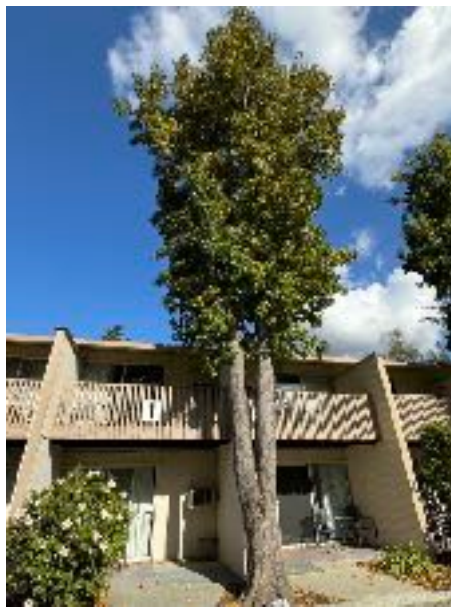
Tag 4968: Included bark noted between the two main uprights at first main crotch.

Branches of the canopy growing over the roof, significant and weight noted in upper canopy.

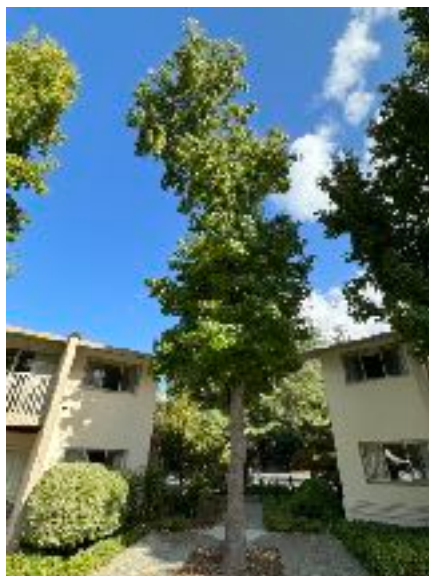
Tag 4969: Moderate end weight in upper canopy.

Tag 4970: Significant and weight noted and upper canopy on main upright, leaning towards property structure.

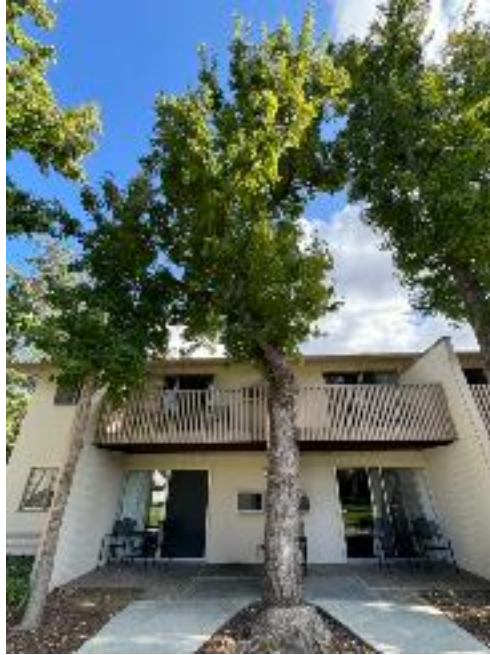
Tag 4971: Upper canopy is colliding with canopy of neighboring liquidambar tree.

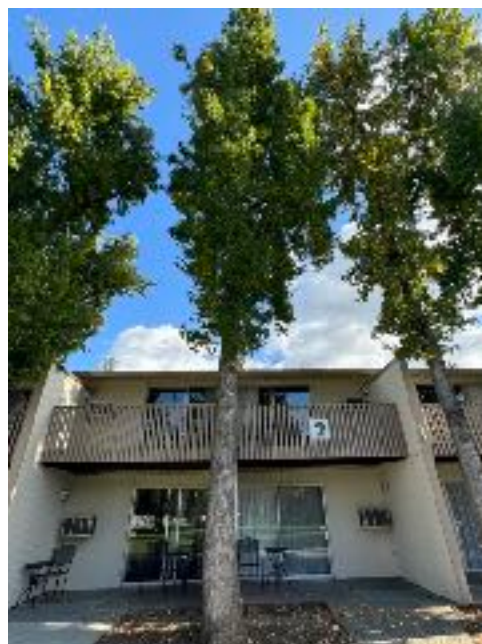
Tag 4972: Branches in the upper canopy are extending over roof of property structure, and the canopy is colliding with canopy of neighboring liquidambar tree.

Tag 4973: Upper canopy is colliding with canopy of neighboring liquidambar tree.

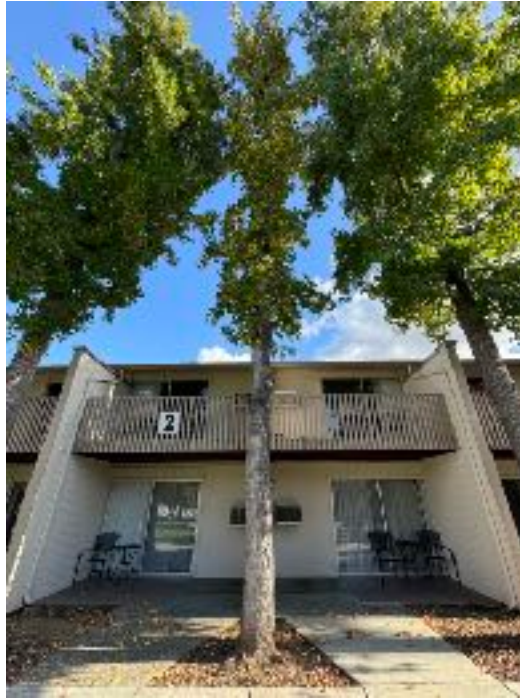
Tag 4974: Canopy has very few significant lateral branches, canopy is consisting of primarily small, secondary growth.

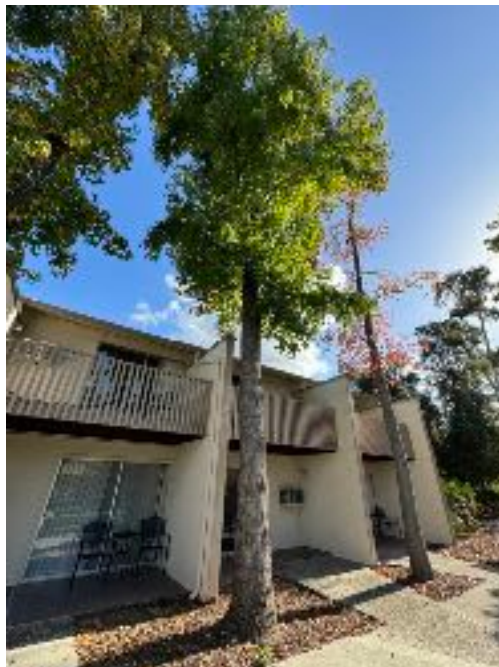
Tag 4975: Upper canopy has moderate to significant end weight.

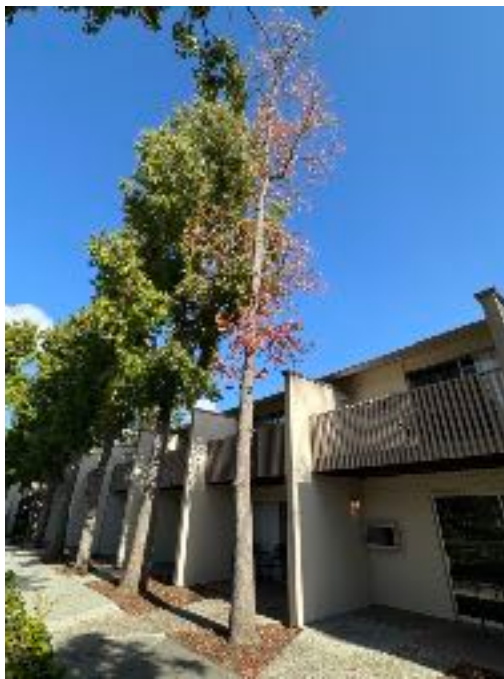
Tag 4976: Canopy is extremely stressed, defoliation of canopy is occurring significantly more rapidly than neighboring liquid ambar trees.

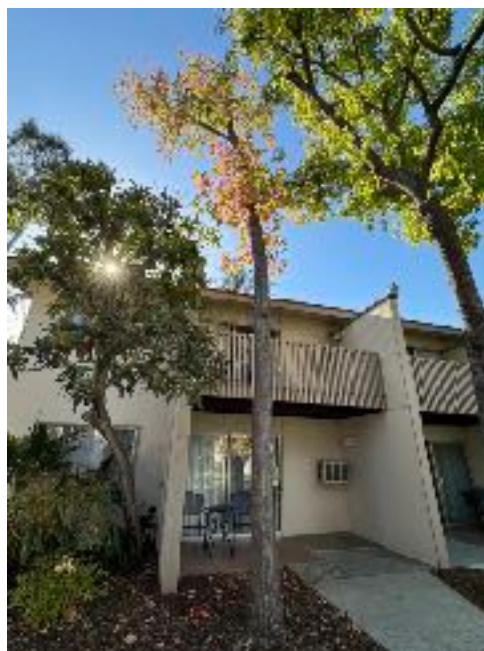
Tag 4977: Upper canopy is colliding with canopy of neighboring Sweetgum. Tree is very stressed and is defoliating at a faster rate than neighboring Sweetgum trees.

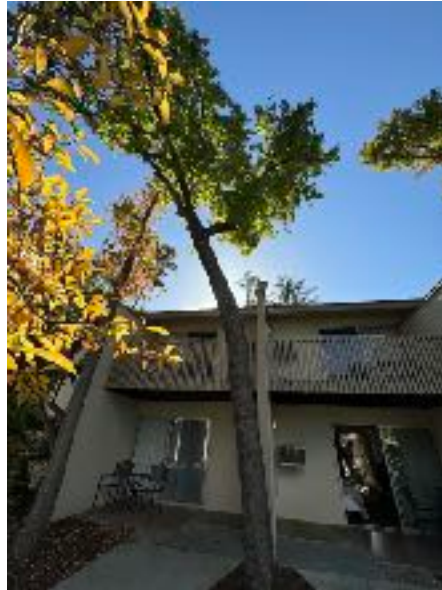
Tag 4978: Trunk has an eastern lean, upper canopy has partially corrected to the southwest.

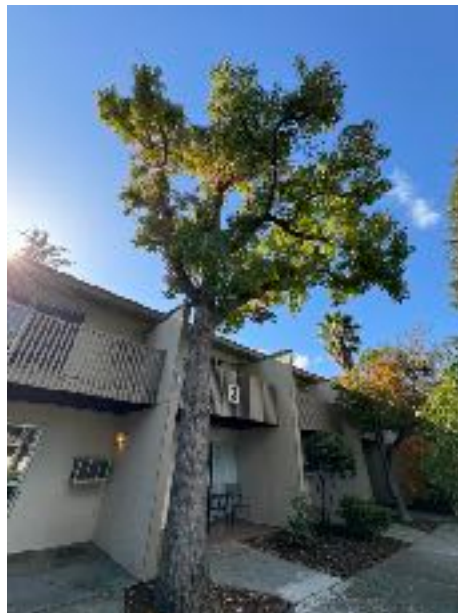
Tag 4979: Upper canopy has branches extending over the roof of the property structure.
Beehive is a apparent in property structure directly adjacent to tree.

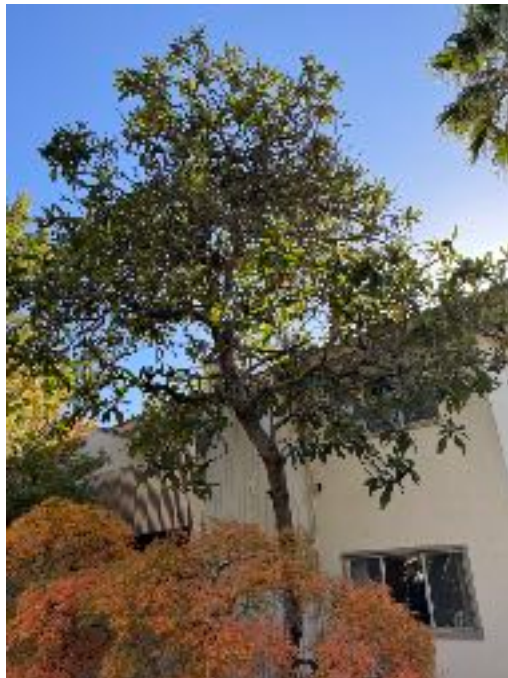
Tag 4981: Moderate die back in upper canopy. Significant deadwood is apparent.

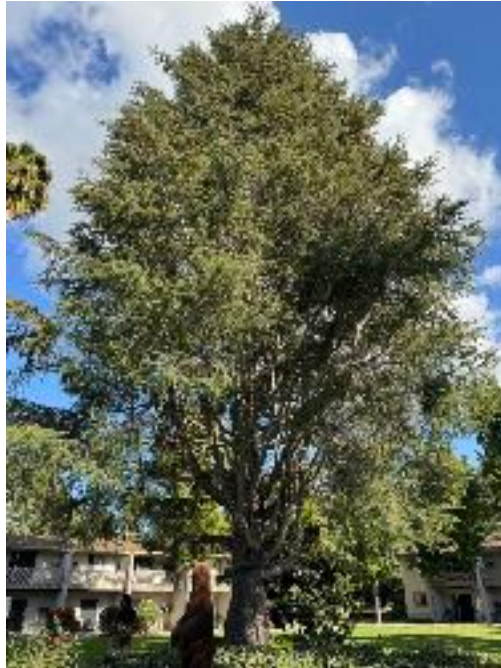
Tag 4982: No notable observations.

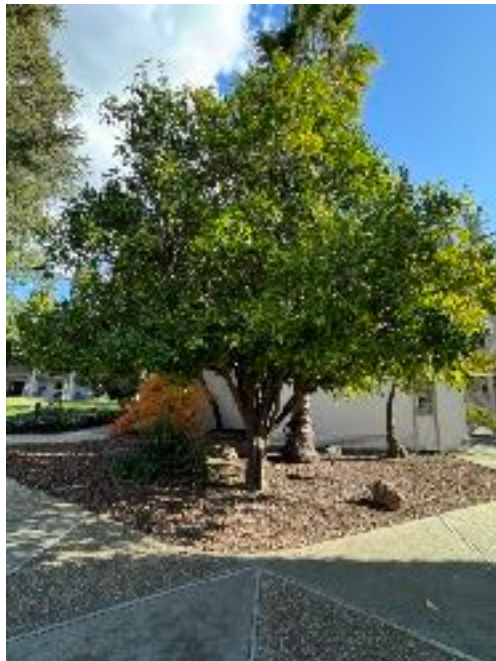
Tag 4983: Fusing is major uprights at approximately 3.5-4ft above grade.

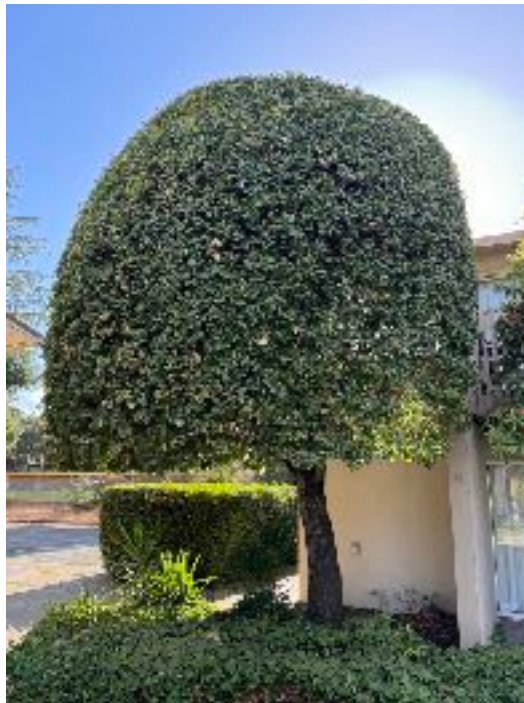
Tag 4984: Hole has been cut out in center of upper canopy, two 2x4 boards were placed in upper canopy.
Due to style of pruning, significant deadwood in the center of the canopy.

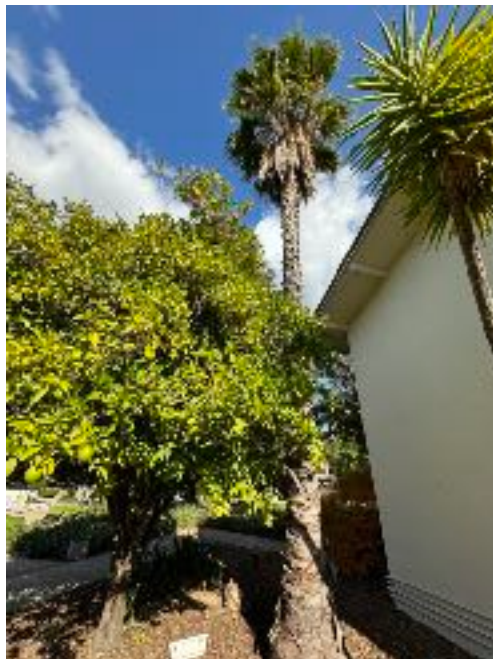
Tag 4985: Canopy of the neighboring lemon tree is in contact with trunk.

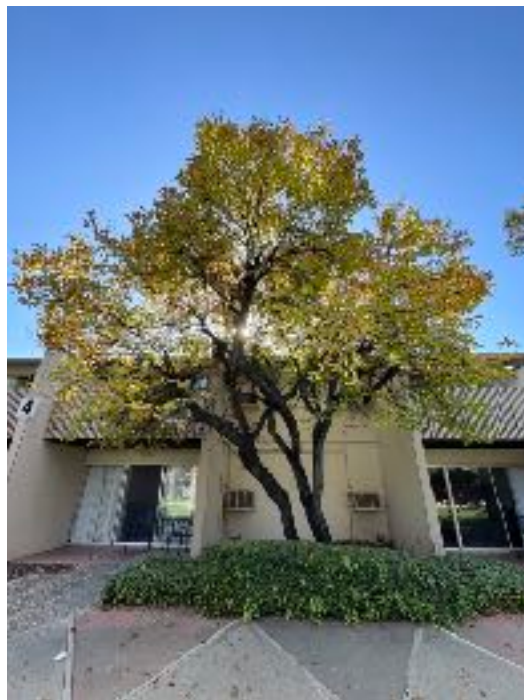
Tag 4987: Significant die back in the canopy, fused limbs in canopy, dead moss evident on trunk and main uprights.

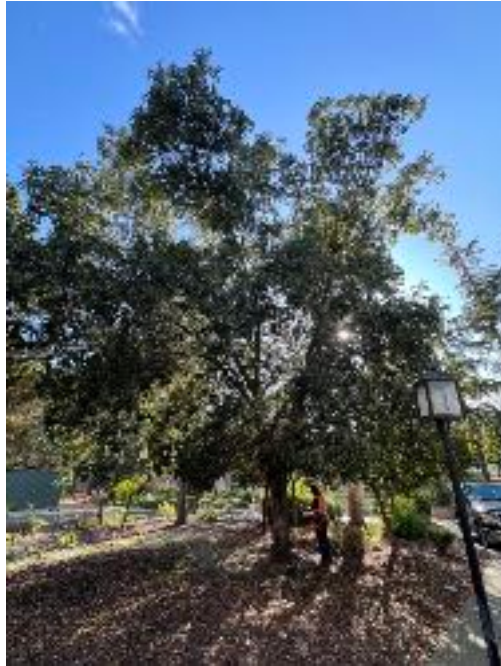
Tag 4988: Canopy contains birds nest, canopy is very dense with slight die back.
